BusConnects Core Bus Corridors  
Ballymun/Finglas to City Centre  
Scheme

Stage 1 Road Safety Audit

**Document Ref:** P21-026-PSW1-RP-001

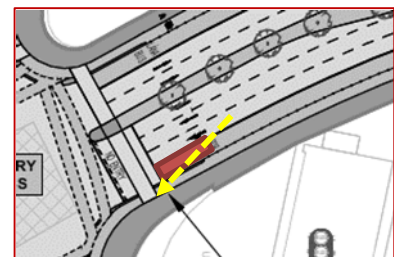
The proposed number of lanes and the provision of a nearside bus lane along the CBC routes is such that drivers approaching signalised junctions/crossings may fail to have adequate visibility to the primary signal heads due to the lateral distance to the footpath, where the signal heads are most likely to be located, and the possibility that their view of the signals may be obscured by a high-sided vehicle or bus in the adjacent lane.

This could result in a driver being insufficiently aware of the signal status and a failure to stop, leading to overshoot into the pedestrian crossings or junctions, resulting in vehicular/pedestrian collisions or side-on collisions.

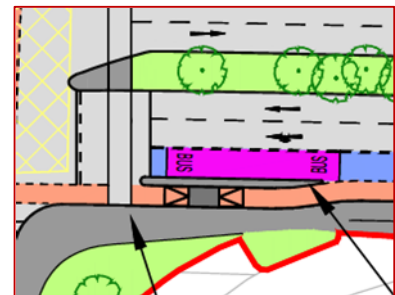
In addition, it is unclear if the width of the proposed islands is sufficient to allow a wheelchair user to access public transport safely, in particular, where there are other passengers embarking/disembarking at the same time.

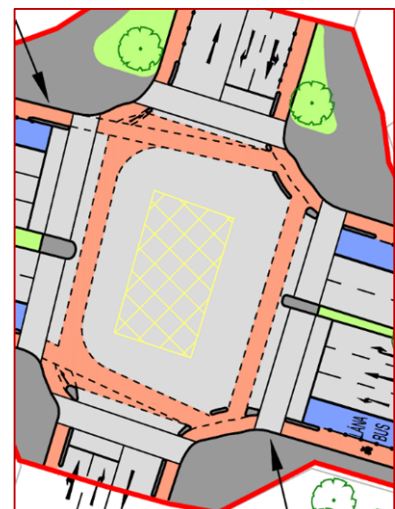
The relatively small size of the islands, and their number within a junction, may be impractical to sign, and lead to these signs being struck by vehicles and cyclists, leading to material damage and loss of control collisions.

Ensure physical islands can accommodate traffic signs and provide at least 450mm between the kerb and sign edge.

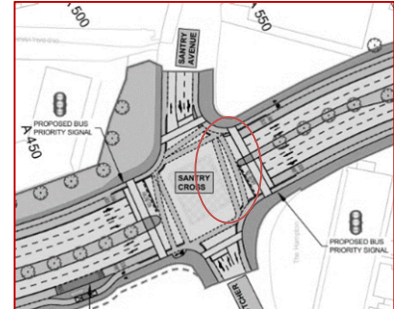
The proposed layouts could result in confusion for cyclists, who may misinterpret the layout as consisting of bi-directional cycle lanes, leading to erratic or inappropriate/unsafe manoeuvres resulting in collisions with other cyclists using the junction.

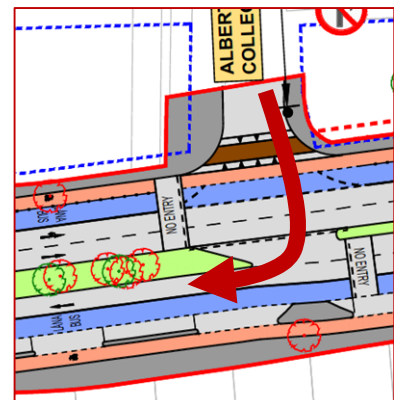
*Summary: Central median layout at a number of side roads is wide and may allow for unsafe manoeuvres to be undertaken.*

The road layout at these locations includes a relatively wide break in the median such that vehicles can and, as observed during the Site Visit, do turn right from these side roads onto the Ballymun Road.

Vehicles turning right from the side roads at these locations are at greater risk of collisions with through-traffic on the multi-lane carriageway and also present a risk to right-turning drivers wishing to turn into the side road who may not anticipate a vehicle turning right from the side road.

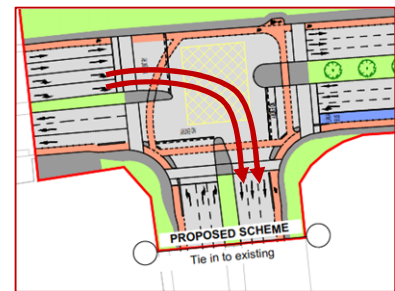
There is a risk of poor lane discipline resulting in possible side-swipe collisions where one vehicle strays into the adjacent turning lane.

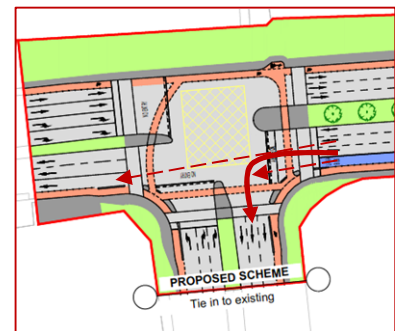
In addition, it is proposed to allow left turns into St Margaret’s Road from the northbound bus lane and the adjacent general left-turning traffic lane at the same time.

However, not all traffic in the bus lane will wish to turn left. Vehicles, other than buses, are permitted to use bus lanes (e.g. taxis) and some of these may wish to proceed straight-ahead leading to possible conflicts with left turning traffic in the adjacent general traffic lane.

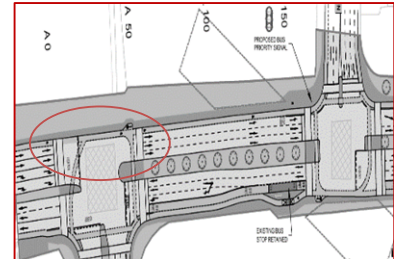
The nearside straight-ahead lane on the southbound carriageway on the approach to the St Margaret's Road junction becomes a left-turn only lane at the downstream junction with Northwood.

There is a concern that drivers unfamiliar with the road layout who wish to proceed south may find themselves inadvertently in the left-turn only lane, leading to late lane-change manoeuvres and possible side-swipe collisions.

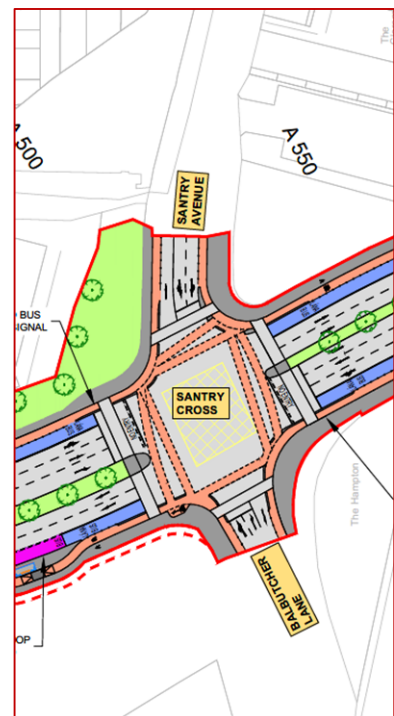
Inappropriate tie-ins may result in the approach alignments being inadequate, this can lead to poor lane discipline which can result in conflicts.

Ensure that appropriate & safe tie-ins are provided with the existing road network outside of the proposed Scheme extents.

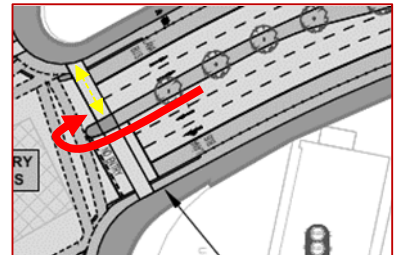
Should a southbound vehicle undertake a u-turn at the junction this could result in vehicular/pedestrian collisions.

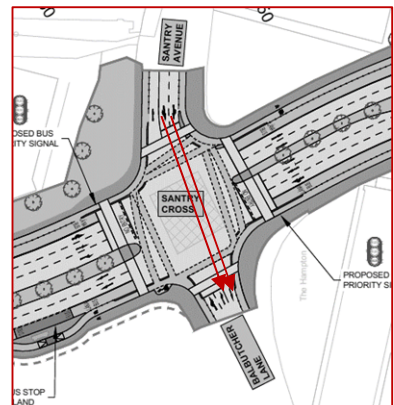
However, there is only a single exit lane onto Balbutcher Lane on the other side of the junction. Should traffic from both lanes proceed at the same time the road layout on the downstream exit from the junction could result in sideswipe collisions.

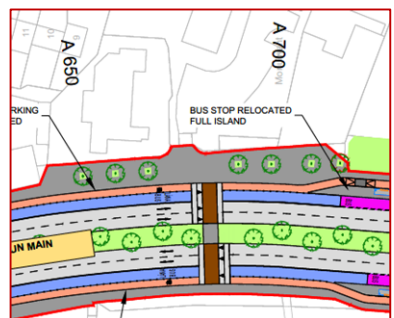
There is a risk that drivers wishing to access these properties may seek to do so at the pedestrian crossing at Chainage A680 approximately, resulting in unsafe manoeuvres and possible vehicular/pedestrian collisions.

In addition, new planting has been indicated to the north of the entrance to the Nursing Home at this location. It is unclear what species of vegetation is proposed at this location, however, there is a risk that the planting may impede visibility for drivers of exiting vehicles towards approaching cyclists/traffic resulting in unsafe exiting manoeuvres and possible side-on collisions.

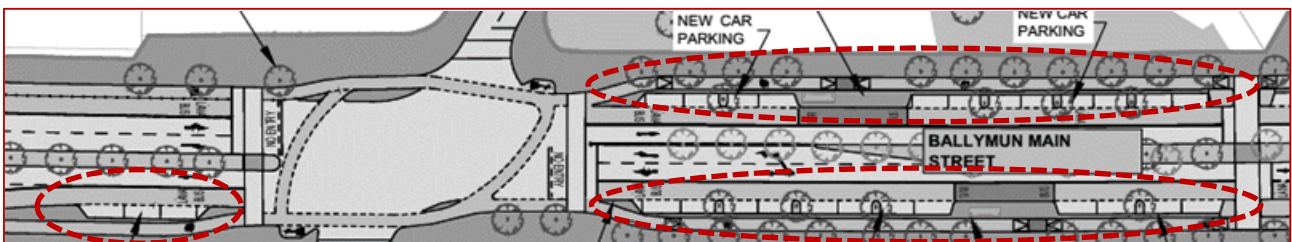
*Summary: Narrow buffer area/island between parking spaces and cycle lanes may result in conflicts should car occupants open the door onto the cycle lane.*

Parking has been indicated on both sides of Ballymun Main Street, to the north & south of the junction with Balbutcher Lane & Shangan Road. The cycle lanes have been indicated to the rear of these parking spaces, separated by an island. It is unclear from the information provided what the width of this island is to be in these areas.

Should the separation between the parking spaces and the cycle lane be insufficient, there is a risk that the doors of parked vehicles may open into the cycle lane as vehicle occupants enter/exit their vehicle, presenting a “dooring” hazard to cyclists.

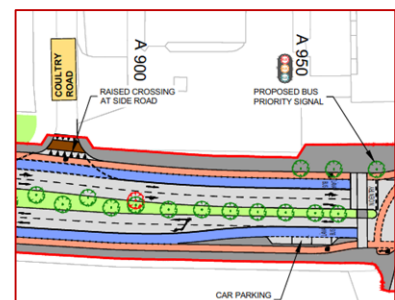
This restriction is not clearly indicated by the upstream road markings or the upstream road layout. This could result in some drivers, in particular those unfamiliar with the area, finding themselves in the wrong lane for their intended destination, leading to late lane-change manoeuvres and possible side-swipe collisions.

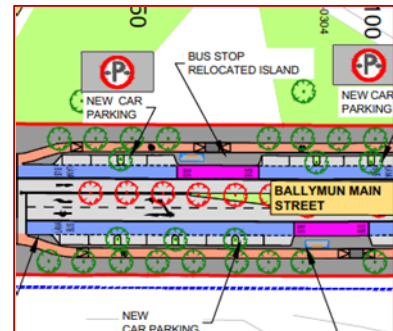
*Summary: Trees and their canopies may present a hazard to pedestrians on the footpath or cyclists on the adjacent cycle track.*

Should insufficient clearance be provided to the adjacent footpath & cycle lane, the tree canopy could present a hazard to visually impaired pedestrians or to cyclists on the cycle track, leading to personal injury.

During the subsequent Design Development phases, the tree species chosen should have canopies, when mature, that will not present a hazard to pedestrians or cyclists on the adjacent footpaths & cycle tracks/lanes.

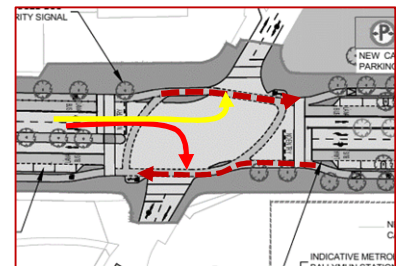
Similarly, right-turning manoeuvres from Ballymun Road are permitted to proceed at the same time as straight-ahead cyclists. There is a concern that that a right-turning driver may not be sufficiently aware of the potential for a straight-ahead cyclist proceeding at the same time, resulting in possible side-on vehicle/cyclist collisions.

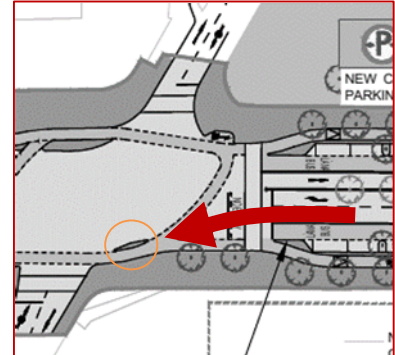
There is a relatively lengthy gap between the northbound traffic lane stop line and this island. There is a concern that left-turning drivers might position themselves close to, or on, the cycle track on the approach to the left-turn, leading to sudden avoidance measures or conflicts with cyclists in the cycle lane.

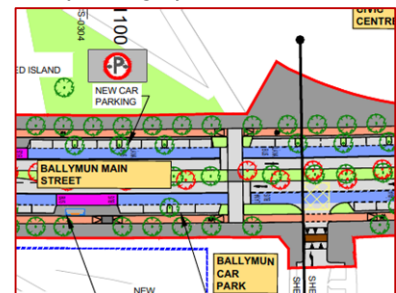
The location of these parking spaces may block inter-visibility between approaching drivers and pedestrians using the crossing which may lead to pedestrians entering the crossing when it not safe to do so, or approaching drivers being insufficiently aware of a pedestrian commencing a crossing.

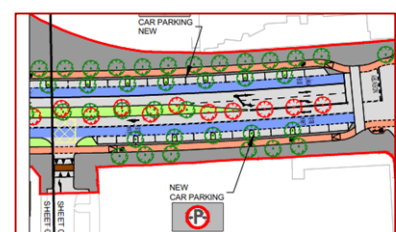
Parking spaces have been indicated on either side of Ballymun Main Street between Chainage A1020 & A1 250 approximately. It is unclear if there will be sufficient visibility to the right for drivers exiting Silloge Road, with visibility possibly impeded by vehicles in the parking spaces to the south of the junction, leading to possible unsafe exit manoeuvres and side-on collisions.

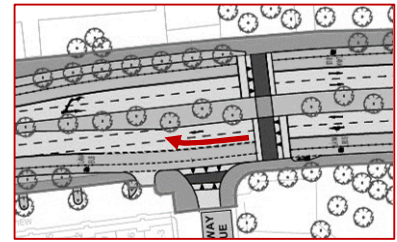
Vehicles in the nearside lane are generally slower moving (i.e. goods vehicles) which may find it difficult to merge with faster moving traffic in the offside lane, resulting in driver frustration, unsafe merging manoeuvres and possible side-swipe collisions.

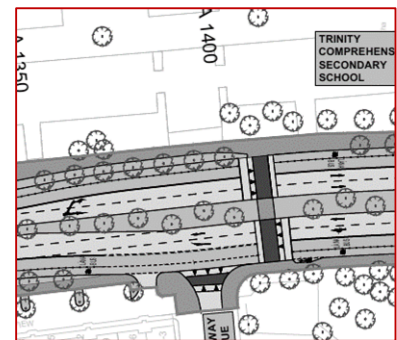
It is not clear from the information provided whether the proposed ramped crossing at Chainage A1410 may obscure the road markings downstream of the crossing for approaching northbound drivers. Should drivers be unable to see the upcoming lane-drop/merge in sufficient time this could lead to them being insufficiently aware of the upcoming lane-drop and the requirement to merge, resulting in sudden braking and rear-end-shunts.

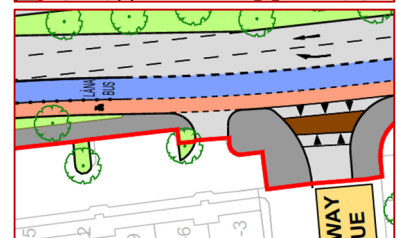
Discontinuities in the footway present difficulties for visually-impaired or partially-sighted individuals safely and independently navigating the road layout.

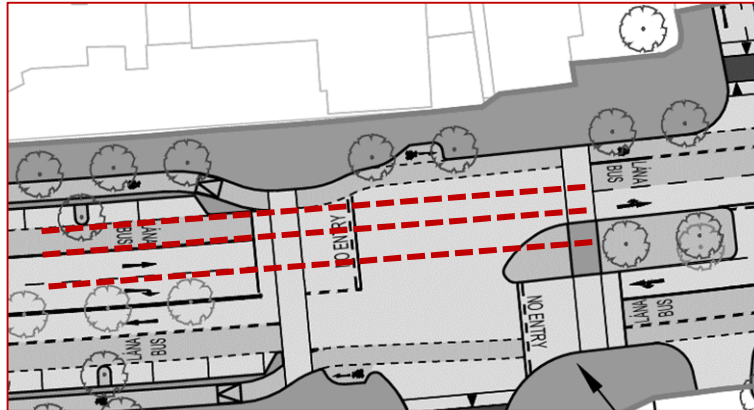
*Summary: Southbound lane alignment through the Gateway Crescent junction may result in side-swipe collisions.*

The southbound traffic lanes & the bus lane on the approach to the junction with Gateway Crescent do not align with the lanes downstream of the junction. This could result in vehicles in the general traffic straight-ahead lane encroaching into the path of a vehicle in the bus lane, resulting in side-swipe collisions within or on the exit from the junction.

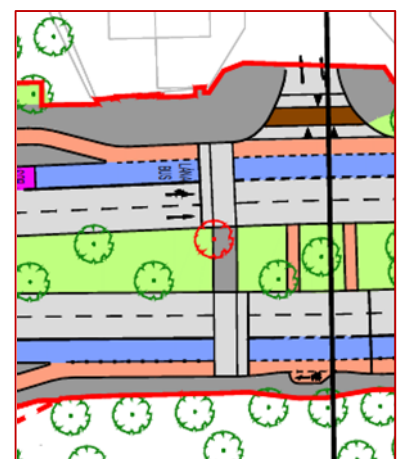
*Summary: Crossing facilities provided from Ballymun Road onto Shanliss Road may result in unsafe crossing manoeuvres.*

The proposed pedestrian crossing north of Shanliss Road should be amended to be a toucan crossing.

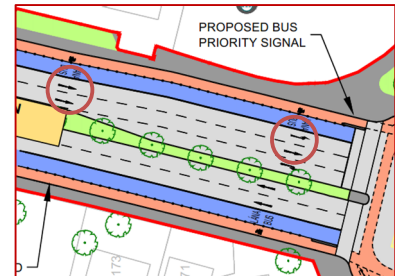
In addition, two lanes have been indicated downstream of the junction which may encourage some drivers to travel within the nearside lane and then proceed straight-head at the junction, a manoeuvre which may not be anticipated by drivers in the straight-ahead lane leading to possible side-swipe collisions through, or on the exit, from the junction.

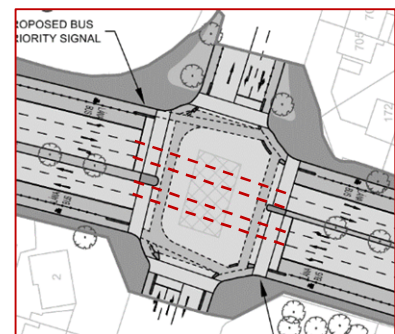
The alignment of the straight-ahead lanes on the northbound & southbound approach to, and away from, the Collins Avenue junction is such that motorists in the general traffic straight-ahead lane who attempt to exit the junction in the offside downstream lane may encroach into the path of a right-turning vehicle in the adjacent right-turn lane, resulting in side-swipe collisions within the junction.

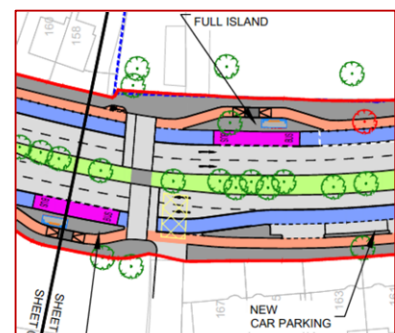
The number of traffic lanes on the northbound carriageway increases from 1 to 2 on the immediate approach to the signalised crossing at Chainage A1950 approximately.

There is a concern that the proposed layout might result in drivers not paying sufficient attention to the pedestrian crossing while switching lanes resulting in overshoot type collisions.

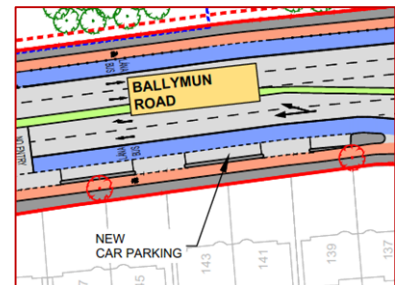
Should the gap be of insufficient width there is a risk of a vehicle occupant opening a door into the path of an oncoming cyclist resulting personal injury incidents.

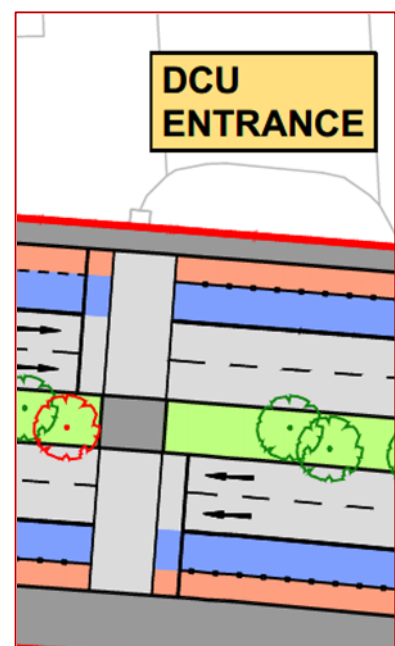
It is unclear if the proposed signalised crossing of the Ballymun Road at Chainage A2330, near the DCU entrance, will be a toucan crossing. During the Site Visit evidence of cyclists crossing at the location of the existing signalised pedestrian crossing was noted, and it is expected that there would be a demand for cyclists wishing to cross this location. Should the crossing provided not be of sufficient width, there is an increased risk of cyclists/pedestrian collisions at this location.

The width of the crossing should be adequate to cater for the anticipated volumes of pedestrians & cyclists during peak times.

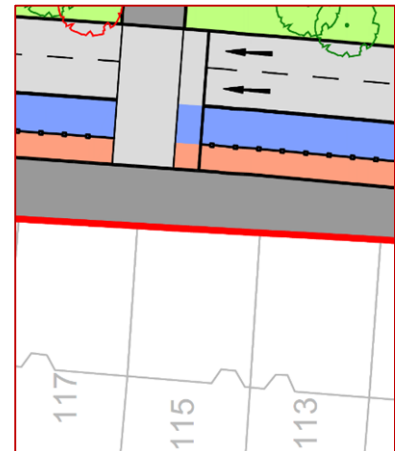
Bollards have been indicated across the face of all of the residential accesses along the western side of the Ballymun Road in the vicinity of this crossing, which would further impede vehicular access/egress.

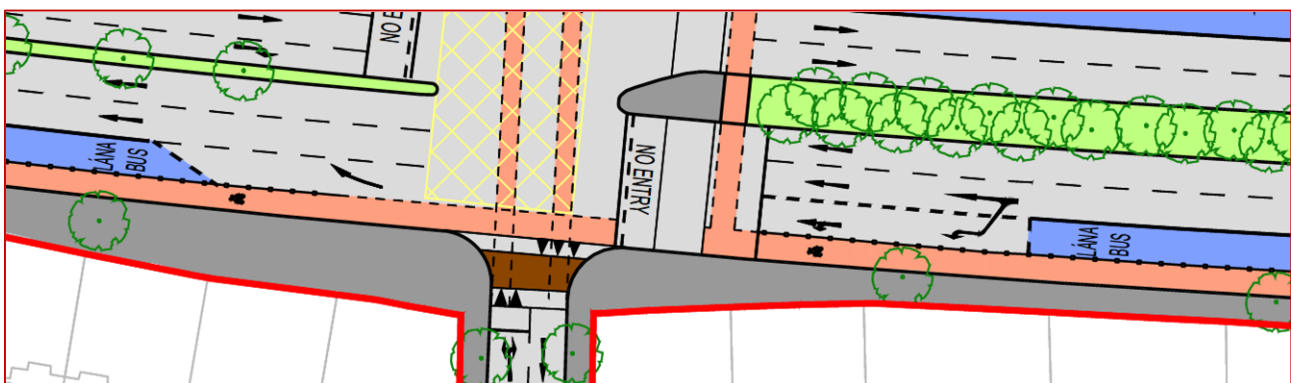
*Summary: Creation and subsequent termination of additional straight-ahead lane through junction increases the risk of sideswipe collisions downstream of the intersection.*

A short length of straight-ahead & left-turn lane is indicated on the northbound approach to the intersection with St Canices Road. This additional straight-ahead lane is removed a short distance downstream from the junction, before the bus lane resumes. This arrangement requires general traffic in this nearside lane to merge with traffic in the adjacent lane increasing the risk of side-swipe collisions.

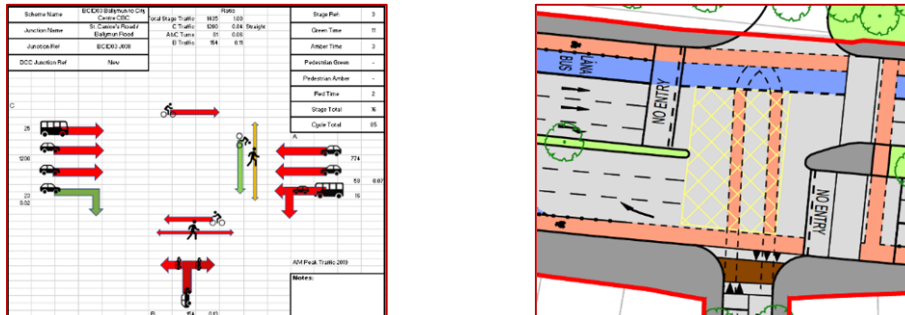
At the St Canices Road junction right-turning cyclists are to turn right at the same time as southbound right-turning traffic. Right-turning drivers may be unaware of, and unprepared for, a right-turning cyclist given the distance between the starting positions of vehicles/cyclists. This may result in conflicts between right-turning vehicles & right-turning cyclists as they traverse the junction and/or on the entry to the side road.

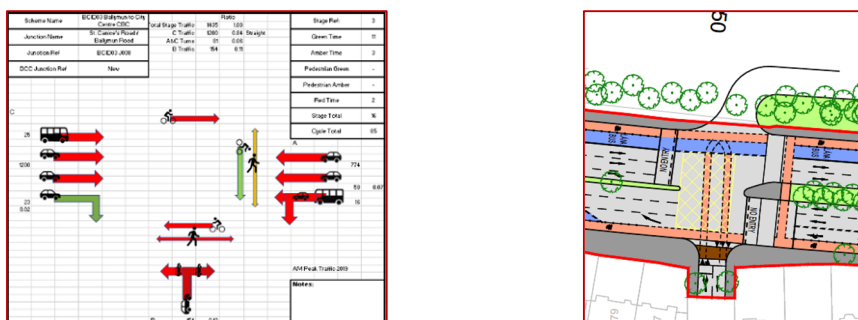
A new access is shown on the eastern side of the Ballymun Road at the junction with St Canices Road, however this arm of the junction is not included on the signal phasing information provided. Should the traffic to/from this arm of the junction not be adequately catered for within the signal phasing this could result in unsafe entry/exit manoeuvres and conflicts with vehicles, cyclists or pedestrians at this junction.

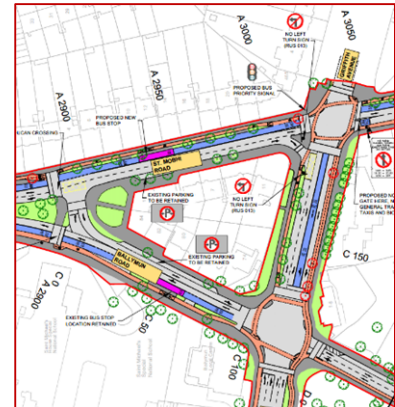
*Summary:* Changes to road layout at Griffith Avenue junction may give rise to inappropriate/unsafe manoeuvres, in particular in the initial weeks/months following implementation of the revised layout.

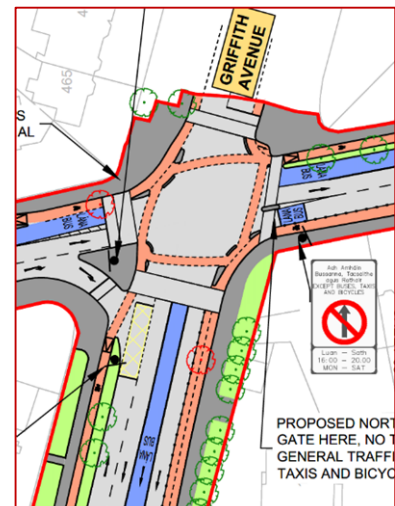
It is unlikely that cyclists will follow this lengthy route, but rather proceed into the westbound cycle lane across the St Mobhi Road arm of the junction against the flow of oncoming cyclists, resulting in unsafe manoeuvres by these cyclists leading to possible collisions with oncoming cyclists.

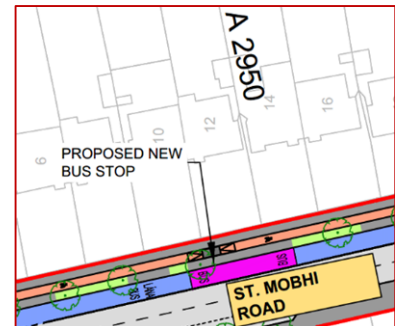
The proposed bus stop location at Chainage A2940 may impede vehicular access/egress to the private dwellings on the eastern side of St Mobhi Road, resulting in unsafe access/egress manoeuvres and possible conflicts with passengers waiting at the bus stop.

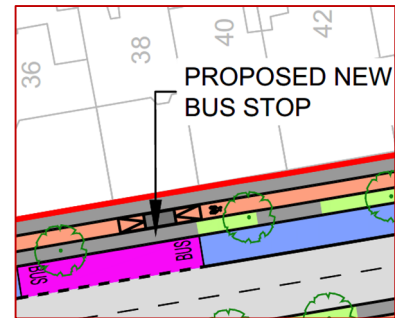
The proposed bus stop location at Houses Numbered 36 & 38 on St Mobhi Rd may impede vehicular access/egress to these dwellings, resulting in unsafe access/egress manoeuvres and possible conflicts with passengers waiting at the bus stop.

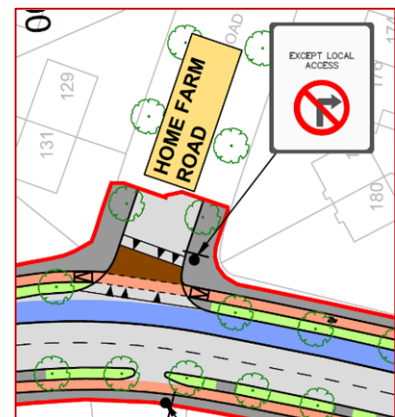
*Summary: Potential for unsafe right-turns by cyclists should visibility towards approaching traffic be impeded by existing/proposed planting.*

However, cyclists turning into Home Farm Road may have their view of approaching vehicles obscured by the trees within the grass verge either side of this opening, resulting in possible unsafe turning manoeuvres and vehicle/cyclist collisions.

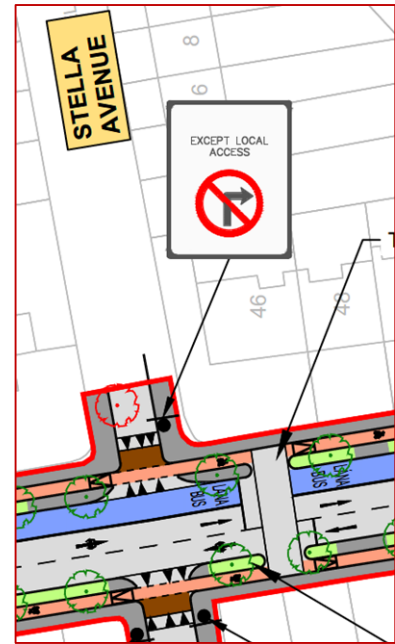
*Summary: Proximity of signalised crossing to side road junction, and the position of planting on the approaches to the crossing, could result in drivers failing to stop resulting in overshoot and possible vehicle/pedestrian collisions.*

The position of the toucan crossing at Chainage A3200 is in close proximity to the Stella Avenue junction, and there is a risk that drivers turning out of Stella Avenue may fail to see the signals, resulting in overshoot into the pedestrian crossing and possible vehicle/pedestrian collisions.

In addition, the vegetation on the approach to the crossing may result in approaching drivers failing to see the signals, resulting in a failure to stop and possible vehicle/pedestrian collisions.

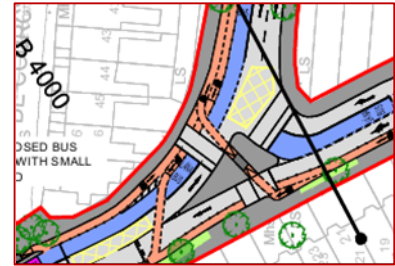
In addition, queued vehicles could extend in both directions over the cycle crossing and present difficulties for cyclists in completing this manoeuvre safely, in particular where visibility towards cyclists on the northbound cycle lane which they are joining is limited, resulting in possible cyclist/cyclist collisions.

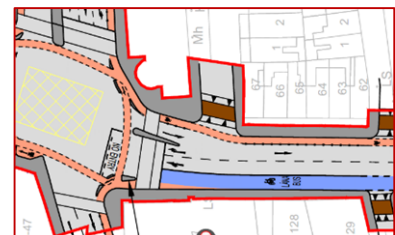
This could result in driver frustration with straight-ahead or left-turning traffic entering the bus lane upstream of the junction, leading to possible conflicts between vehicles and cyclists in the cycle lane and/or unsafe manoeuvres at the junction.

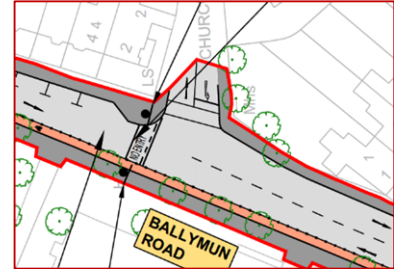
Should signals not be provided at this junction, there is an increased risk of conflicting manoeuvres, in particular between right-turning northbound vehicles into Church Avenue & southbound vehicles on Ballymun Road who may presume that they have priority.

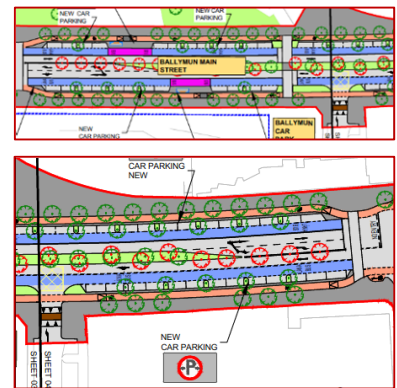
- 4.3 Trees have been indicated within the median of the Ballymun Road. Some have been indicated in close proximity to the signalised crossings at Northwood Avenue. No information is available at this early stage in the design process on the proposed tree species.

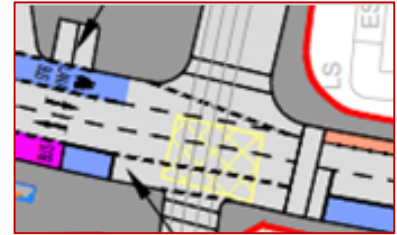
- 4.8 Bus cage markings have been indicated within the bus lane on the southbound carriageway at Chainage A2000 approximately. These are indicated to the south of the proposed floating-island bus stop, and may be a draughting error.
