Coastal Quarter SHD 2

Stage 1 Quality Audit

Shankill Property Investments Limited

Sept 2022

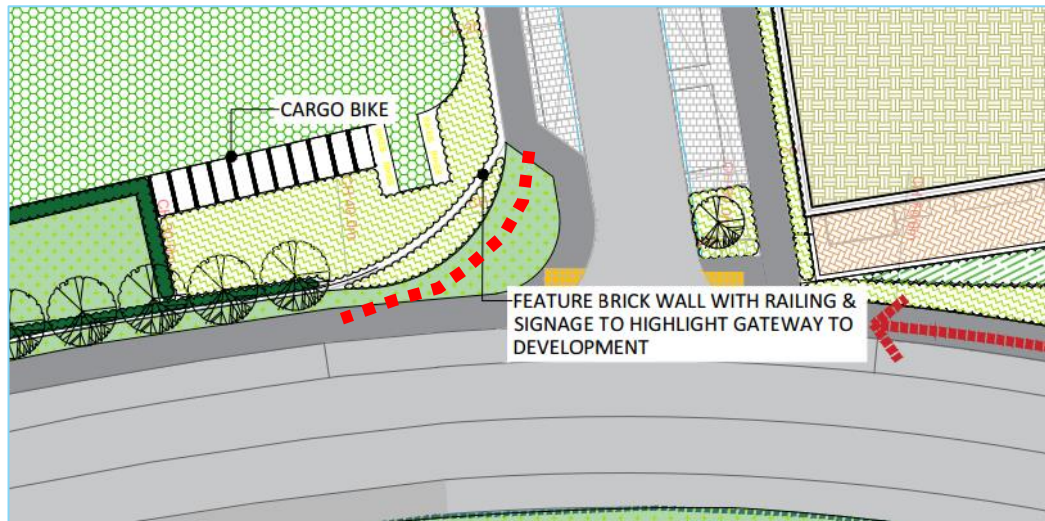
Figure 3-3 – Desire Line at Junction 12

3.1.3. Problem: Pedestrian Desire Line

Location: Junction 12

The landscape drawings do not appear to have catered for likely the pedestrian desire line pictured below in **Figure 3-3**. Footfall on this landscaped area could pose a risk to vulnerable users potentially leading to slipping, tripping or falling

The Designer should ensure that likely pedestrian desire lines are catered for at this location.

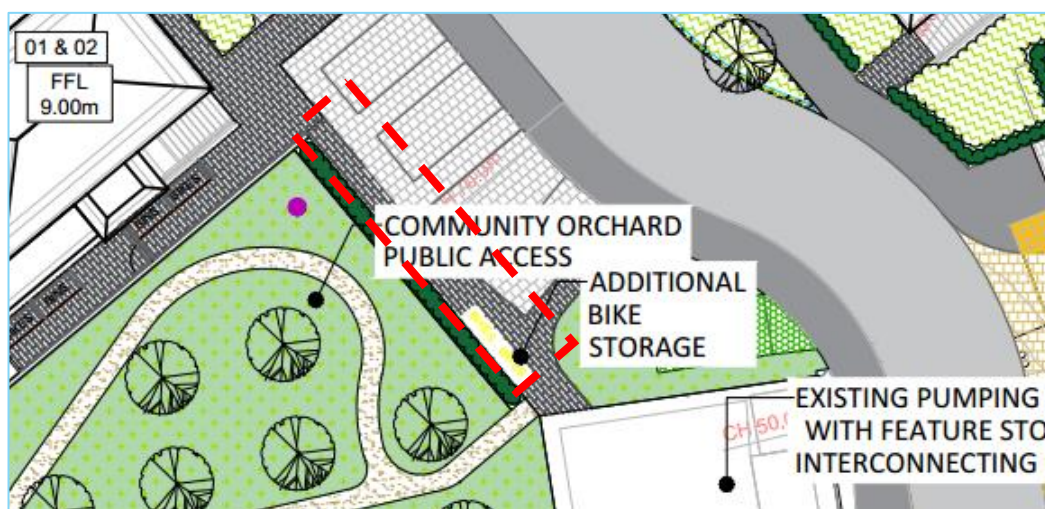
Figure 3-4 – Narrow Pedestrian Path

3.1.4. Problem: Narrow Pedestrian Path

The landscape drawings detail a narrow pedestrian path to the rear of the parking bays as shown in **Figure 3-4** below. Lack of adequate width along the path may impede the movement of those less abled. Potential arises for personal injury to those in wheelchairs looking to use the facilities made available. The narrow width might result in vulnerable users pushed into the parked cars when facing oncoming footpath traffic.

The Designer should ensure that sufficient width is provided to vulnerable road users along the footpath.

3.1.4	y	n	The dedicated footpath along the route is positioned directly adjacent the street and is of sufficient width to cater for all users.	Yes. The Designer has confirmed design proposals are adequate.

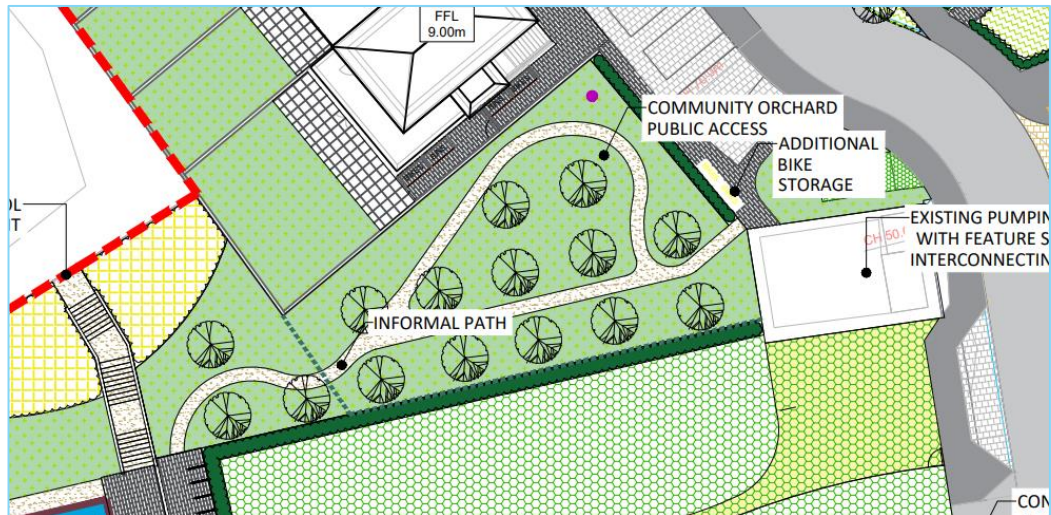
Figure 3-5 – Informal Path on Approach to the School Entrance

3.1.5. Problem: Informal Path

The landscape drawings detail a narrow informal path on approach to the school entrance steps as shown in **Figure 3-10** below. Lack of adequate width along the path may impede the movement of those less able. Potential arises for vulnerable user slips, trips and falls at this location.

The Designer should ensure the path is wide enough to cater for likely demand and user needs.

3.1.5	y	n	The community orchard is an informal space with limited access and any stepped connection with the school is subject to agreement. Width and material of paths to be developed at detail design stage	Yes. To be considered further at detailed design.

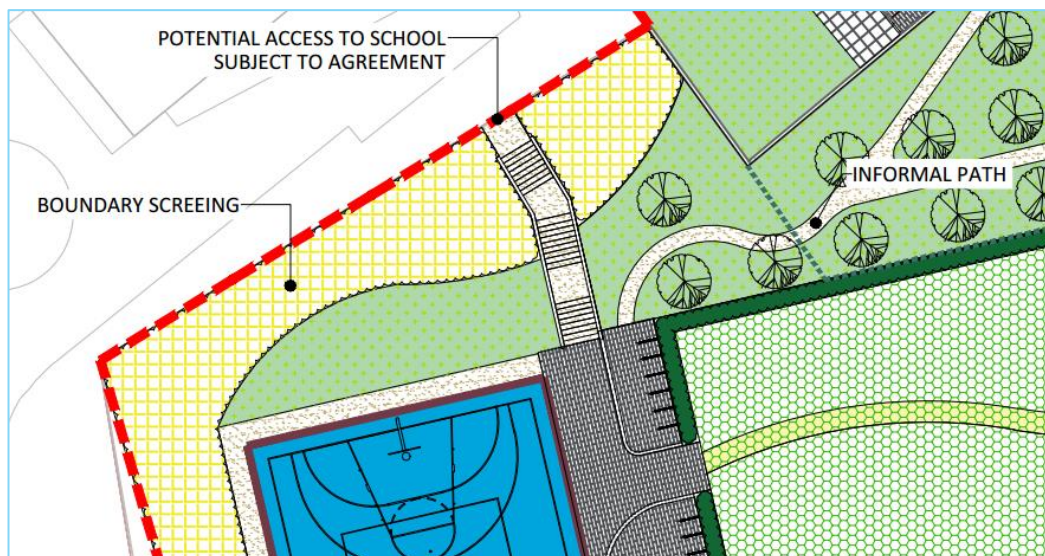
Figure 3-6 – Access for Wheelchair Users on Approach to School Entrance

3.1.6. Problem: Access for Wheelchair Users

The landscape drawings appear to be missing adequate wheelchair friendly facilities as shown by the steps on approach to the boundary in **Figure 3-6** below. Lack of adequate wheelchair facilities can impede the movement of those less able.

The Designer should consider the provision of wheelchair friendly facilities.

3.1.6	y	n	Infrastructure for a compliant and designated less abled movement entrance has been provided by the school just outside the application red line boundary on the west corner of the site. Potential stepped access has been designed as a secondary linkage to the school and it is subject to agreement.	Yes. Provided for elsewhere. This connection is noted for later agreement.

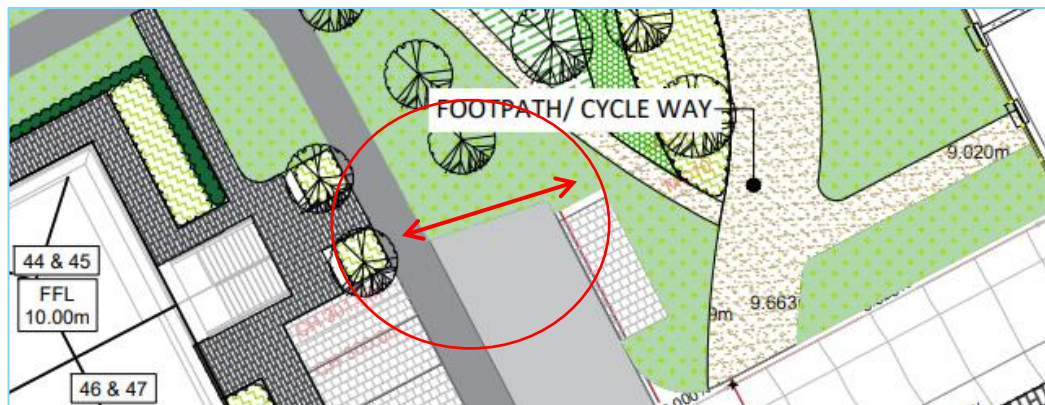
Figure 3-7 – Pedestrian Crossing Facilities

3.1.7. Problem: Pedestrian Crossing facilities

The landscape drawings appear to be missing adequate pedestrian crossing facilities to cater for pedestrian desire lines from the housing block to the adjacent park and greenspace. This may result in pedestrians entering the live carriageway or utilising a desire line in the grass as pictured in **Figure 3-7**.

The Designer should consider providing a pedestrian path along the head of the road connecting these houses to the nearby greenspace.

3.1.7	y	y	The pedestrian desire lines are catered for by the paths proposed as part of the landscape design.	Final materials, colours and textures to be examined at detailed design stage.

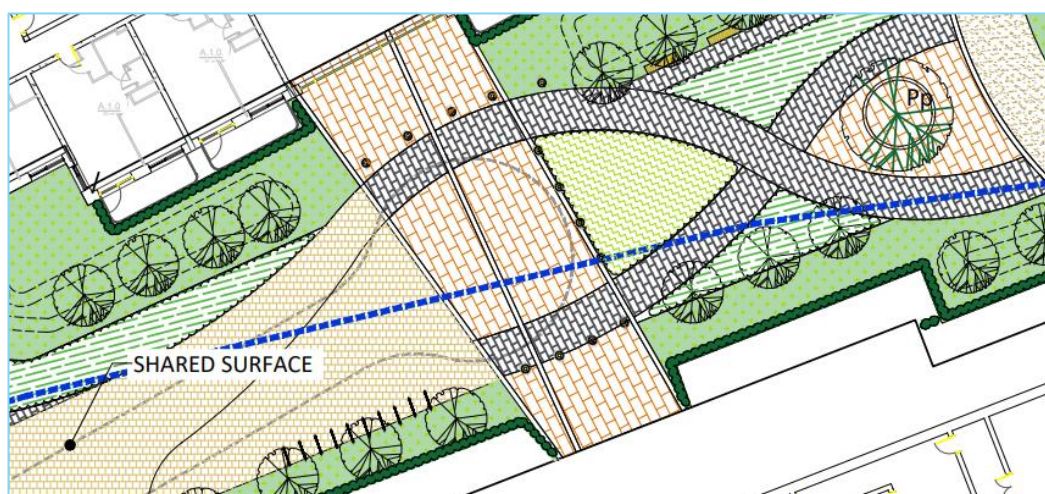
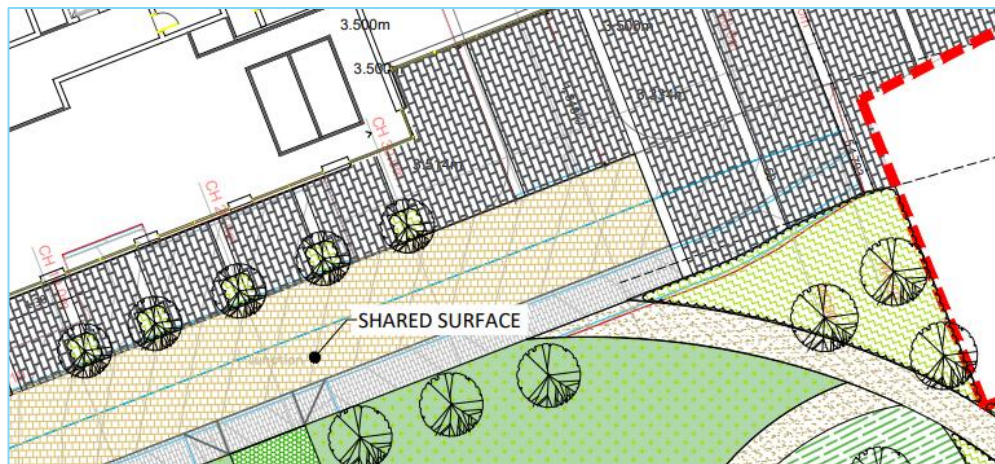
3.1.8. Problem: Transition from Shared Space to Pedestrian Zone

There is no tactile warning provided at the transition between pedestrian zone and shared space at the locations shown in **Figure 3-8** and **Figure 3-9** below. This may result in vulnerable and visually impaired pedestrians unknowingly entering the shared space. This may cause vehicle pedestrian conflicts.

Figure 3-8 – Transition from Shared Space to Pedestrian Zone

Figure 3-9 - Transition from Shared Space to Pedestrian Zone

The Designer should consider the provision of tactile tiles to mark the transition between pedestrian and shared zones.

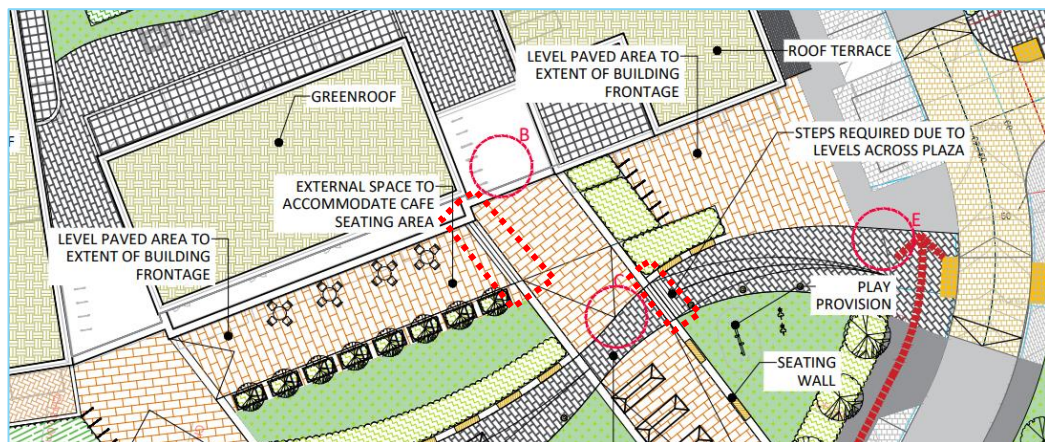
Figure 3-10 – Access for Wheelchair Users

3.1.9. Problem: Access for Wheelchair Users

The landscape drawings appear to be missing adequate wheelchair friendly facilities as shown by the steps on approach to the boundary in **Figure-16** below. Lack of adequate wheelchair facilities can impede movement of those less abled.

The Designer should consider the provision of wheelchair friendly facilities in this area.

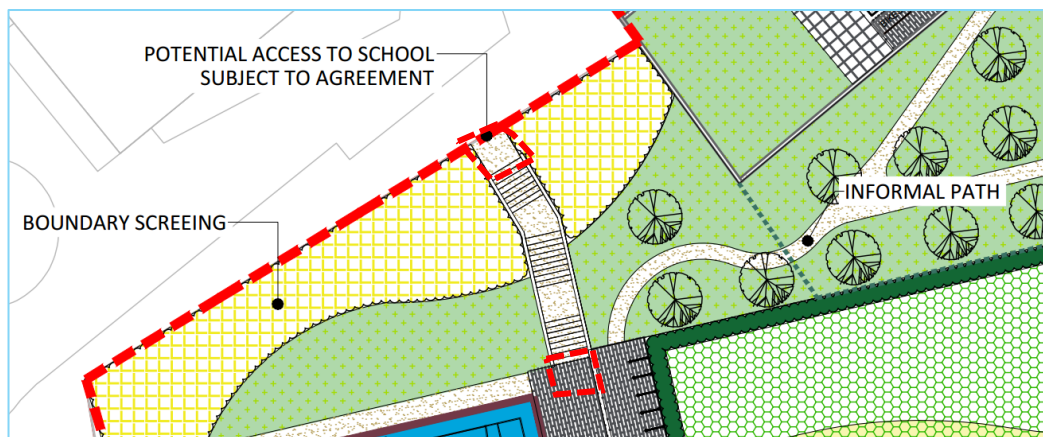
Figure 3-11 – Requirement for Corduroy Paving at Top and Bottom of Steps

3.1.10. Problem: Requirement for Corduroy Paving

From the landscape drawings the provision of corduroy paving to the top and bottom of the steps throughout the scheme does not appear to have been made. Omission of corduroy paving may result in pedestrian slips, trips and falls which may result in injury type collisions.

Corduroy paving should be provided at the top and bottom of steps throughout the site in accordance with good practice.

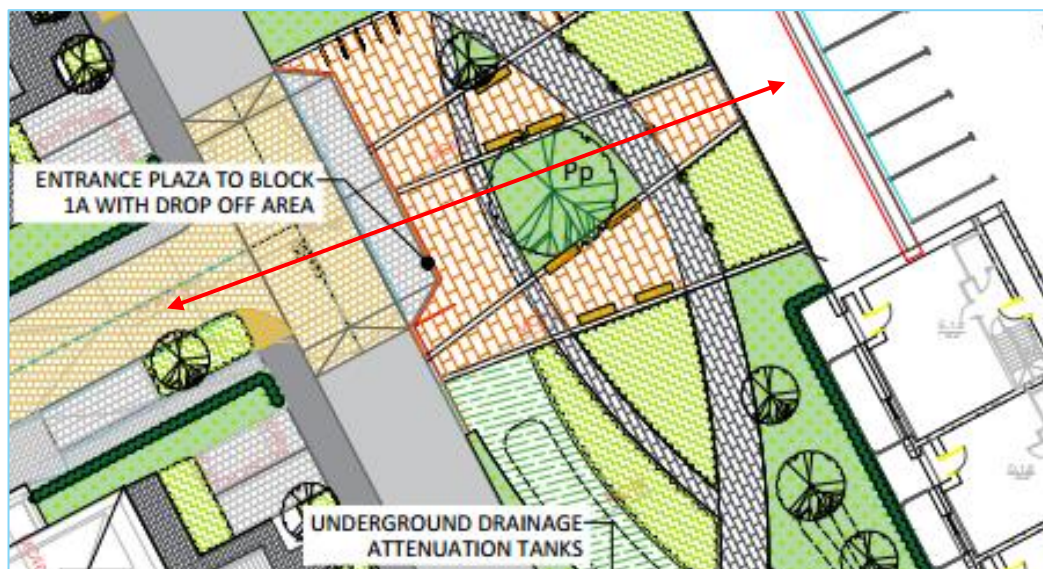
Figure 3-12 – Plaza Layout

3.1.11. Problem: Tree Planting Impeding Pedestrian Movement

The landscape drawings show a large tree located in the centre of a key pedestrian desire line toward Block A. Planting at this location may compromise movement and lead to slips trips and falls and progression issues for less abled users.

The Designer should rationalise the tree planting at this location as part of the detailed design.

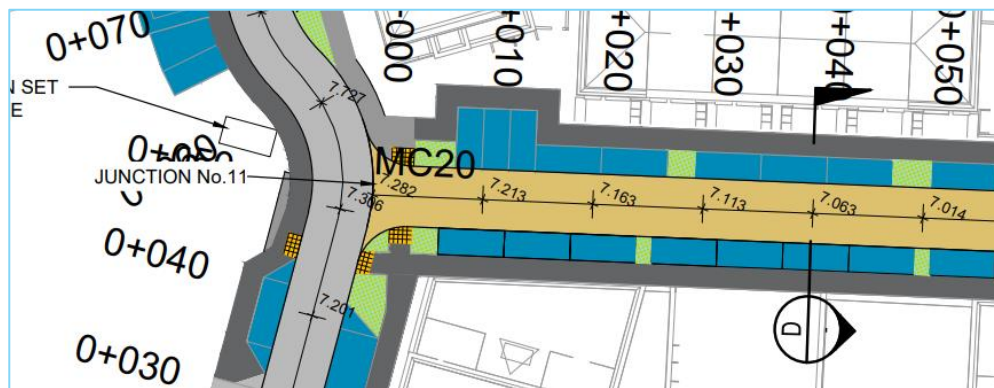
Figure 2-1 – Junction 11

Larger vehicles to the east of Junction 11 may reverse onto the pedestrian crossing facilities as they look to manoeuvre out of the perpendicular parking bays. The presence of trees may exacerbate the issue. This may result in vehicles colliding with crossing pedestrians and may result in injury.

The designer should consider increasing the setback at this location to ensure large vehicles do not reverse onto the crossing point.

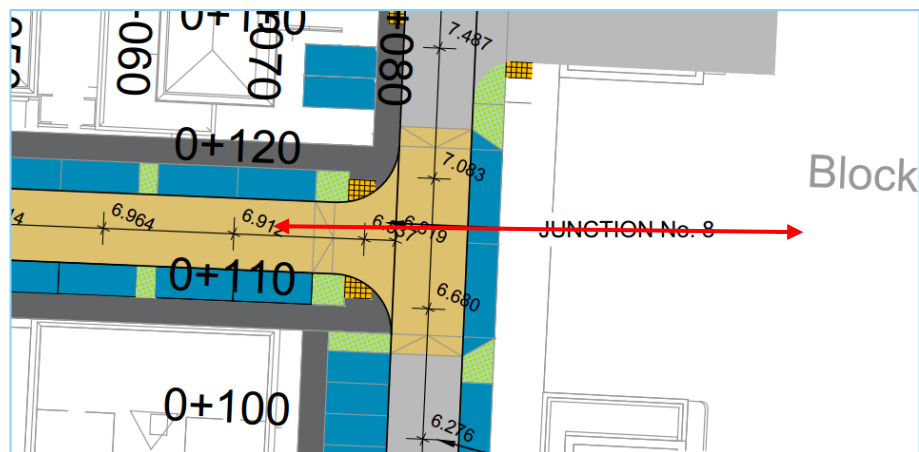
Figure 2-2 – Junction 8

The design drawings indicate the presence of parallel parking bays along the east of Junction 4 and Junction 8 as shown in **Error! Reference source not found.** Figure 2-3 below. These arrangements will obstruct pedestrians looking to cross east/west at the junctions and likewise drivers being less able to see pedestrians crossing. This may result in pedestrians having to enter the roadway at undesignated locations which may result in pedestrian to vehicle collisions. These locations are the main entrance to point to the adjacent apartment blocks. It would likely people wishing to travel east-west and vice versa will wish to take this path and will be obstructed by the movement of parked or manoeuvring vehicles.

The Designer should ensure that pedestrian desire lines are catered for at these junction crossing points. Pedestrians desire lines should not be obstructed by vehicles.

2.2	y	y	A crossing will be facilitated in vicinity to the south of Junction 8 to accommodate this desire line. A crossing to the immediate north of Junction 4 is already provided.

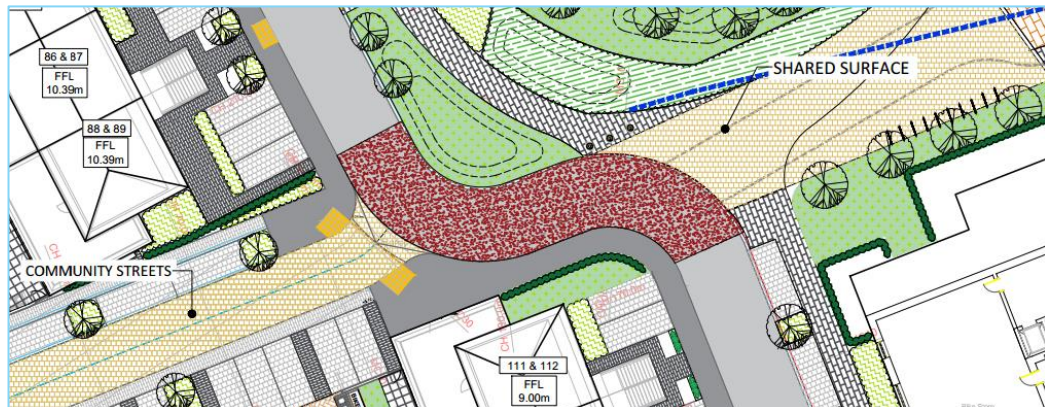
Figure 2-4 – Surfacing and Lack of Crossing Facilities at Junction 6

Junction 6 forms a key link for the east to west and north to south desire lines and may direct vulnerable users into an active carriageway where it is unsafe for them to enter. The transition from pedestrian zone to shared space appears unmarked/lacking delineation, leaving vulnerable and visually impaired pedestrians in danger of entering a live carriageway.

The layout should be reviewed and amended to address the risks highlighted. Appropriate measures should be provided to adequately guide / warn and delineate vehicles and non-motorised traffic in this area.

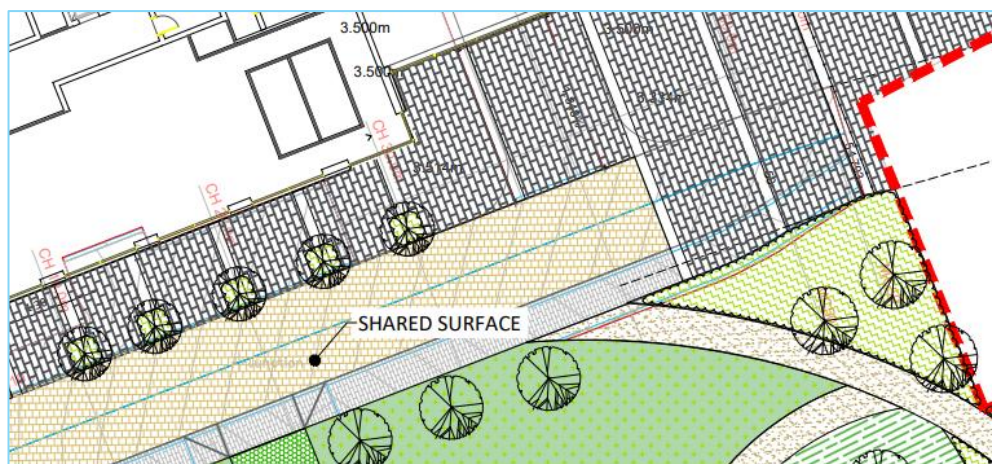
Figure 2-5 – Visibility of Underground Car Park Entrance

There is an entrance to an underground carpark at this location which is difficult to identify based on the surfacing materials chosen. The lack of pedestrian warning on approach may lead to vulnerable users slipping, tripping or falling into the junction and the risk of vehicle pedestrian conflicts.

The designer should consider how pedestrians are being warned on approach to the underground carpark entrance.

2.4	y	y	<p>To facilitate pedestrian movement, a designated crossing point has been provided, materials and surfacing have been addressed to provide separation and a clear delineation along with a traditional kerb line separation. Pavement material will be considered and specified at detailed design.</p>
