# **Appendix A14.1** Scheme Walkover Summary

## Appendix A14.1: Scheme Walkover Summary

The following is a summary of the observations by the Land, Soils, Geology and Hydrogeology Environmental Impact Assessment team following physical walkovers of the proposed scheme. The walkovers occurred on 20 January 2020 and 7 July 2021.

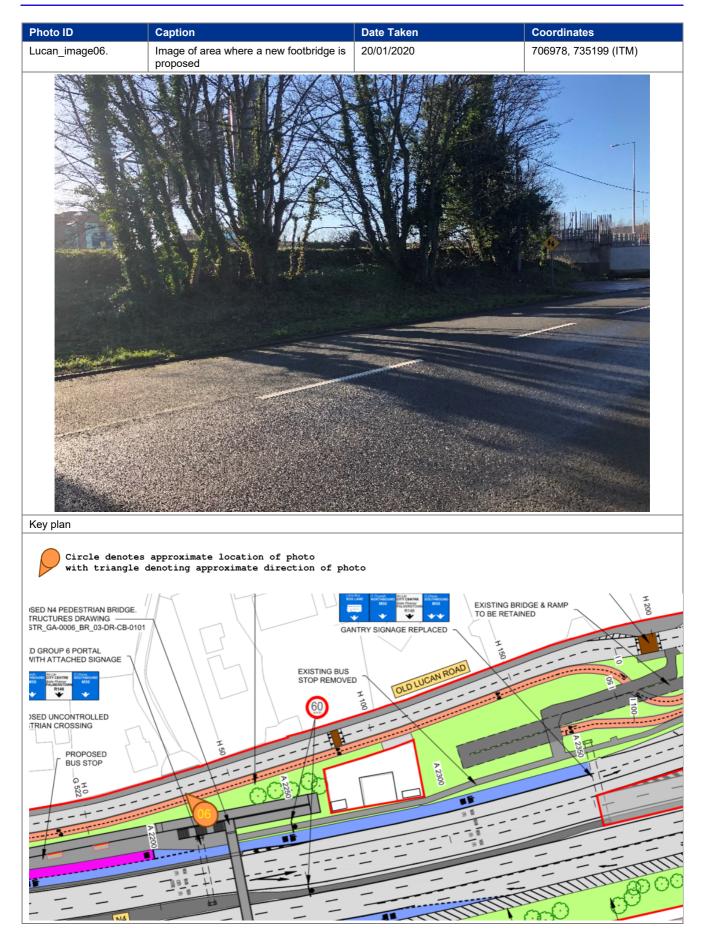
Observation General Arrangement Drawing Sheet Number*		Description	Possible Impact	Photo Number
Hermitage Golf Club retaining wall	Sheet 3	The wall sits between the golf club and the N4. It appears to be acting as a retaining wall. This may have an impact if it is changed to accommodate cycle lanes.	This may pose an issue for the earthworks balance and waste assessment.	Lucan_image03.
Footbridge	Sheet 8	There is earth embankment/slope noted at this location. There is a significant difference between the current road level and the embankment. The current make- up of the embankment is unknown.	This may pose an issue for the earthworks balance and waste assessment.	Lucan_image06.
King's Hospital	Sheet 9	There is a significant level change (up to 3m in places) between the existing green verge in King's Hospital and the existing road.	This may pose an issue for the earthworks balance and waste assessment.	Lucan_image07.

Photo ID	Caption	Date Taken	Coordinates
Lucan_image03.	Image of Retaining wall between the Hermitage Golf Club and N4	20/01/2020	705417, 735494 (ITM)
Key plan			
Circle der with triar	notes approximate location of ph ngle denoting approximate direct	oto ion of photo	
BUS STOP LOCATIONS BUS SHELTER THEE (EXISTING AND PRI- HERITAGE TEATURES SITE BOUNDARY LINE TEMPORARY LAND ACOL	e WALL TO SLOPED AT
