**APPENDIX 3: GKCE EXISTING BUILDING STRUCTURAL CONDITION SURVEY**

## 1-6 City Quay, Dublin Existing Building Structural Condition Survey

Address : 1-6 City Quay Dublin

Survey type Condition survey

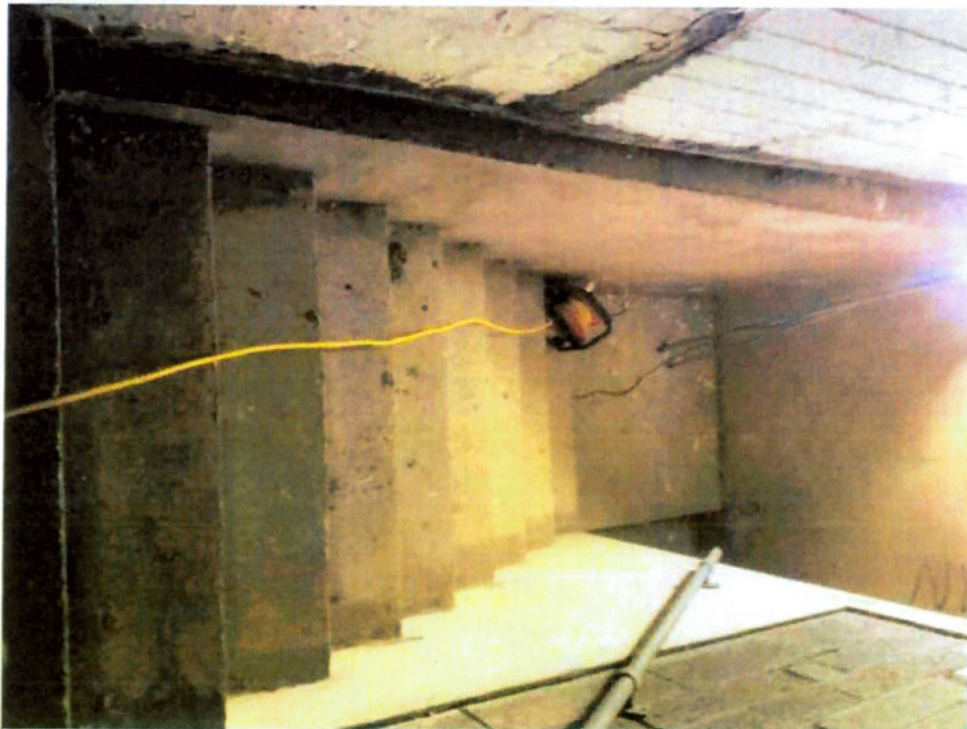
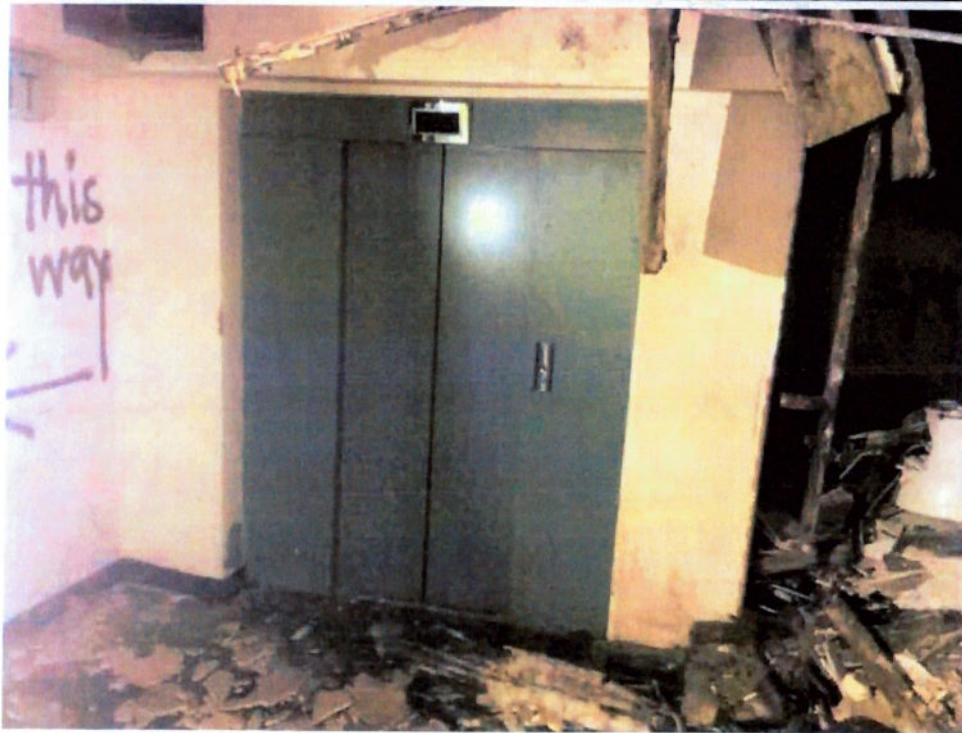
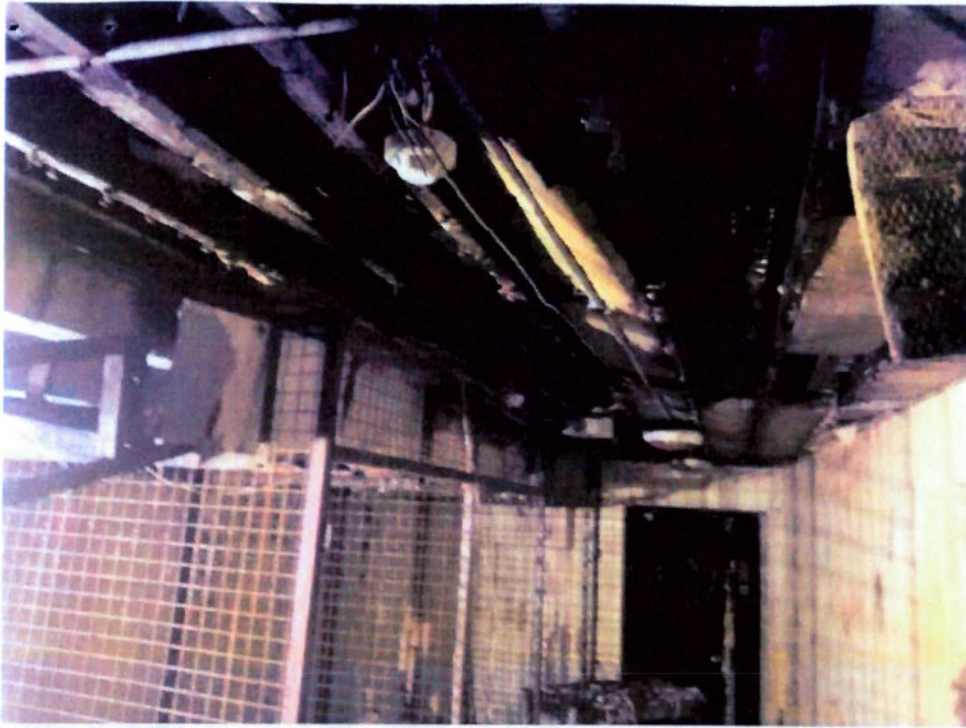
11 Comments

The basement access is limited. Areas of the ground floor have collapsed into the basement & doors are sealed shut on some rooms

The photos below illustrate the various rooms where access was available

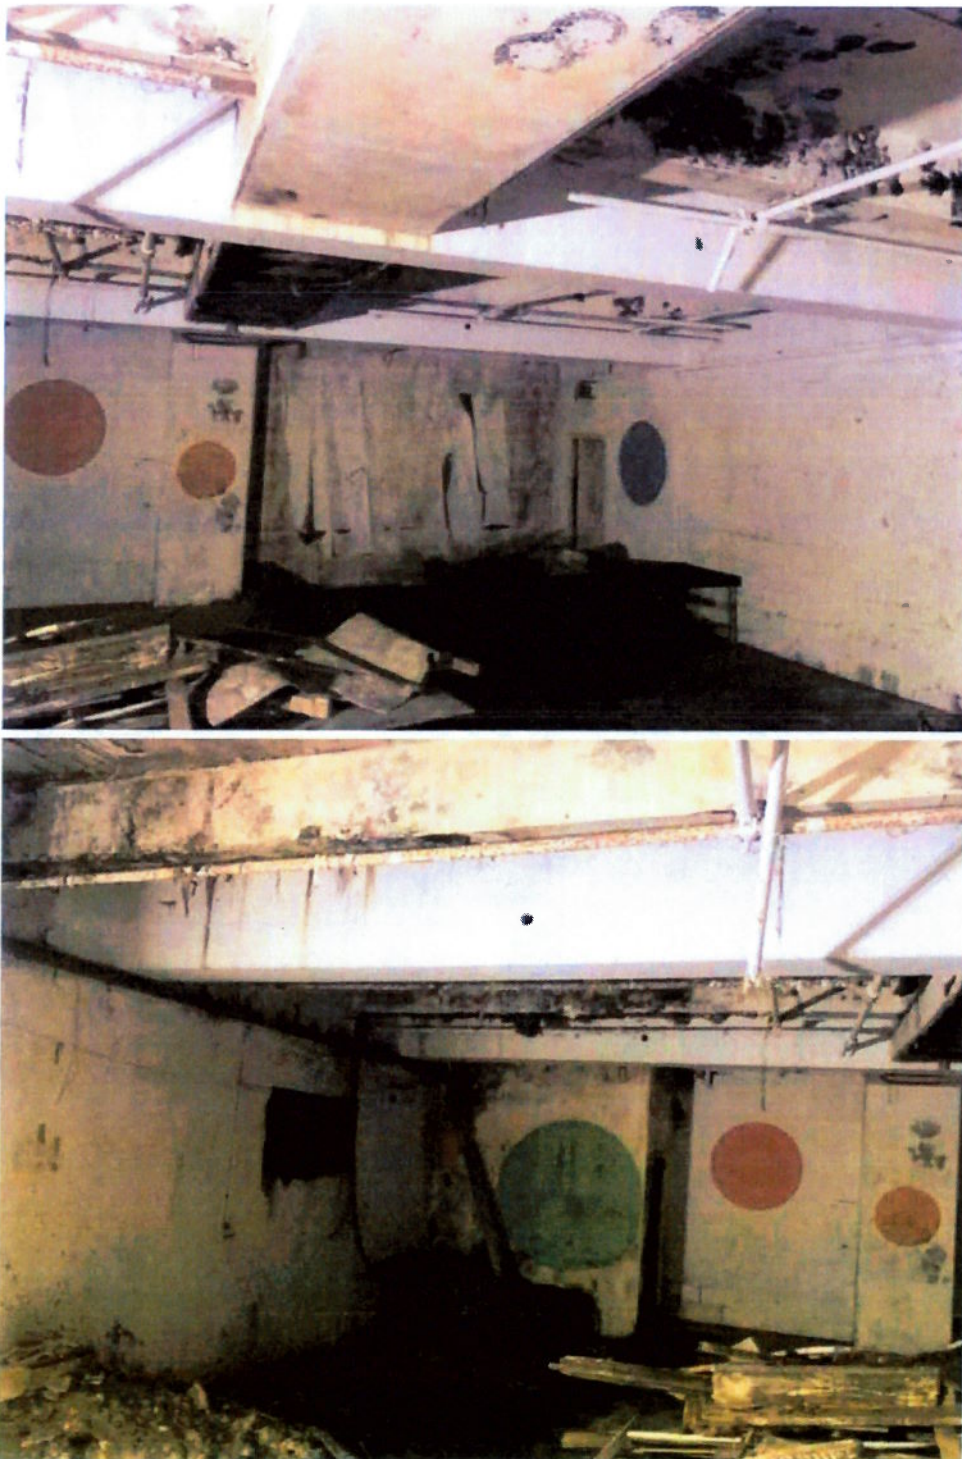
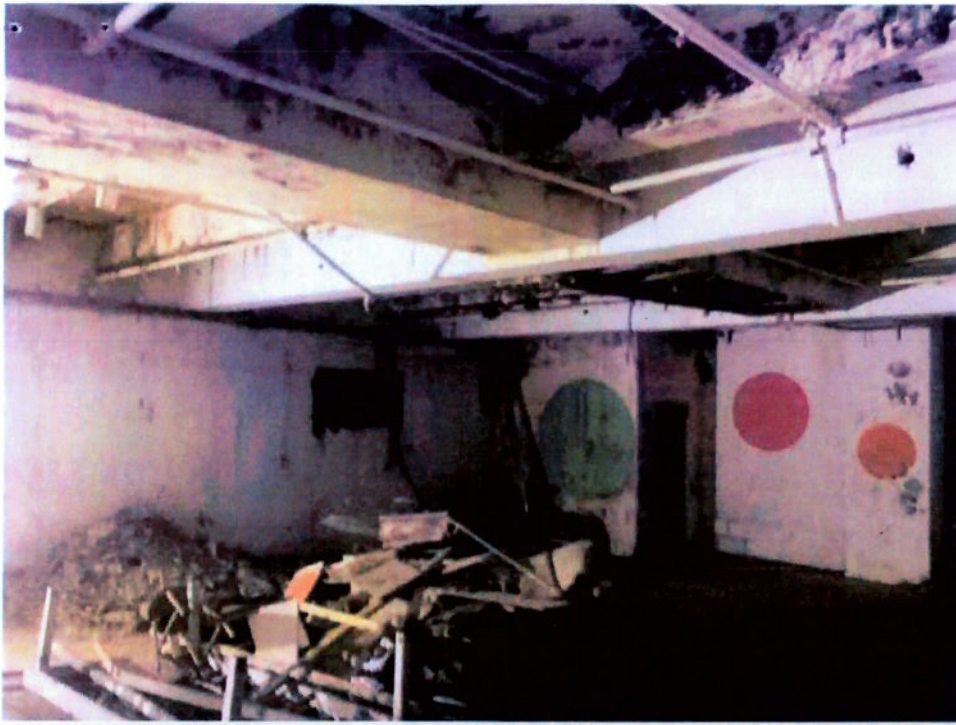
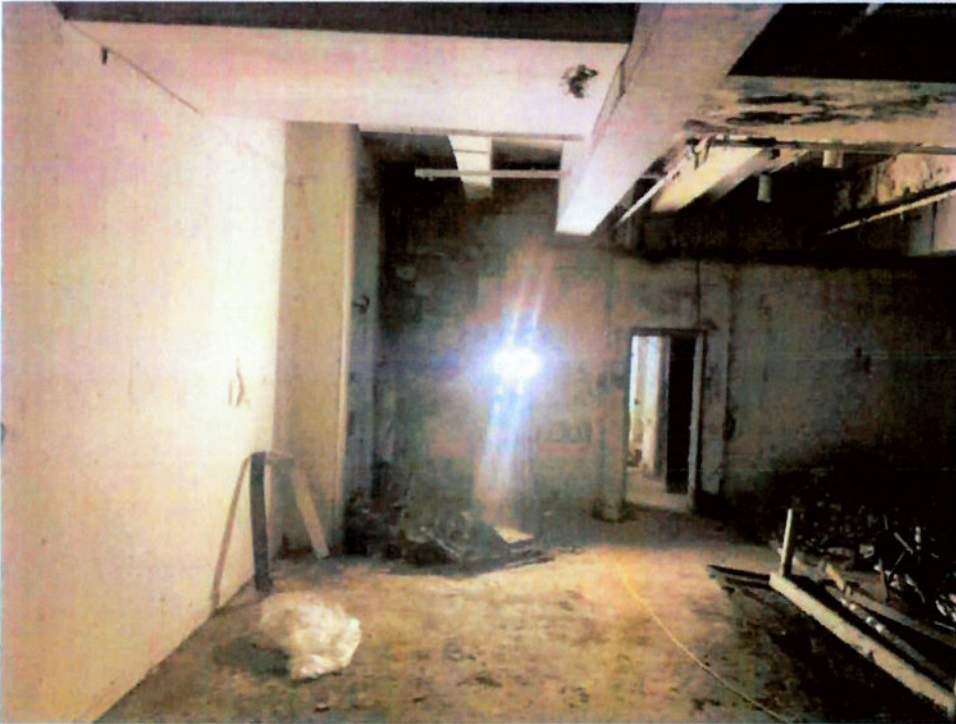
1 Comments

We note evidence of structural alterations to this room. The columns overhead do not transfer to ground level. Concrete beams transfer the column loads. The ground floor slab is concrete. The first-floor ceiling overhead is perished from water damage.

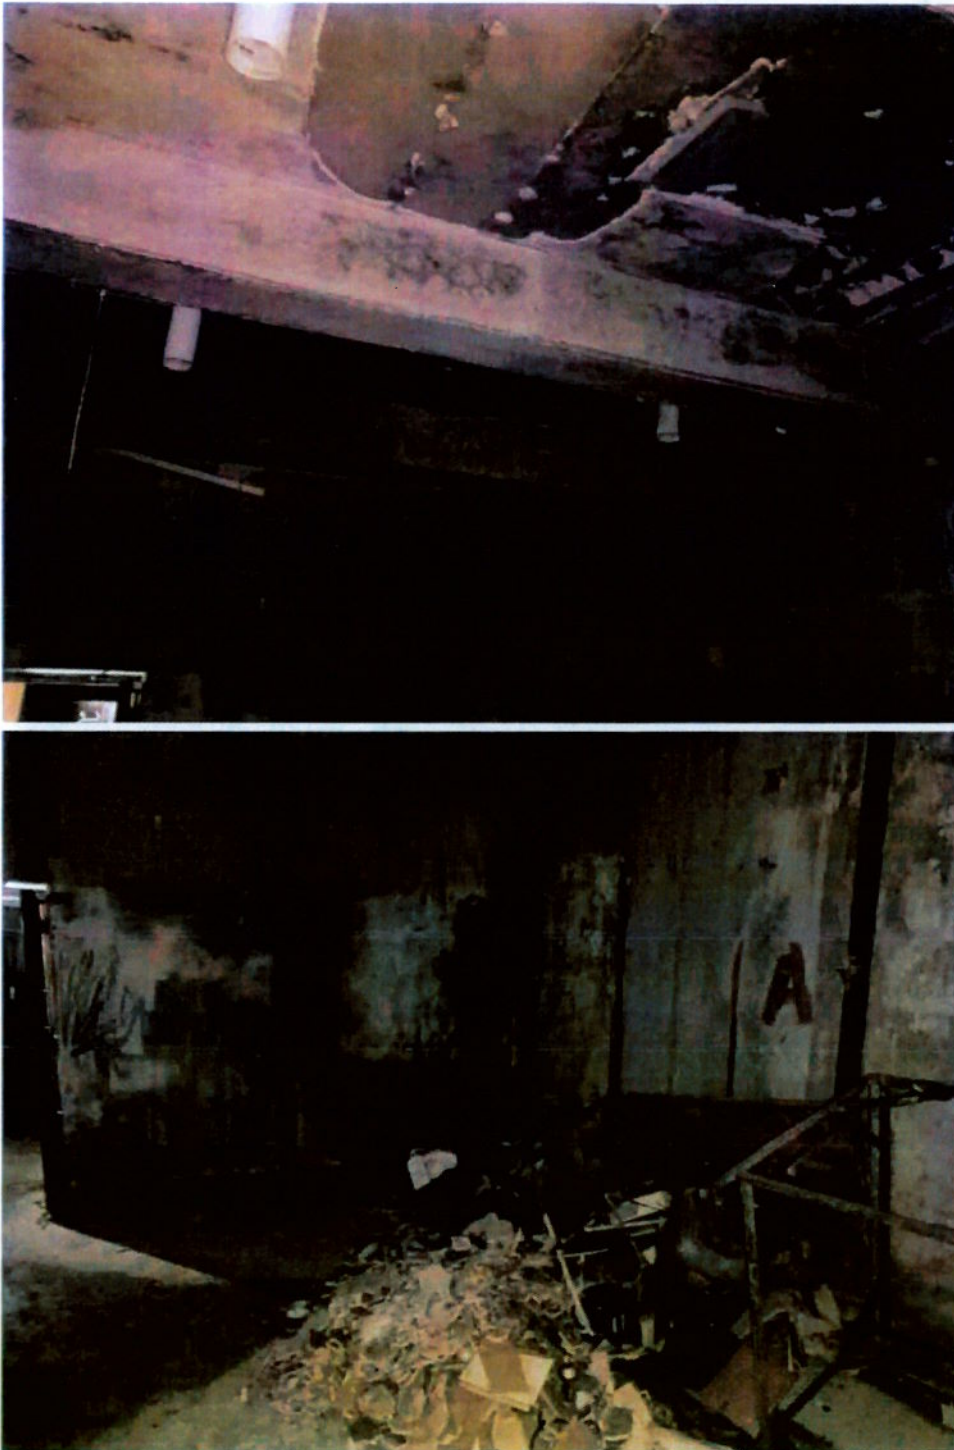
3 Comments

The timber ceiling & floor overhead has perished & is at risk of collapse

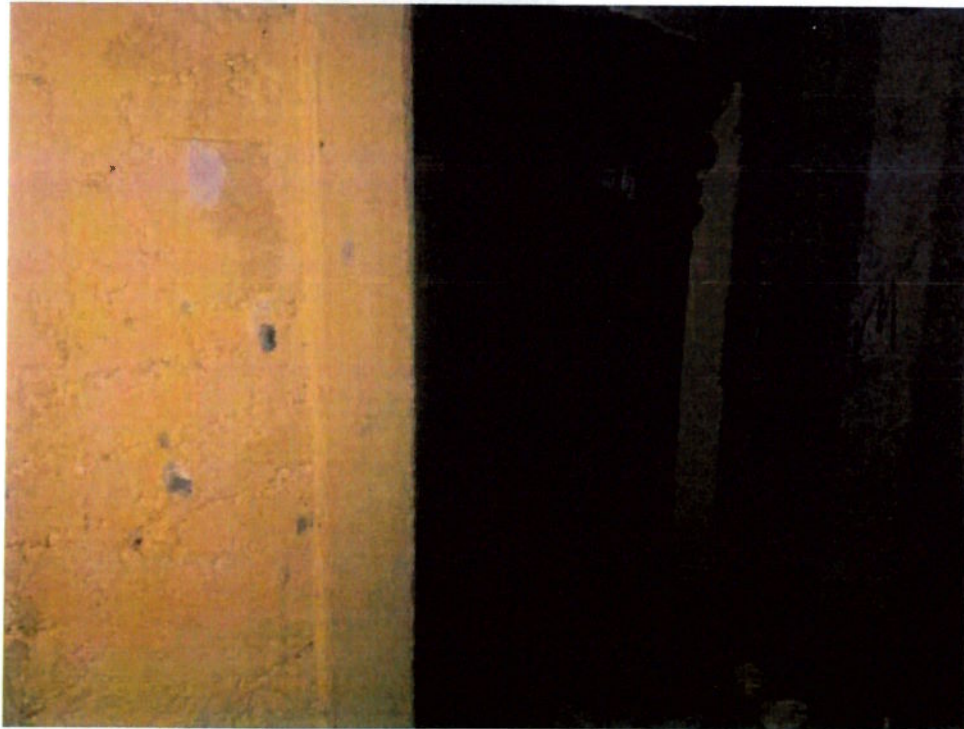
8 Comments

The timber floor overhead is perished & at risk of collapse

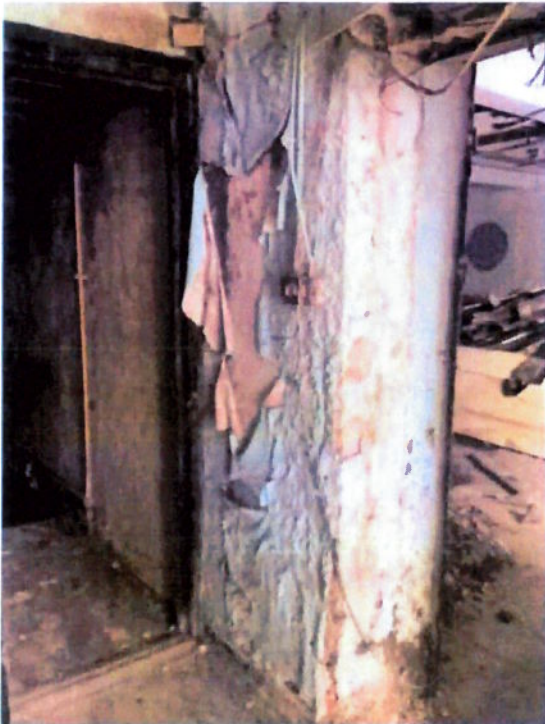
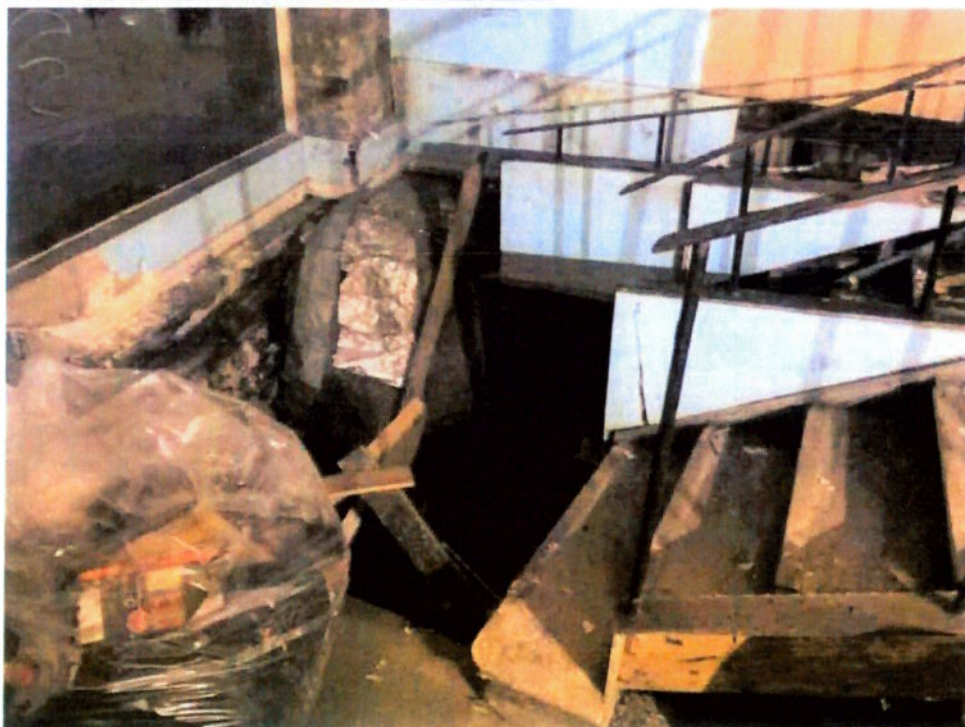
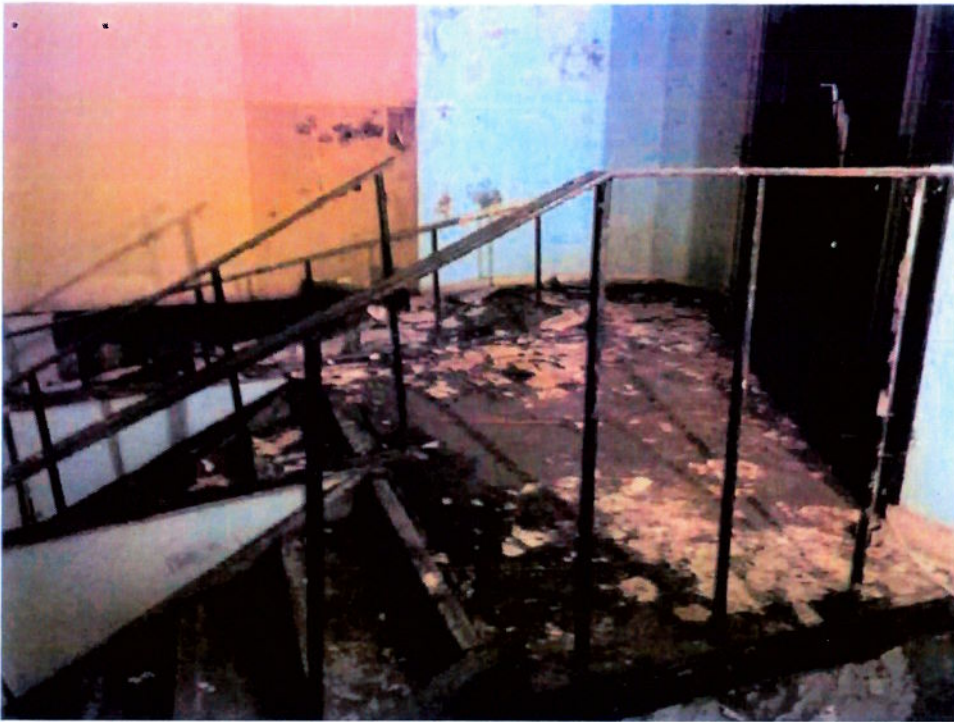
12 Comments

The timber floor overhead has collapsed. The remaining floor is unsafe. The existing floor under has also partially collapsed & is unsafe for access

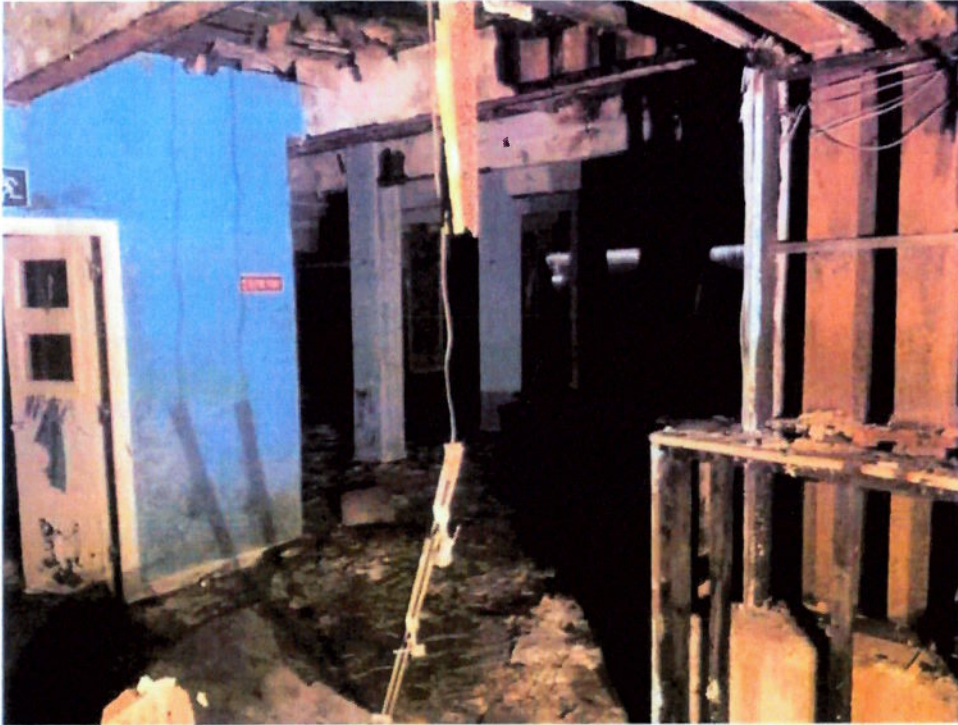
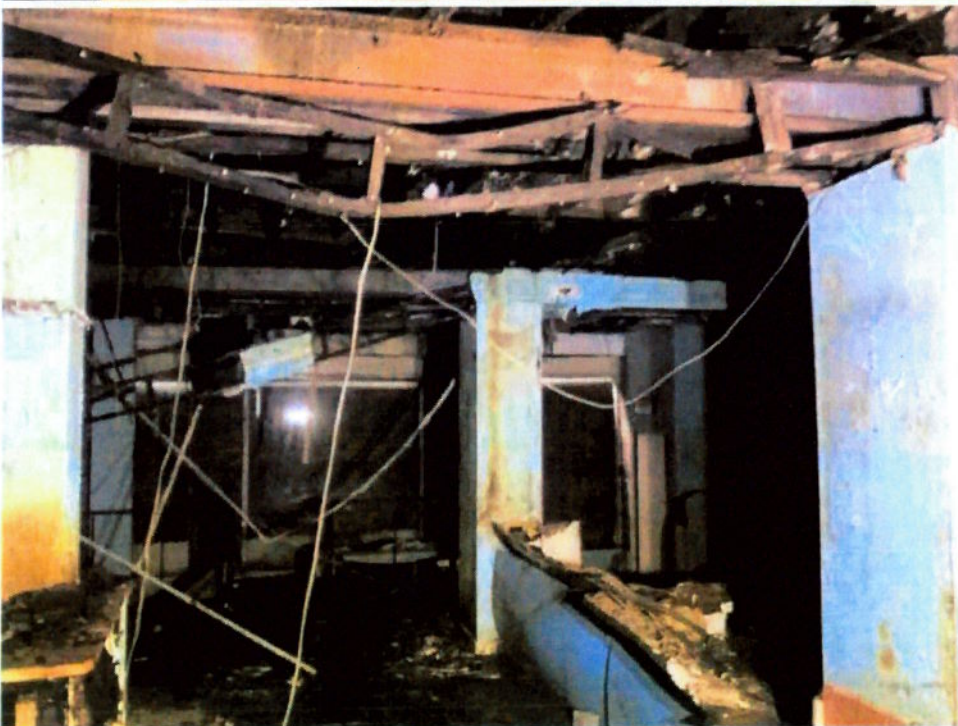
14 Comments

Access to this area is limited. The floors are unsafe & ceiling overhead has collapsed. Floors perished and not safe to walk on

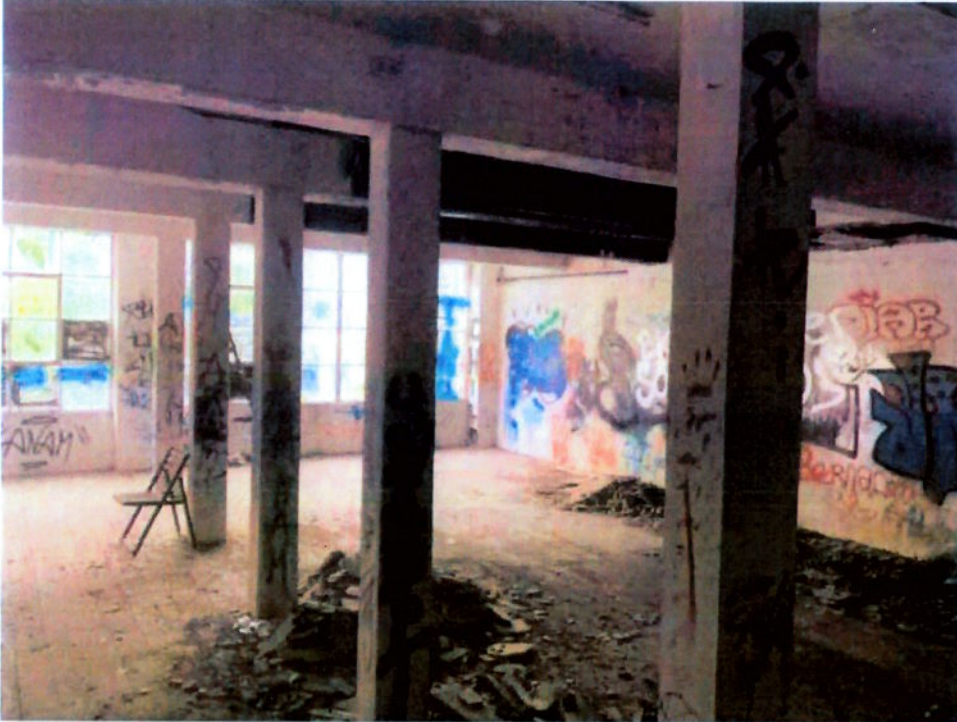
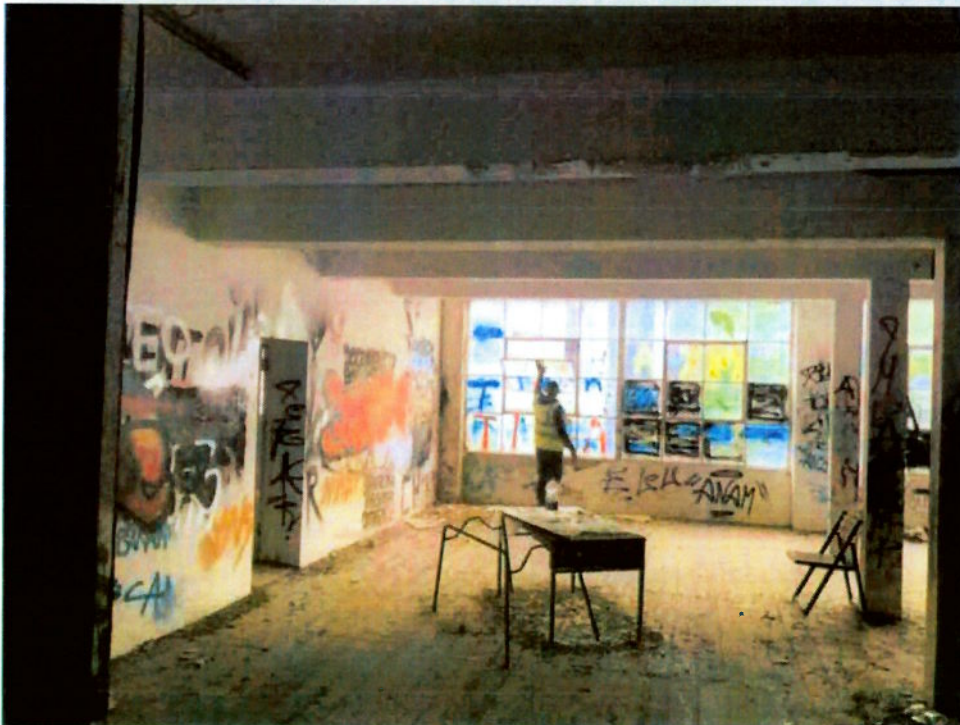
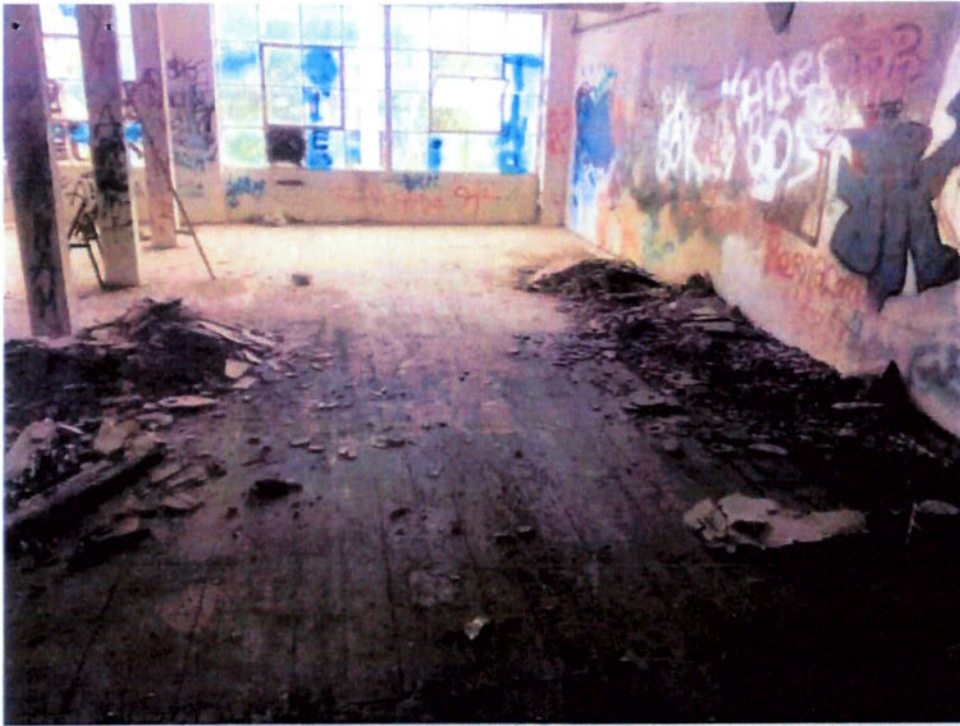
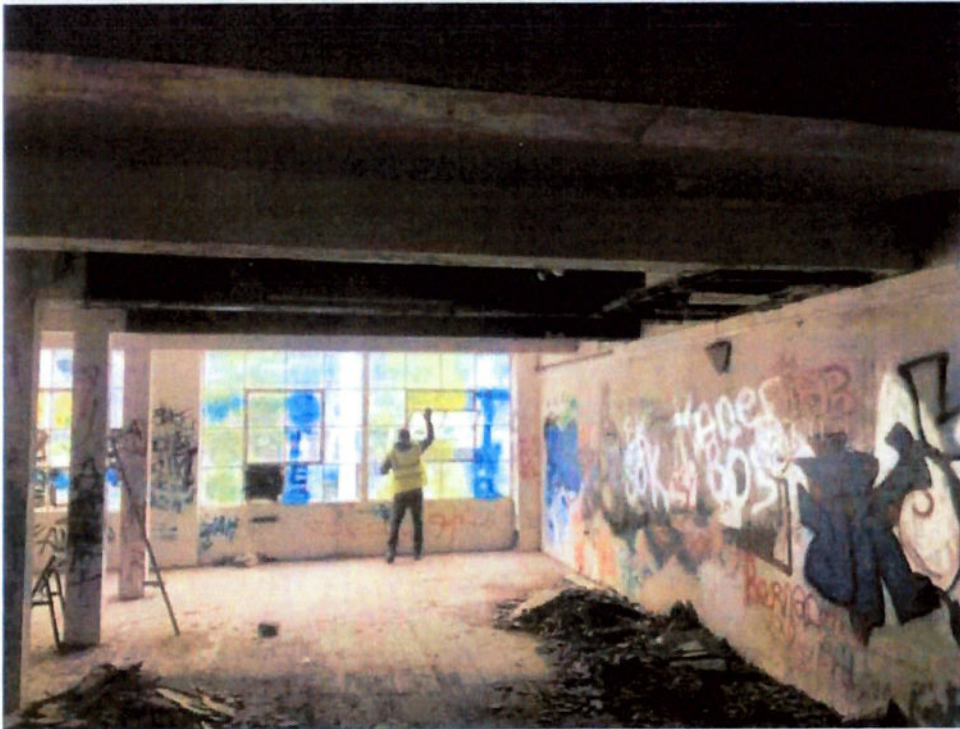
16 Comments

There are holes in the floor & evidence of perished timber joists from below. This floor is unsafe for access

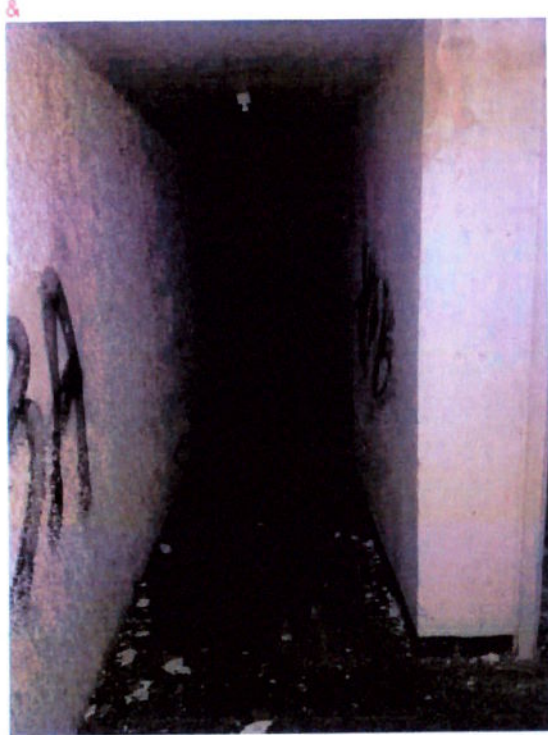
17 Comments

Floors are unsafe to walk on

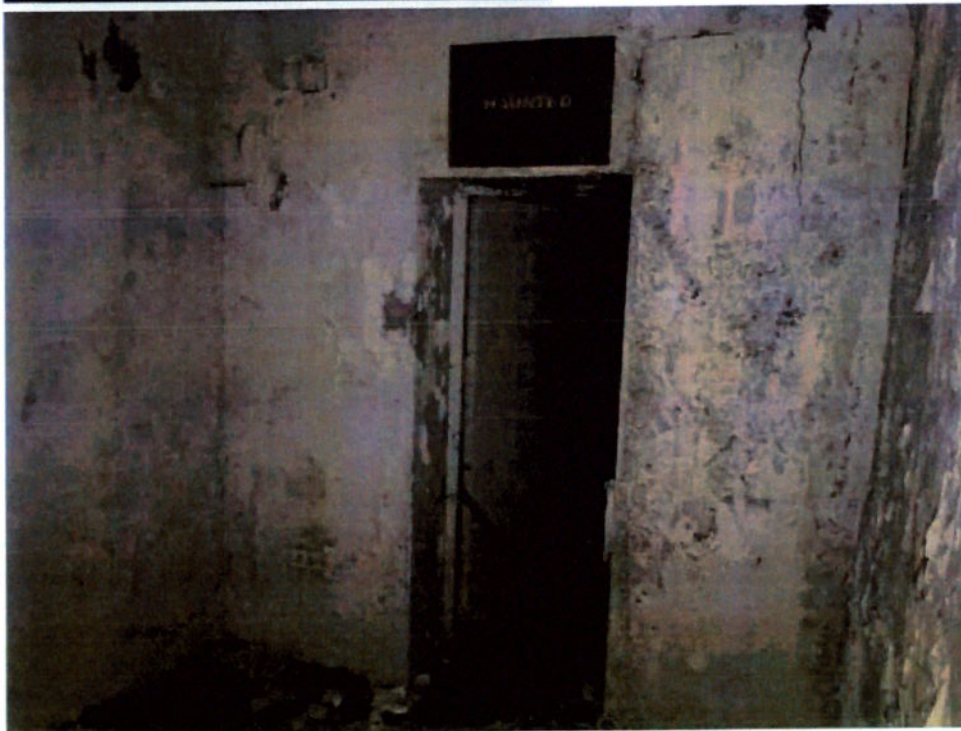
19 Comments

Access to this area is restricted, the floor is not safe to walk on

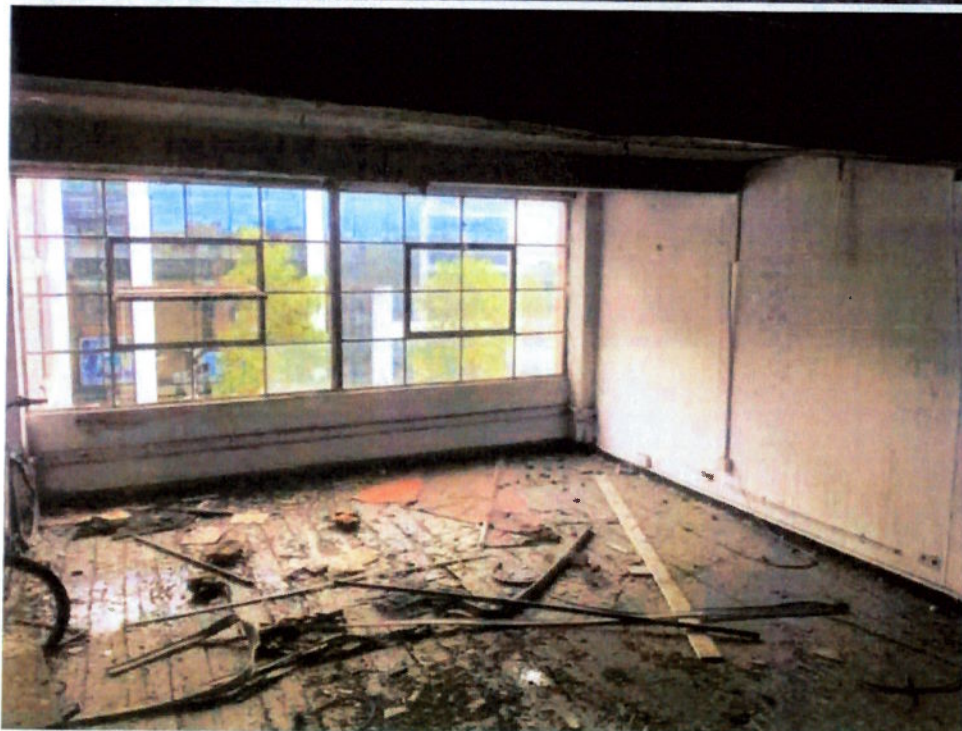
31 Comments

Floor has holes & is dangerous. Access is limited

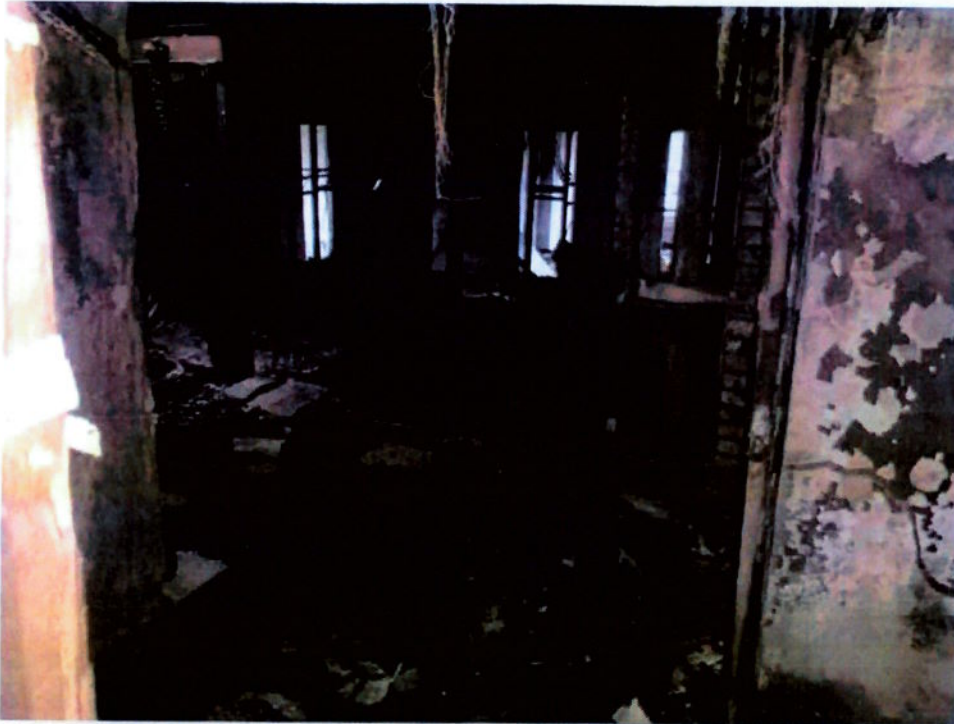
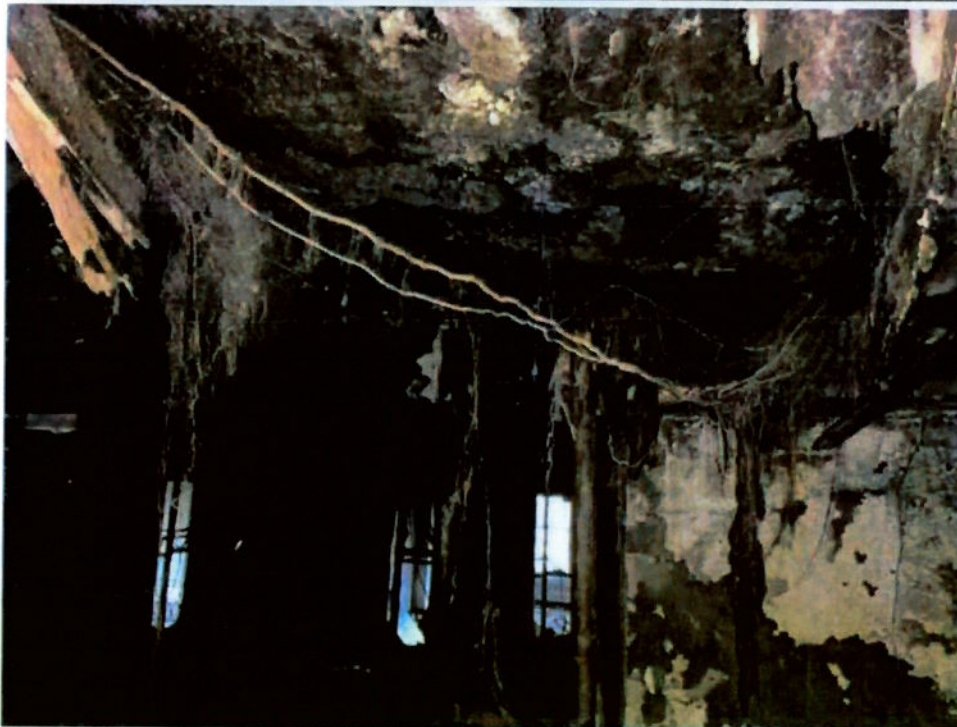
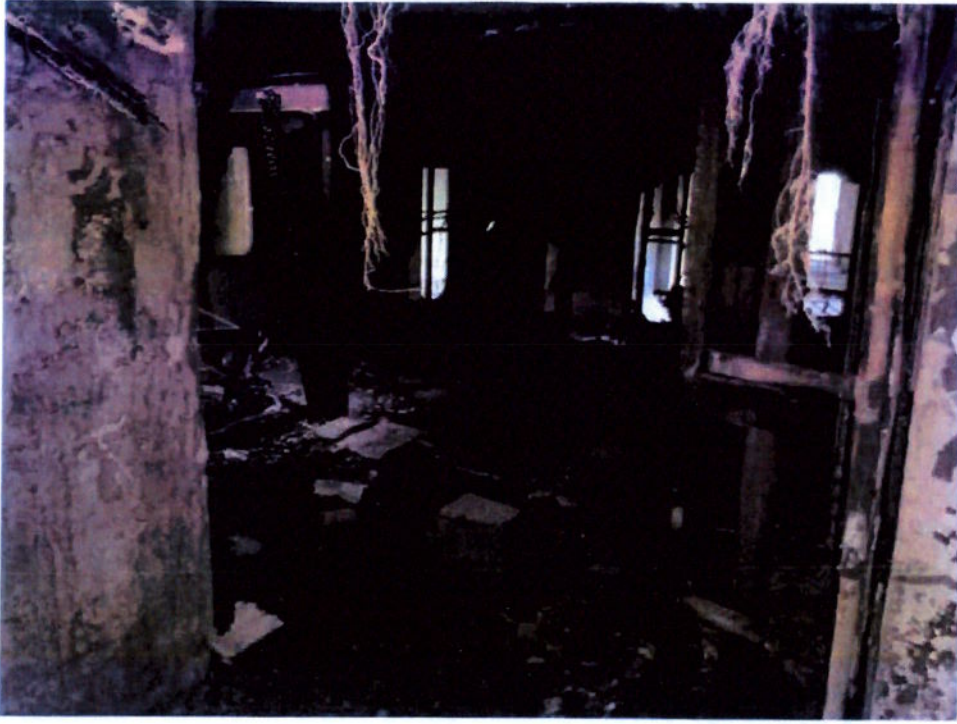
32 Comments

Extensive structural damaged by fire. Evidence of timber charring & smoke damage throughout

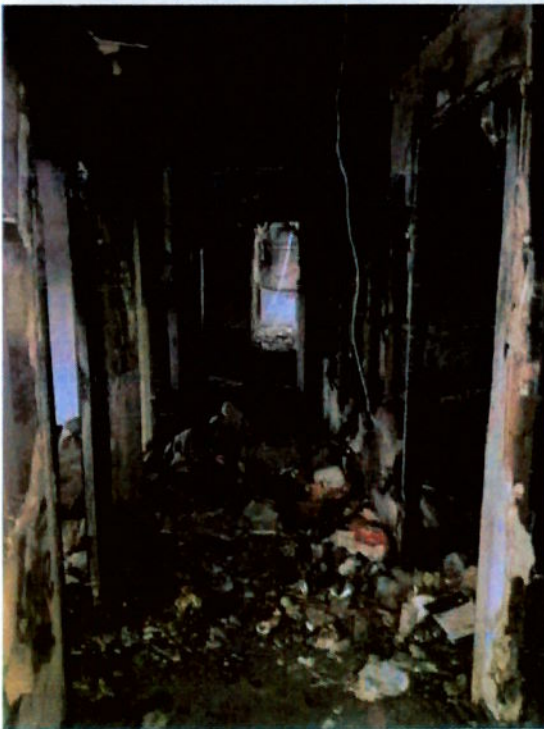
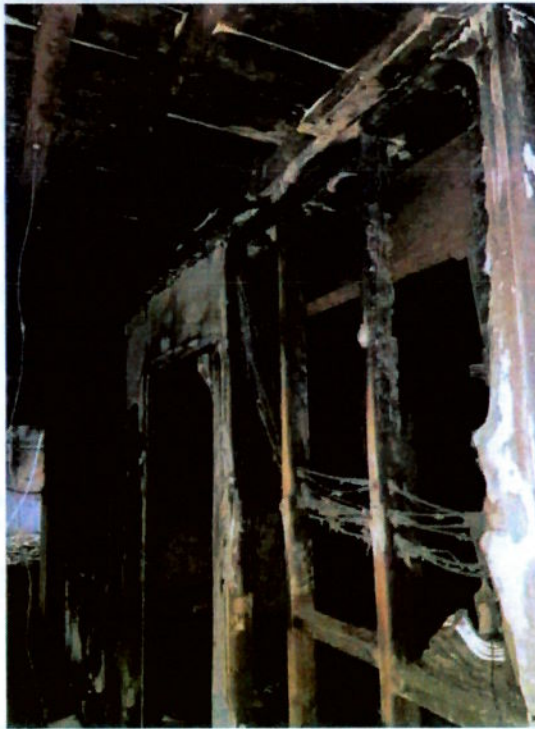
Extensive structural fire damaged & risk of collapse

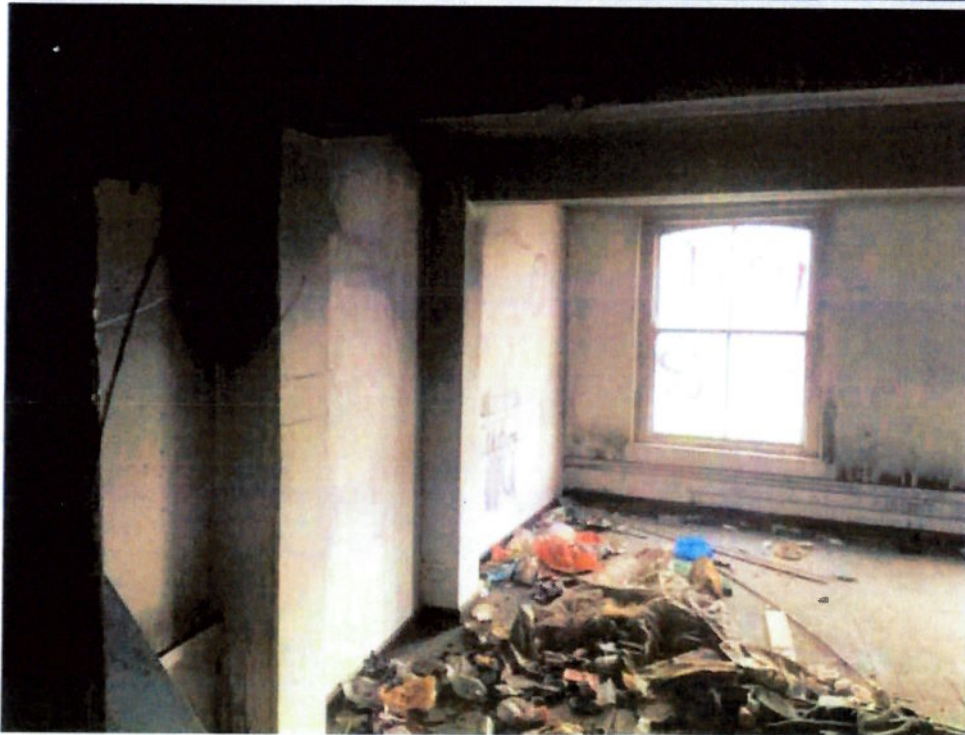
37 Comments

Evidence of illegal occupation or squatting in the building. We have concerns the building is not safe & there is potential for a severe injury or fatality to individuals who are walking on these floors

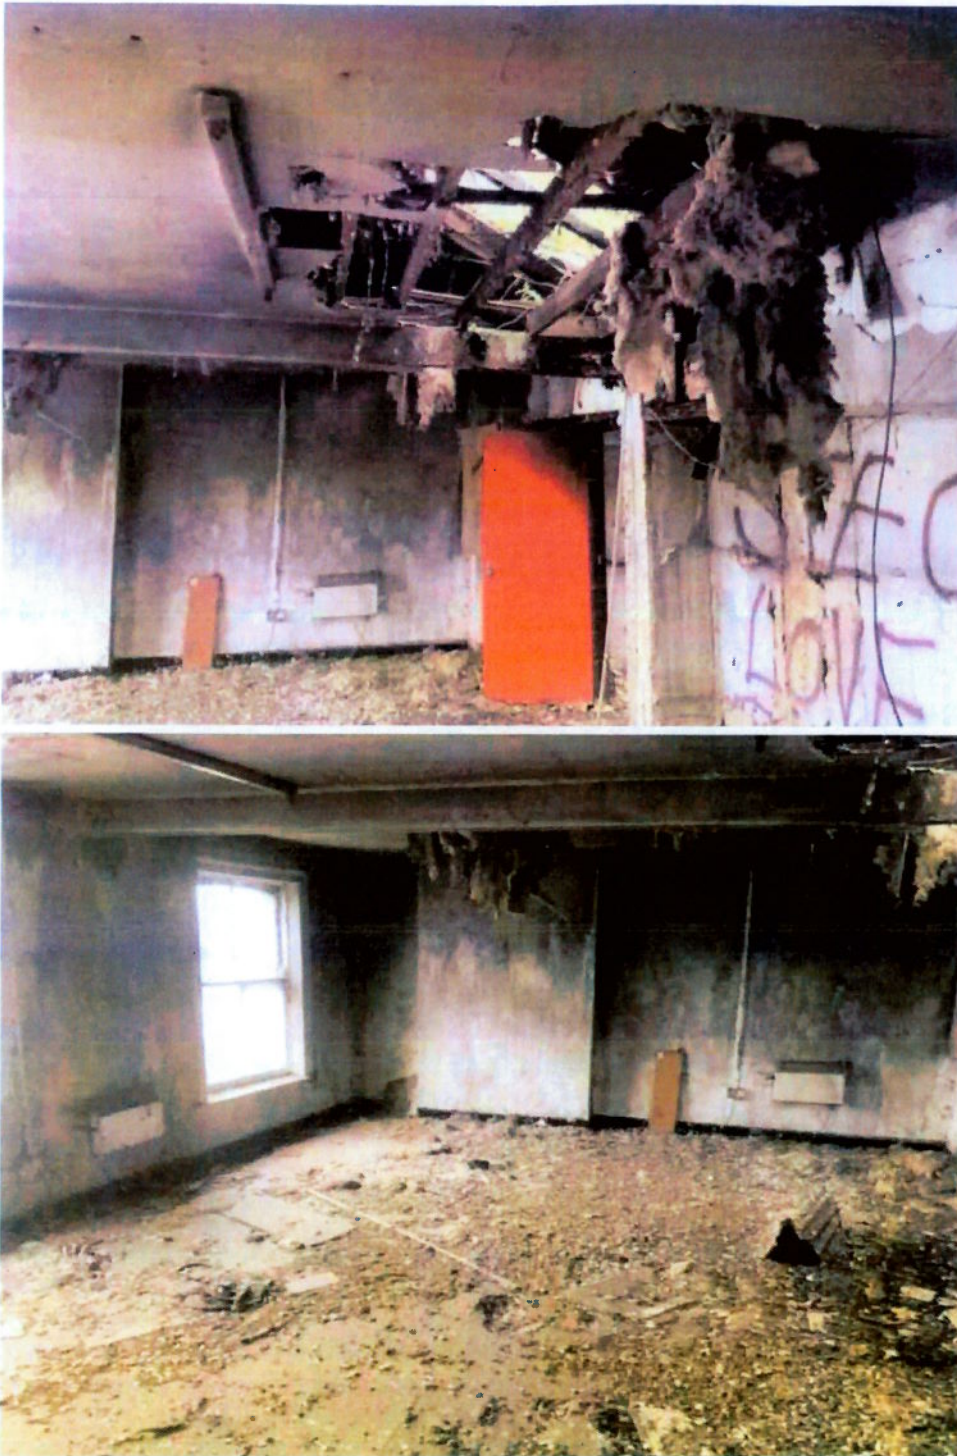
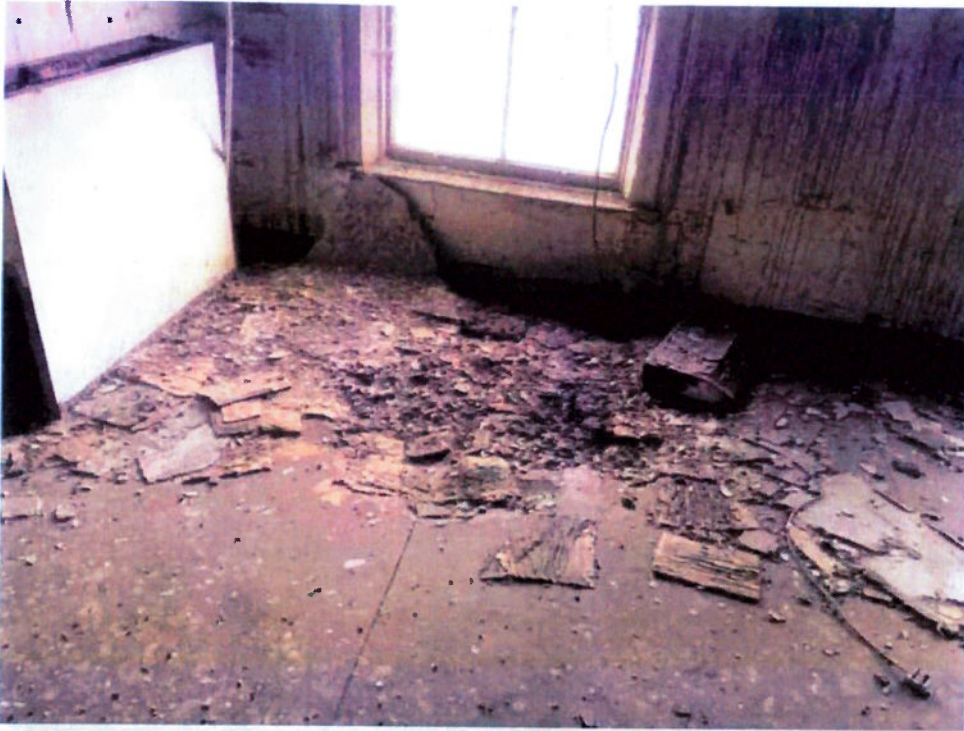
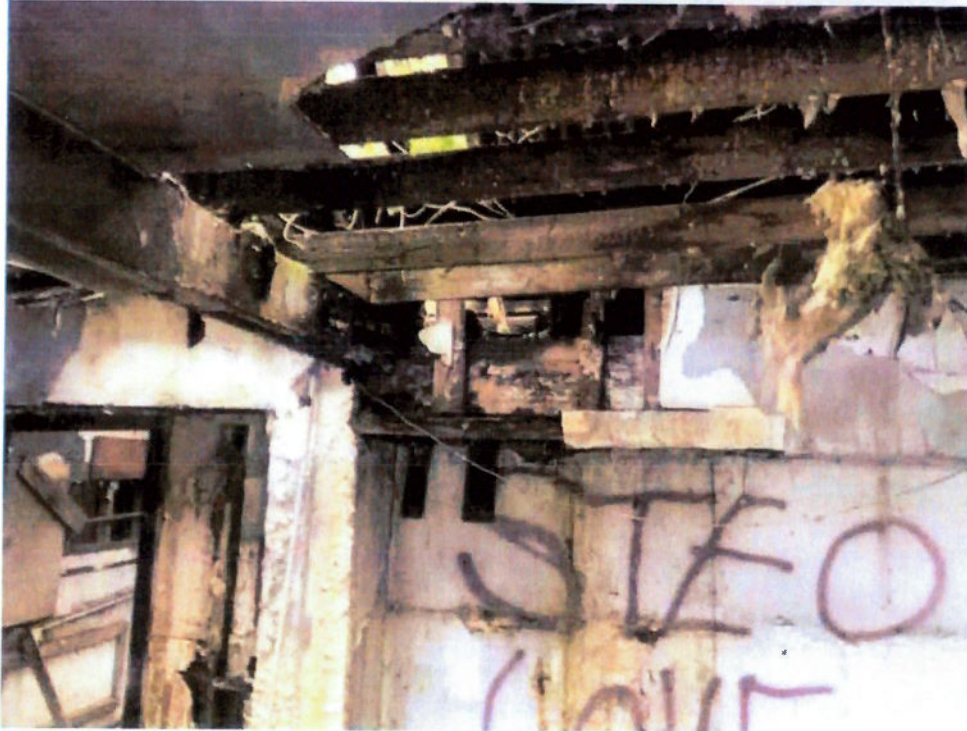
39 Comments

Ceiling and roof overhead has completely perished & at risk of collapse
