**APPENDIX 3: GKCE EXISTING BUILDING STRUCTURAL CONDITION SURVEY**

## 1-6 City Quay, Dublin Existing Building Structural Condition Survey

Address : 1-6 City Quay Dublin

Survey type Condition survey

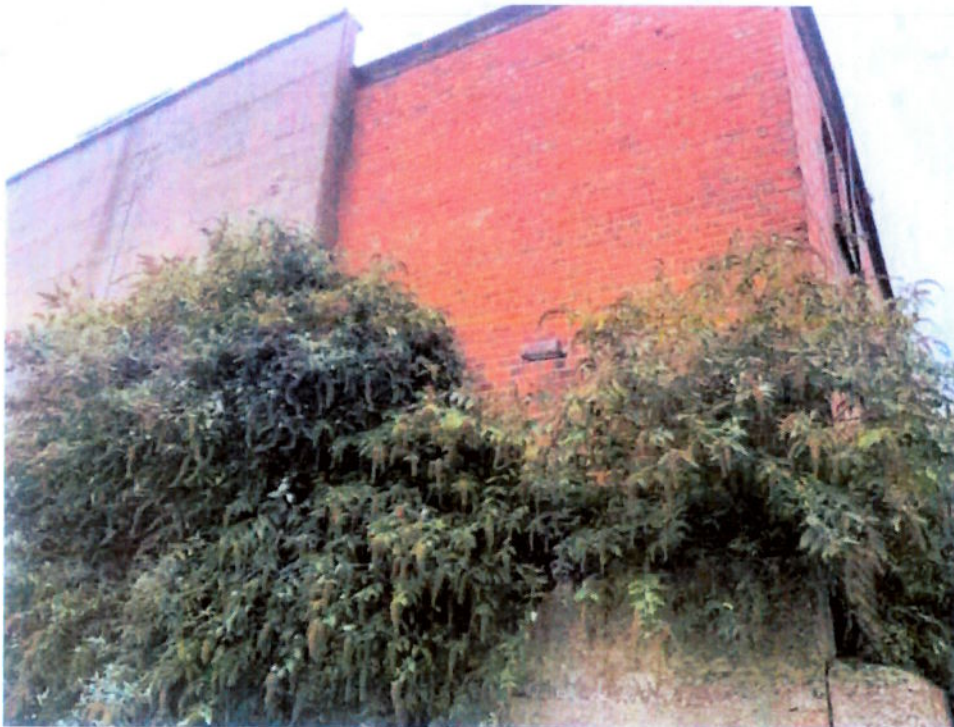
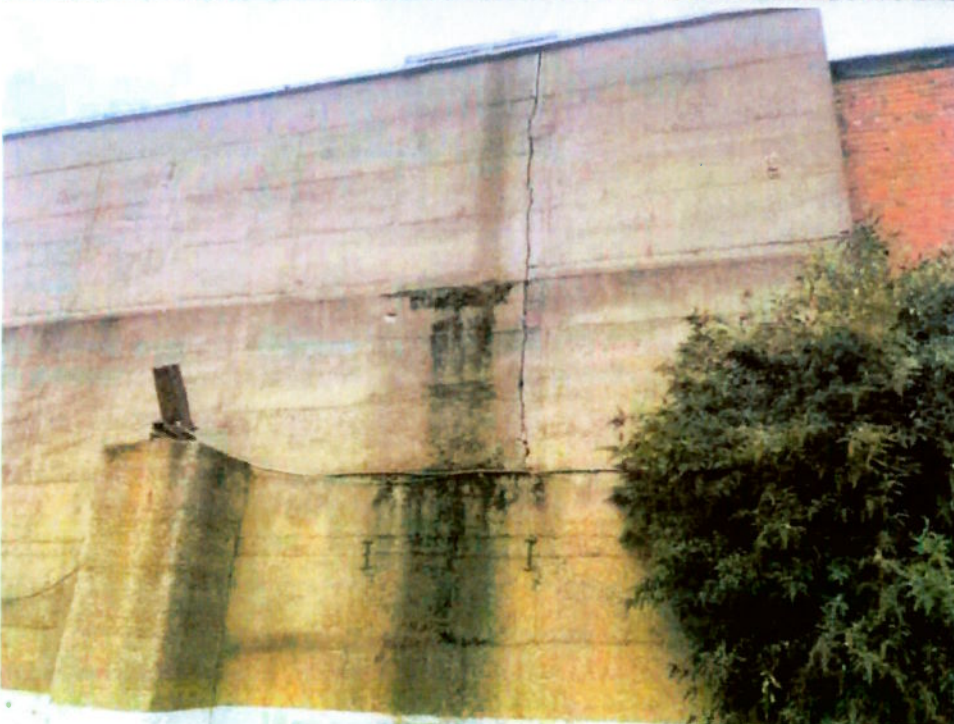
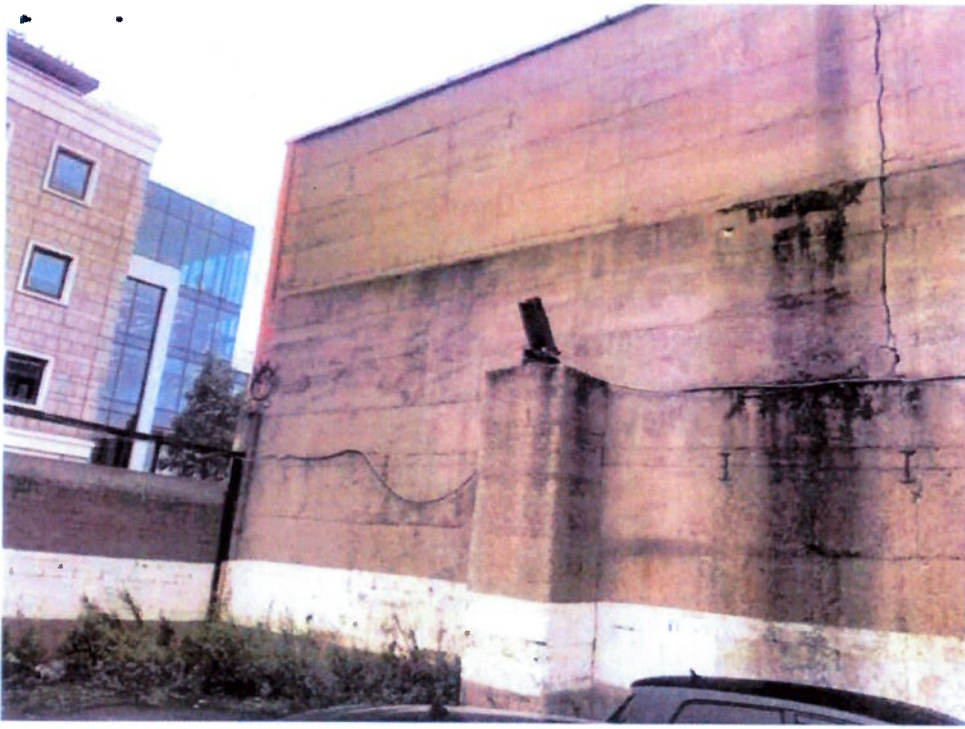
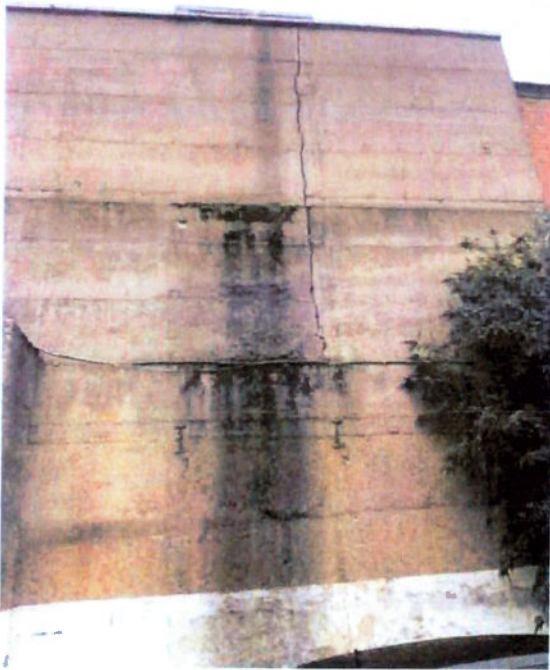
47 Comments

There is a significant structural crack over the full height of the wall. We have concerns the wall has debonded from the building structure & will potentially fall away into the car park. This is a risk to the general public.

We recommend this building is condemned & demolished.

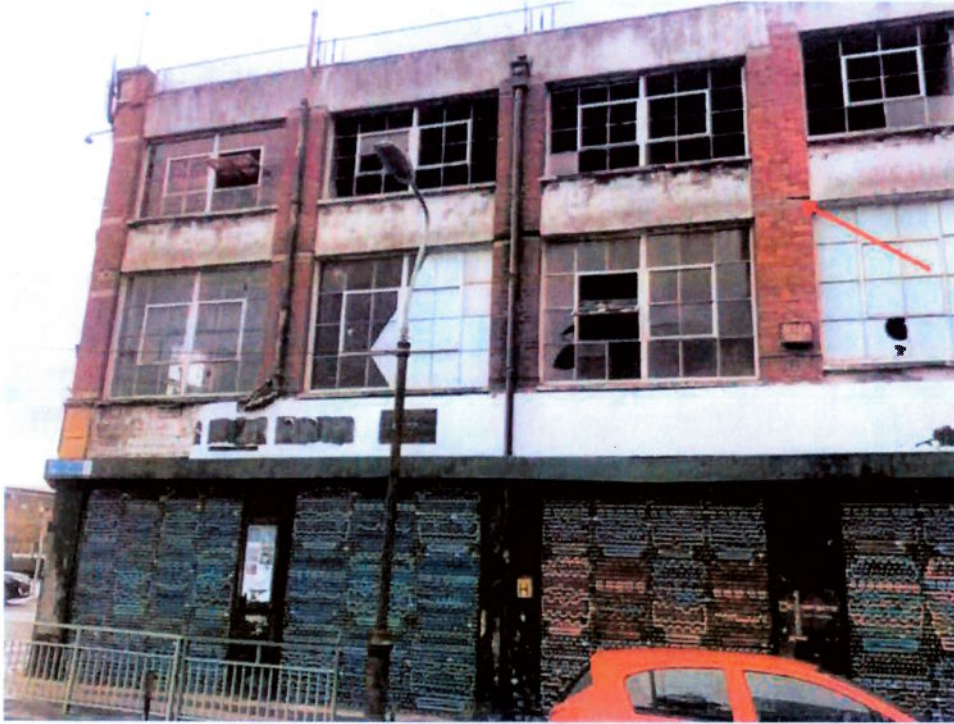
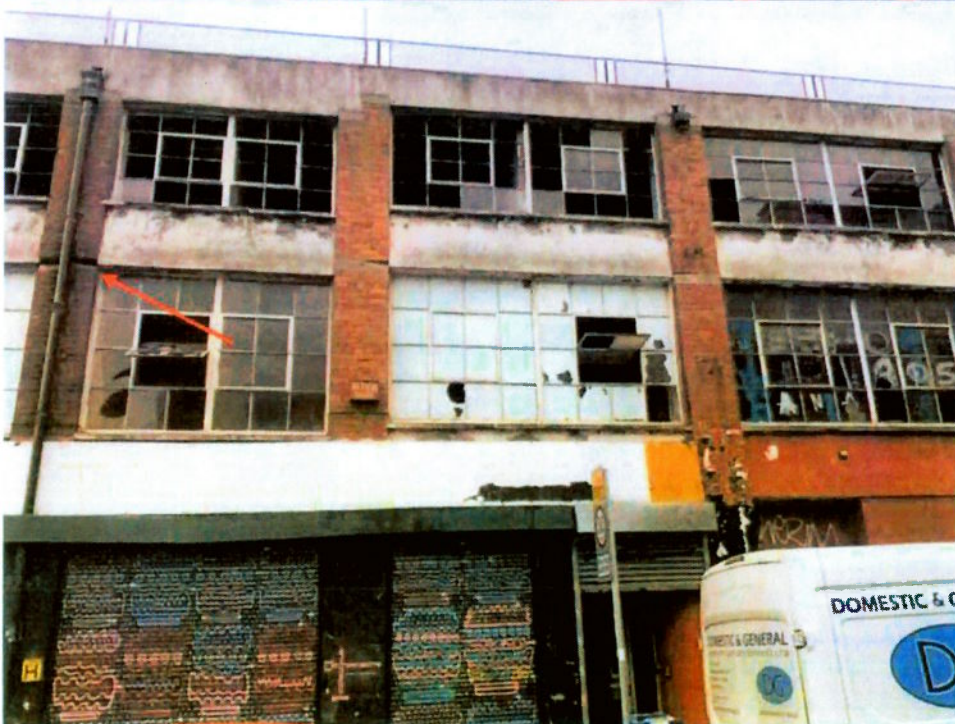
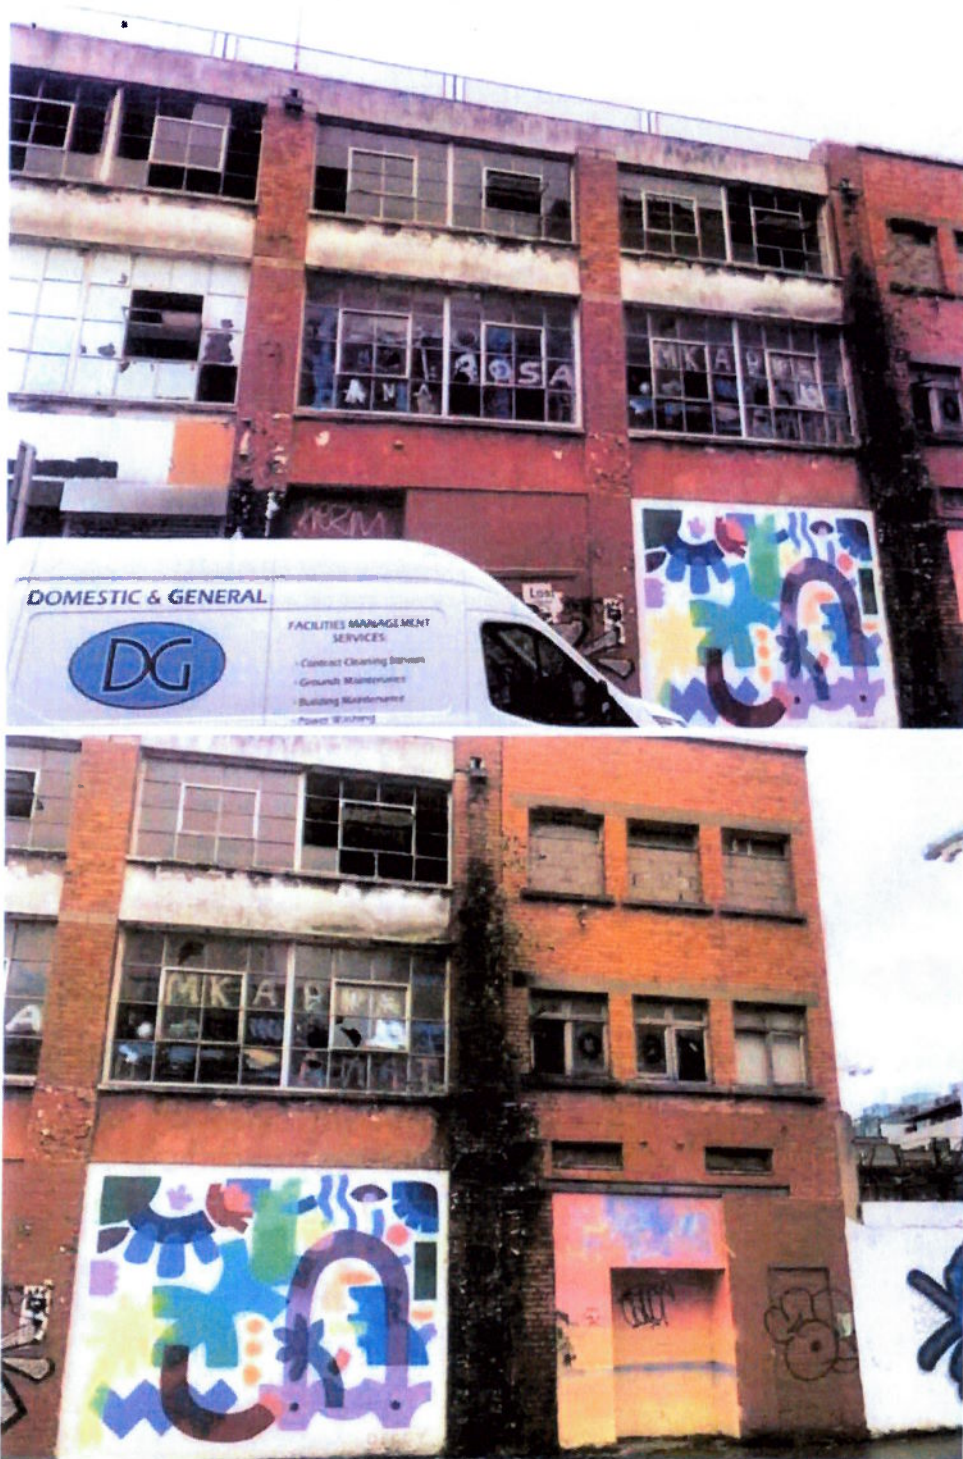
44 Comments

The vertical masonry piers have slipped at second floor level. Masonry has loosened and fallen away in some instances. This is an immediate concern for the building. There is a high risk of collapse of the vertical load bearing piers & danger to the public footpath below.

We regard the condition of this building to be dangerous. A considerable area of the building floor plates have perished & are not capable of loadbearing. In some areas the floors have collapsed under their own self weight. The masonry walls on the external elevations have cracked. On the Moss Street elevation the brick piers have already slipped laterally. We have concerns these piers are not capable of loadbearing. There is a risk to anyone using the public footpath below, of falling debris.

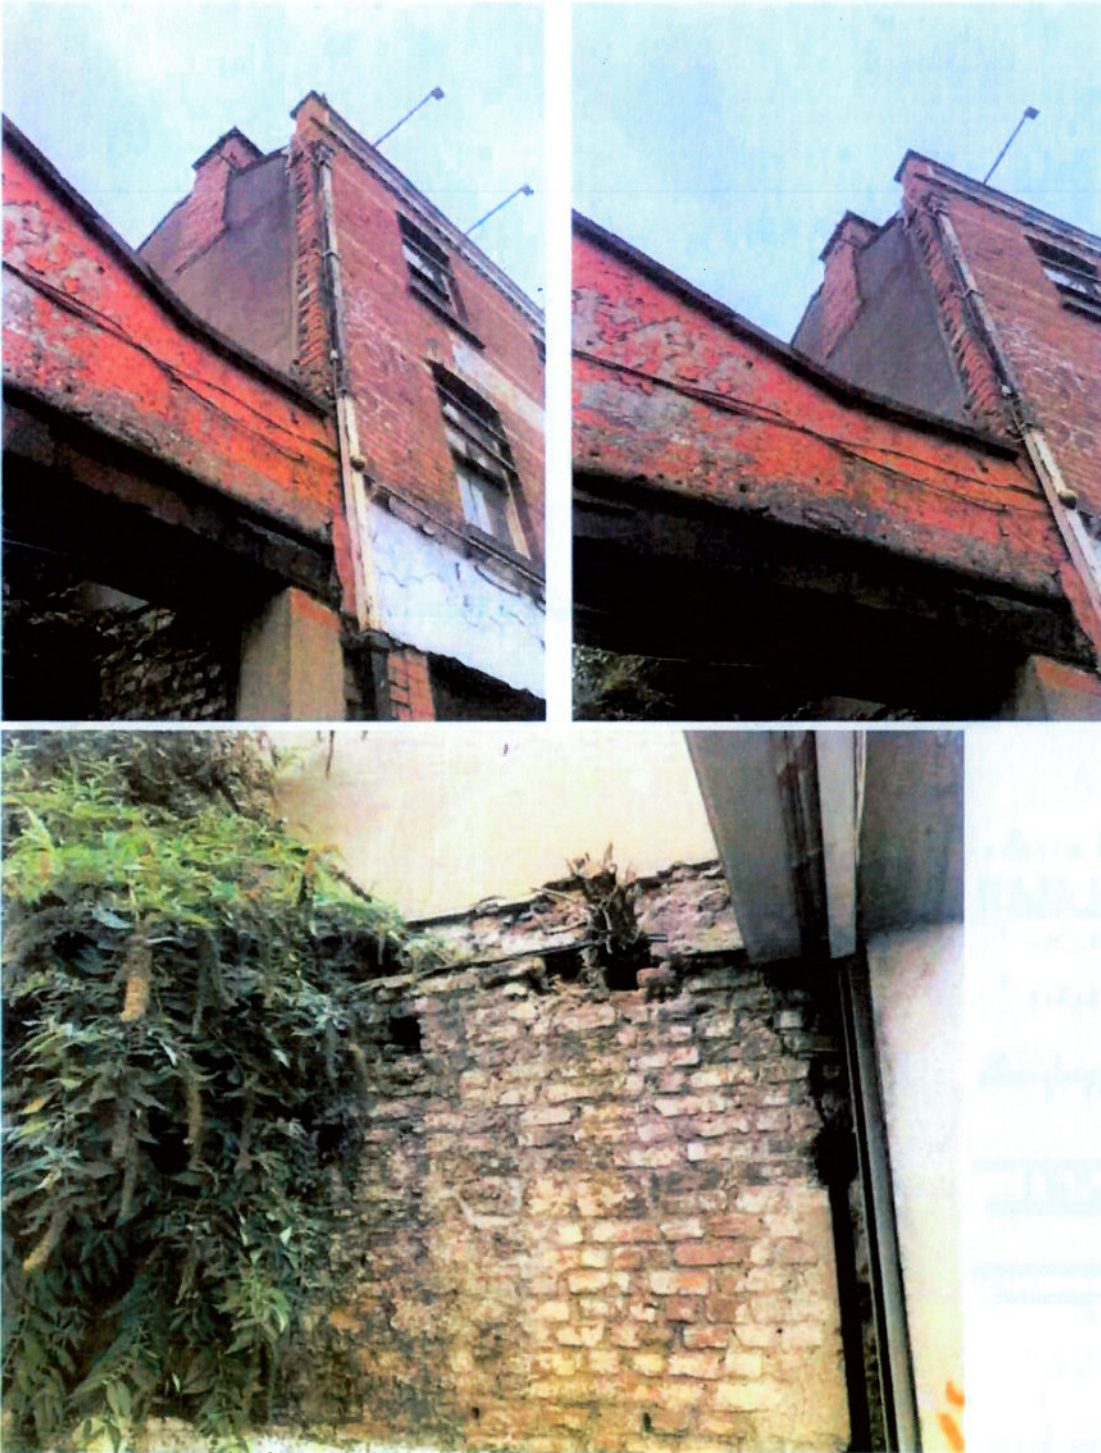
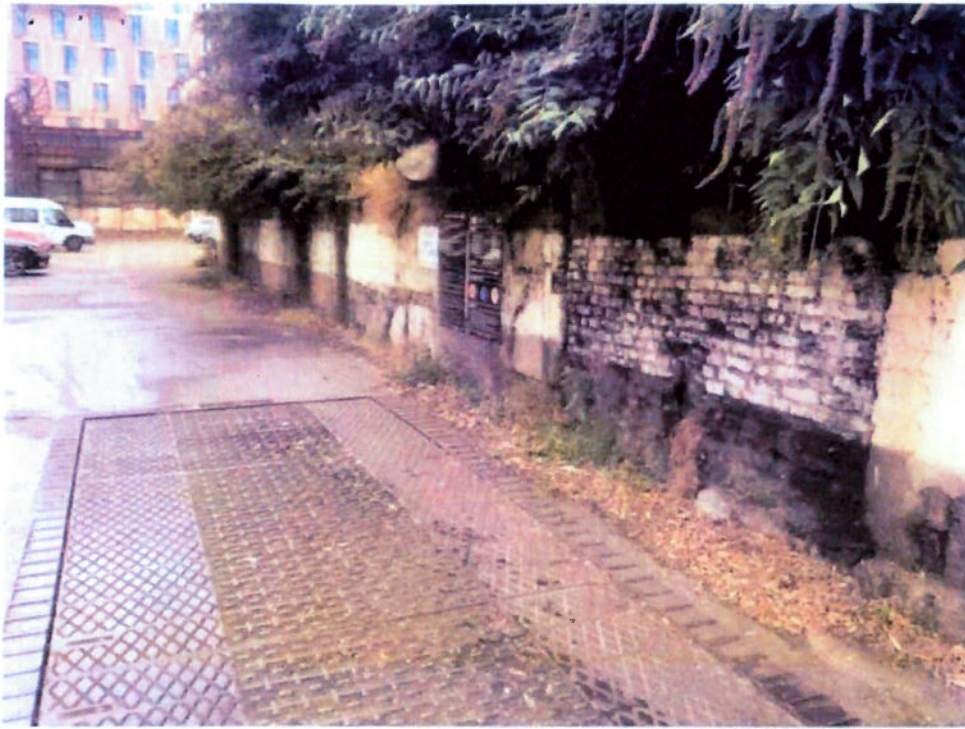
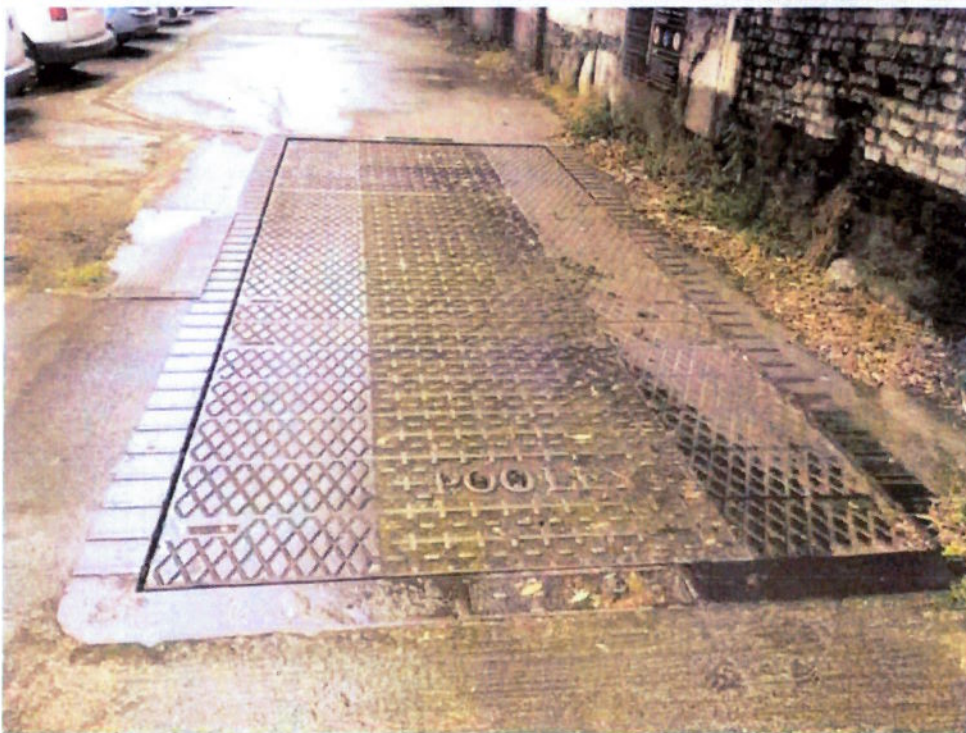
46 Comments

There is evidence of vertical structural cracking on this elevation
