**ARBORICULTURAL ASSESSMENT
&
IMPACT REPORT
DONORE PROJECT**

Project No.
TDON004

Date
21/11/22

Revision
B

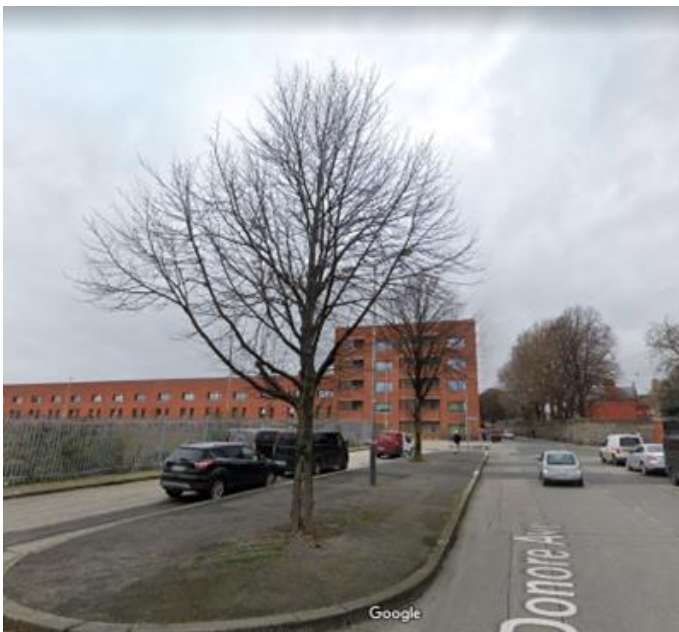
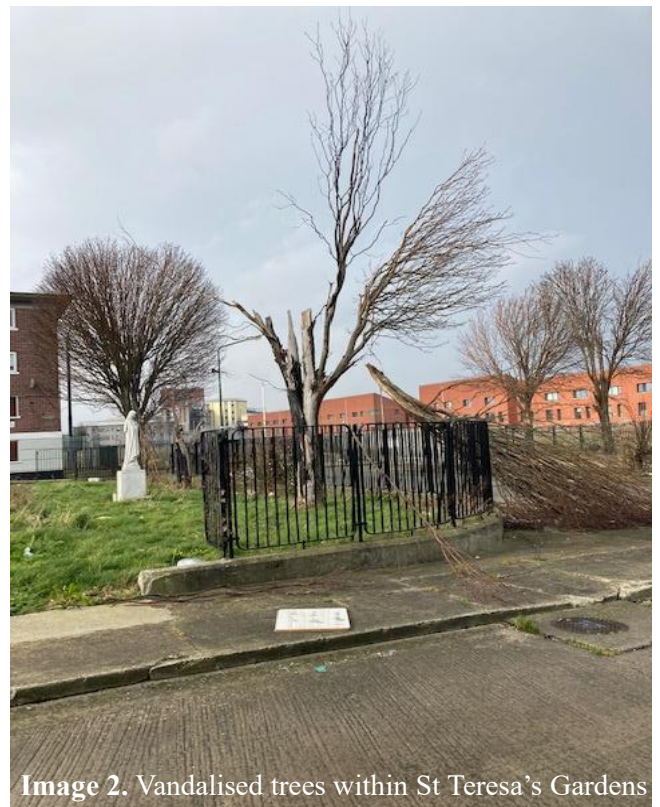
The quality of the trees within St Teresa's Gardens is very poor due to issues around vandalism (image 2) and inadequate management. The trees on Donore Avenue are in good condition overall and form a relatively strong presence within an area of low street tree cover.

Image 2. Vandalised trees within St Teresa's Gardens
