White Hill Wind Farm

Annex 13.1: Stage I Road Safety Audit

White Hill Wind Farm, Co. Carlow

Stage 1 Road Safety Audit

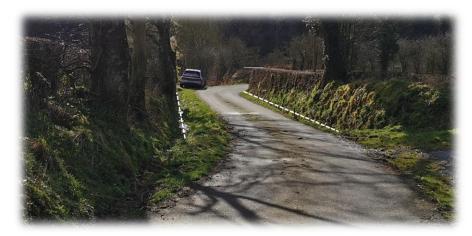
Location: Local Road

2.1 Problem: Open Drain Channels close to Carriageway Edge

Open drain channels are located close to the carriageway edge on both side of the local road between the two proposed access junctions. A large vehicle could enter the drain channel leading to the vehicle becoming trapped or overturning.

Figure 2.1 - Open Drain Channels

Recommendation

Drainage measures should be provided to prevent large vehicles becoming trapped or overturning.

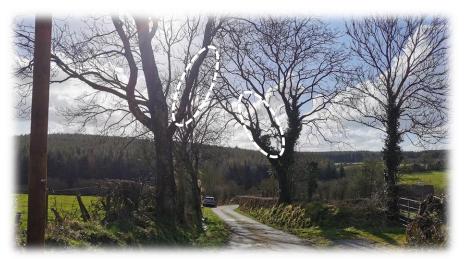
Location: Local Road

2.2 Problem: Trees Overhanging Carriageway

A number of trees located along the local road have branches that overhang the carriageway, this could result in vehicle strikes leading to driver/passenger injury.

Figure 2.2 – Overhanging Trees

Recommendation

Trees generating a hazard should be removed or cut back as appropriate.

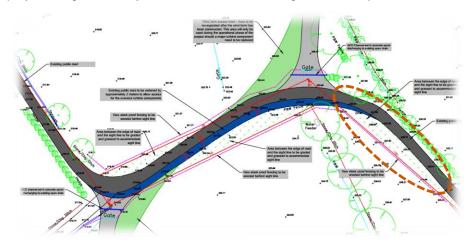
Location: Eastern Access Junction onto Local Road

2.3 Problem: Existing Ground Profile Along Visibility Splay

The existing ground profile to the east of the access junction may result in an obstruction of the visibility splay leading to visibility issues for vehicles exiting the access junction.

Figure 2.3 - Eastern Access Junction Visibility Splay

Recommendation

The ground profile should be graded to ensure the access junction visibility splay is not obstructed.

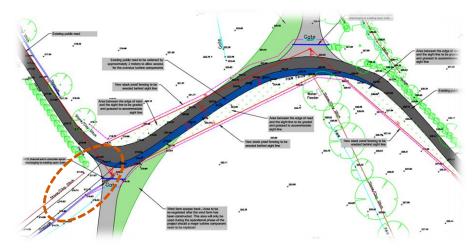
Location: Access Track onto Local Road

2.4 Problem: Access Track Connection

Failing to provide an appropriate interface between the access track and the western access junction could lead to driver confusion and conflict.

Figure 2.4 - Access Track

Recommendation

Provide an appropriate interface between the access track and the western access junction.

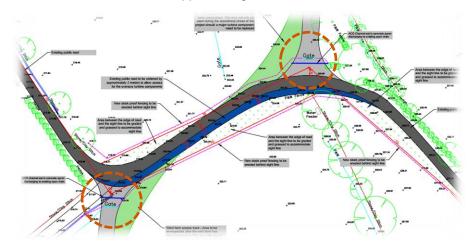
Location: Access Junctions onto Local Road

2.5 Problem: Setback of Access Gates from Carriageway Edge

The set back of the gates at the access junctions may not be sufficient enough to allow a service vehicle to pull in fully off the road. This could result in a service vehicle overhanging onto the local road which would create a hazard for approaching vehicles.

Figure 2.5 - Gate Setback

Recommendation

The gates at the access junction should be set back a sufficient distance to allow a service vehicle pull in without obstruction the local road.
