Appendix 14G  
Bridge Condition Survey

# Structures Visual Inspection Report

Project Tynagh

Project reference: Project Tynagh  
Project number: 60661667

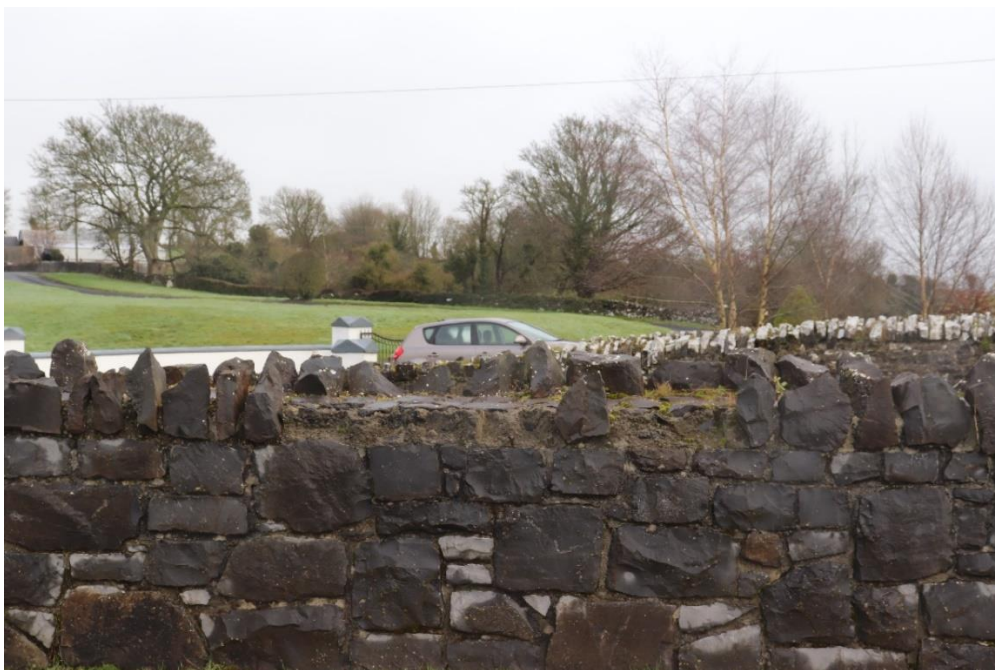
Figure 17 - Loss of Masonry Facing

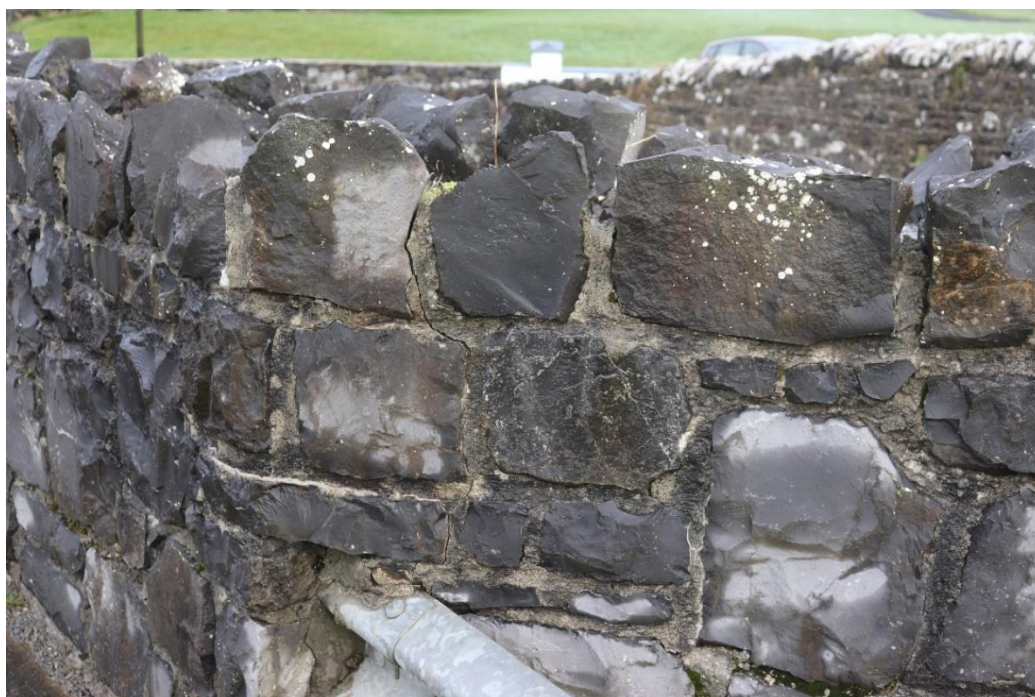
Figure 18 - Cracking of Masonry Pointing

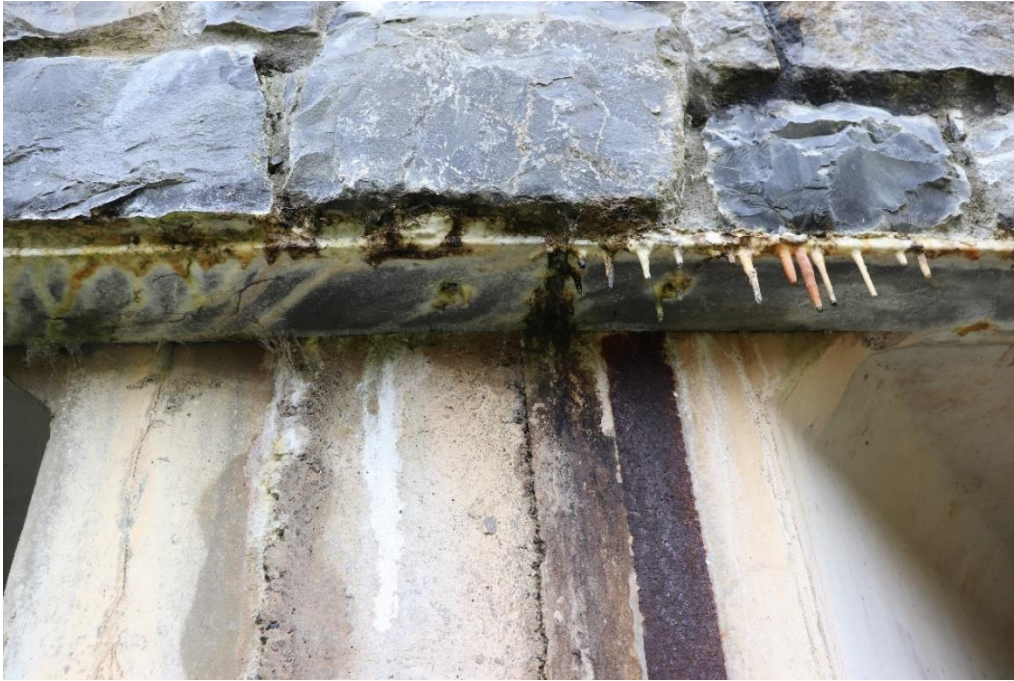
**Figure 19 - Stalactites and Staining on Parapet Edge Beam**

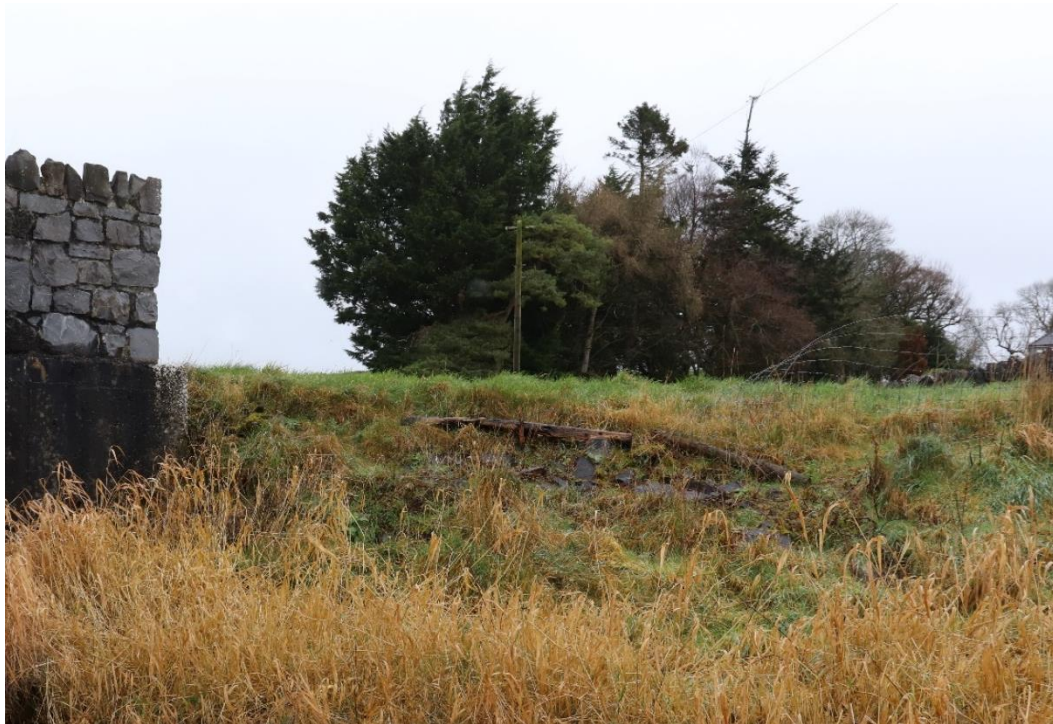
Component No.	Component	Condition Rating	Maintenance Required	Defect Type	Photos	Comments	
1	Bridge Surface	0	Y	-	Y	Surfacing over bridge structure was found to be in good condition with no defects noted, see Figure 7 in Appendix A.	
2	Expansion joint	N/A	N/A	N/A	N/A	Not applicable to this structure in Appendix A.	
3	Footway / Median	0	Y	-	Y	No defects were noted to the concrete verges over the structure from inspection, see Figure 7 and Figure 8 in Appendix A.	
4	Parapet/safety Barrier	2	Y	32 45	Y	Inspection of parapets was undertaken from the bridge deck and riverbed on east side of the bridge. Minor defects noticed including loss of masonry facing and cracking of the pointing. A number of stalactites with staining have formed on the parapet edge beam. See Figure 8, Figure 17, Figure 18 and Figure 19 in Appendix A.	
5	Embankments / Revetments	2	Y	26	Y	Timber post and wire fencing has fallen on both the north and south embankments on the east side of the bridge. A large PVC pipe was lying on the south east embankment and extending into the river. See Figure 15, Figure 20 and Figure 21 in Appendix A.

**Figure 20 - Fallen Timber Post and Mesh Fence**

Maintenance Actions
From inspection of the structure it is advised that the following maintenance actions are undertaken; - Repair rubber filler along horizontal joint in the portal legs; - Repair/replace the timber post and wired fencing along the crest of the river embankment; and - Removal of calcite build-up from parapets and joints.
Inspector's Comments
Inspection of the top surface of the bridge and the parapets was carried out from the bridge deck. Inspection of the substructure elements was carried out from the riverbed and embankments on the east side of the bridge. Due to high water levels, a heavy flow in the river and protective fencing, access to the embankments and riverbed on the west side of the bridge was not possible. From the limited visibility granted from the road level the condition at the west side of the bridge appeared similar to the east side. From inspection the structure appeared to be in good condition with no visible signs of significant distress to the structure or its primary elements.

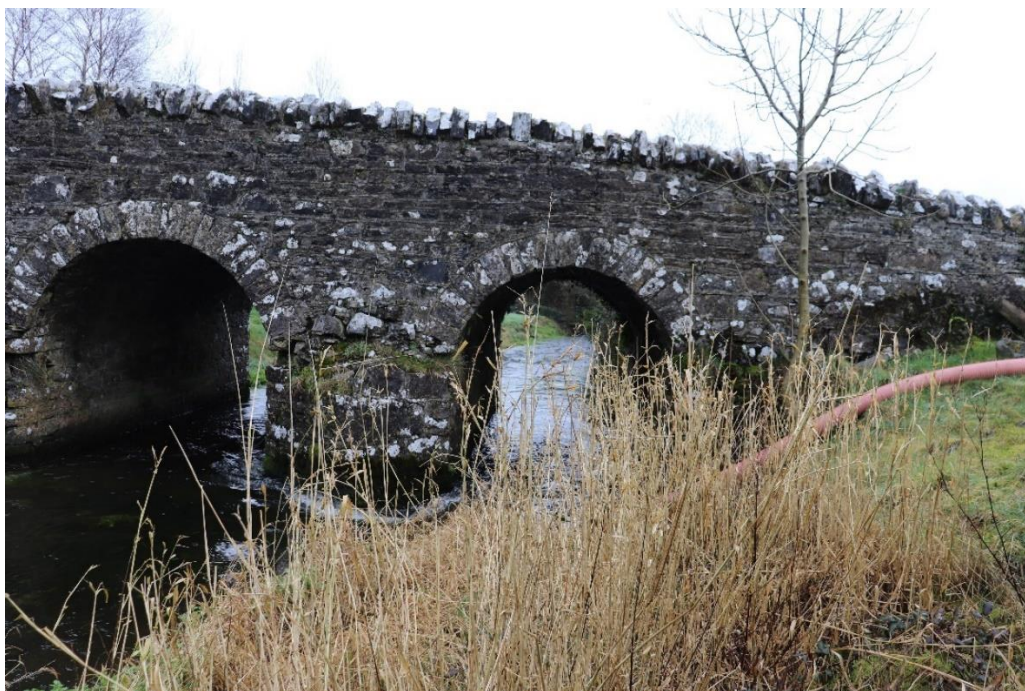
**Figure 21 - Pipe on River Embankment Downstream of ST01 (Masonry Arch Bridge visible here is parallel to ST01 and not included in this inspection)**

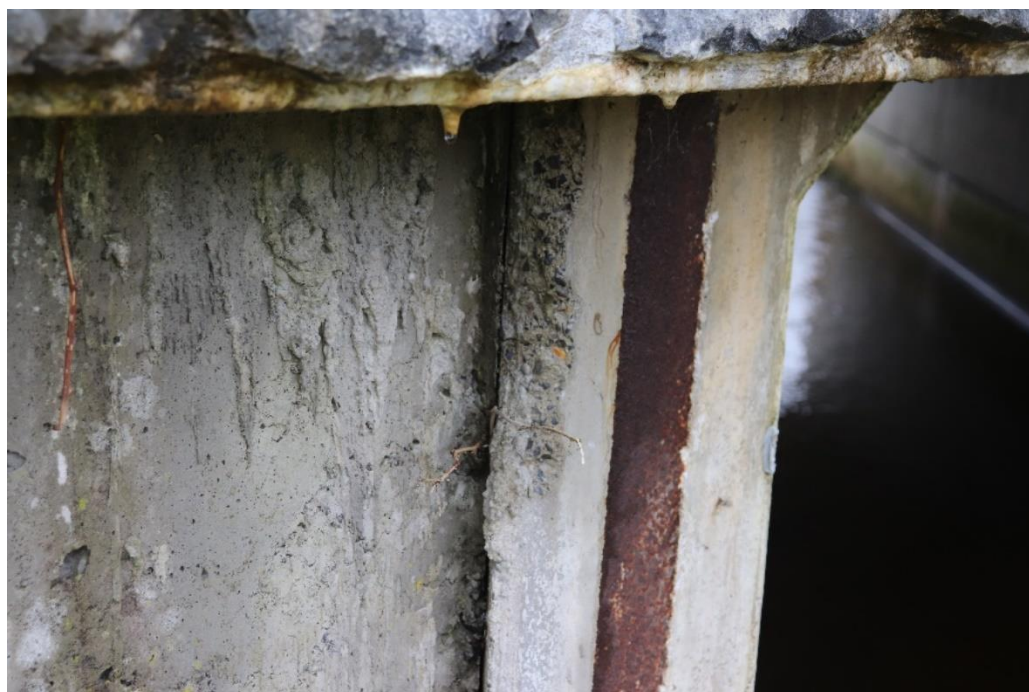
Component No.	Component	Condition Rating	Maintenance Required	Defect Type	Photos	Comments
6	Wingwalls / Spandrel Walls / Retaining Walls	0	Y	-	Y	Wing walls to structure were found to be in good condition. See Figure 15 and Figure 16 in Appendix A.
7	Abutments	2	Y	12 17 20 23 35	Y	South Abutment had visible structural damage at the joint with the wingwall. In addition, loss of rubber filler has occurred at the horizontal joint in the portal leg. Minor spalling and structural damage noted on the north abutment leg, although no visible rebar. There is a noticeable difference in the south abutment leg between the eastern and western sides of the vertical joint. See Figure 22 to Figure 27 in Appendix A.
8	Piers	2	Y	10 13 23	Y	Minor vertical cracking is present on the extreme east end of the north pier. Some minor concrete loss on the south pier. Heavy leaching with rusting/carbonation indicators (red/brownish colour) were noted in a number of areas on the piers, concentrated around gaps in the rubber filler in the portal legs and at the vertical joints between the portal units. There is a noticeable difference in the north pier between the eastern and western sides of the vertical joint. See Figure 28 to Figure 31 in Appendix A.

**Figure 22 - Damage and Concrete Loss to South Abutment**

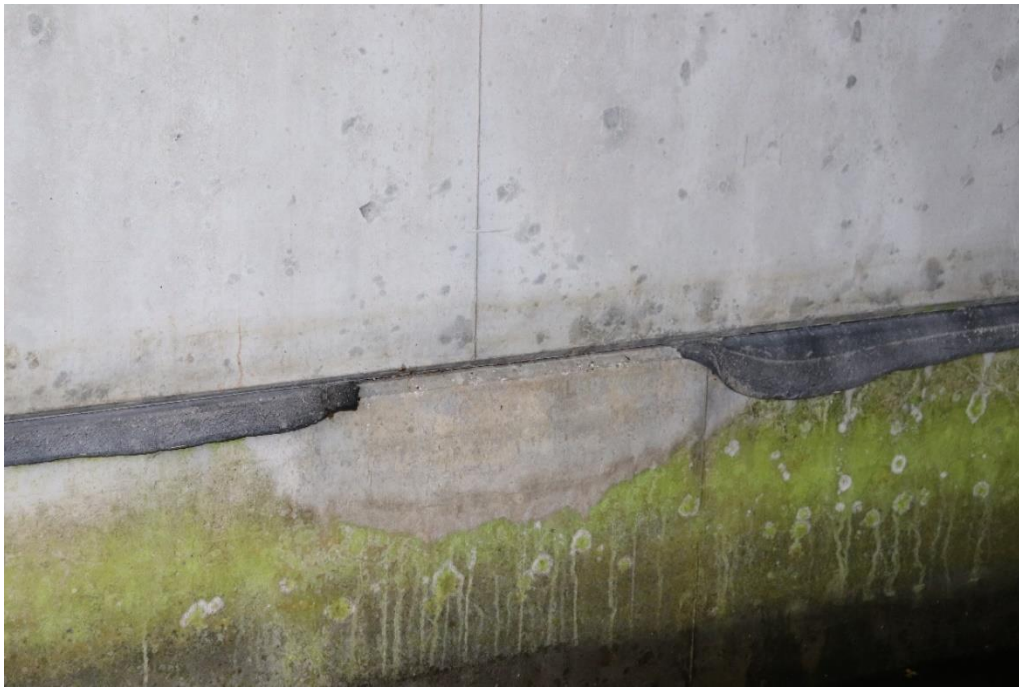
**Figure 23 - South Abutment Joint Filler Loss**

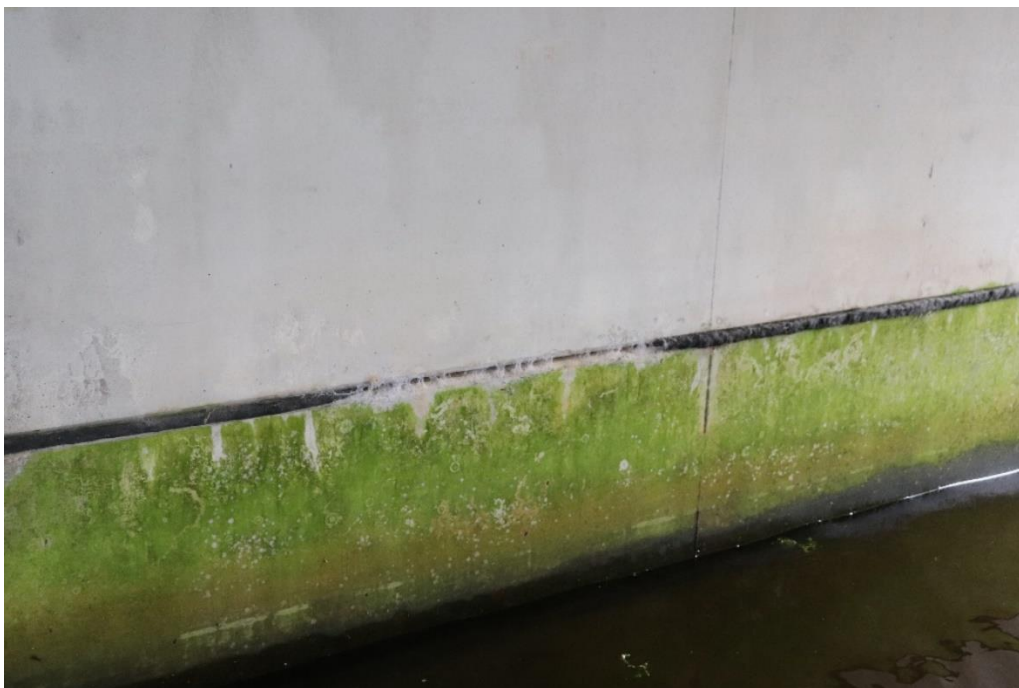
**Figure 24 - South Abutment Additional Joint Filler Loss**

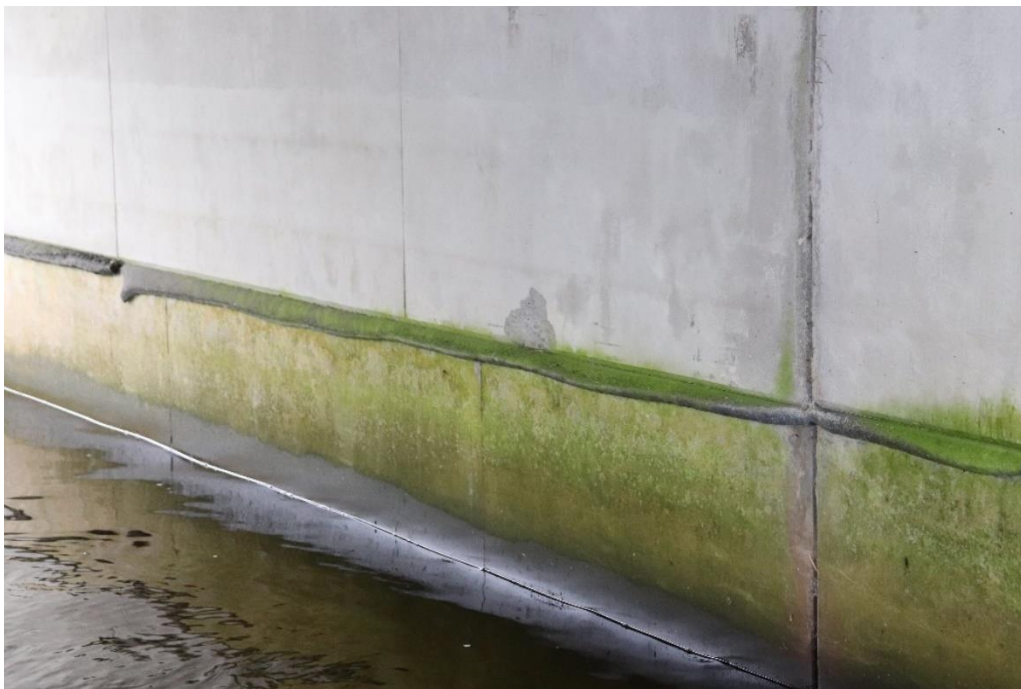
**Figure 25 - Spalling of Concrete on North Abutment**

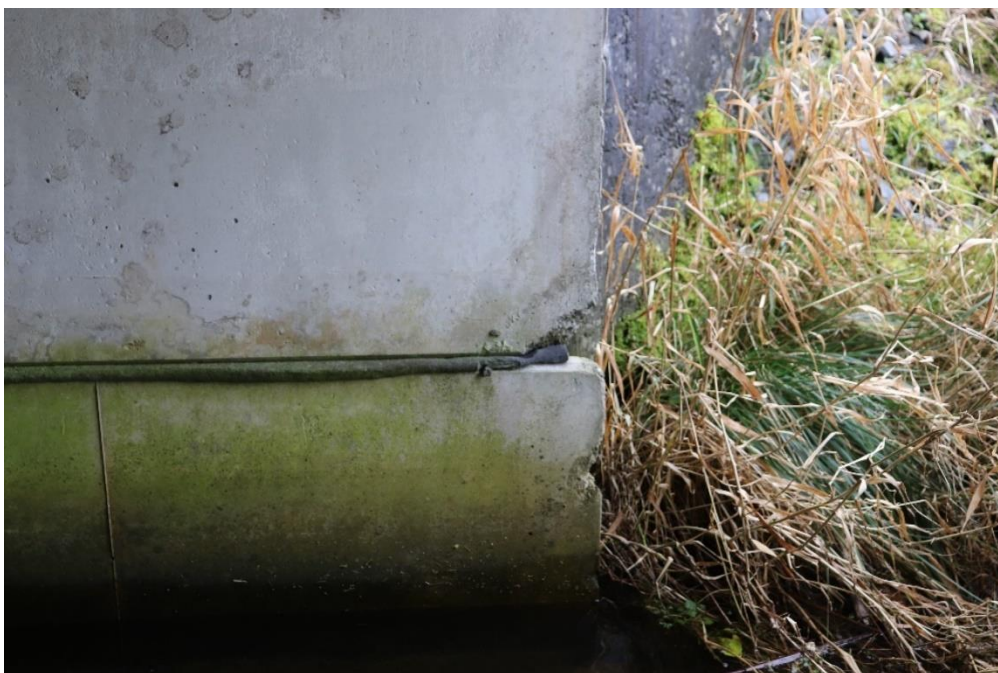
**Figure 26 - Damage and Concrete Loss to North Abutment**

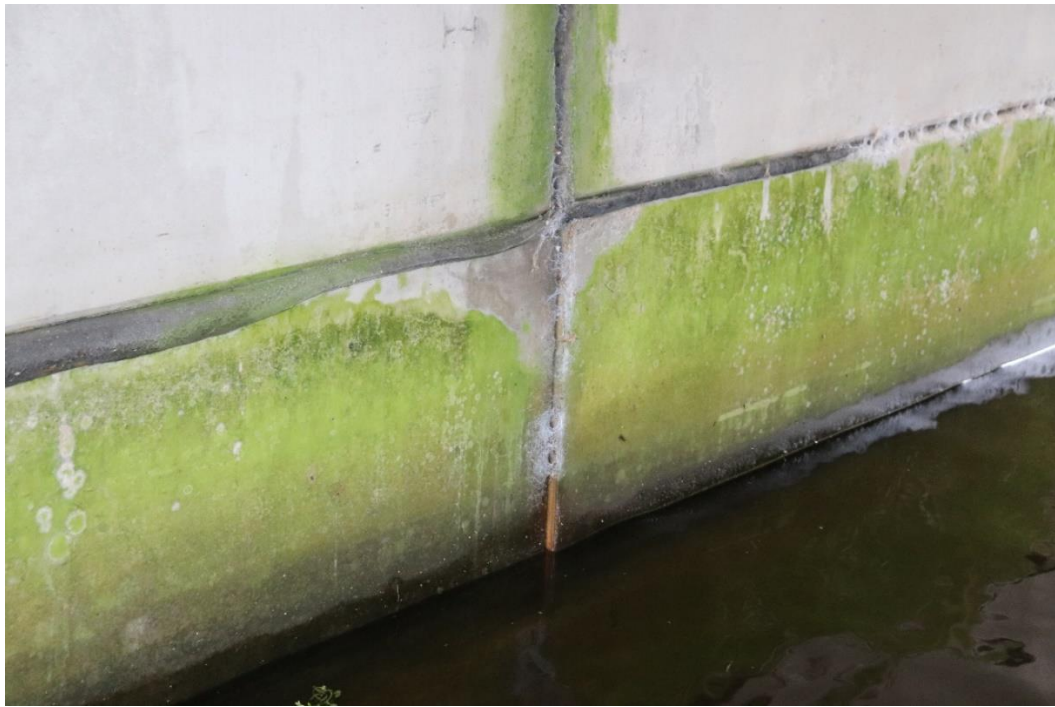
**Figure 27 - Position Difference in South Abutment at Vertical Joint**

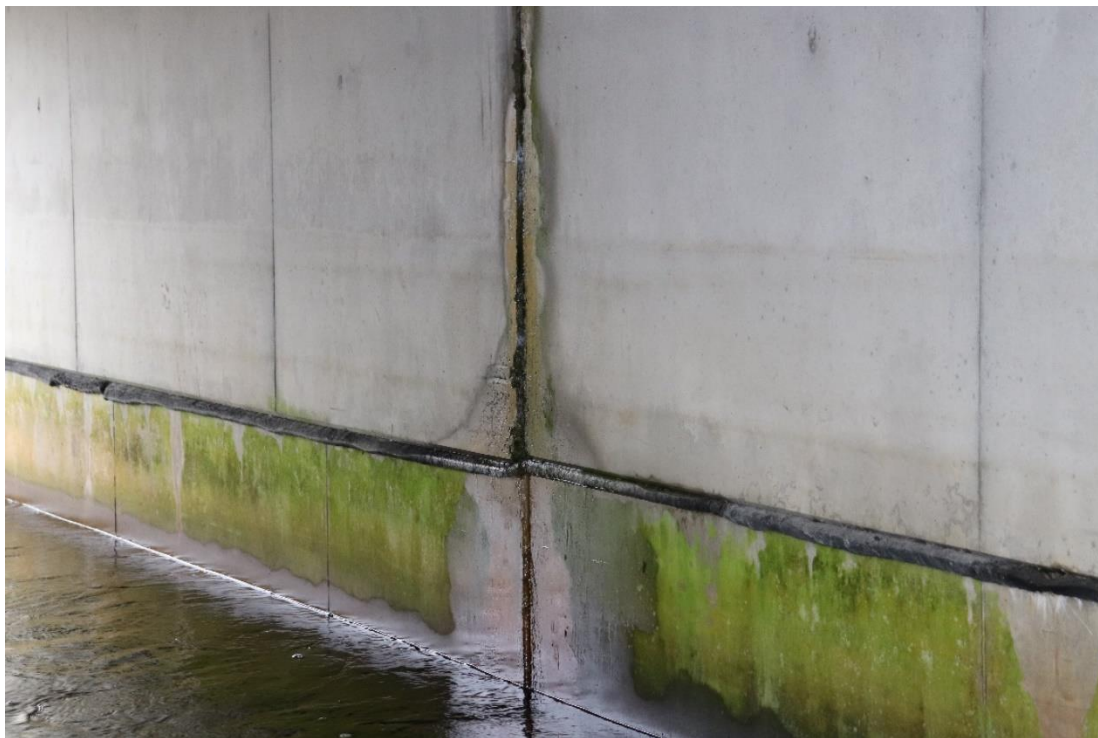
**Figure 31 - Position Difference in North Pier at Vertical Joint**

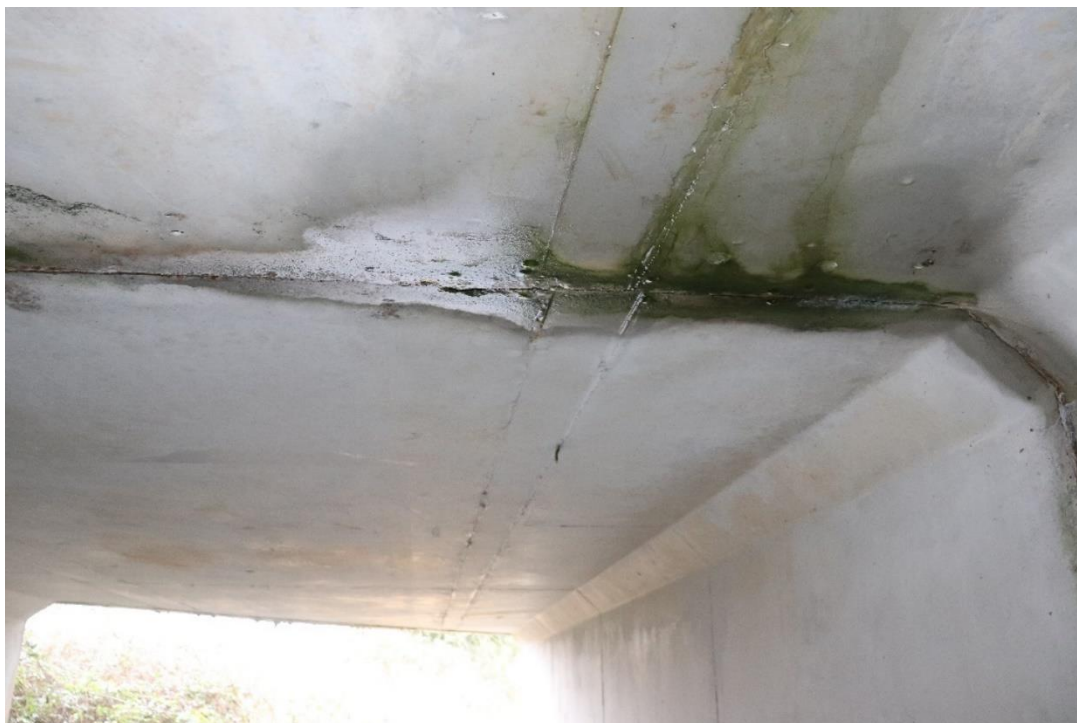
9	Bearings	N/A	N/A	N/A	N/A	Not applicable to this structure.
10	Deck/Slab	1	Y	17 22	Y	No defects noted to the deck soffit of the structure. It was visible from the riverbed that water can seep through the deck at the main joint location, leaching onto the soffit causing staining. One very minor area of concrete loss was noted. See Figure 32 and Figure 33 in Appendix A.
11	Beams / Girders / Transverse Beams	N/A	N/A	N/A	N/A	Not applicable to this structure.
12	Riverbed	1	Y	26 36	Y	Riverbed was generally in good condition. Immediately upstream and downstream of the bridge, vegetation build-up is restricting the channel capacity. Silt build-up was noticed in the north and south spans. See Figure 5 and Figure 6 in Appendix A.
13	Other Elements	0	Y	12 35 38	Y	Vertical steel strips are visible in the end elevation of all portal legs which are now heavily rusted. Their purpose is unknown. Concrete cover of the steel strip on the north abutment has spalled from the surface. See Figure 11, Figure 12 and Figure 34 in Appendix A.

**Figure 32 - Leaching and Water Seepage on Soffit of South Span**

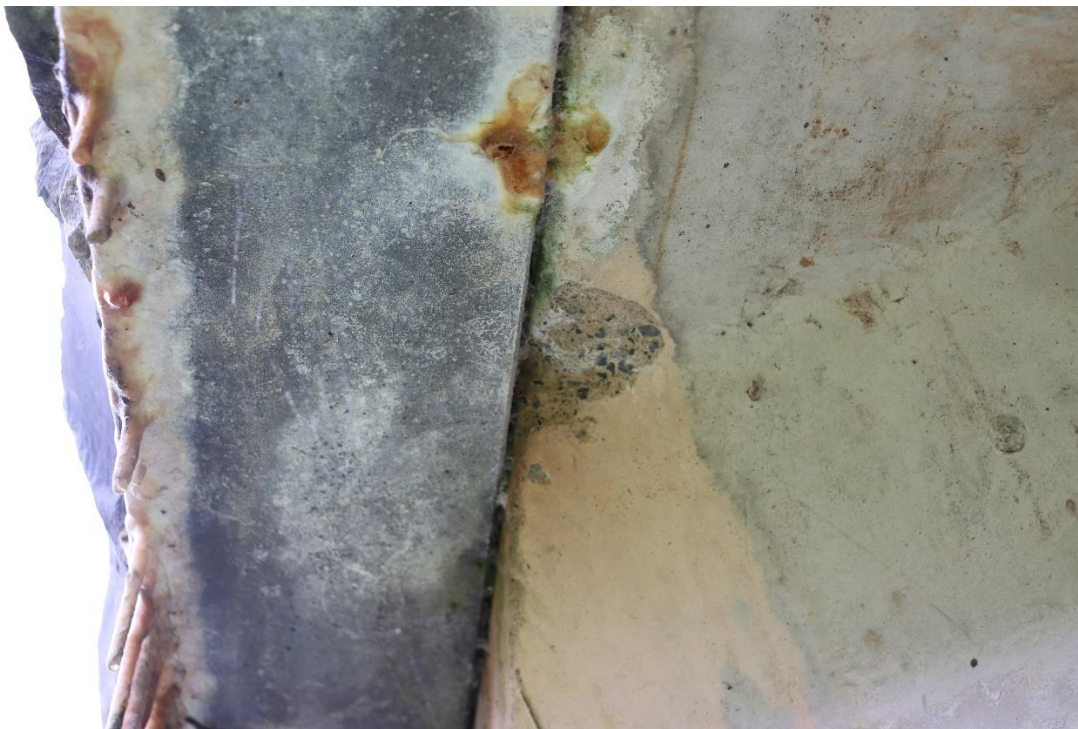
**Figure 33 - Damage and Concrete Loss to Soffit of North Span**

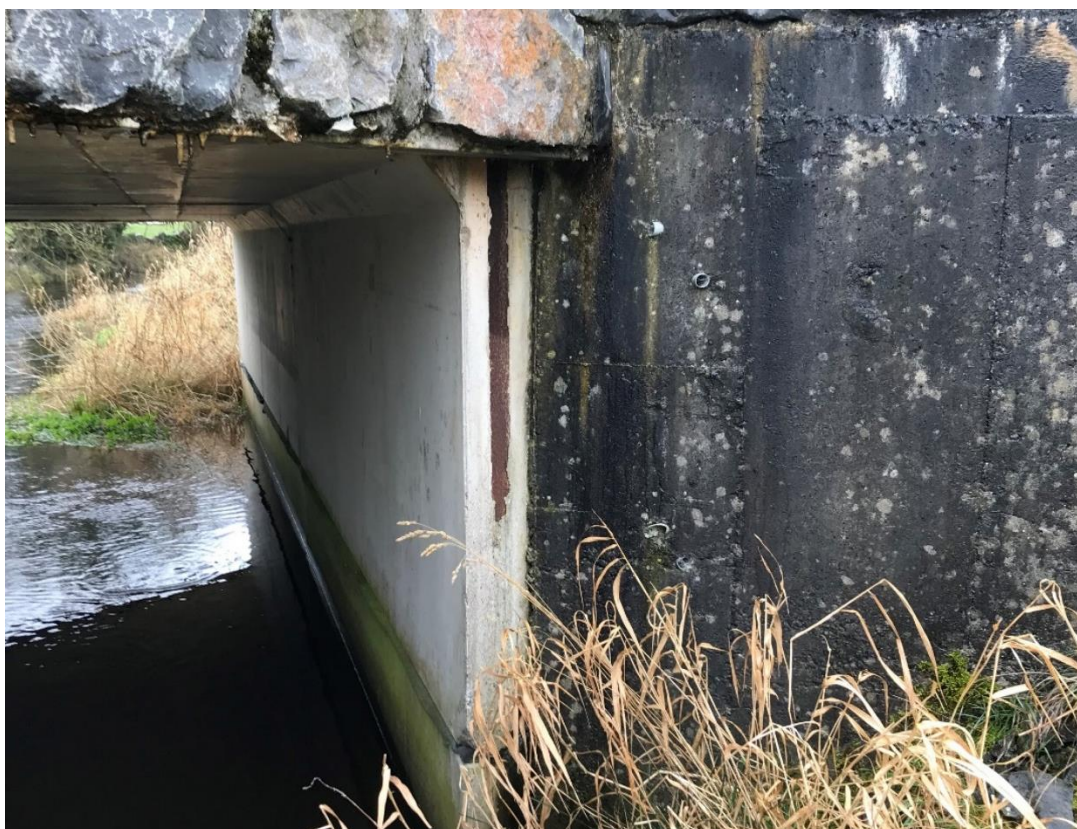
**Figure 34 - Concrete Spalling around Corroded Steel Strips**

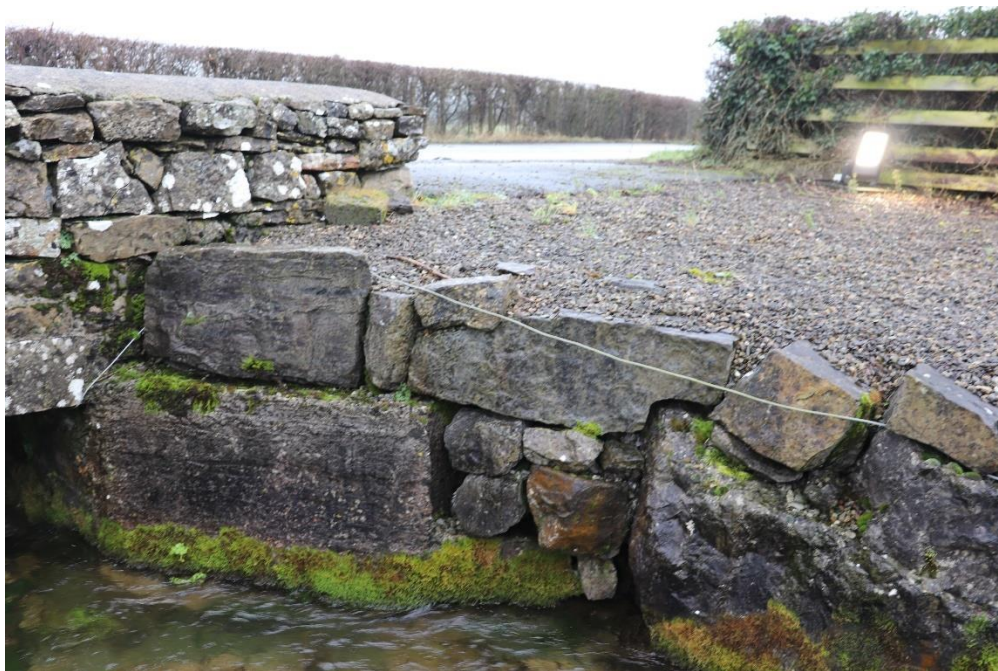
7	Abutments	2	N	26	Y	Abutments to the structure were found to be in good condition with some vegetation growth, see Figure 40 and Figure 48 in Appendix B. Access to the abutments on the east was limited due to excessive vegetation.
8	Piers	0	N	-	Y	Central Pier was found to be in good condition with no defects noted, see Figure 41 in Appendix B.
9	Bearings	N/A	N/A	N/A	N/A	Not applicable to this structure.
10	Deck/Slab	0	N	-	N	No defects noted to the deck soffit of the structure. Due to the limited clearance within the structure, <1m, inspection of the soffit was not possible.
11	Beams / Girders / Transverse Beams	0	N	-	Y	Transverse capping stones and beams were found to be in good condition with no defects noted. See Figure 42 and Figure 44 in Appendix B.
12	Riverbed	2	Y	26 36	Y	Debris and silt build-up on the northeast of the structure. Otherwise, the riverbed is in good condition. See Figure 46 and Figure 49 in Appendix B.

**Figure 40 – Southwest Wingwall and Abutment**

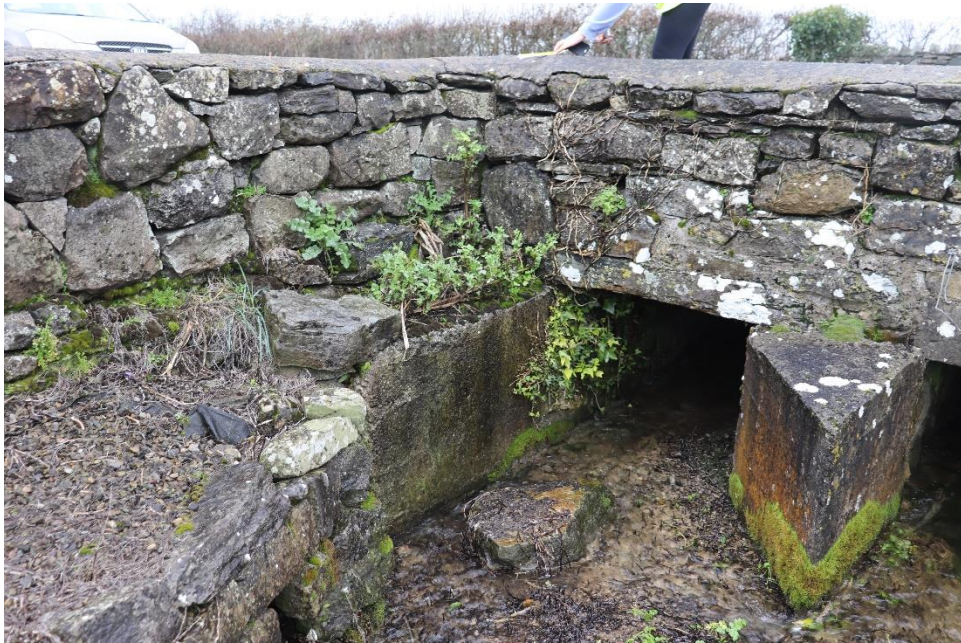
Figure 48 – Northwest Wingwall and Abutment with Vegetation Growth

13	Other Elements	0	N	-	Y	A service duct runs through the southern culvert. No defects were noted to this service duct. See Figure 47 in Appendix B.
14	Structure in General	0	Y	-	Y	Structure was found to be in good condition with some defects to elements noted. No defects were noted to ancillary elements which would indicate that the primary elements of the structure were in distress.
<b>Maintenance Actions</b>						
<p>From inspection of the structure, it is advised that the following maintenance actions are undertaken;</p> <ul style="list-style-type: none"> <li>- Remove excess vegetation from the structure; and</li> <li>- Remove debris from the riverbed.</li> </ul>

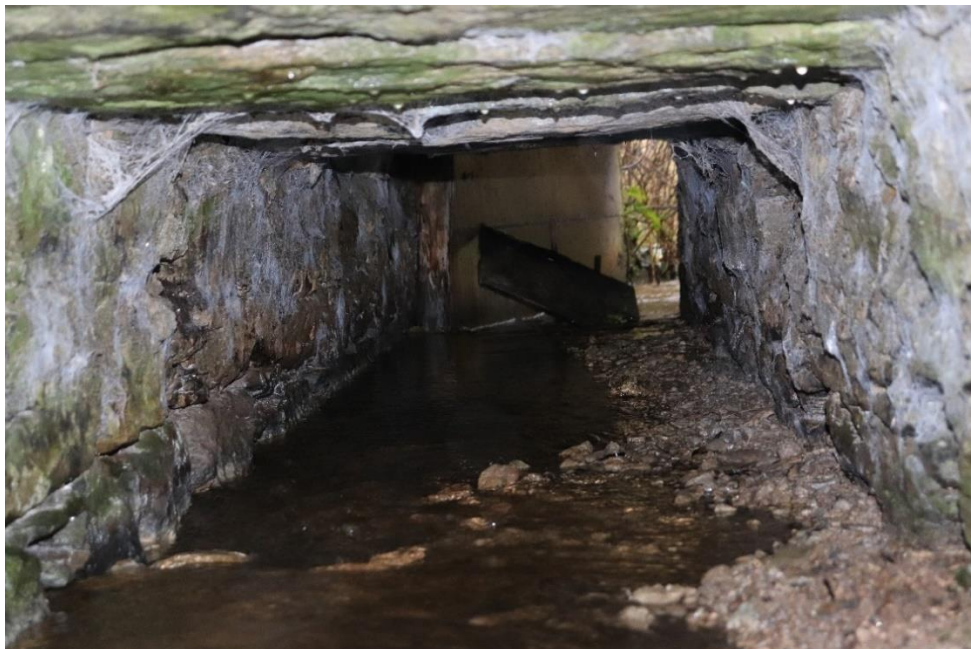
Figure 49 – Debris and Silt Build-up in Riverbed
