ASBESTOS REFURBISHMENT SURVEY REPORT

Castletroy WWTP

Limerick CIP

Project Number
23777/D

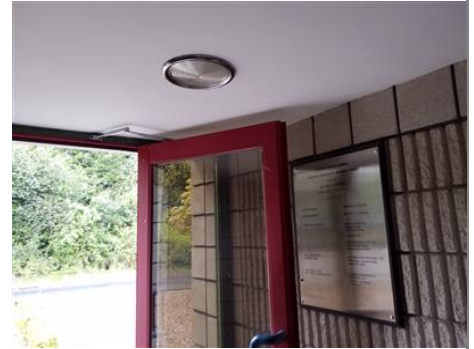
Location Details 289615 No Asbestos Found

Building/Area : Control Building
 Room/Section : Entrance
 Location : All Walls Floor and Ceiling
 Description : Solid and Plasterboard
 Sample No. :
 Confirmation : --N\A--
 Access : Full Access
 Normal Use :
 Recommendations :

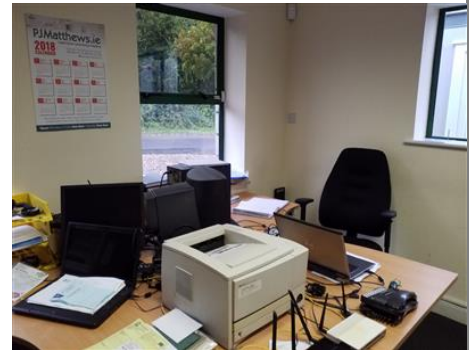
Location Details 289616 No Asbestos Found

Building/Area : Control Building
 Room/Section : Office
 Location : All Walls Floor and Ceiling
 Description : Solid and Plasterboard
 Sample No. :
 Confirmation : --N\A--
 Access : Full Access
 Normal Use :
 Recommendations :

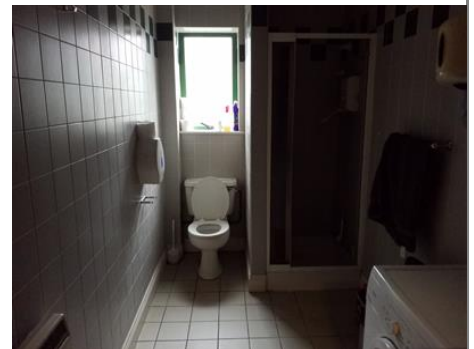
Location Details 289617 No Asbestos Found

Building/Area : Control Building
 Room/Section : Toilet
 Location : All Walls Floor and Ceiling
 Description : Solid and Plasterboard
 Sample No. :
 Confirmation : --N\A--
 Access : Full Access
 Normal Use :
 Recommendations :

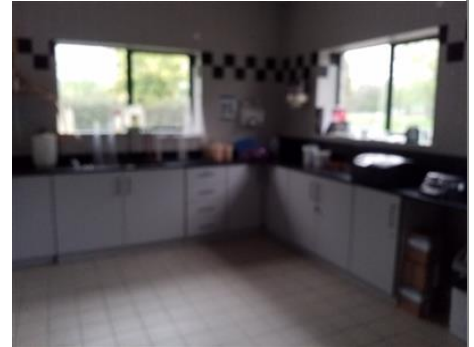
Location Details 289618 No Asbestos Found

Building/Area : Control Building
Room/Section : Laboratory
Location : All Walls Floor and Ceiling
Description : Solid and Plasterboard
Sample No. :
Confirmation : --N\A--
Access : Full Access
Normal Use :
Recommendations :

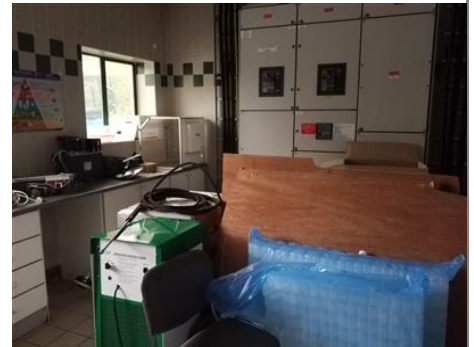
Location Details 289619 No Asbestos Found

Building/Area : Control Building
Room/Section : Canteen
Location : All Walls Floor and Ceiling
Description : Solid and Plasterboard
Sample No. :
Confirmation : --N\A--
Access : Full Access
Normal Use :
Recommendations :

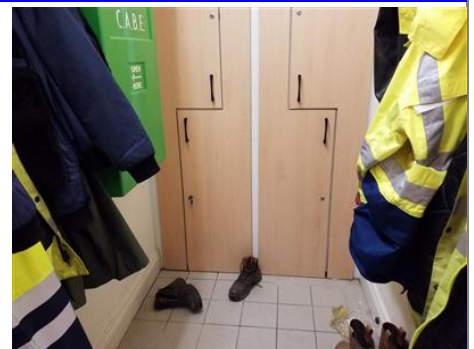
Location Details 289620 No Asbestos Found

Building/Area : Control Building
Room/Section : Locker Room
Location : All Walls Floor and Ceiling
Description : Solid and Plasterboard
Sample No. :
Confirmation : --N\A--
Access : Full Access
Normal Use :
Recommendations :

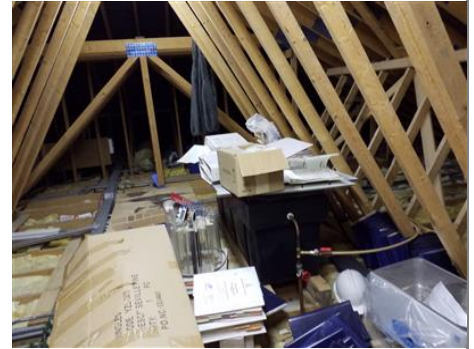
Location Details 289621 No Asbestos Found

Building/Area : Control Building
Room/Section : Attic
Location : All Walls Floor and Ceiling
Description : Solid and Plasterboard
Sample No. :
Confirmation : --N\A--
Access : Full Access
Normal Use :
Recommendations :

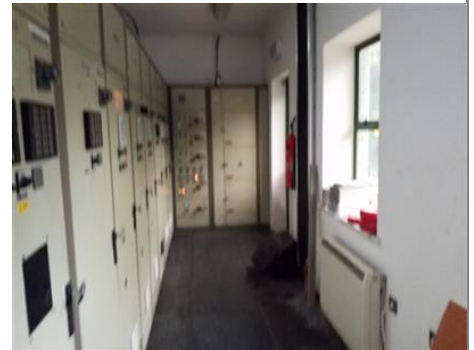
Location Details 289622 No Asbestos Found

Building/Area : Control Building
Room/Section : Electrical Room
Location : All Walls Floor and Ceiling
Description : Solid and Plasterboard
Sample No. :
Confirmation : --N\A--
Access : Full Access
Normal Use :
Recommendations :

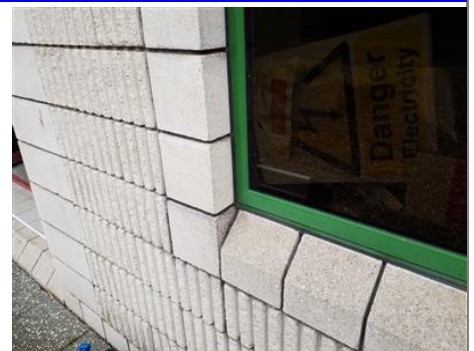
Location Details 289623 No Asbestos Found

Building/Area : Control Building
Room/Section : Facade
Location : Windows
Description : Putty
Sample No. : AMB20180501001
Confirmation : Sample Taken
Access : Full Access
Normal Use :
Recommendations :

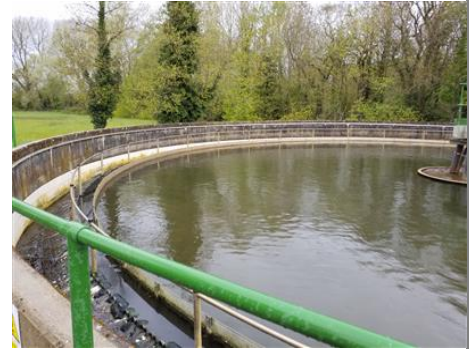
Location Details 289624 No Asbestos Found

Building/Area : Tanks
Room/Section :
Location : All Walls and Floor
Description : Solid and Tiled
Sample No. :
Confirmation : --N\A--
Access : Full Access
Normal Use :
Recommendations :

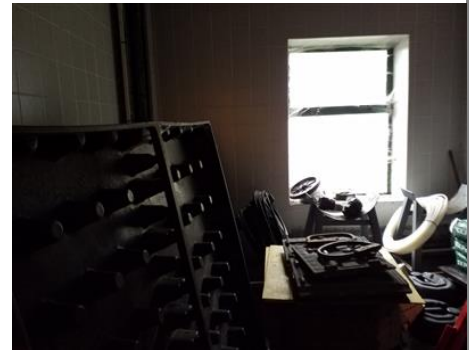
Location Details 289625 No Asbestos Found

Building/Area : Bell Press
Room/Section : Ground Floor Store
Location : All Walls and Floor
Description : Solid and Tiled
Sample No. :
Confirmation : --N\A--
Access : Full Access
Normal Use :
Recommendations :

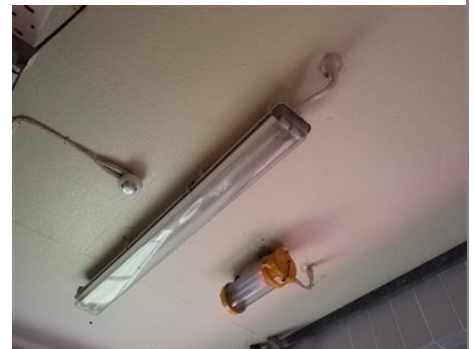
Location Details 289626 No Asbestos Found

Building/Area : Bell Press
Room/Section : Ground Floor Store
Location : Ceiling
Description : Stipple
Sample No. : AMB20180514001
Confirmation : Sample Taken
Access : Full Access
Normal Use :
Recommendations :

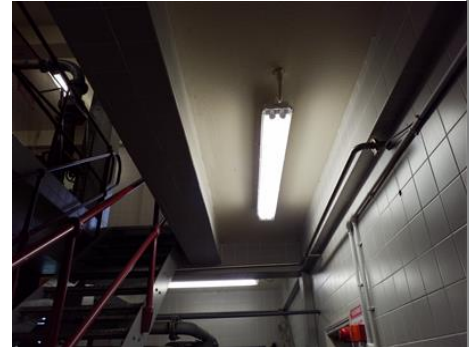
Location Details 289627 No Asbestos Found

Building/Area : Bell Press
Room/Section : Ground Floor Stairwell
Location : Ceiling
Description : Stipple
Sample No. : AMB20180514002
Confirmation : Sample Taken
Access : Full Access
Normal Use :
Recommendations :

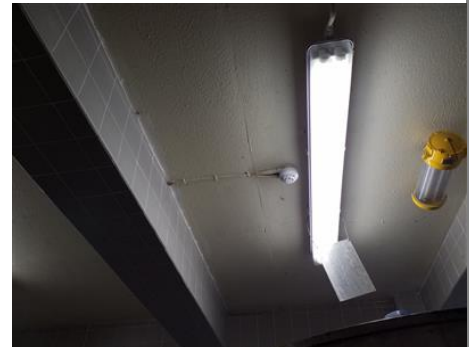
Location Details 289628 No Asbestos Found

Building/Area : Bell Press
Room/Section : Ground Floor Chemical Room
Location : Ceiling
Description : Stipple
Sample No. : AMB20180514003
Confirmation : Sample Taken
Access : Full Access
Normal Use :
Recommendations :

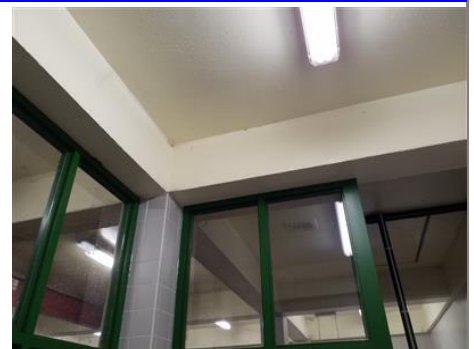
Location Details 289629 No Asbestos Found

Building/Area : Bell Press
Room/Section : 1st Floor Press Room
Location : Ceiling
Description : Stipple
Sample No. : AMB20180514004
Confirmation : Sample Taken
Access : Full Access
Normal Use :
Recommendations :

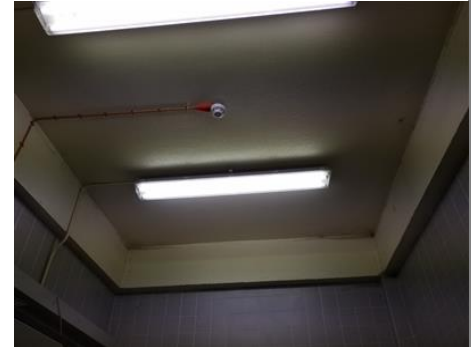
Location Details 289630 No Asbestos Found

Building/Area : Bell Press
Room/Section : 1st Floor Control Room
Location : Ceiling
Description : Stipple
Sample No. : AMB20180514005
Confirmation : Sample Taken
Access : Full Access
Normal Use :
Recommendations :

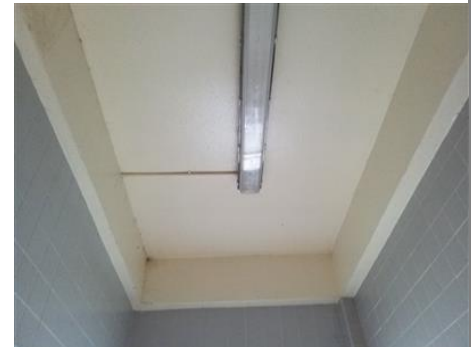
Location Details 289631 No Asbestos Found

Building/Area : Bell Press
Room/Section : 1st Floor Toilet
Location : Ceiling
Description : Stipple
Sample No. : AMB20180514006
Confirmation : Sample Taken
Access : Full Access
Normal Use :
Recommendations :

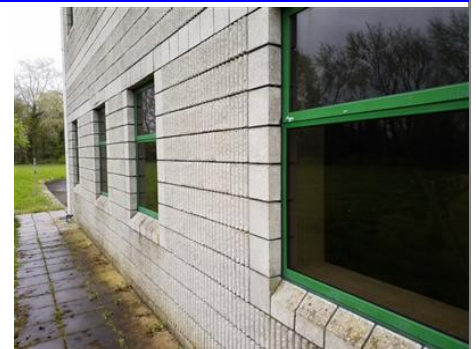
Location Details 289632 No Asbestos Found

Building/Area : Bell Press
Room/Section : Facade
Location : Windows
Description : Putty
Sample No. : AMB20180501004
Confirmation : Sample Taken
Access : Full Access
Normal Use :
Recommendations :

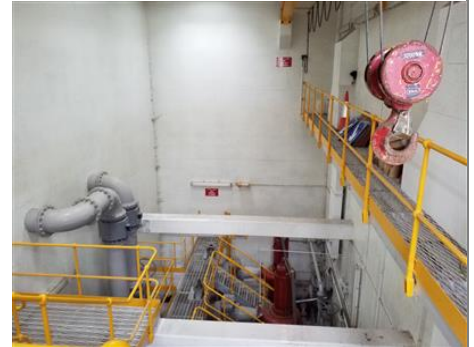
Location Details 289633 No Asbestos Found

Building/Area : Intake
Room/Section :
Location : All Walls Floor and Ceiling
Description : Solid
Sample No. :
Confirmation : --N\A--
Access : Full Access
Normal Use :
Recommendations :
;

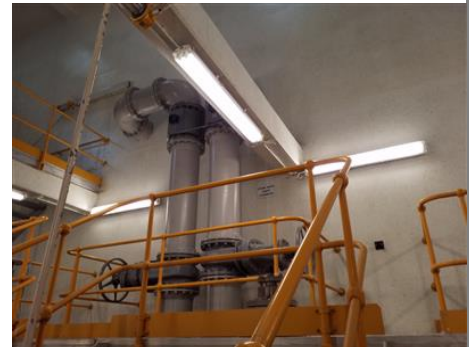
Location Details 289634 No Asbestos Found

Building/Area : Intake
Room/Section :
Location : All Walls Floor and Ceiling
Description : Solid
Sample No. :
Confirmation : --N\A--
Access : Full Access
Normal Use :
Recommendations :
;
