Appendix I1
Accessibility Audit Report

National Transport Authority
**Templeogue/Rathfarnham to City
Centre Core Bus Corridor Scheme**
Accessibility Audit Report

268401-00

Issue | 06 January 2022

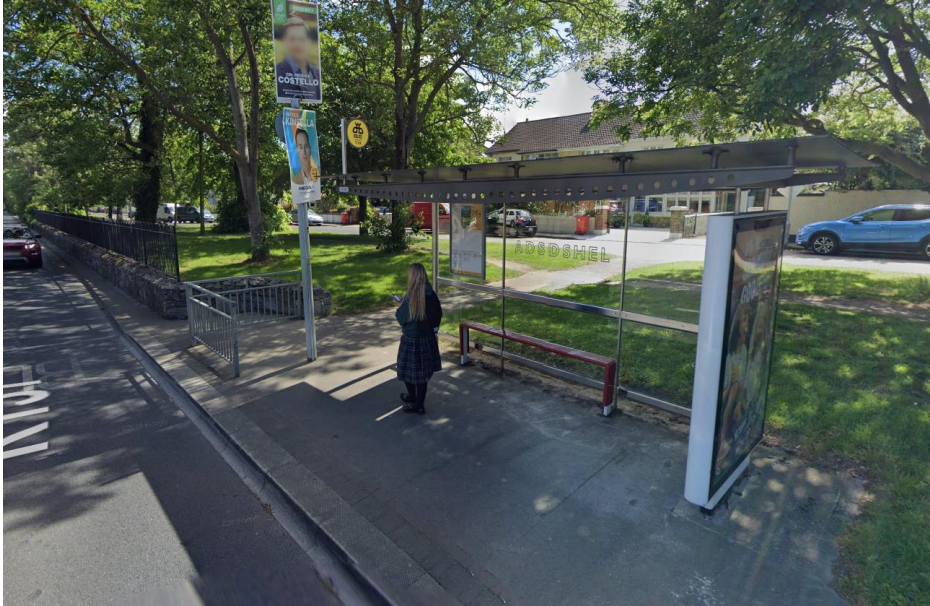
The southern footpath runs as far as Bus Stop 1124, before it ends. Pedestrians are redirected to use the footpath on Rathdown Drive, which runs parallel with Templeogue Road, for approximately 400m. before the footpath on Templeogue Road becomes wide enough for pedestrian use again, as shown in Figure 5.

Figure 5: Footpath at Templeogue Road becomes too narrow for pedestrians to navigate for approximately 400m

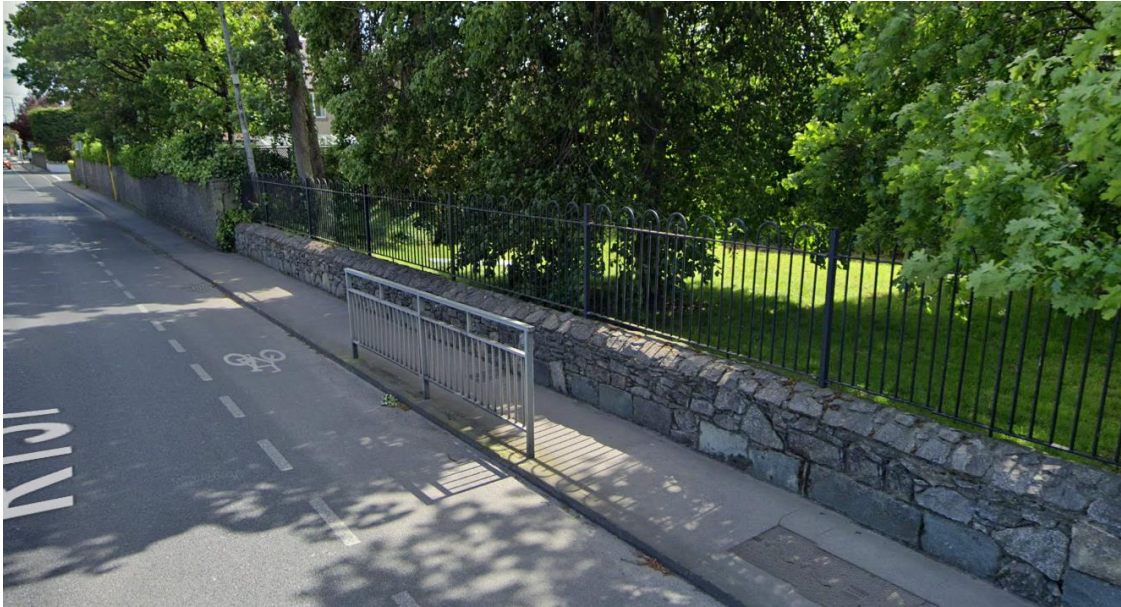
Similar guardrails are located across the road on the northern footpath as seen in Figure 6, suggesting the locations were previously used as bus stops, for example.

Figure 6: Guardrails - Templeogue Road

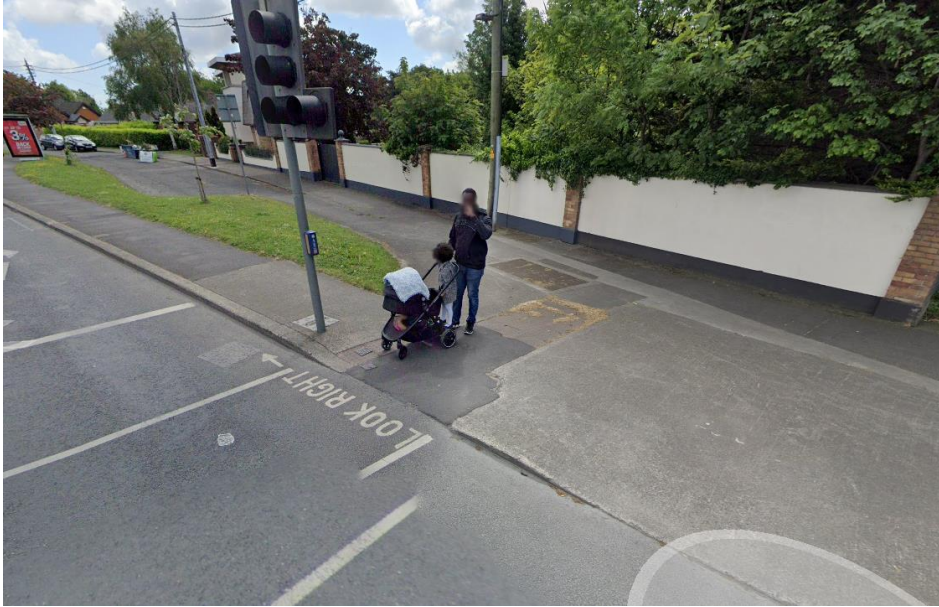
Pedestrian crossing points are present at all of the major intersections along the route – Wellington Lane, Cypress Grove Road, Springfield Avenue, Fortfield Road, Rathdown Avenue and Terenure Road West. All of these are controlled crossings, featuring dropped kerbs. The width of these crossings varies; however, most are greater than 2m wide. Tactile paving is present at each of these crossings however, the crossing on the southern footpath of Templeogue Road at the intersection with Cypress Grove Road/Old Bridge Road has been repaired with asphalt as shown in Figure 7. The asphalt has been used to adjust the height of the tactile paving surface, which has sunken below that of the surrounding concrete. The majority of the tactile surface is now covered by asphalt as a result.

Figure 7: Pedestrian Crossing - Templeogue Road

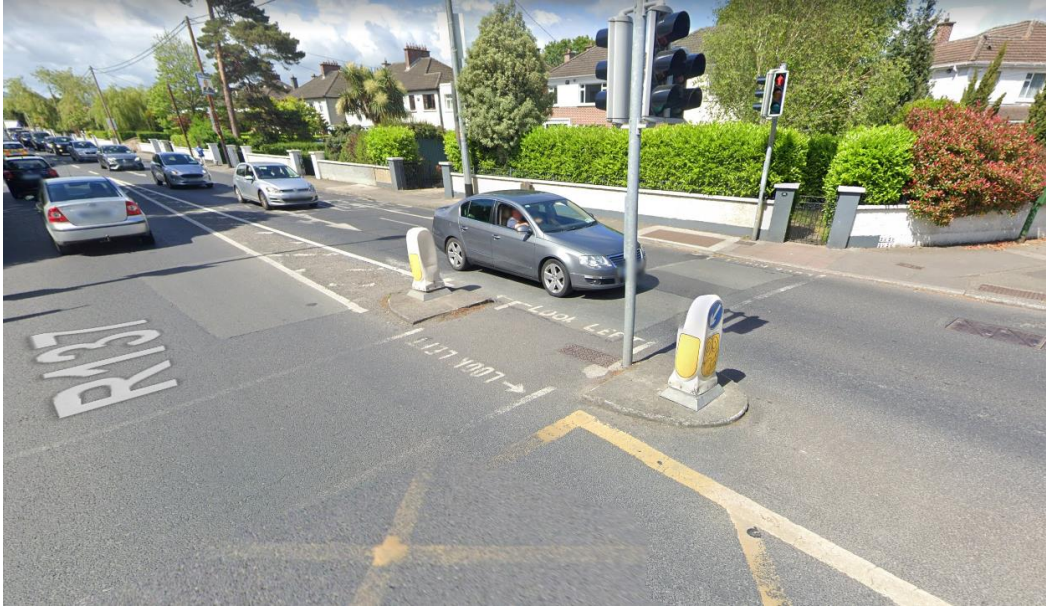
There are a number of controlled crossings along the proposed scheme. The crossing of Templeogue Road near Templeogue Wood is divided by the central median, which acts as refuge island. Both sections of the crossing are signalled, with audible push button units and tactile paving installed. Pedestrian guardrails provide an enclosed area for waiting, with a minimum width of 2m, which provides sufficient room for the visually or mobility impaired to pass other pedestrians travelling in the opposite direction. Refuge islands are also noted at the Cypress Grove Road and Springfield Avenue, both are fitted with audible pushbutton units and tactile pavement. The pedestrian crossing at the junction with Fortfield Road features a refuge island, as shown in Figure 8. Unlike the other refuge islands along the route, the island itself is uncontrolled and is therefore intended for use by those who cannot make it across the road in a reasonable time. The width of the island, (1.35m approx.) does not provide enough comfort to the pedestrians who may be waiting there, many of them likely to be vulnerable road users.

Figure 8: Controlled Crossing - Templeogue Road

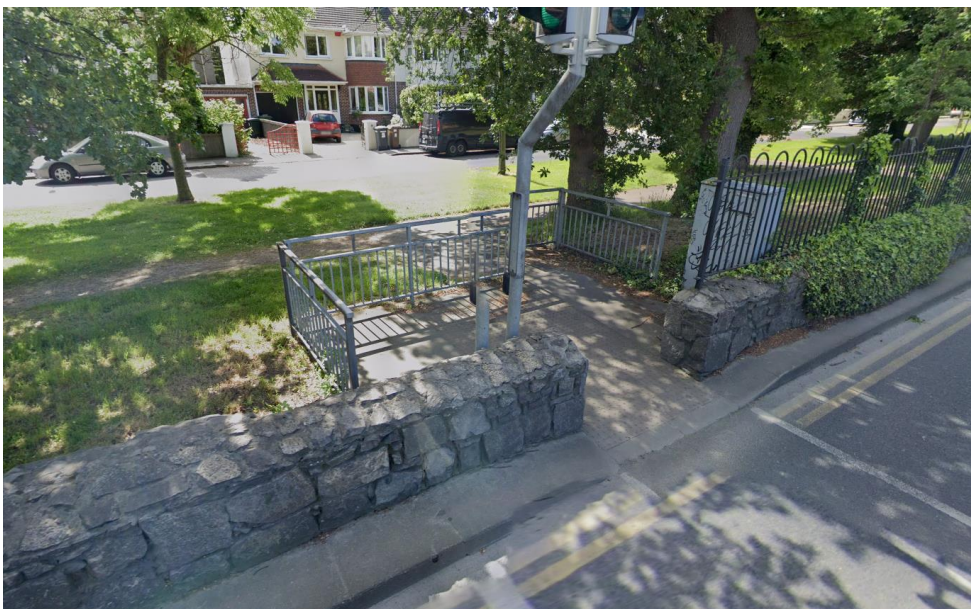
A controlled crossing on Templeogue Road near Lakelands Park provides access from the northern side of the road to Rathdown Drive, through a narrow gap in the masonry wall that separates Templeogue Road from the large grassy verge as shown in Figure 9. The southern footpath includes tactile paving and an audible pushbutton unit, as well as pedestrian guardrails which have been positioned to slow progress from Rathdown Drive to the crossing. Given the narrow footpath at this location, this is an important intervention.

Figure 9: Controlled Crossing - Templeogue Road

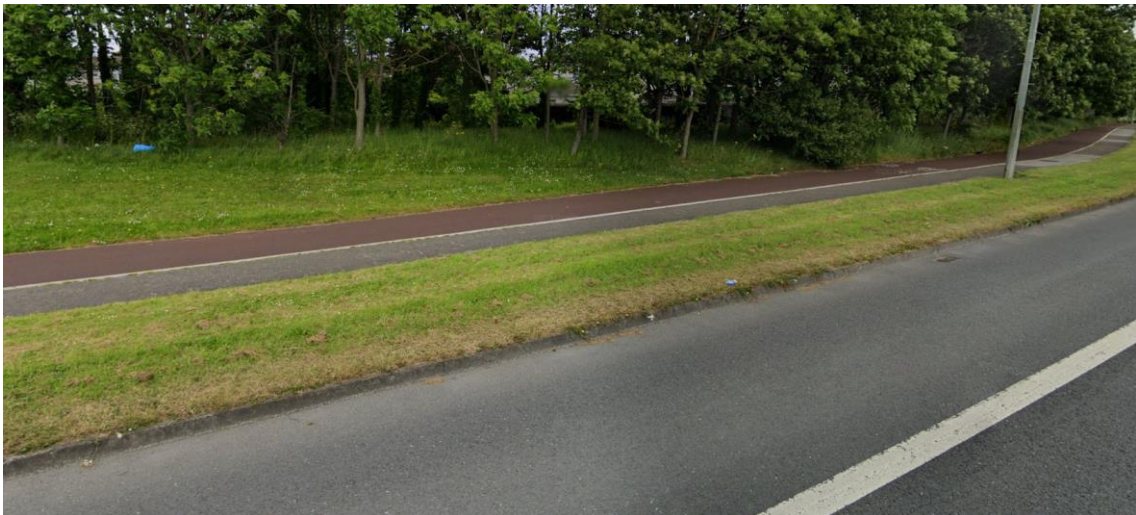
A similar shared cyclist/pedestrian space runs along the southern footpath on Templeogue Road, from the junction with Old Bridge Road to the entrance to Cheeverstown (approximately 350m).

Figure 10: Shared Spaces - Tallaght Road

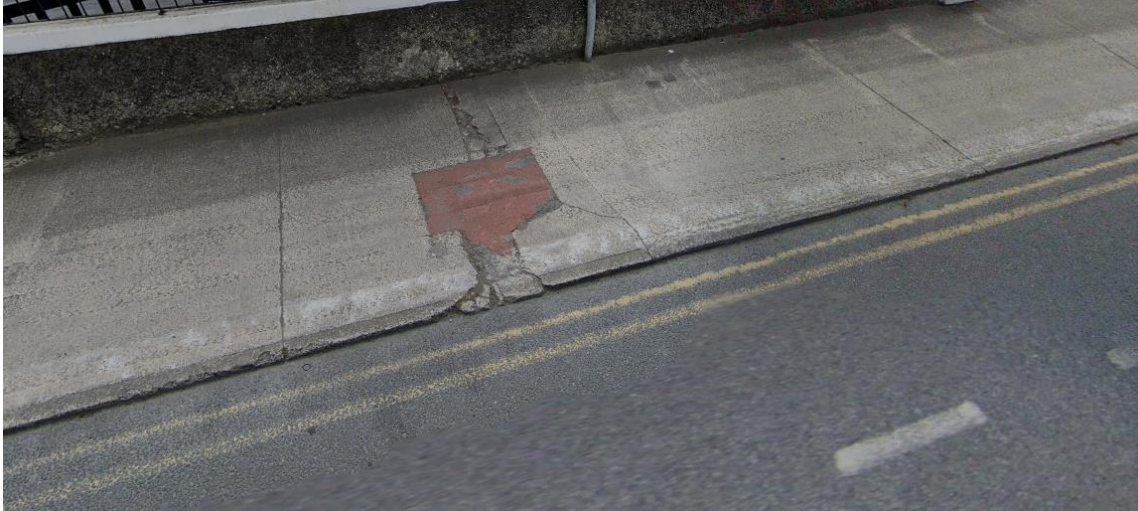
The surface material along the route is predominantly cast in-situ concrete. Both footpaths feature wide grassy verges from the beginning of the scheme up to Cypress Grove Road. Some parts of the footpath along this section have a concrete paving tiled surface, with concrete kerbs. Both the tiles and kerbs are in poor condition. The grout between kerb stones has deteriorated in many places.

The southern footpath immediately east of the Village is asphalt. The various surfaces are shown in the Figure 11 and Figure 12.

Figure 11: Surface Material - Templeogue Road

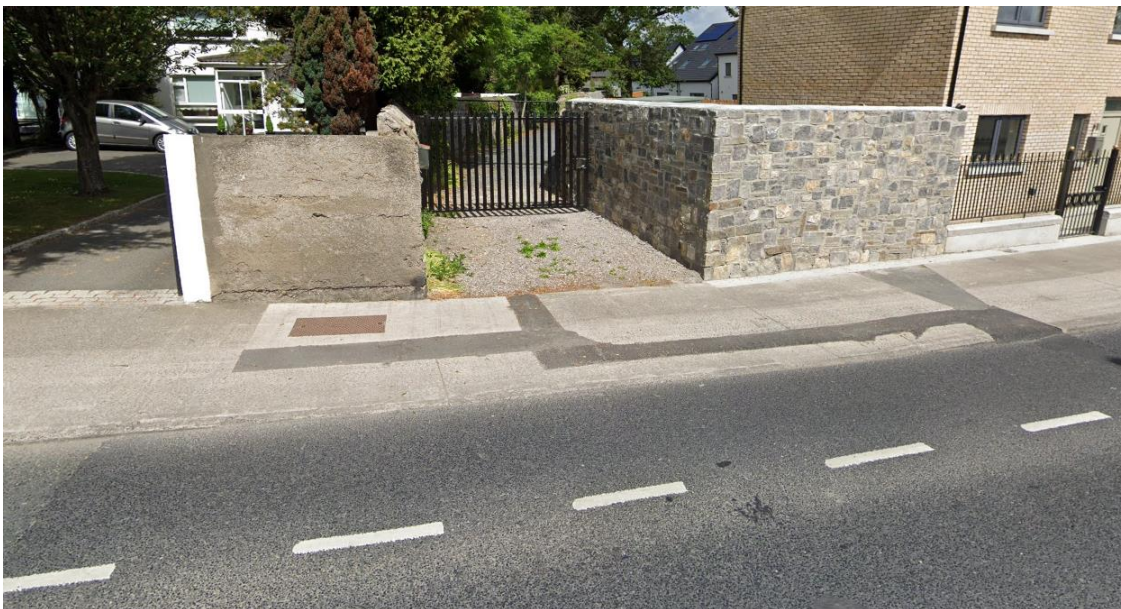
Figure 12: Surface Material - Templeogue Road

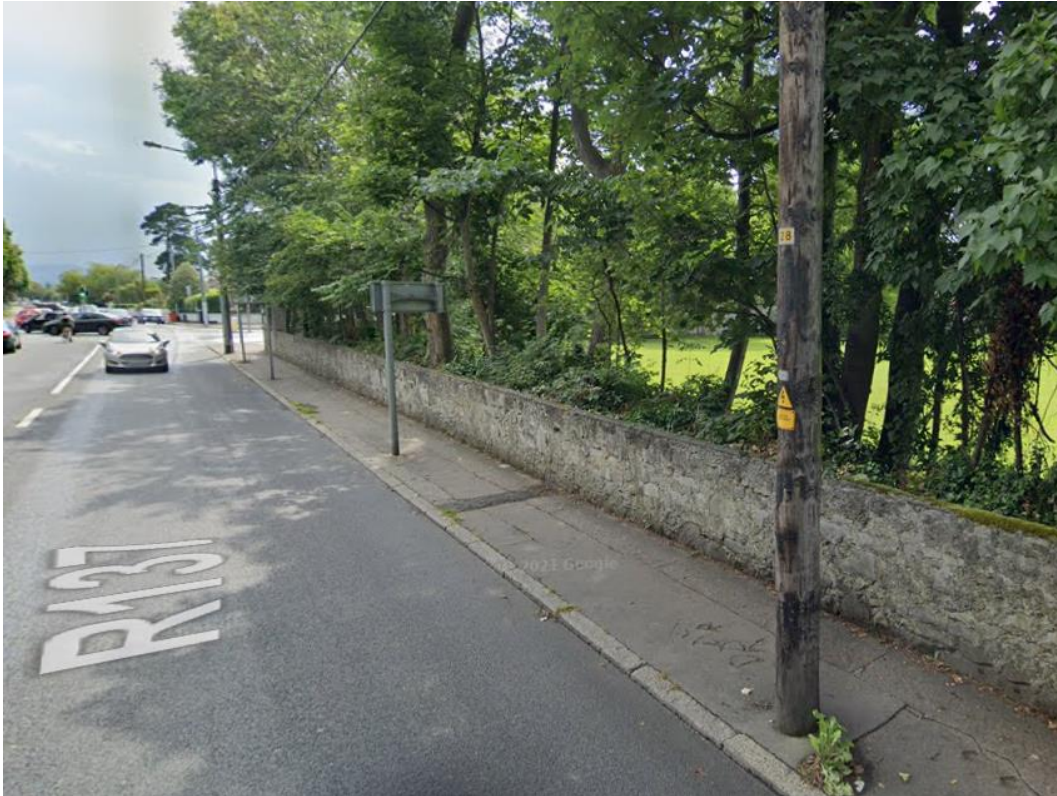
Beyond Templeogue Village, the density of street furniture is similar but when combined with narrow footpaths, pinch-points are created at regular intervals reducing the effective width and causing undue difficulty of passage to the mobility and visually impaired. An example is shown in Figure 13.

Figure 13: Street Furniture - Templeogue Road

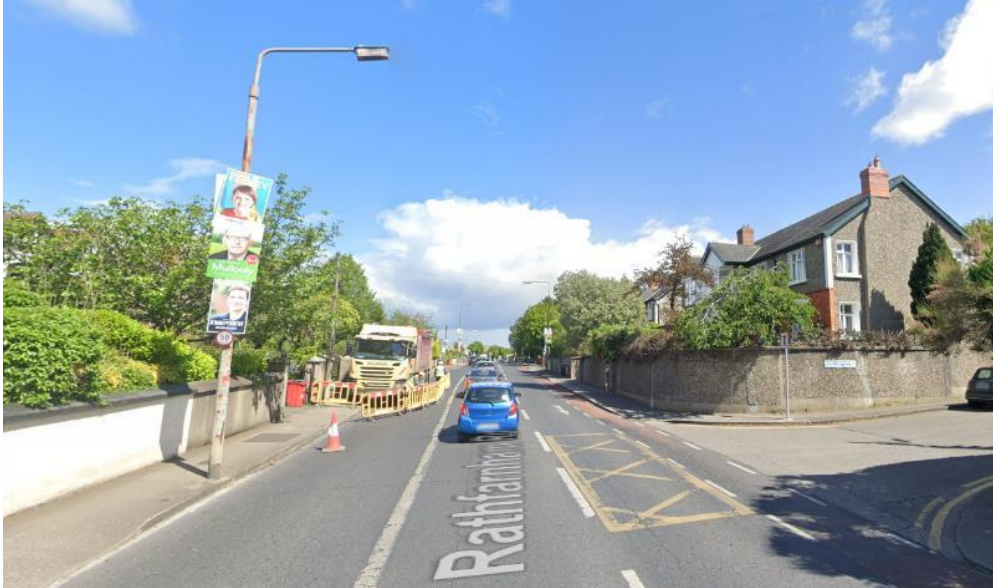
This transitions to a 3m wide pedestrian footpath at Willbrook Road and retains this width until the junction with Mainstreet where it reduces to approximately 2m. The eastern footpath along this section of the route is less constrained than the western footpath, due to less on-street retail outlets and a generally wider path.

Figure 14: Street Furniture creating pinch point on narrow footpath, Rathfarnham Road

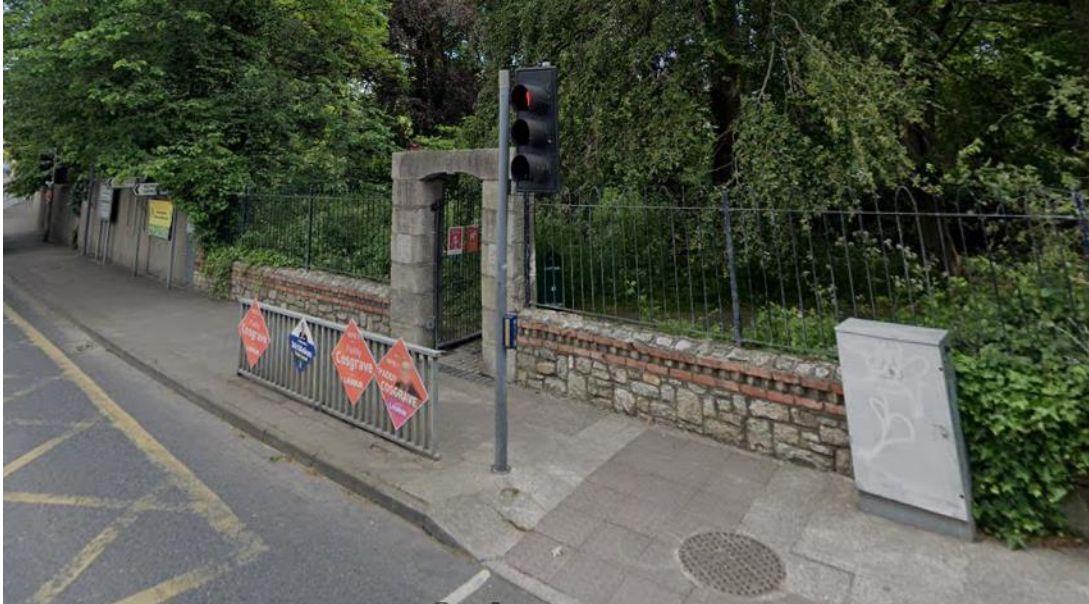
Pedestrian Guardrails have been observed along this section of the route, primarily at intersections, adjacent to pedestrian crossings. Guardrails were also noted at the pedestrian entrance/exit to St Mary's Boys' National School on Grange Road, at the pedestrian entrance to Rathfarnham Castle Park as shown in Figure 15, and at the junction between Grange Road and Willbrook Road. These guardrails are at strategic locations to prevent errant vehicles from mounting the kerb and to prevent vulnerable pedestrians such as children or the visually impaired from erroneously stepping onto the road.

Figure 15: Guardrails -Rathfarnham Castle Park

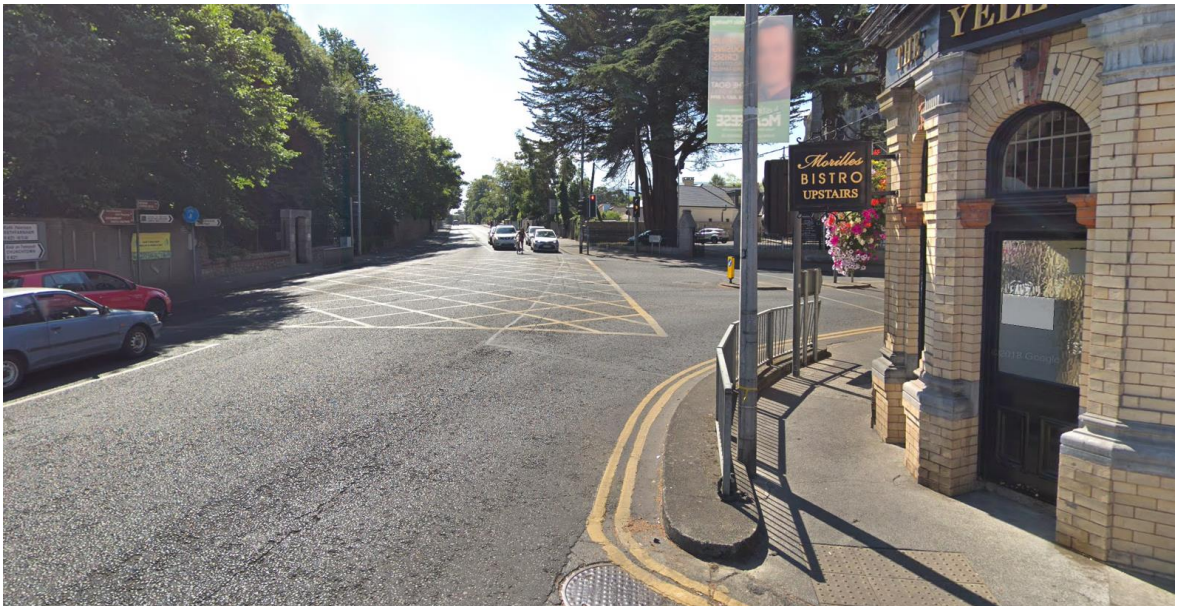
At most of these locations, the width of the footpath is generous enough to accommodate disabled users, even with the reduced effective width caused by the pedestrian guardrails. The western footpath through the Grange Road – Willbrook Road Junction has guardrails and street furniture at a tight geometry which could prove difficult for disabled users to navigate as shown in Figure 16.

Figure 16: Guardrails – Grange Road

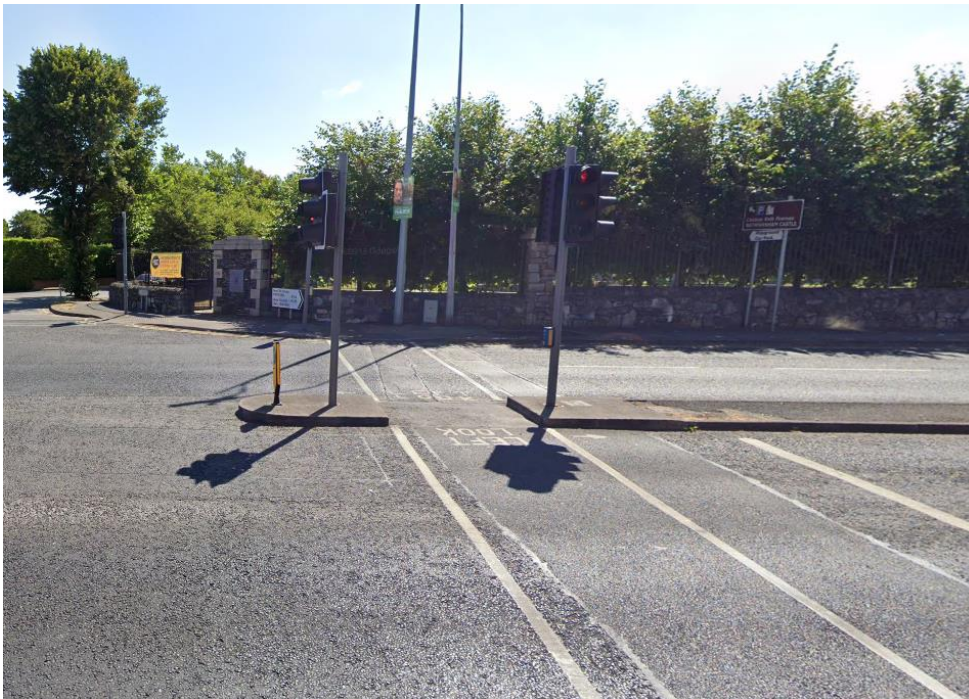
The pedestrian island at the junction between Rathfarnham Road and Main Street is approximately 1.4m wide and has no pedestrian guardrail as shown in Figure 17. The narrow island has been dropped to road level at the intersection with the pedestrian crossing, further reducing the safety of waiting pedestrians. The dropped level section is approximately 2m wide. This same arrangement has been used in the intersection between Rathfarnham Road and Bushy Park Road.

Figure 17: Pedestrian Crossing Point - Rathfarnham Road

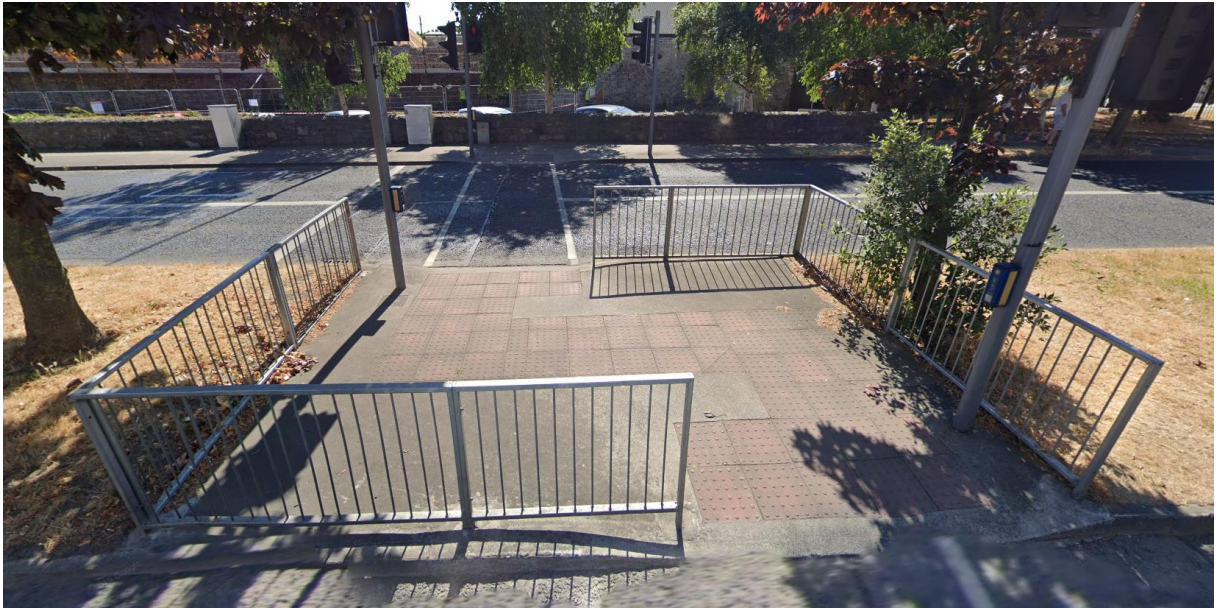
All controlled crossings feature tactile paving surfaces on both footpaths. The pedestrian island to the Rathfarnham Castle car park also features tactile paving as shown in Figure 18.

Figure 18: Tactile Paving - Rathfarnham Road

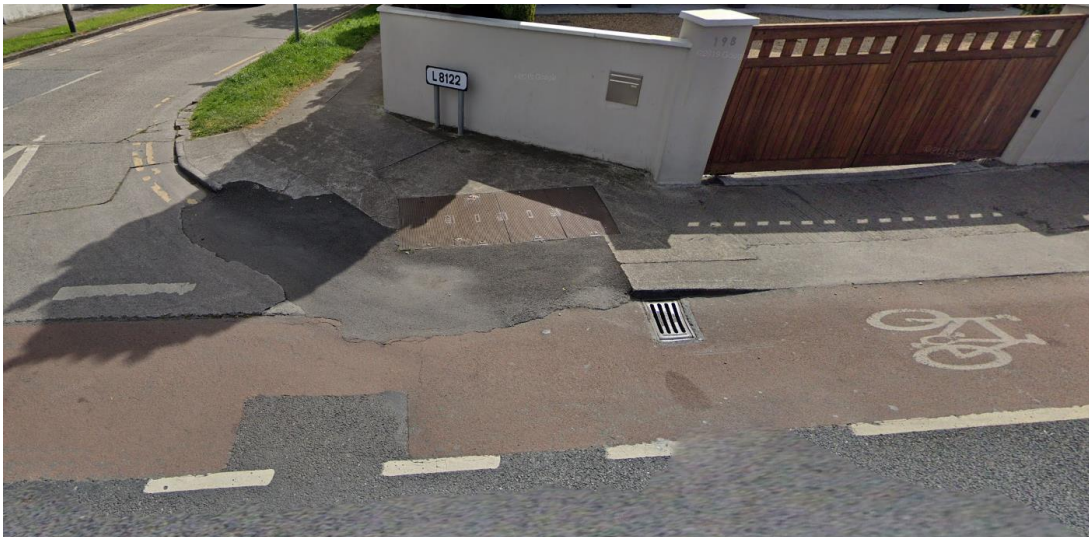
Asphalt and concrete have both been used as materials to make patch repairs along both footpaths. In some instance this has led to undulating, uneven surfaces caused by settlement of the patch repair material.

This is a hazard to pedestrians and cyclists. The junction between Rathfarnham Road and Crannagh Road is a particularly poor example of patch repair, where asphalt has been poured onto a raised kerb to produce the effect of a lowered kerb as shown in Figure 19.

Figure 19: Surface Material - Rathfarnham Road

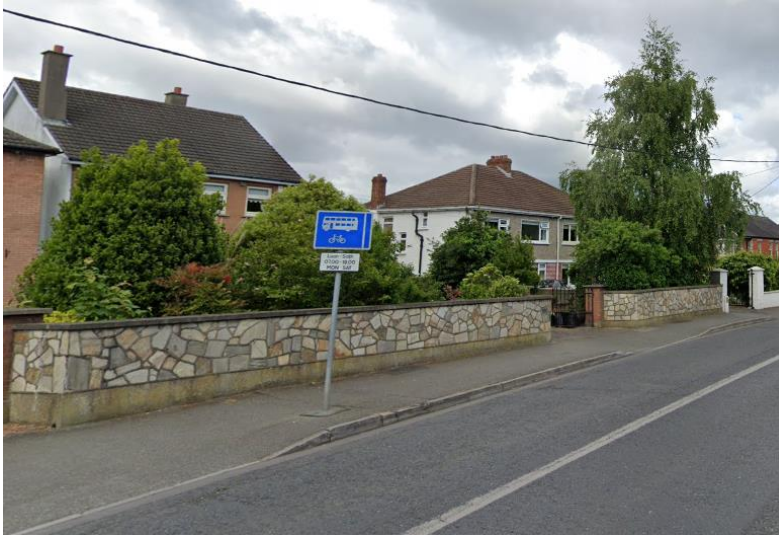
Street Furniture is present at varying densities throughout the length of this section. The most common street furniture is traffic signage and signalling poles, usually located toward the edge of the footpath. An example is shown in Figure 20.

Figure 20: Street Furniture – Grange Road

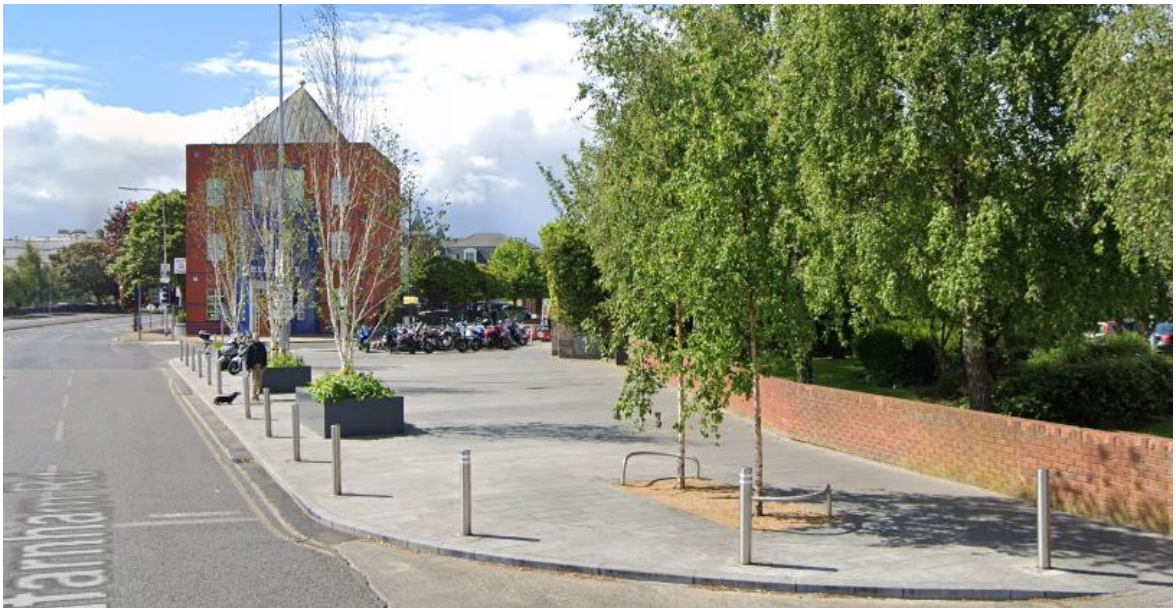
Bollards are used along Rathfarnham Road near the junction with Main Street to prevent vehicle access onto the footpath as shown in Figure 21. The footpath is suitably spacious, and the bollards are well spaced out, and would therefore be unlikely to cause difficulty to the mobility impaired. Bollards suitably spaced (over 1.8m) are appropriate.

Figure 21: Street Furniture – Rathfarnham Road

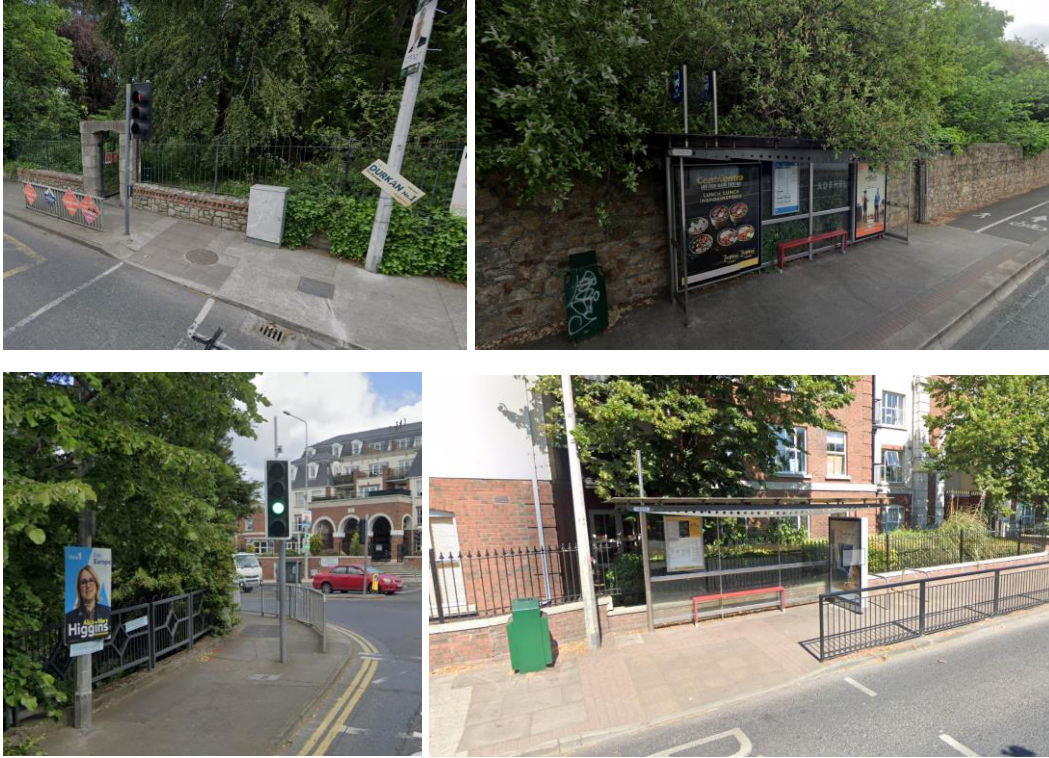
There are multiple instances of street furniture ‘clusters’ such as those shown in Figure 22 below. Often, these clusters coincide with a pedestrian crossing or busy intersection, or as in (b), the beginning of the shared cycle/pedestrian facility.

Figure 22: (a-d clockwise from top left): Examples of street furniture clusters. Where the footpath is wide enough, clusters do not obstruct passage, despite negative interactions (b,c). Elsewhere, the position of clusters of street furniture should be reconsidered (a,d)

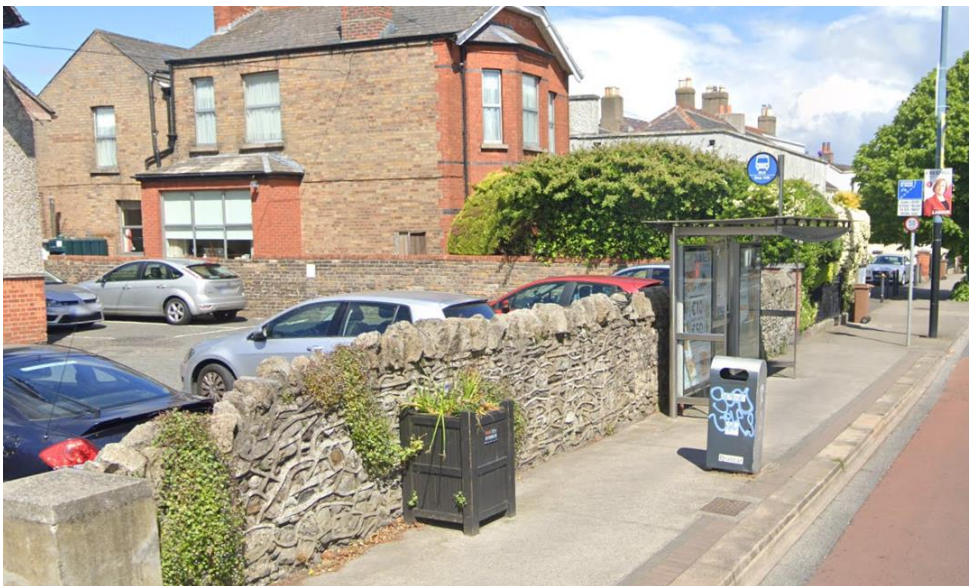
Frequently, the street furniture alternates between being closer to the edge of the footpath and being closer to the back of the footpath, in quick succession (see Figure 23) which presents an added challenge for the mobility and visually impaired. This is an example of negative interaction between street furniture. Instances of negative interaction between street furniture should be rectified to ensure a clear path is maintained. Signage and street lighting poles should be placed either at the edge of the footpath or the back, not a combination of both.

Figure 23: Street Furniture – Rathfarnham Road

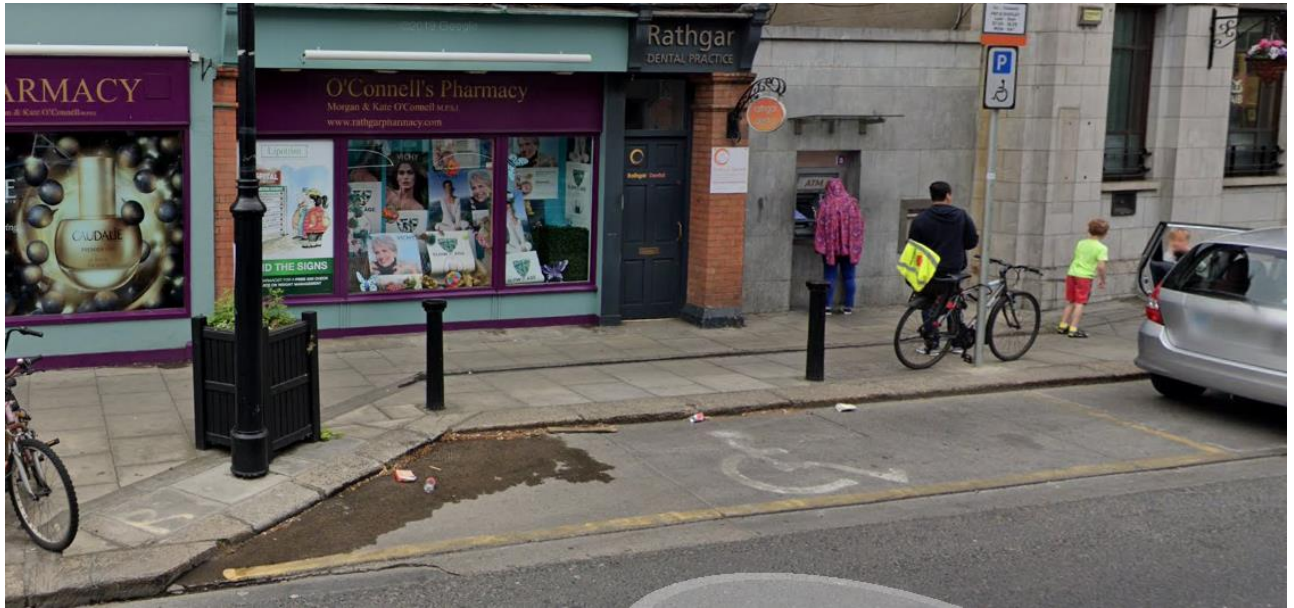
The angled chamfer of the footpath to accommodate the parking space facilitates easier entrance and exit into what is a relatively narrow space.

Figure 24: Disabled parking space with adjacent street furniture

Bollards and other street furniture surround the space and may cause difficulty exiting the vehicle on the side of the footpath. Exiting the vehicle on the driver's side is hazardous due to the narrow width of the space and the proximity to westbound traffic.

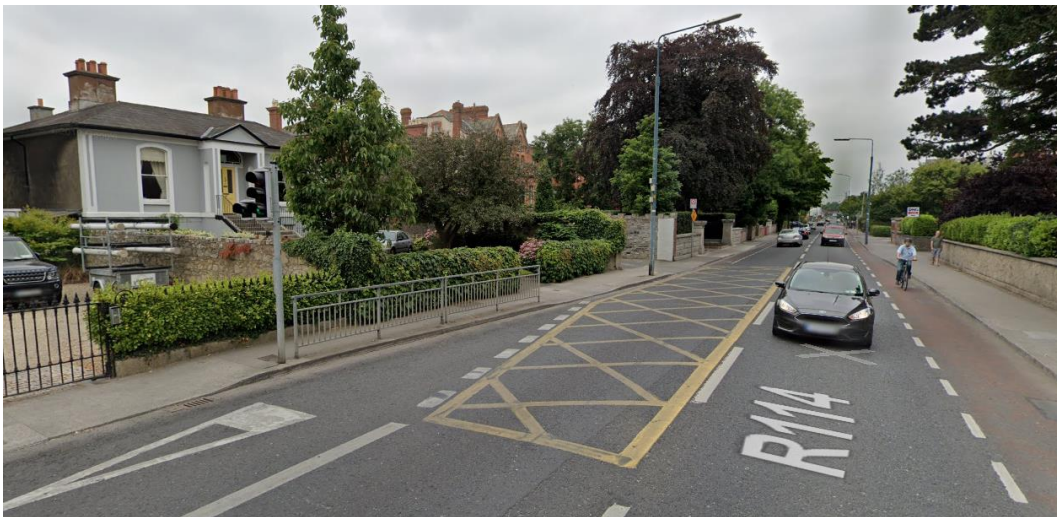
Guardrails are also installed at the pinch point where Terenure Road East widens from 2 to 3 traffic lanes, tapering the footpath to a minimum width of approximately 1.3m. The guardrails at this location are necessary to protect pedestrians from errant westbound vehicles that do not slow to merge into the 2-traffic lane configuration and as a result, mount the kerb. However, there is insufficient room for the mobility or visually impaired to pass another pedestrian travelling in the opposite direction.

Figure 25: Guardrails – Rathgar Road

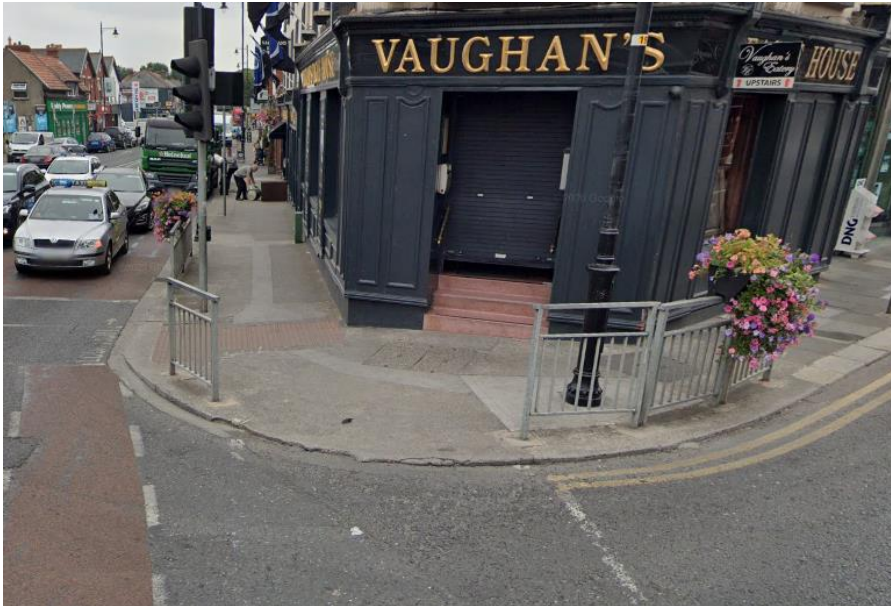
Pedestrian crossings along this section of the route are all fitted with dropped kerbs however, the dropped kerb at the pedestrian crossing on Terenure Road East, at the junction with Rathfarnham Road is in poor condition as shown in Figure 26. The bevelled edge is damaged and poses a tripping hazard for all pedestrians, especially the mobility or visually impaired.

Figure 26: Pedestrian Crossing Point – Terenure Village

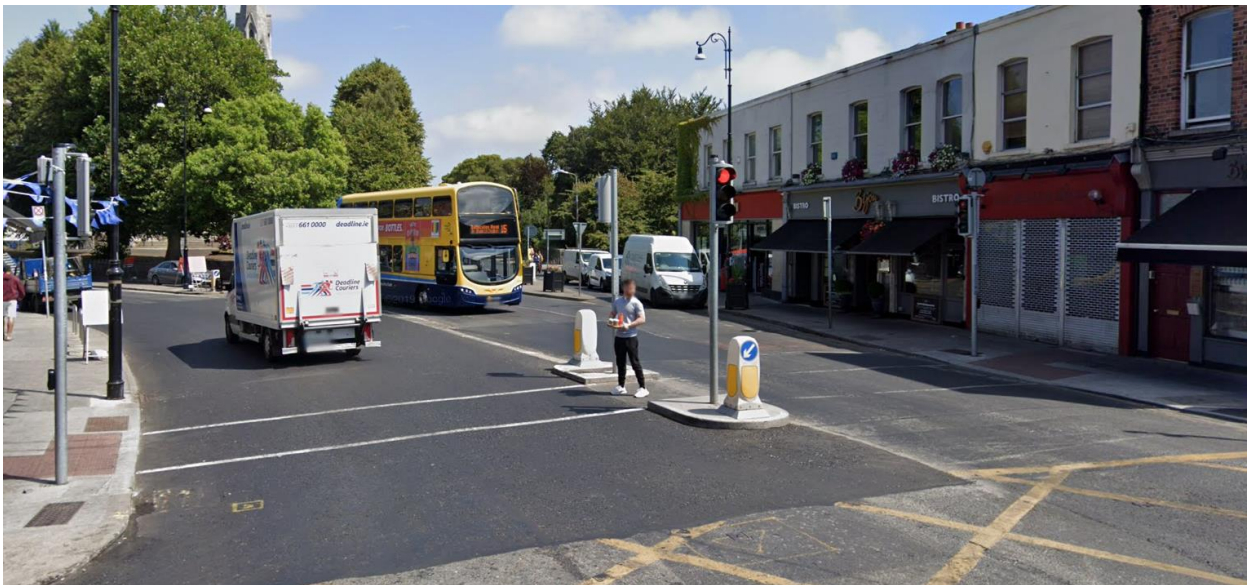
The island provides minimal protection to waiting pedestrians from vehicles turning on to Rathgar Road from Rathgar Avenue or Orwell Road, particularly those with a mobility impairment that requires the use of a wheelchair.

Figure 27: Pedestrian Crossing Point – Rathgar Village

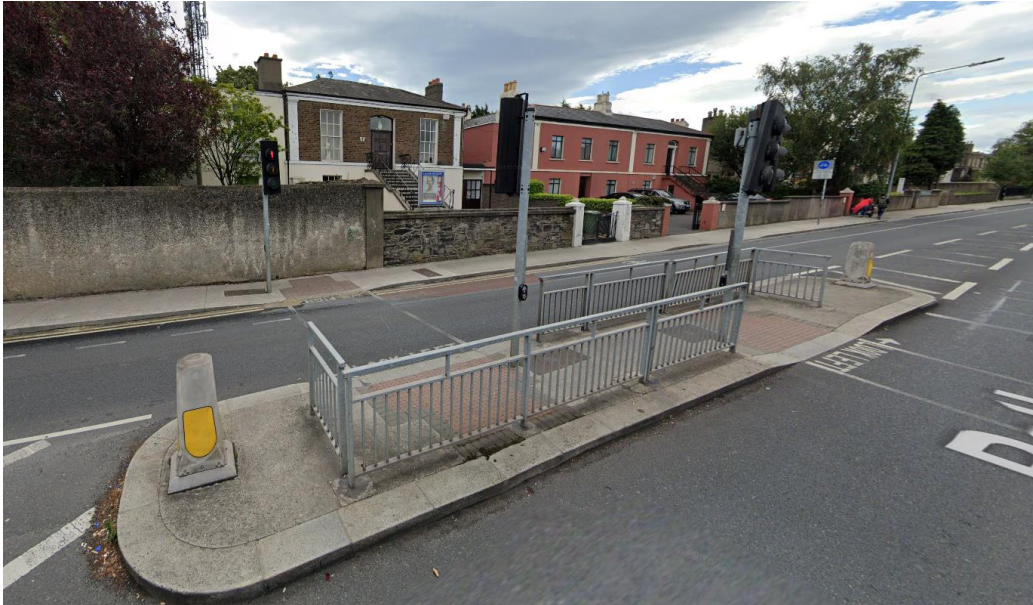
The longitudinal distance between the 2 sections of the crossing is approximately 6m, which provides sufficient space for the mobility impaired and other pedestrians to safely wait before completing the crossing however, the narrow channel this distance creates may prove difficult for the mobility impaired and other pedestrians travelling in opposite directions to navigate past each other.

Figure 28: Pedestrian Crossing Point – Rathgar Road

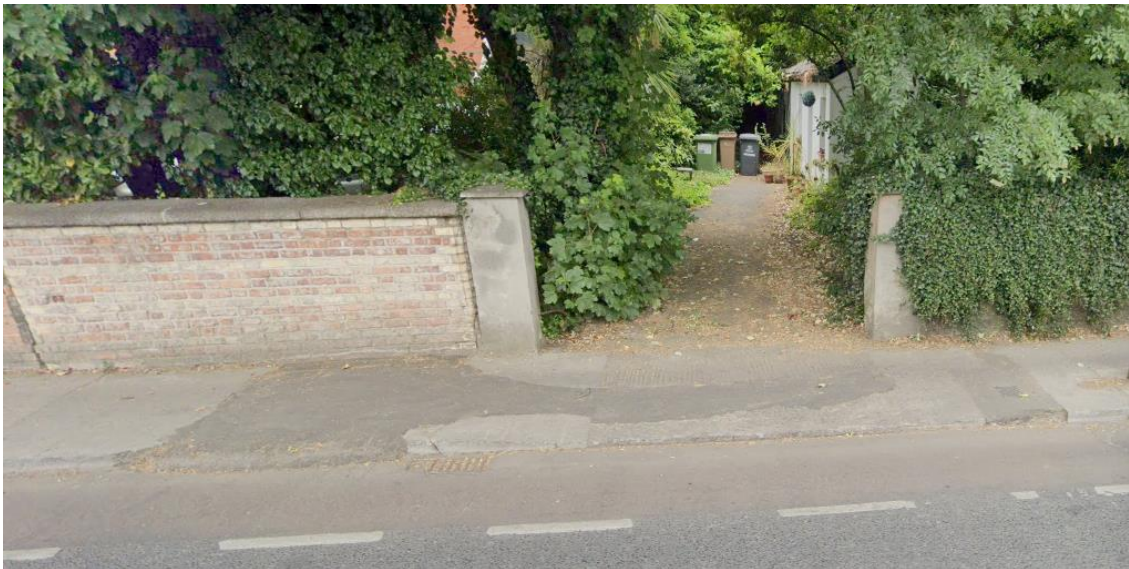
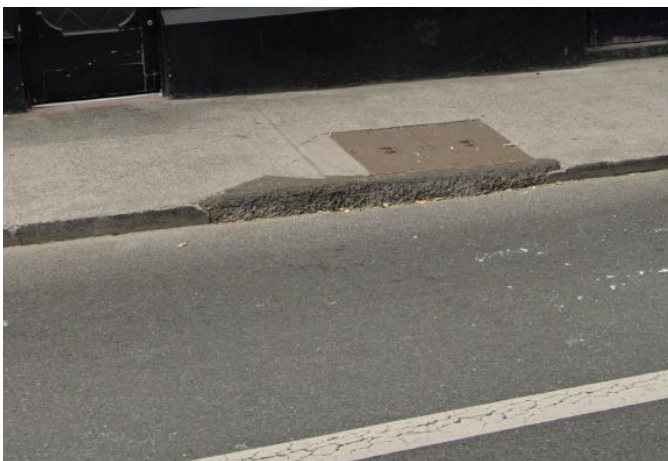
Figure 29 (a-b): Surface Material

Footpath surface material along this section of route is predominantly concrete – either precast paving tiles and kerbs or cast in situ concrete. There are multiple instances of patch repair work, where surface material has been broken out and replaced, either by in-situ concrete or asphalt. The quality of these patch repairs varies from acceptable to inadequate.

Poor-quality asphalt patch repairs were noted at Terenure Road East southern footpath), immediately west of the junction with Ferrard Road. The surface of the repair is uneven, with asphalt protruding past the raised kerb, forming a bevel that leads directly out onto the adjacent cycle track. This is a tripping hazard and could potentially cause a visually impaired person to mistake the bevel for a lowered kerb. Examples of surface material in this section are shown in Figure 29 (a-b) below.

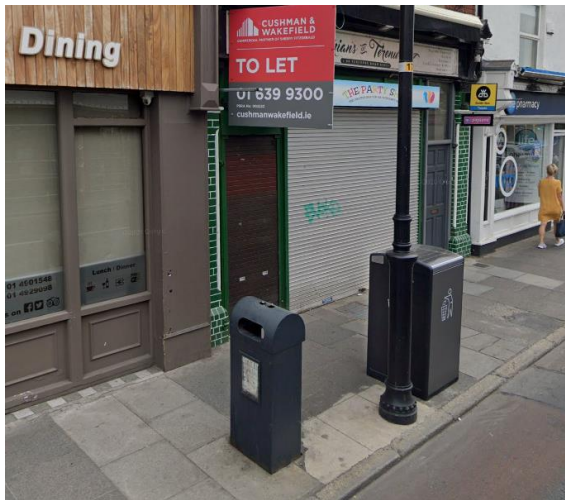
Similar to the previous section of the route, there are multiple examples of street furniture clusters that unnecessarily crowd the footpath, reducing the effective width and causing undue difficulty of passage to the mobility and visually impaired. An example of street furniture in this section is shown in Figure 30.

Figure 30: Street Furniture – Terenure Road East

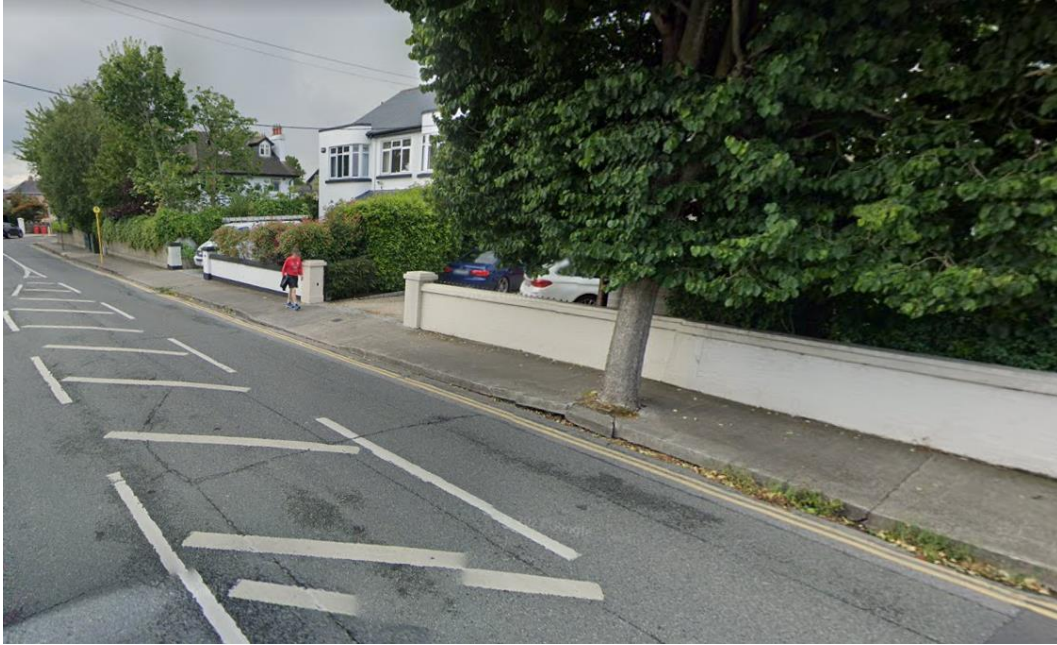
Footpaths along this section of the scheme are generally 1.5 - 2m in width but the width is restricted in places due to street furniture or mature trees as can be seen in Figure 31.

Figure 31: Footpath on Bushy Park Road

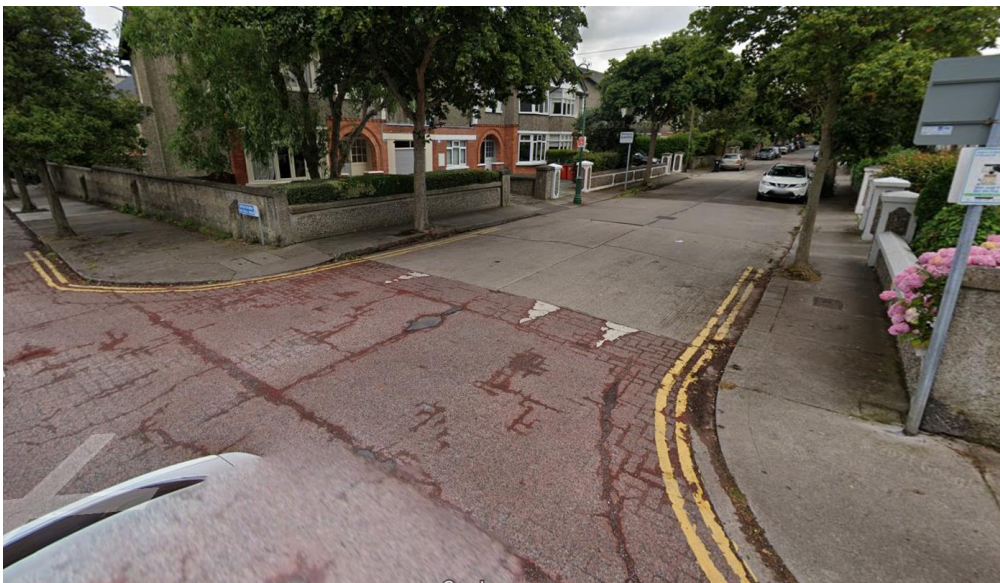
The section of this scheme through Wasdale Park and Victoria Road is provided in a residential neighbourhood setting and the road is traffic calmed throughout by the use of raised tables and ramps to control speeds. There are a number of side road crossings along this section but no tactile paving has been provided to assist visually impaired users as can be seen in the example in Figure 32. There are similar instances of this at side road crossings on Orwell Road.

Figure 32: Uncontrolled Crossing on Victoria Road

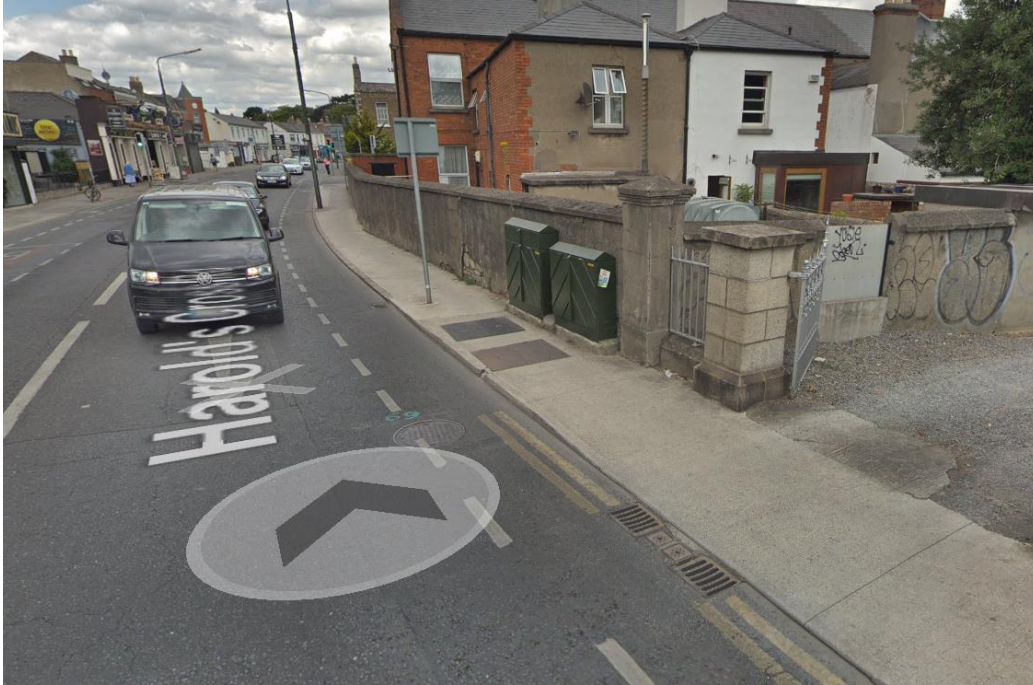
There are areas along this section where the footpath width is narrow, and this coupled with a combination of poor street furniture placement can make these areas difficult for mobility impaired users to navigate safely as shown in Figure 33.

Figure 33: Street Furniture on Harold's Cross Road
