Appendix I1
Accessibility Audit Report

National Transport Authority
**Templeogue/Rathfarnham to City
Centre Core Bus Corridor Scheme**
Accessibility Audit Report

268401-00

Issue | 06 January 2022

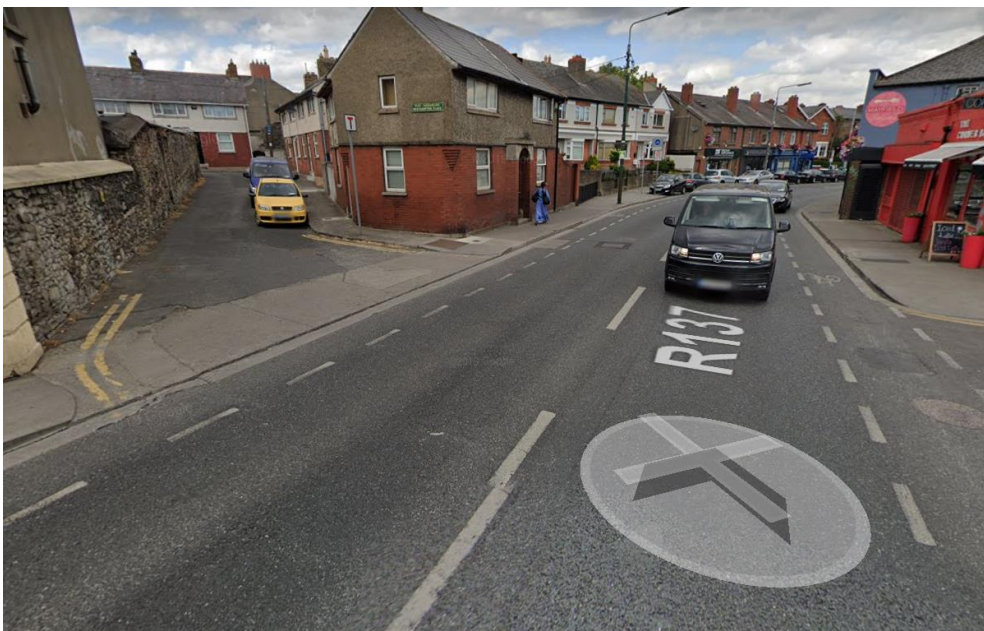
Some crossings in this section are poorly laid out for mobility impaired users, with poor demarcation between footpath and carriageway as shown in Figure 34, or not at the correct angle as shown in Figure 35.

Figure 34: Uncontrolled Crossing on Terenure Road North

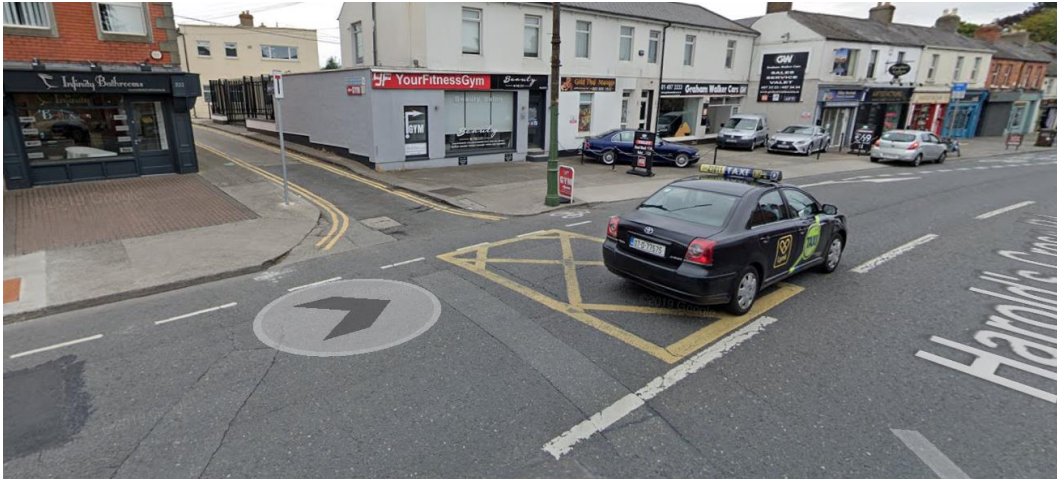
Figure 35: Uncontrolled crossing on Harold's Cross Road

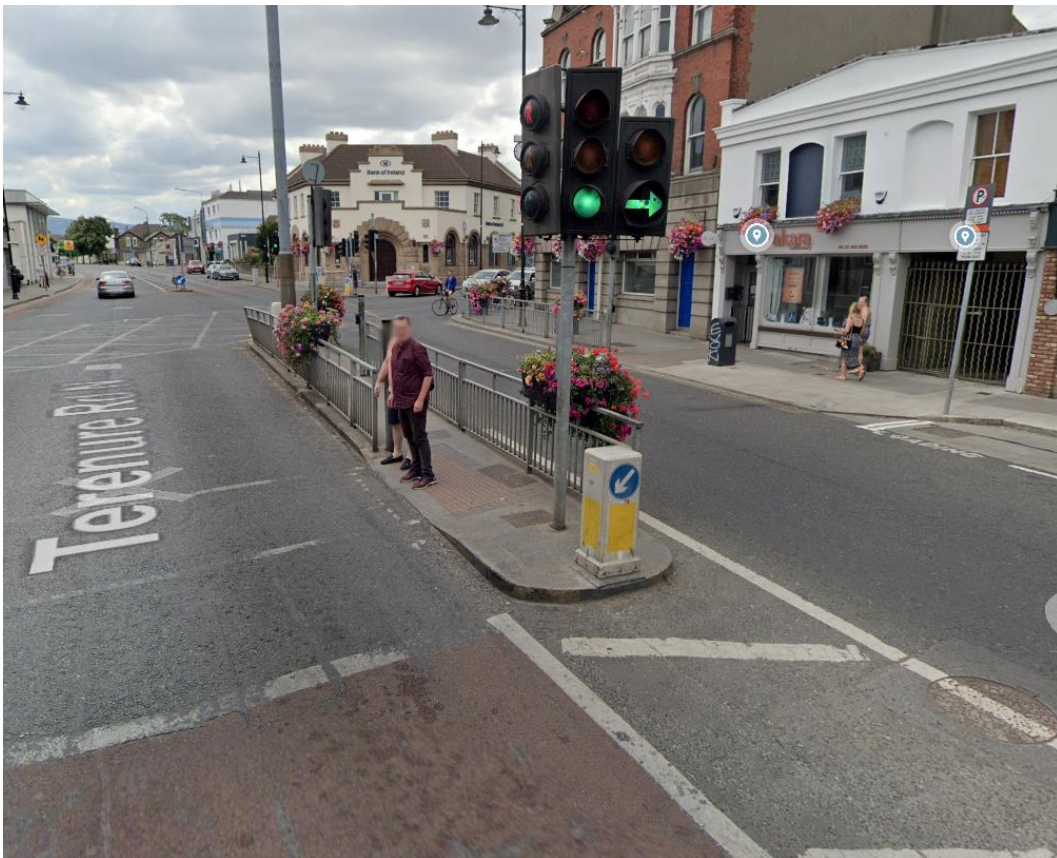
The tactile paving, and space required at the central island on the Terenure Road North Junction with Terenure Road East as shown in Figure 36 does not allow for easy passage for mobility impaired users and pedestrians alike.

Figure 36: Tactile Paving on Terenure Road North

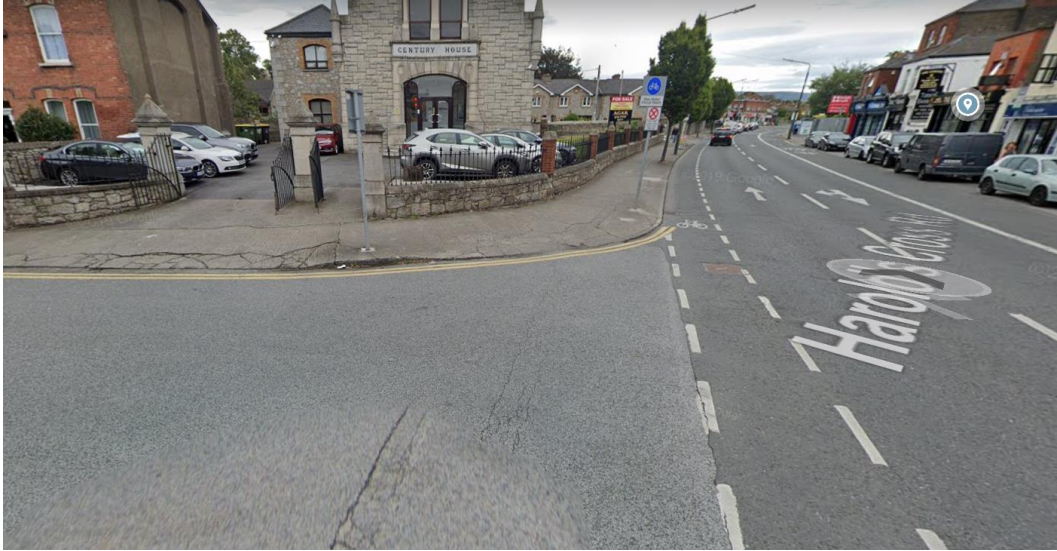
The surface material along this section is acceptable for the most part, however there are localised areas where cracking or asphalt replacement has occurred; leading to undulating, uneven surfaces for mobility impaired users to navigate as show in Figure 37 and Figure 38.

Figure 37: Surface Material on Harold's Cross Road

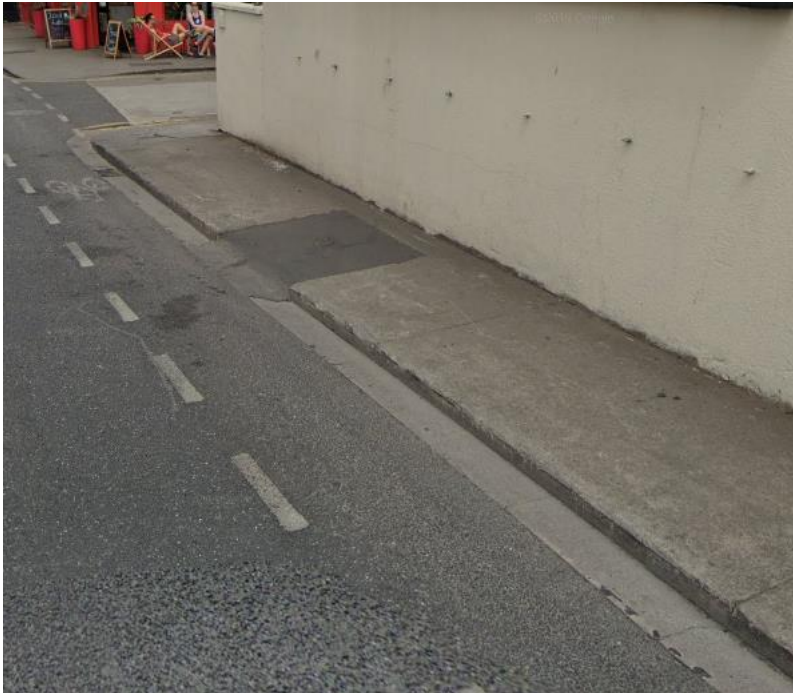
Figure 38: Surface Material on Terenure Road North

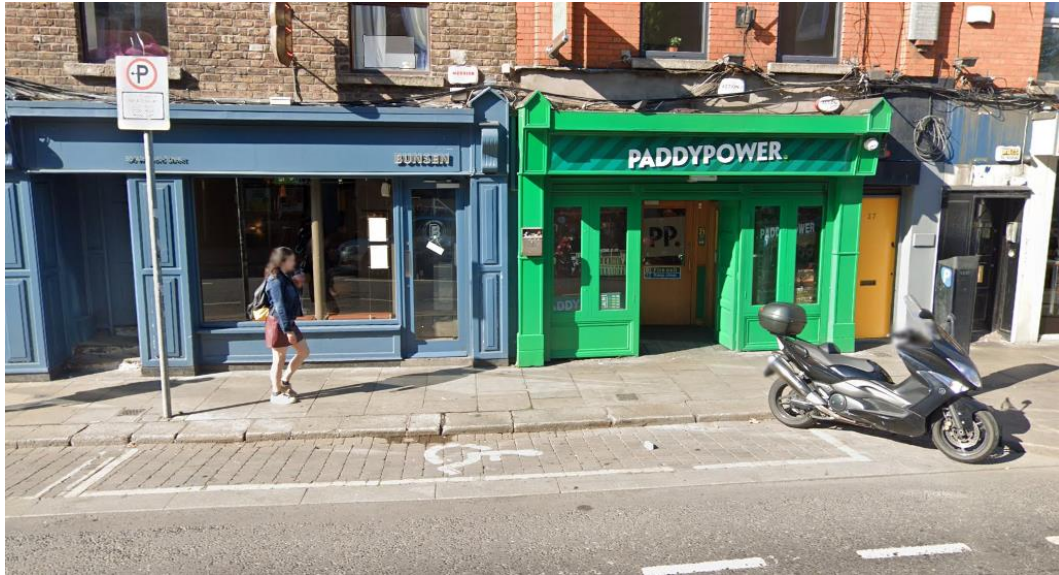
An accessible parking space was observed on the western footpath of Wexford street, close to the intersection with Kevin Street Lower. The space is quite narrow at approximately 1.5m wide and is approximately 5.5m long as shown in Figure 39. This is the only accessible parking space along this section of the route. There are no obstacles obstructing passengers from entering or exiting a vehicle from the footpath side, however, accessing a vehicle from the roadside could be potentially dangerous due to the proximity with northbound traffic.

Figure 39: Disabled parallel parking space - Wexford Street

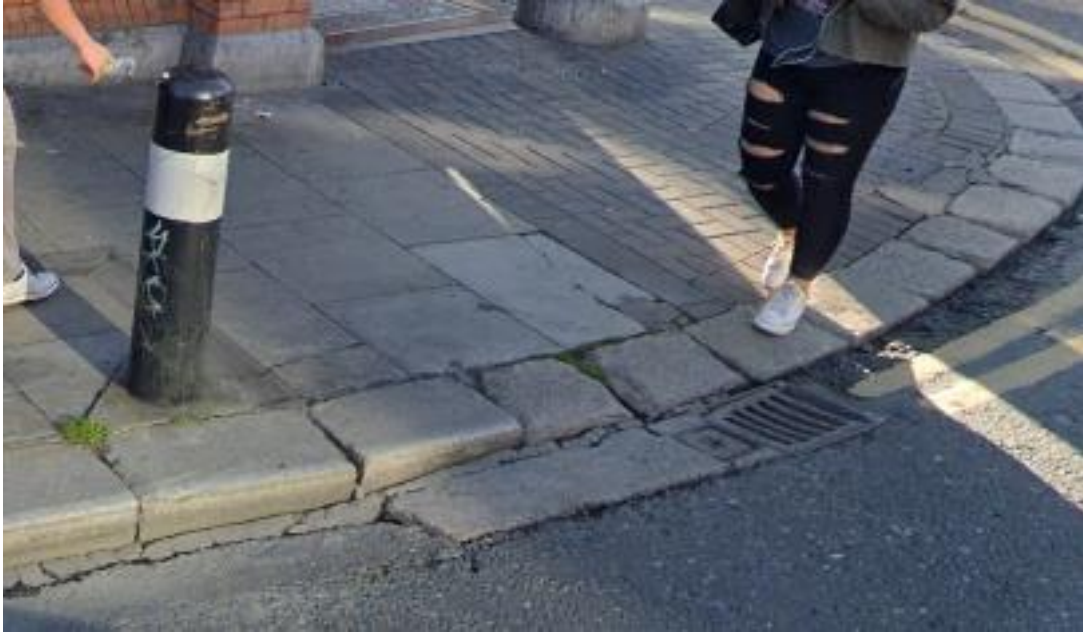
The condition of the road surface at the location of some gullies is poor, such as at the southern end of Aungier Street, at the junction with Digges Street Upper as shown in Figure 40. This can cause ponding at the location of the gully. There is evidence of deterioration of the grouting between kerb stones.

Figure 40: Drainage example of deterioration, both of the kerb and adjacent gully.

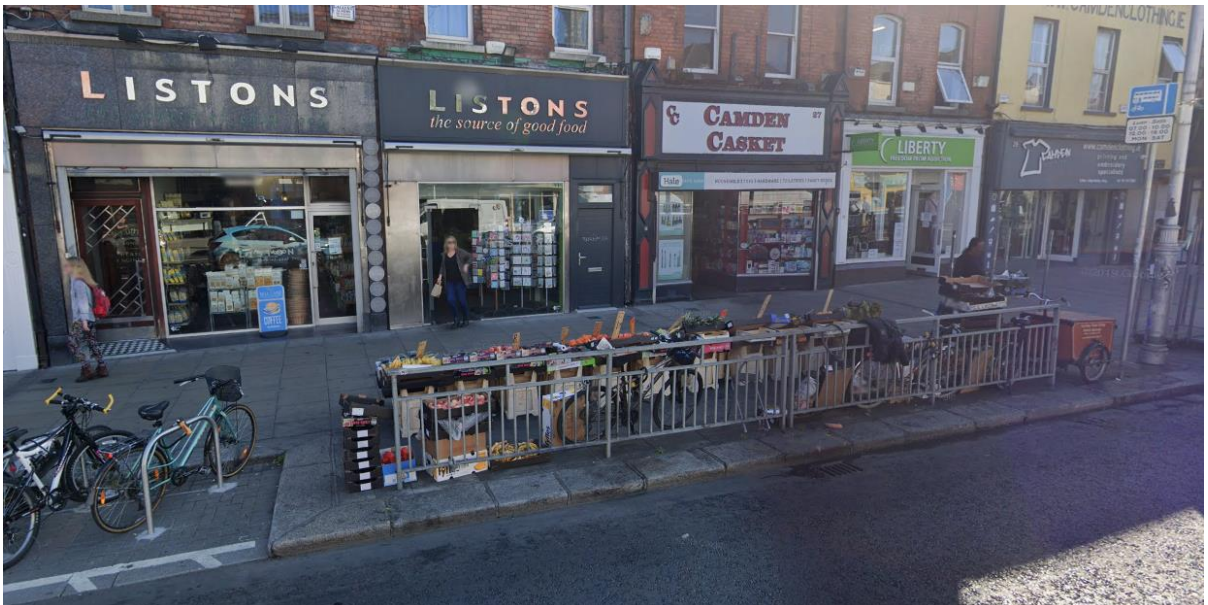
Pedestrian Guardrails were observed throughout this section of the route. Generally, they are positioned at locations where the footpath is relatively wide, and therefore are unlikely to cause difficulty for visually or mobility impaired pedestrians when passing. An example of guardrails in this section is shown in Figure 41.

Figure 41: Guardrails – Camden Street

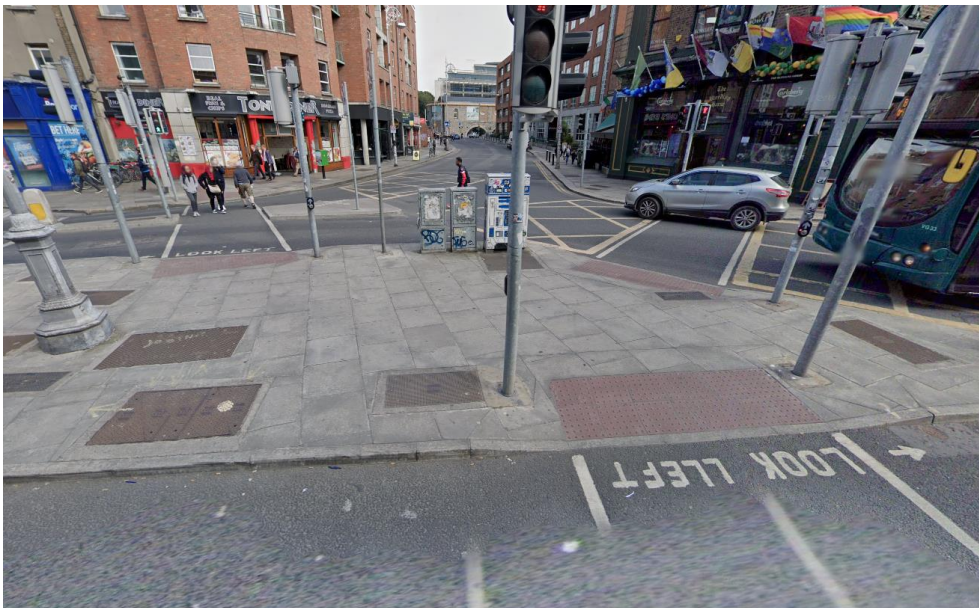
Several crossings are divided into two by a pedestrian island in the middle of the road. The majority of the islands are wide enough to accommodate a mobility impaired person waiting to finish crossing the road, while other islands such as that at the junction between Camden Street and Charlotte Way (see Figure 42) serves as a three-direction crossing with ample room for the mobility or visually impaired to safely cross. In most instances, both the island and crossing are wide enough to accommodate safe waiting on the island.

Figure 42: Pedestrian Crossing Point – Camden St/Charlotte Way

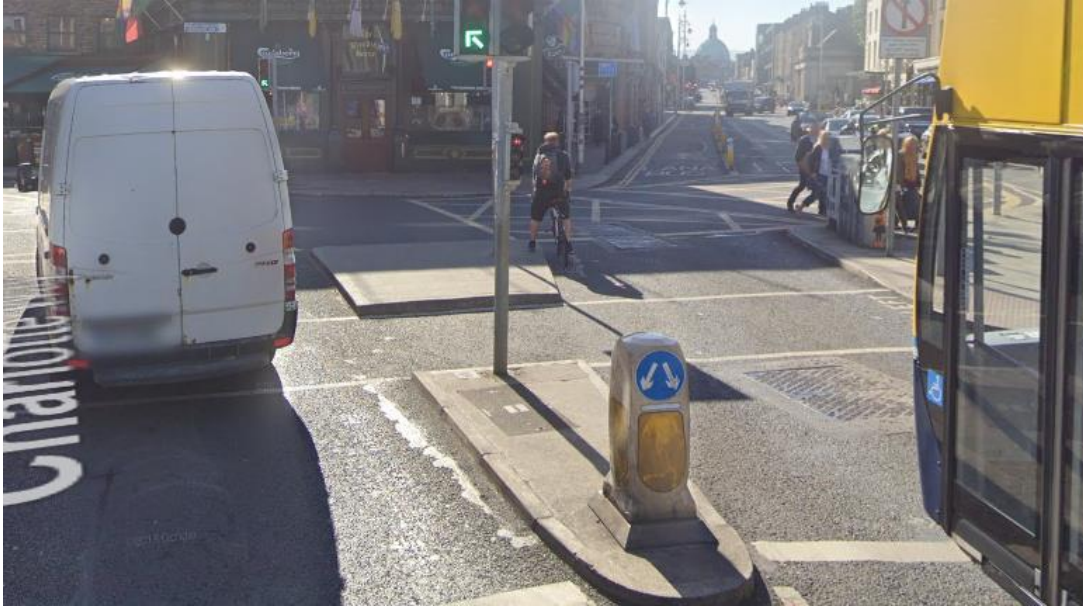
The island that divides the southbound traffic into turning and straight-travelling at the junction between Camden Street and Charlotte Way tapers to follow the bus lane as shown in Figure 43. The island is 1.45m wide at its narrowest. A pedestrian waiting at this island could possibly be in danger due to the proximity with moving busses travelling on a horizontal curve through the junction.

Figure 43: Controlled Crossing Point – Charlotte Way

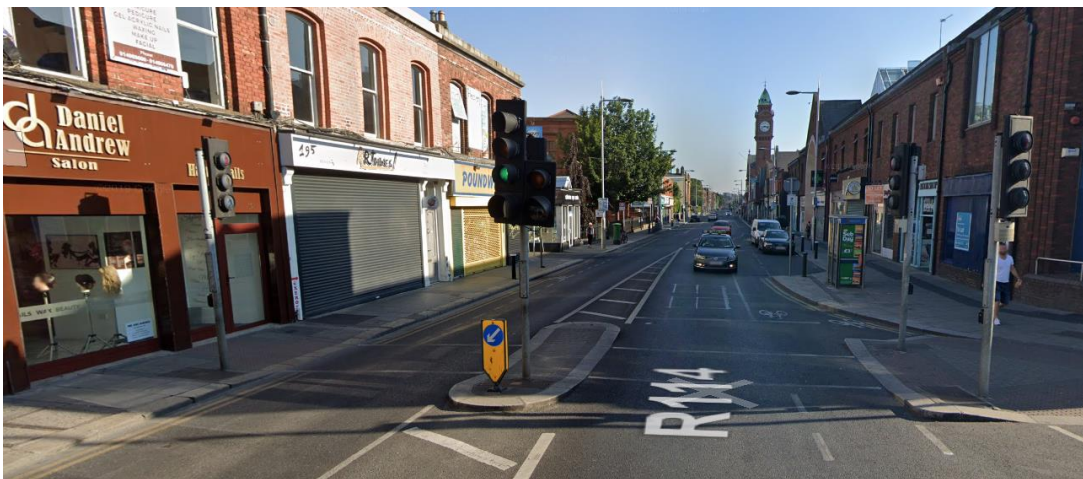
Some of controlled crossings, such as that at Rathmines Road Lower, close to the junction with Castlewood Avenue, feature an island that is not signalled, and does not feature a tactile paving surface as shown in Figure 44. This could potentially cause an issue with the visually impaired. Pedestrian pushbuttons can become inaudible over time and without a signal on the island, a visually impaired person may have difficulty in crossing, or in knowing to stop on the island when the signal changes to red for pedestrians.

Figure 44: Controlled crossing - Rathmines Village

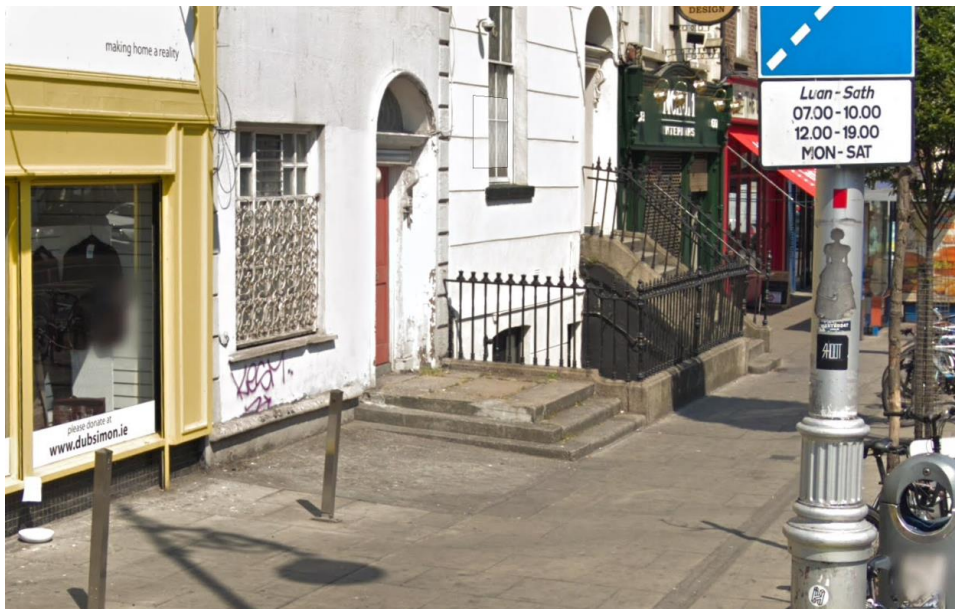
No significant changes in level were observed along this section of route. Several Georgian-era buildings have stepped access between their entrance and the footpath. These usually include a handrail as part of the design, however, one stepped entrance was observed with no handrail on one side and no step hazard identification such as tactile pavement to alert the visually impaired to the hazard as shown in Figure 45.

Figure 45: Changes in Level – Camden Street

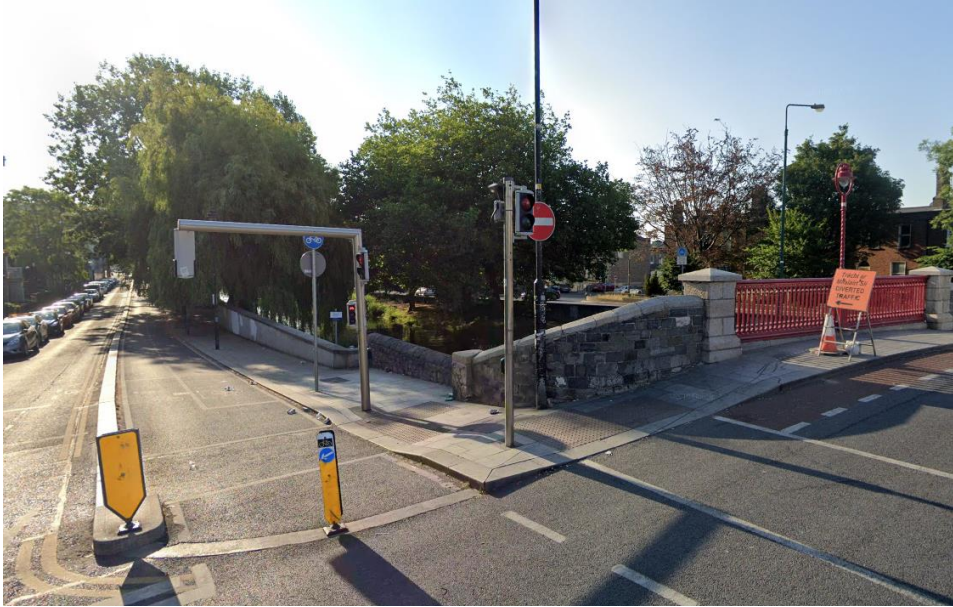
Figure 46: Shared Spaces – Richmond Bridge

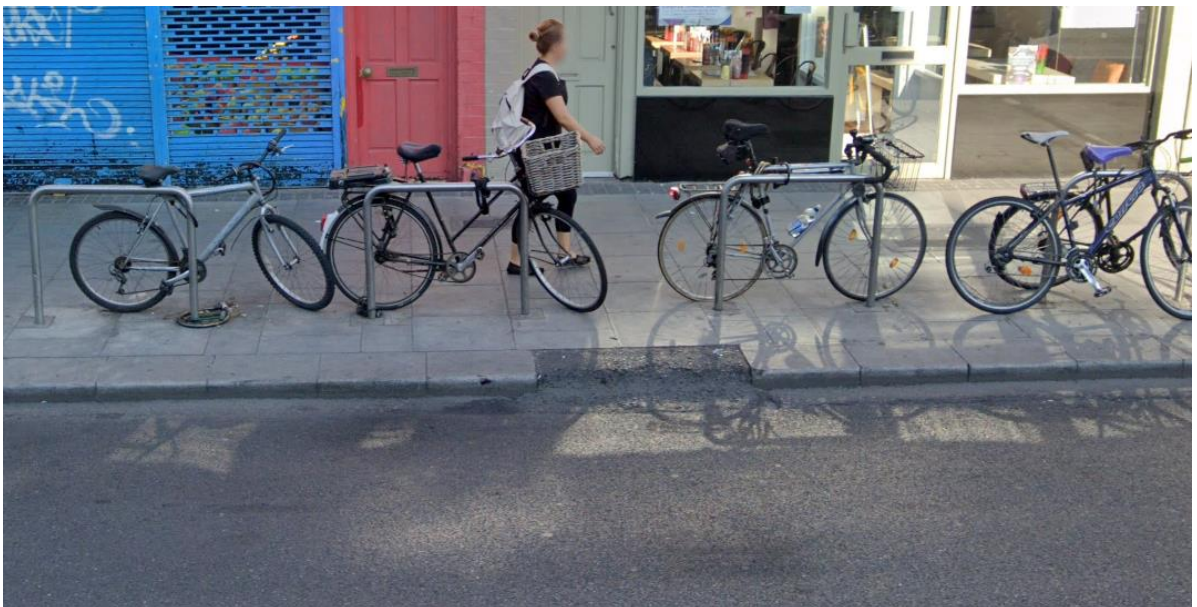
The surface material used for the footpath along this section of the route varies. The footpath through Rathmines is predominantly composed of granite tiles and kerbs as shown in Figure 47. Some in-situ concrete was observed, as well as minor asphalt patch repairs to kerbs.

Figure 47: Surface Material – Rathmines Village

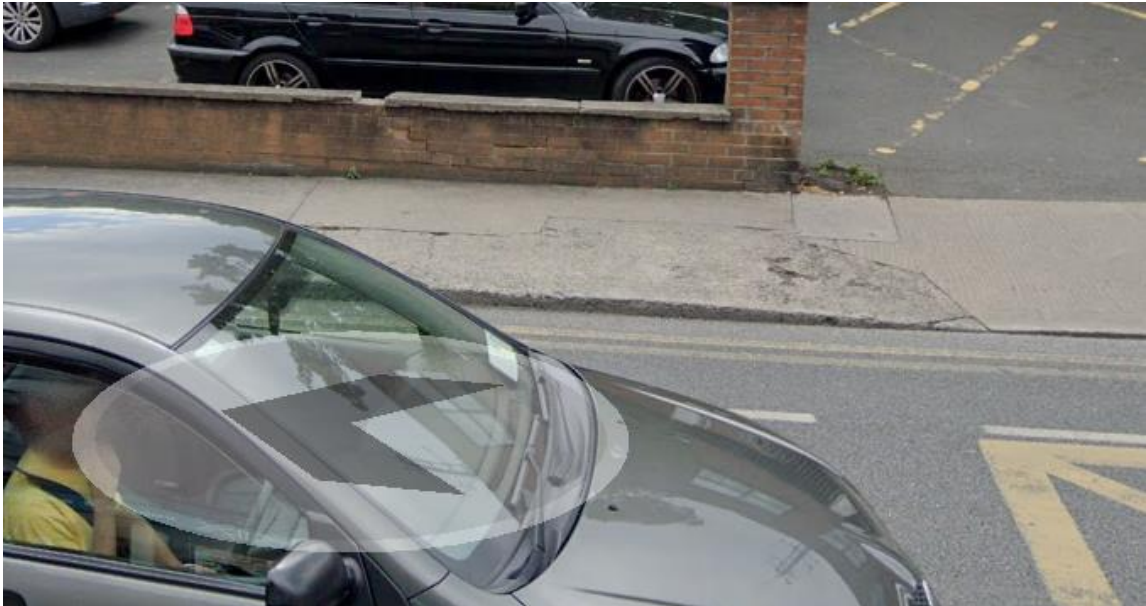
Concrete or asphalt patch repairs that later begin to deteriorate and spall can become uneven and lead to drainage problems and pose a tripping hazard. The majority of this section of route features stone paving tiles rather than cast in situ material and therefore concrete patch repairs are prevalent only along the Rathgar Road.

Figure 48: Surface Material – Rathmines Road

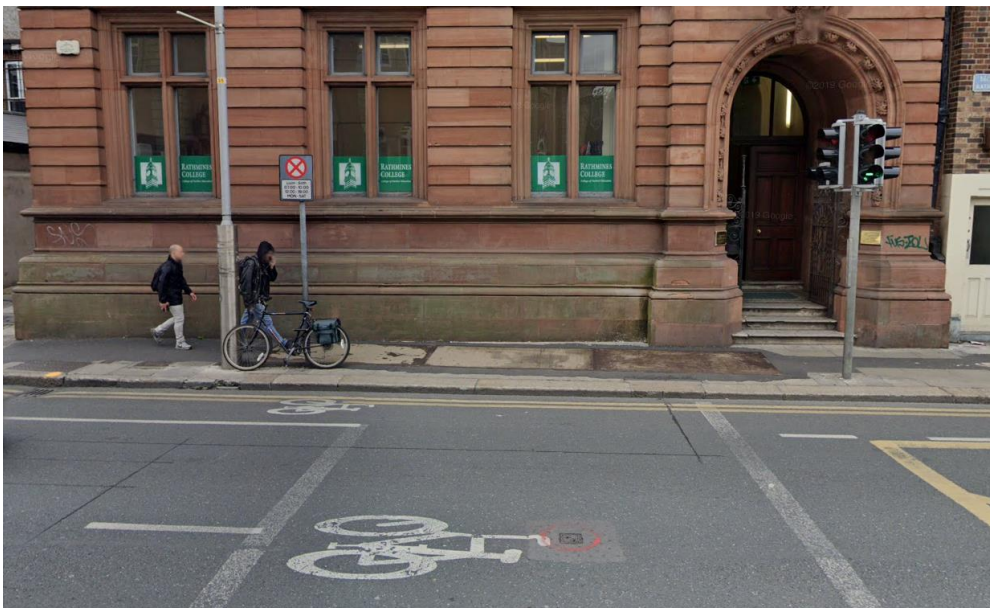
Instances of patch repair over stone paving tiles also occur, however. One asphalt patch repair work is a total of approximately 270m, suggesting a trench was cut through the paving tiles in order to lay services for the many businesses along this stretch on the eastern footpath of Rathmines Road Lower. The quality of the asphalt repair is generally good, however the repair work near the junction with Leinster Road is poor; three sheets of sheet-metal have been laid and set in place into wet asphalt. As well as being unsightly, the sudden changes to surface material may be disorientating to the visually impaired and surface undulations in this area pose a tripping hazard.

Figure 49: Surface Material – Rathmines Village

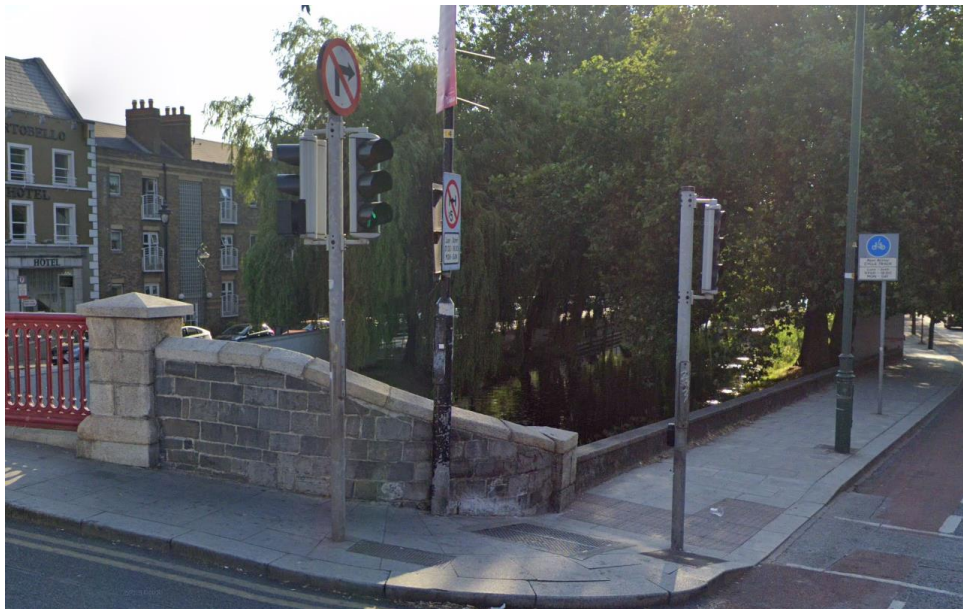
Figure 50: Street Furniture - Portobello

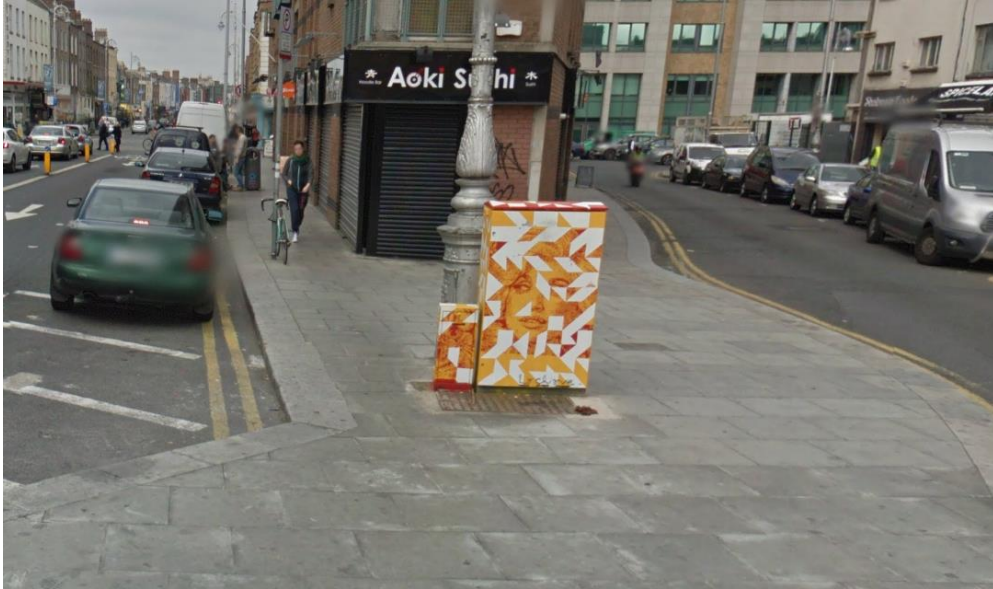
Figure 51: Street Furniture - Portobello

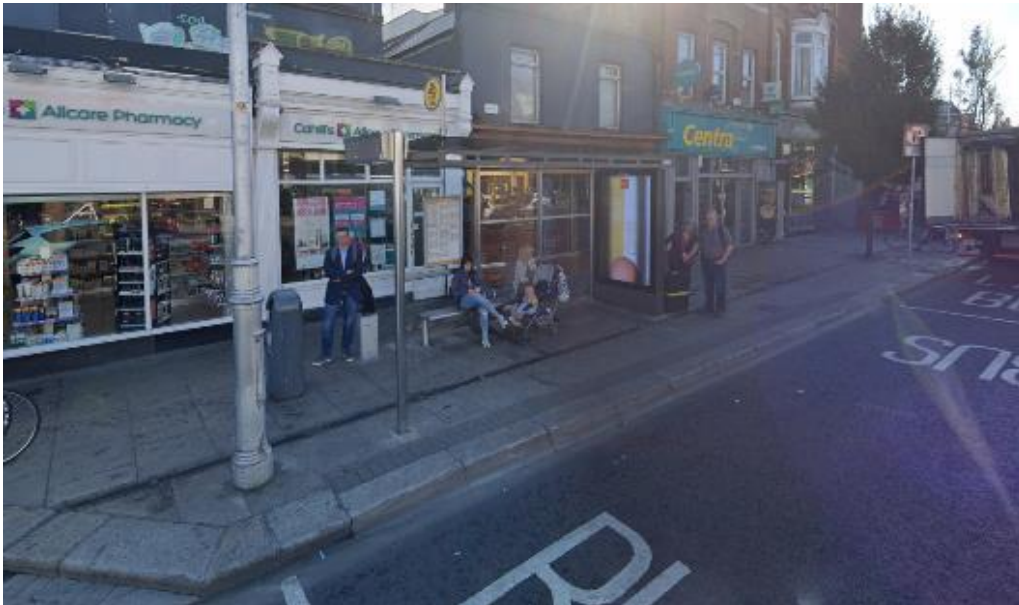
Figure 52: Street Furniture – Camden Street
