Appendix P
Templeogue Arch –
Structural Appraisal and
Outline Recommendations
for Repair

Templeogue Arch, Templeogue, Co. Dublin

Structural Appraisal and outline recommendations for repair

Project 22548

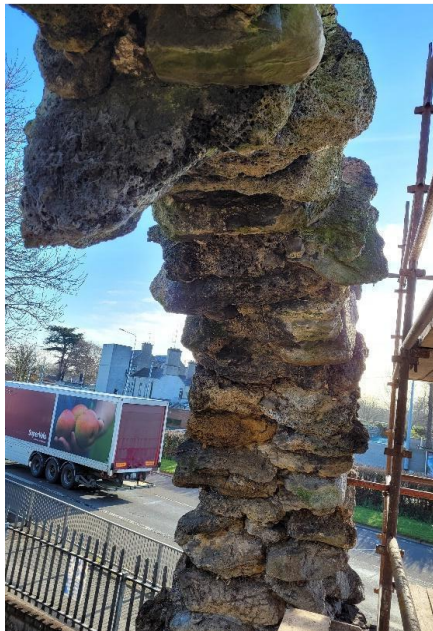
Figure 3 – Underside of arch

There is significant mortar loss on the underside of the arch, where mortar has washed out over time.

- ii. Joints between stones to be repointed, ensuring a self-draining surface. Any large joints between arch voussoirs to be packed tightly with slithers of stone/natural slate. However, joints should be recessed to respect the original intention of a weathered appearance.

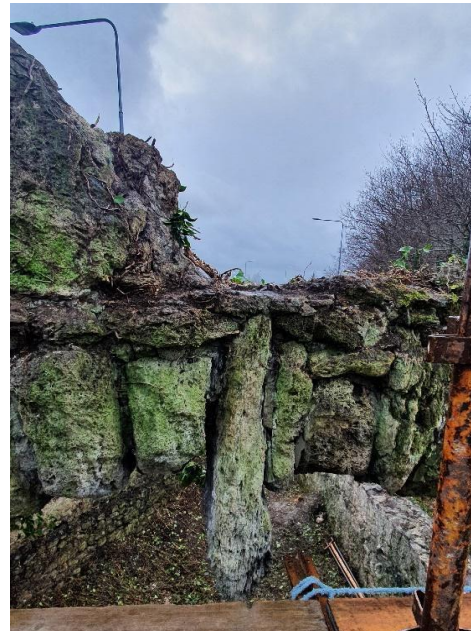
The arch is largely intact and structurally stable. However several stones of the rusticated capping have fallen from the top of the arch; most of these were present on the ground at the base of the arch and were visible once the vegetation had been cleared. This loss of overburden stone is compromising the arch structure, which relies on an even distribution of weight from above in order to act as a 'true arch'.

Figure 4 – Stone missing above arch keystone can be seen in the northeast elevation of the arch

- i. Arch to be consolidated by replacing fallen stone on top of arch, bedded in an appropriate lime-based mortar. The placement of this stone should be informed by careful interrogation of the historic photographs.

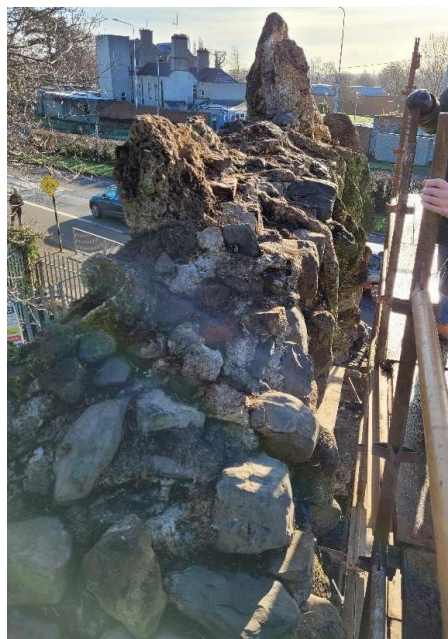
Figure 7 – Top of arch after vegetation removal

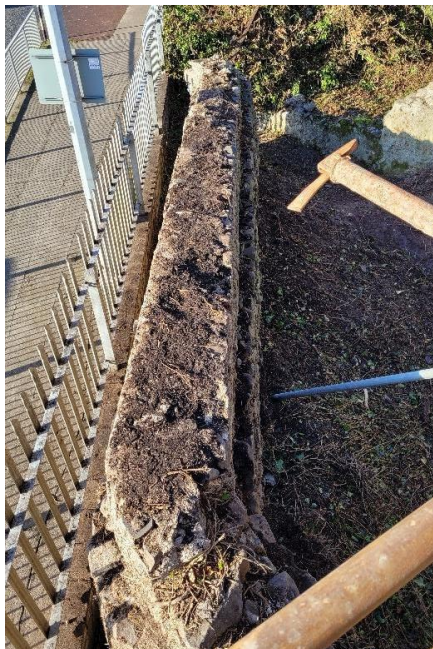
The walls flanking either side of the arch are in reasonable condition. However there has been some stone and mortar loss from the wall tops and there are several vertical cracks in the walls. These cracks were likely caused by the large ivy roots growing within the masonry. The wall tops were covered in vegetation until recently, which has dislodged the top stones. These are now loose and allowing water ingress into the core of the flanking walls.

Figure 8 – Top of southeast flanking wall

- vii. Flanking wall tops to be flanché to shed water. Exact wall top detail to be agreed once exemplars of options presented during works on site.

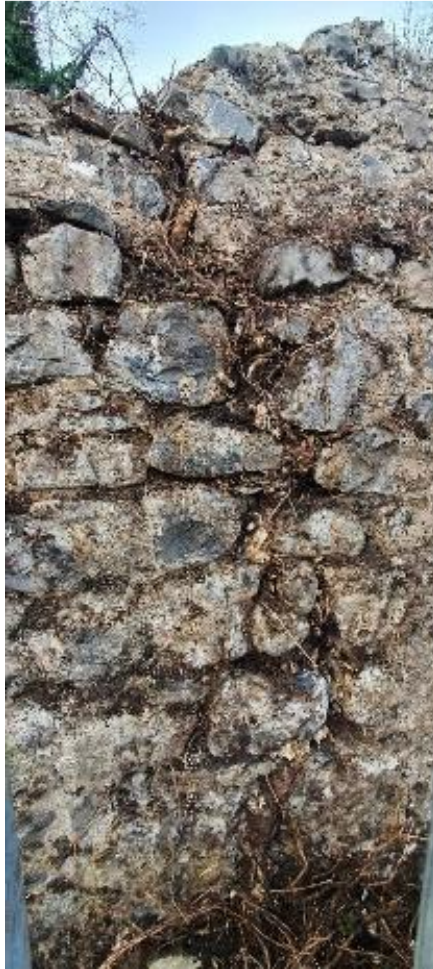
Figure 11 – Vertical crack in southeast flank wall due to roots

- vi. Flanking walls to be repointed in an appropriate lime-based mortar. Any remaining roots in the wall to be treated and removed as masonry works proceed. Once roots are removed, vertical cracks to be stitched using long stones across the crack.

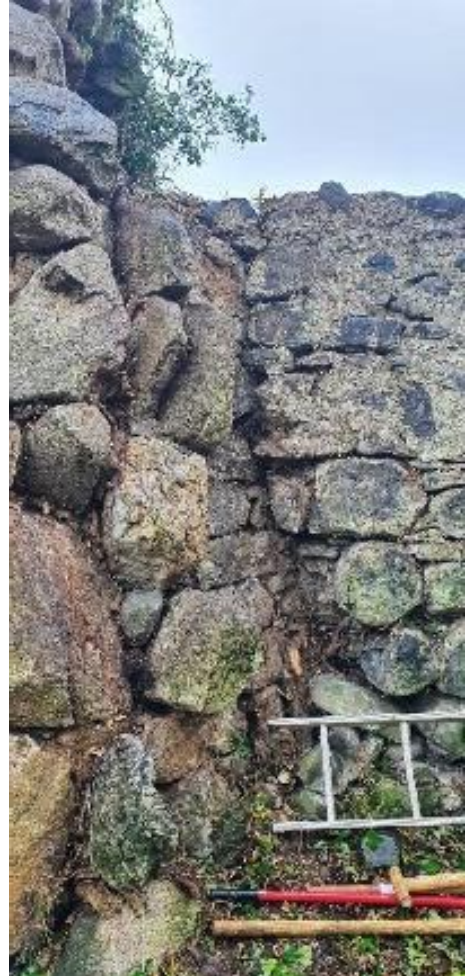
Where the walls abut the arch, there is some stone and mortar missing.

Figure 12 – Stone missing where wall abuts arch

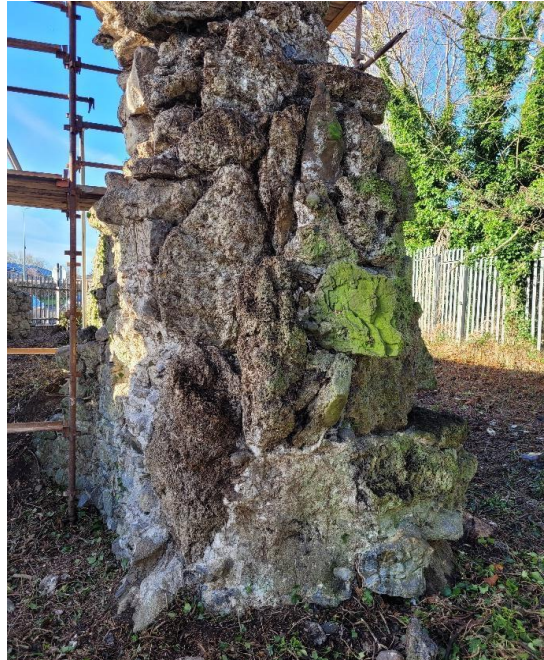
Figure 17 – Base of arch with various stone types and algae/lichen-stained stone

- iii. All algae and lichen growth on stones to be cleaned off using an appropriate biocide.
- iv. Banked earth/debris against base of flanking walls to be carefully removed to give a level surface between the walls at a similar level to the outside face of the walls.

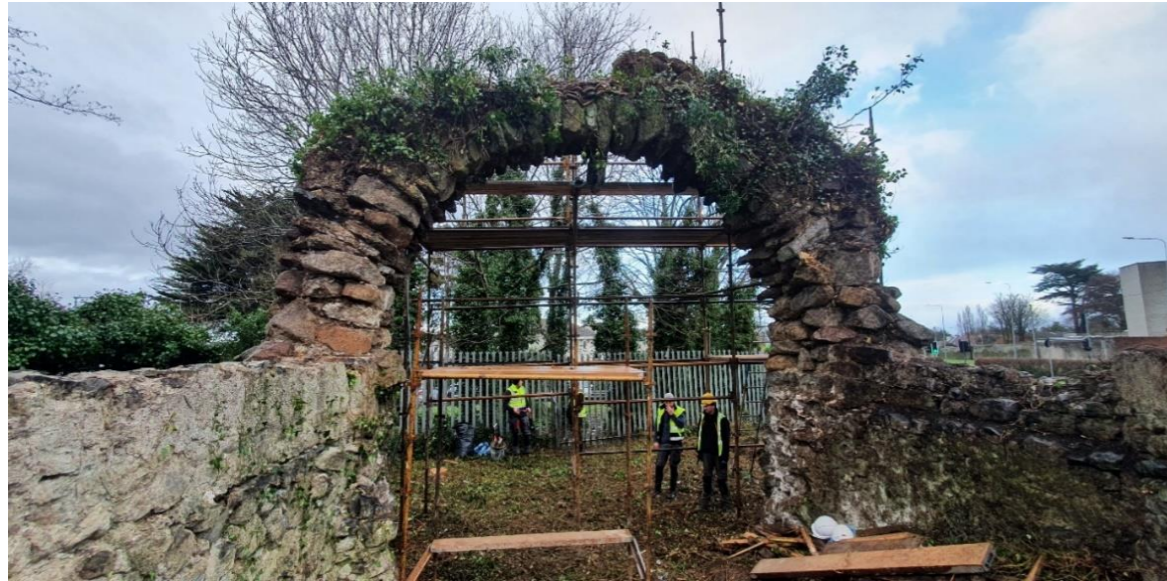
Arch during vegetation removal viewed from South-West

Vegetation which had grown around the arch has been removed early 2022. Removal of vegetation exposed large joints around the arch - a significantly large joint was pinned and repointed promptly. Tops of the flanking walls show significant loss of stone and mortar and several vertical cracks likely due to vegetation growth. Remaining vegetation will require further treatment as per vegetation control specification prior to masonry repairs.

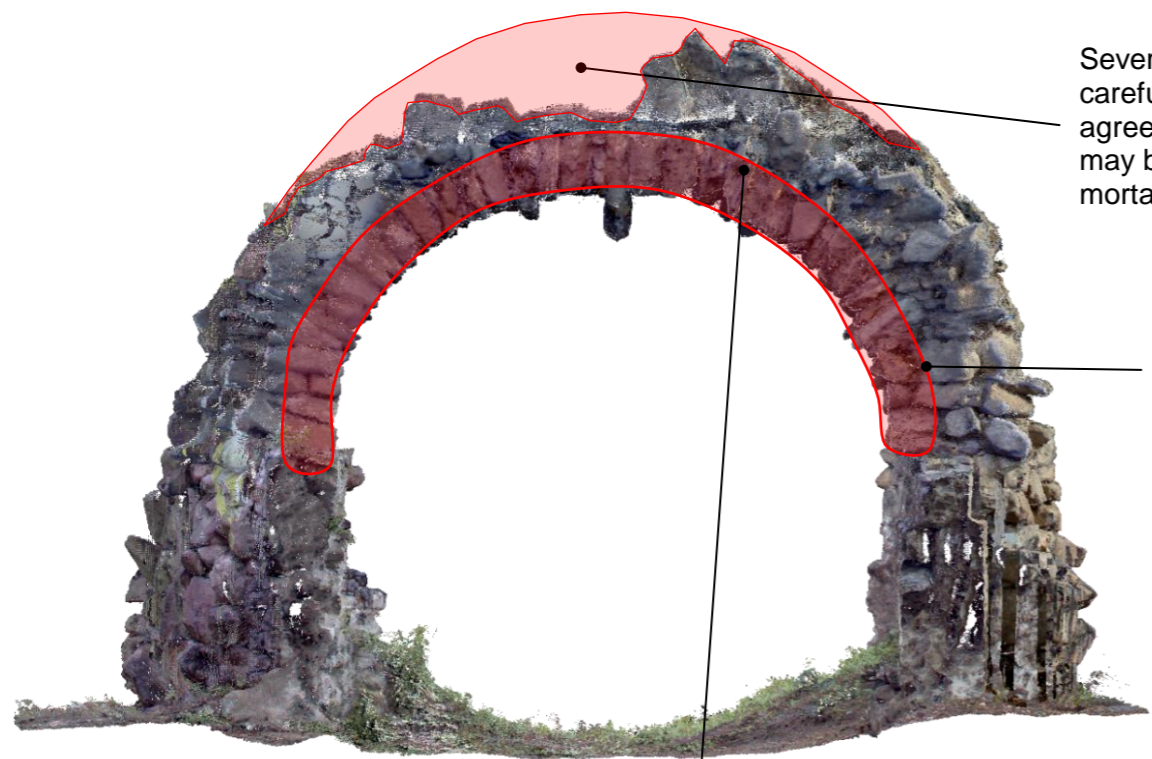
South-West Elevation of Arch

Several stones have fallen off the top of the arch. Fallen stones to be carefully identified and mock up of reinstatement created for agreement with design team. Note some supplementation of stone may be required. Stone to be re-bedded in an appropriate lime-based mortar.

Joints between stones to be repointed, ensuring a self-draining surface. Any large joints between arch voussoirs to be packed tightly with slithers of stone/natural slate. However, joints should be recessed to provide a weathered appearance.

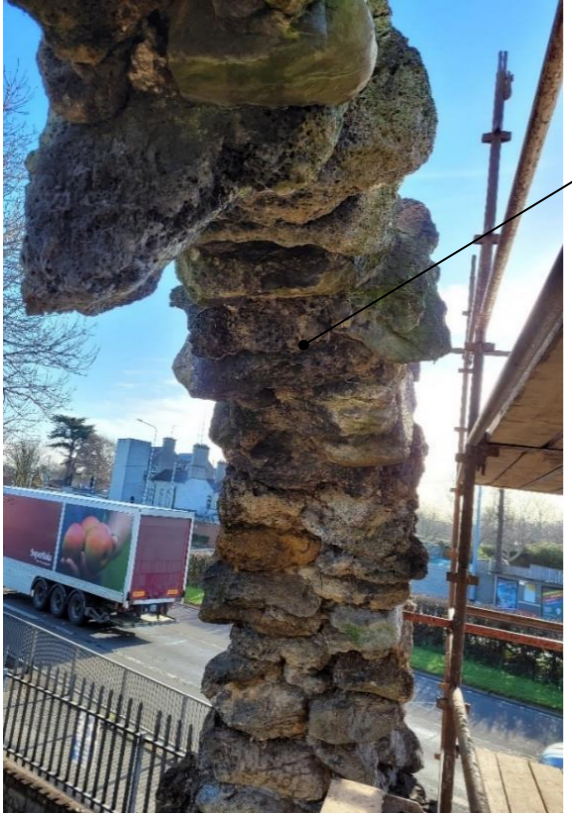
Underside of South-East side of Arch

Significant mortar loss from the underside of the arch. Deep repointing required.

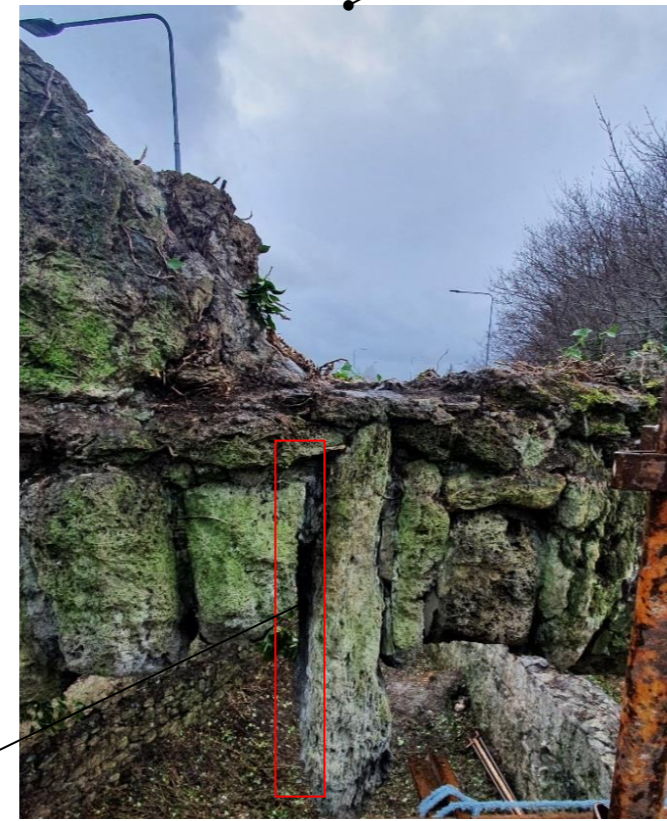
Image of missing stone on top of Arch

Joint located at the left hand side of the key stone was pinned and repointed right after the removal of vegetation.

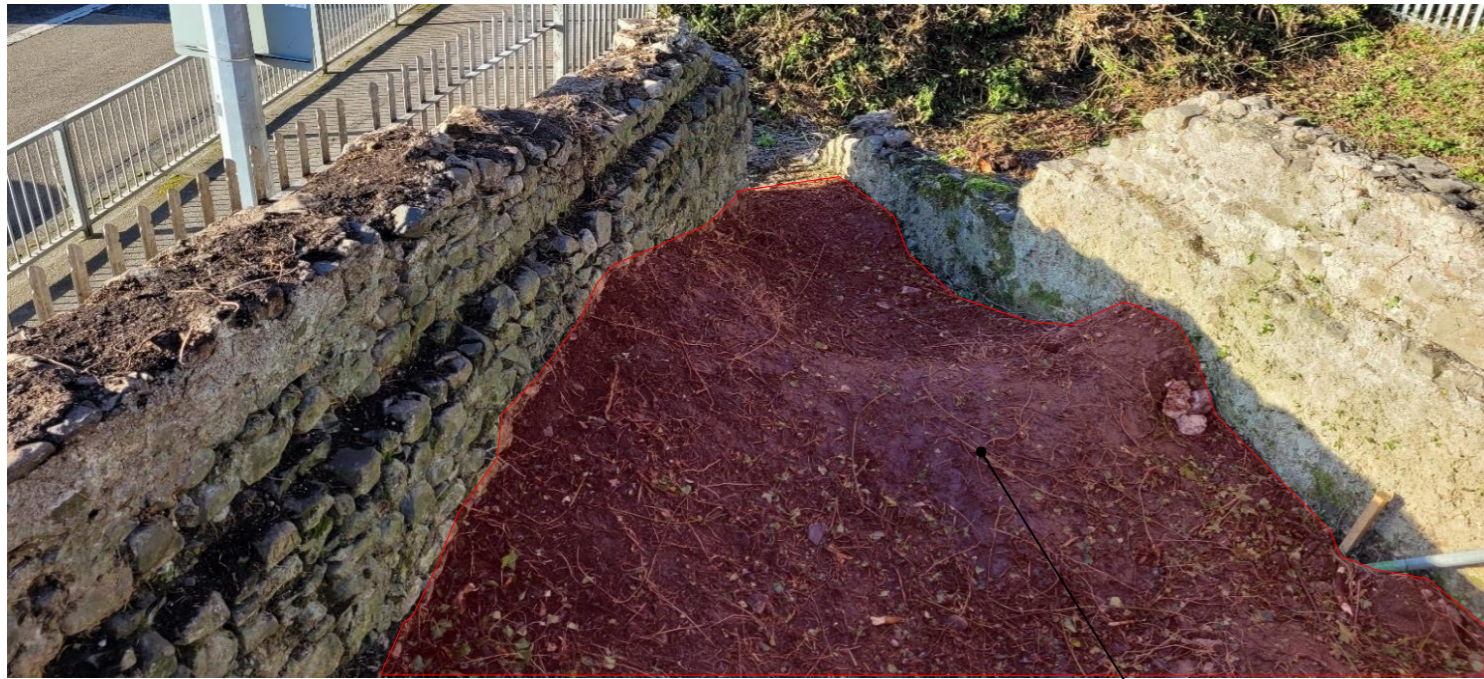
Area between Flanking Walls viewed from the top of the Arch

Stone and mortar loss from on top of flanking walls. Vegetation caused stones of top of walls to become loose and dislodged allowing water to seep into the core of the wall. Top of flanking walls require flaunching after masonry repairs and flanking walls are rebuilt to full height at the west end.

Banked earth/debris against base of flanking walls to be carefully removed to give a level surface between the walls at similar level to the outside face of the walls.

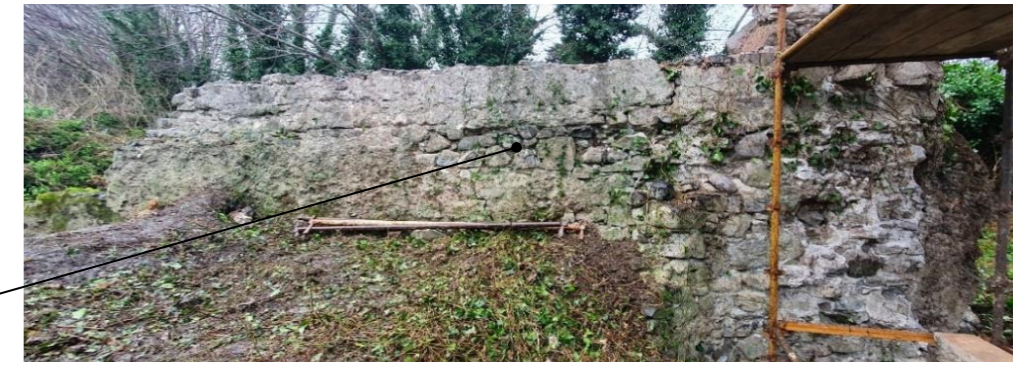
Inner face of North-West Flanking Wall

Missing stones in west end of the flanking walls. West end of flanking walls to be rebuilt to full height where stone has fallen ensuring that the walls are not easy to climb and are structurally secure.

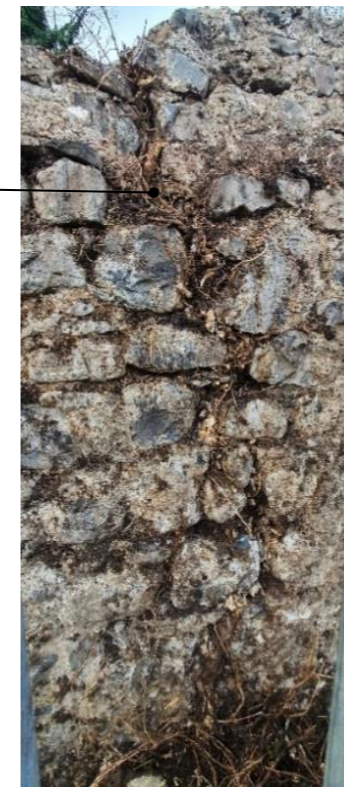
Outer face of South-East Flanking Wall showing vertical cracks

Vertical cracks in the flanking walls caused by the vegetation roots - after removal of roots, stitch vertical cracks using long stones across the crack.

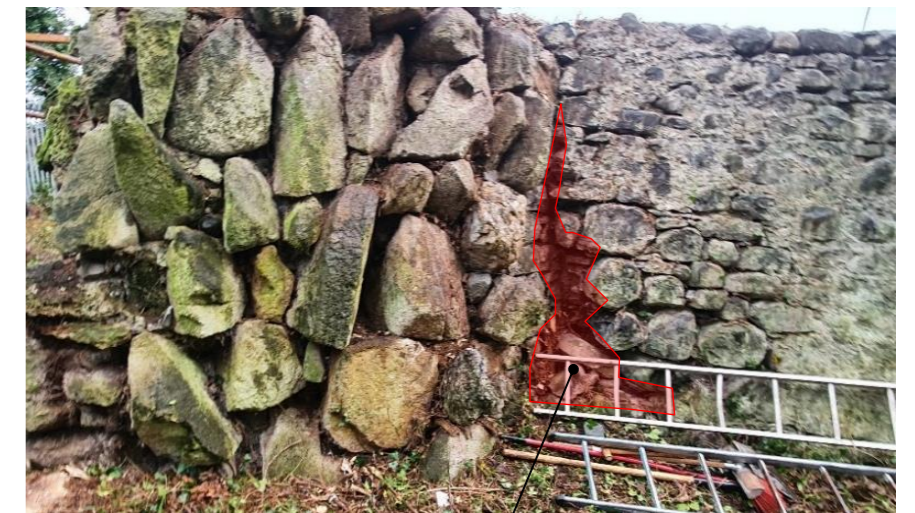
Outer face of North-West Flanking Wall

Missing stones from wall where wall joins with the base of the arch due to vegetation - require masonry works and repointing.
