Title: STAGE 1 ROAD SAFETY AUDIT

**Proposed Residential Development, Churchfields,
Mullhuddart.**

Date: May 2023

Report reference: 1833R01

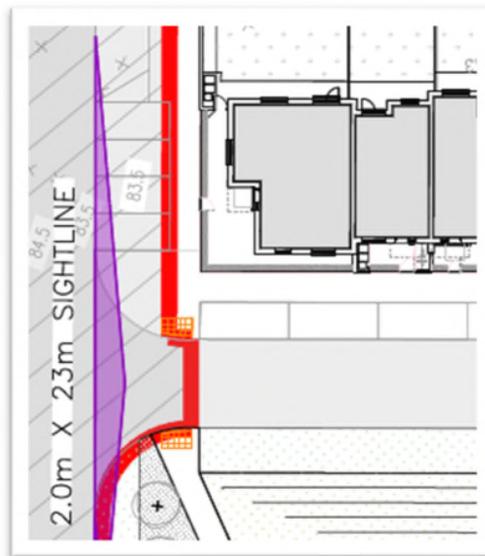
Drawing 20-074 P4115 Rev -, Visibility Splays.

The 23m visibility splay at the north side connection point crosses through car parking spaces. This could lead to a lack of visibility to oncoming traffic resulting in side-impact or rear-end collisions.

It is recommended that the car parking spaces be relocated outside the visibility envelope.

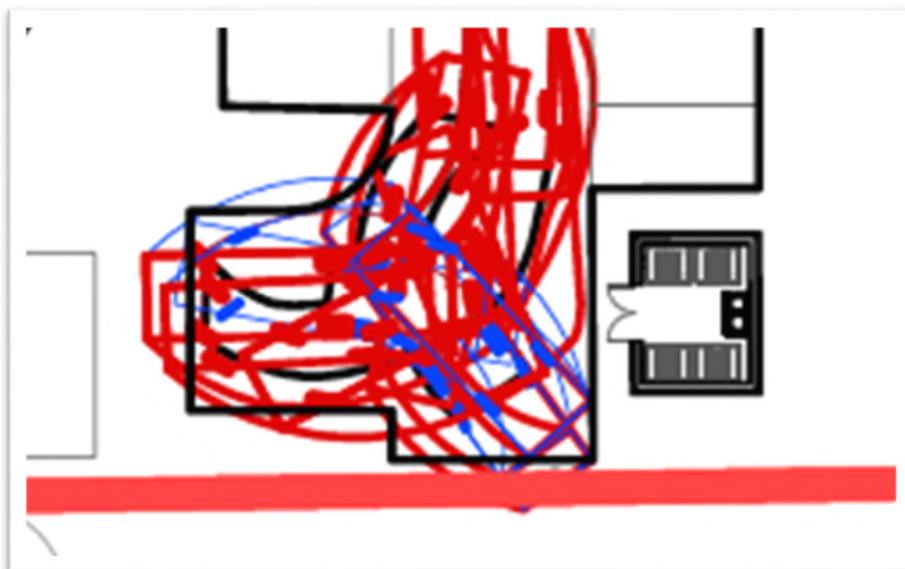
Drawing 20-074 P4111 Rev -, Refuse Vehicle swept path.

The refuse truck will have to carry out a number of movements to turn in the southern end hammer head. Drivers may opt to reverse down the road instead thereby increasing the risk of colliding with vulnerable road users or street furniture.

It is recommended that the turning head be increased in size so that the refuse truck can easily turn and that this option is more attractive for drivers.

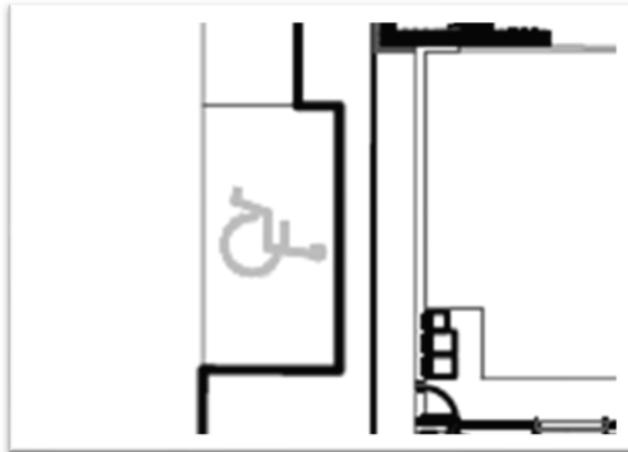
Adjacent to the pond, disabled car parking space.

The presence of the disabled parking space leads to a very narrow footpath. This could result in inaccessibility for mobility impaired pedestrians and lack of a suitably wide access area for wheelchair users.

It is recommended that the footpath be widened locally at the disabled parking bay and that a dropped kerb be provided to the footpath to provide access from the bay.

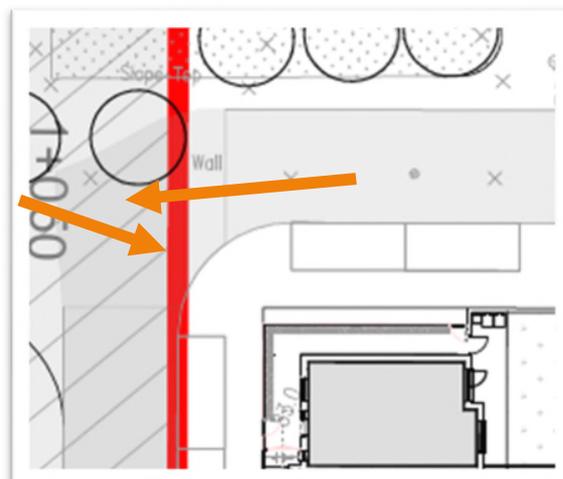
Drawing 20-074 P4115 Rev -, northern vehicular access.

Drivers may be confused over priority at the northern vehicular access due to the horizontal alignment at the junction. A lack of stopping sight distance on the through route and visibility from the sideroad could lead to collisions.

It is recommended that the priority be established and that suitable visibility be provided. Stop control should be provided on the minor arm during the detailed design stage.
