## Primary Route Assessment - Firlough Wind Farm, Near Ballina, County Mayo - Rev 1

381311

Prepared For Jennings O'Donovan

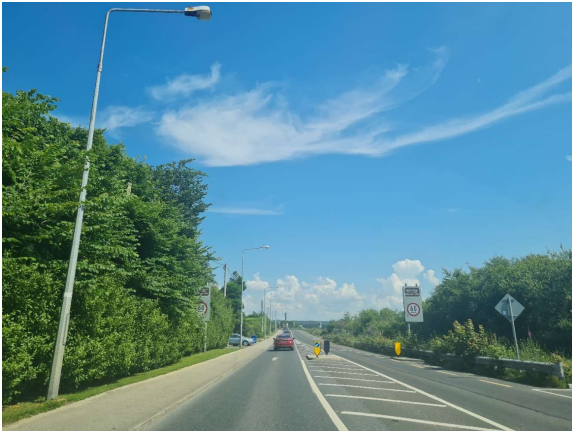
### **Location 3 - Splitter Island On R263**

Visual inspection indicates that the flexi bollards on the Splitter Island are to be removed.

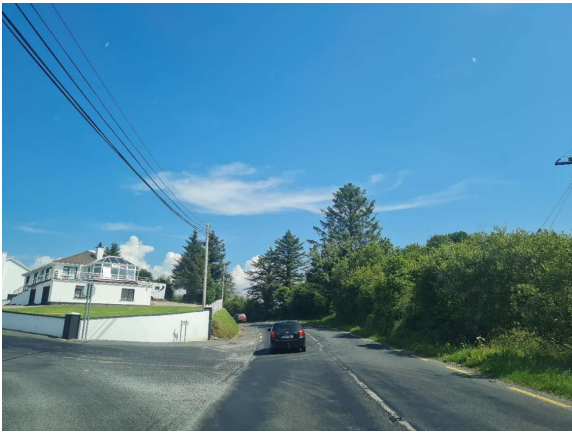
#### **Location 4 - Splitter Island On R263**

Visual inspection indicates that there are no issues at this location.

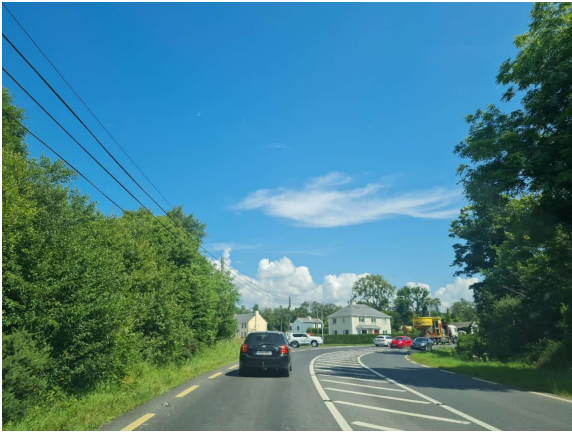
#### **Location 6 - Right Bend At R263/N56 Junction**

Visual inspection indicates that there are no issues at this location.

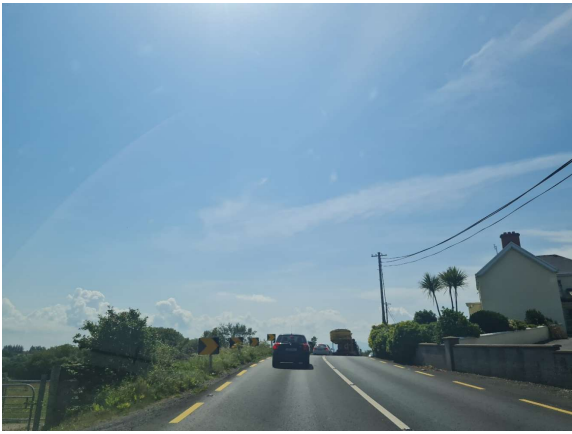
### **Location 7 - Right Bend On N56**

Visual inspection indicates that Road widening is required on the nearside of the bend.

Pruning required on both sides of the road.

Manual steering required.

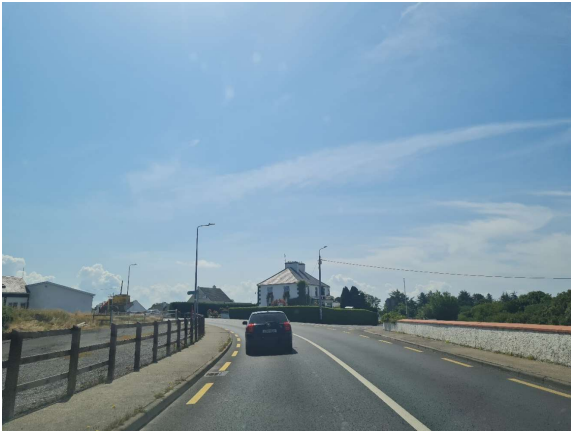
### **Location 9 - Left Bend And Crest On N56**

Visual inspection indicates that vertical analysis is required to determine whether grounding occurs.

Vertical analysis required to confirm modifications.

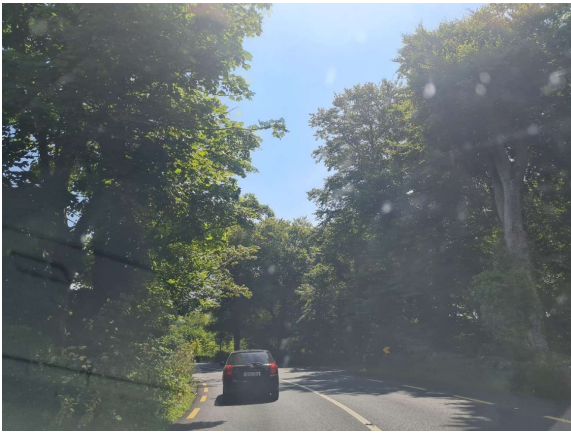
### **Location 10 - Left Bend On N56 In Bruckless**

Visual inspection indicates that third party land is required on the nearside.

Fence and boundary features on the nearside to be removed.

Swept Path Analysis required to confirm modifications.

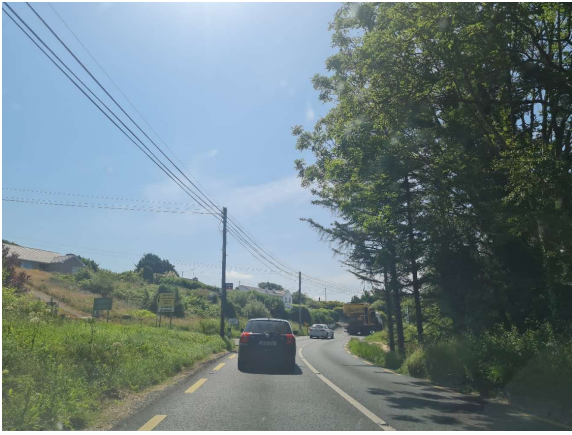
### **Location 12 - Right Bend On N56**

Visual inspection indicates that the loaded blade will navigate this bend utilizing manual steering.

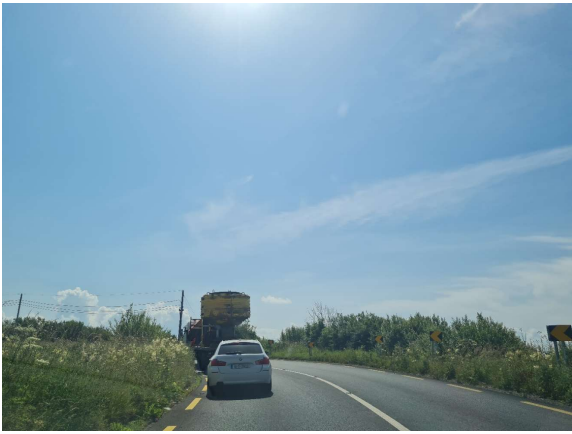
### Location 13 - Right Bend On N56

Visual inspection indicates that road widening is required to avoid third party land.

Utility Poles on the nearside to be removed.

Pruning required on both sides of the road.

Manual steering required

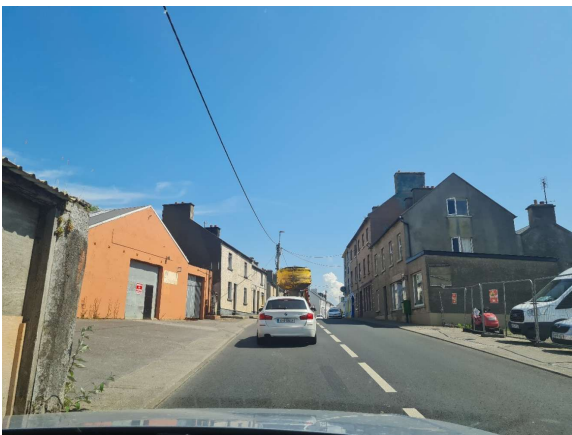
### Location 14 - Left Bend On N56

Visual inspection indicates that third party land is required on the nearside.

Utility Pole on the offside to be removed.

Fence and vegetation on the nearside to be removed.

Pruning required on the offside.

Manual steering required.

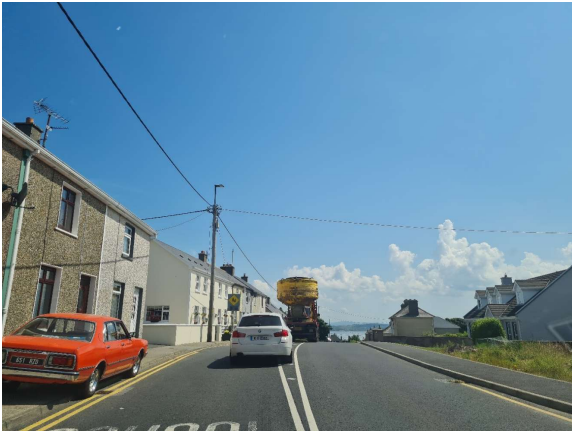
### Location 15 - N56 Through Dunkineely

Visual inspection indicates that parking is to be restricted during deliveries.

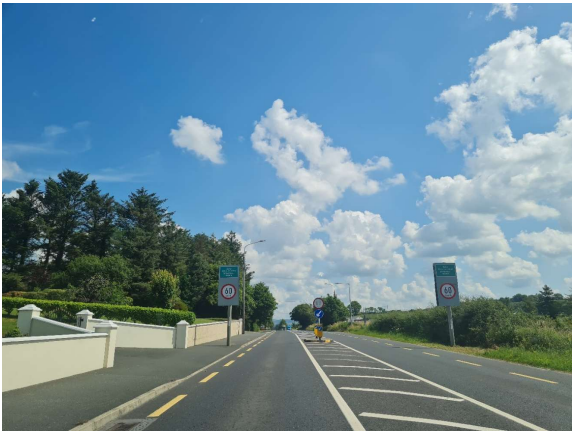
### **Location 16 - Right Bend And Crest On N56**

Visual inspection indicates that vertical analysis is required to determine whether grounding occurs.

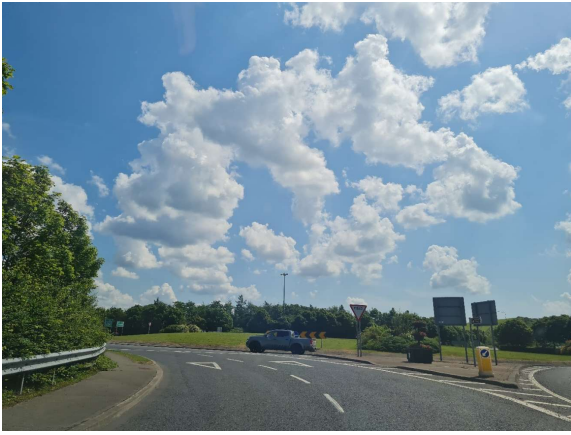
### **Location 18 - N56/R925 Roundabout**

Visual inspection indicates that the loaded vehicle will navigate this location utilising manual steering.

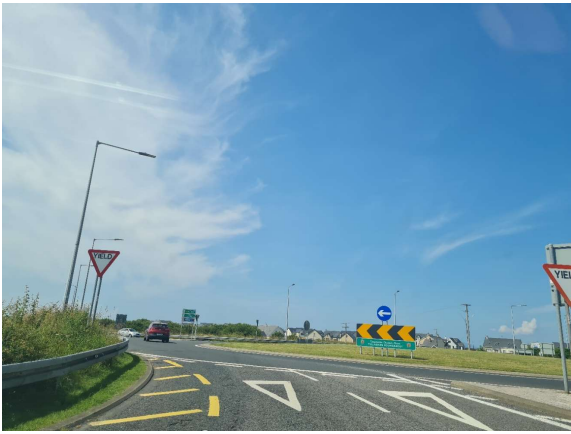
### **Location 22 - N15/R267 Roundabout**

Visual inspection indicates that road widening is required on the central island.

Road sign on central island to be removed.

Manual steering required.

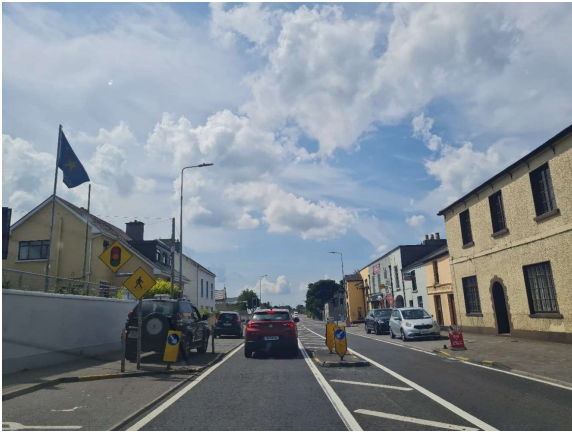
### **Location 24 - Entry Splitter Island At Cliffony**

Visual inspection indicates that the street furniture on the splitter island is to be removed.

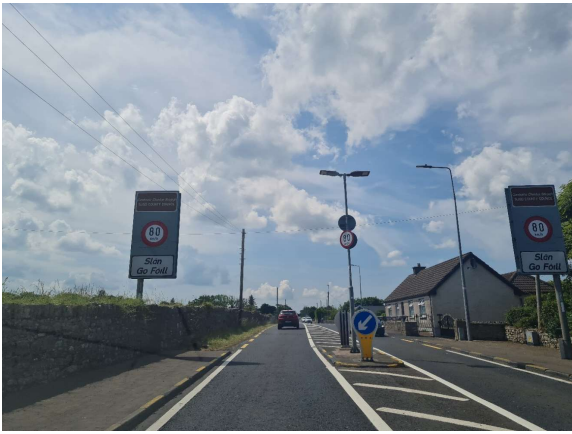
### **Location 25 - Splitter Islands On N15 Through Cliffony**

Visual inspection indicates that the street furniture on the splitter island is to be removed.

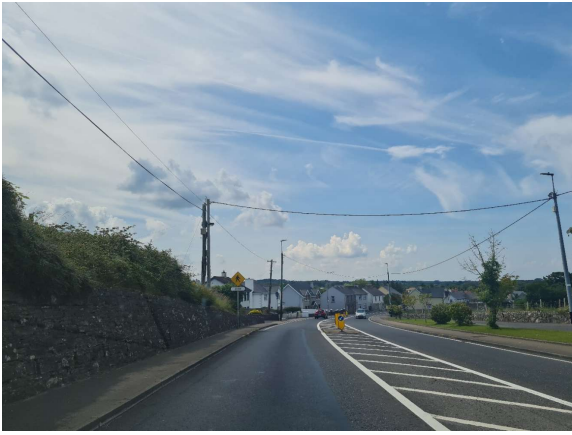
### **Location 27 - Entry Splitter Island On N15 At Grange**

Visual inspection indicates that the street furniture on the splitter island is to be removed.

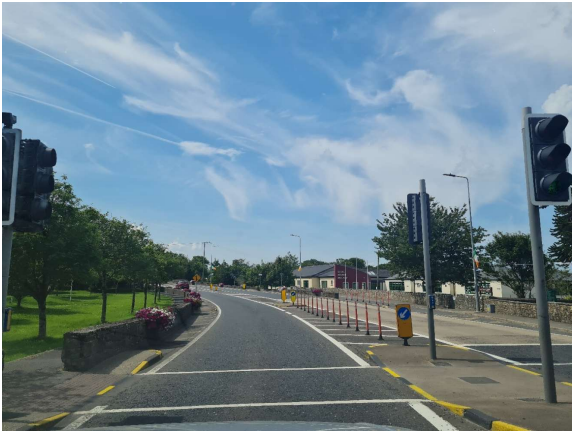
### **Location 30 - Splitter Island On N15 At Grange**

Visual inspection indicates that the street furniture on the splitter island is to be removed.

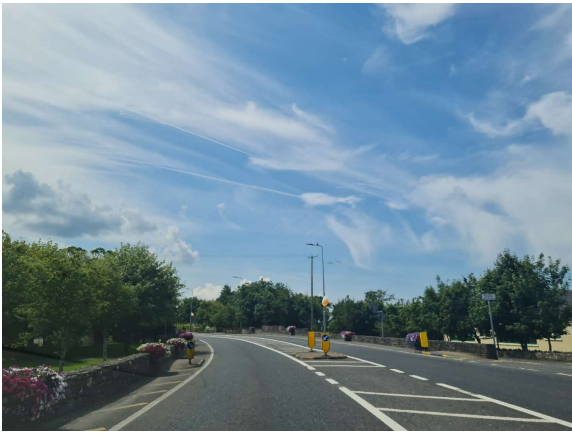
### **Location 31 - Splitter Island On N15 At Grange**

Visual inspection indicates that the street furniture on the splitter island is to be removed.

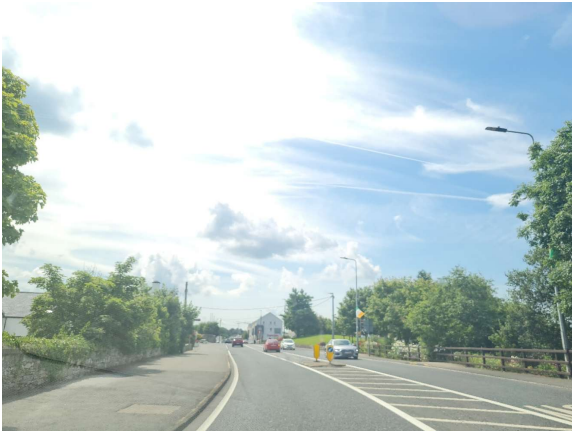
### **Location 33 - Splitter Island On N15 At Grange**

Visual inspection indicates that the street furniture on the splitter island is to be removed.

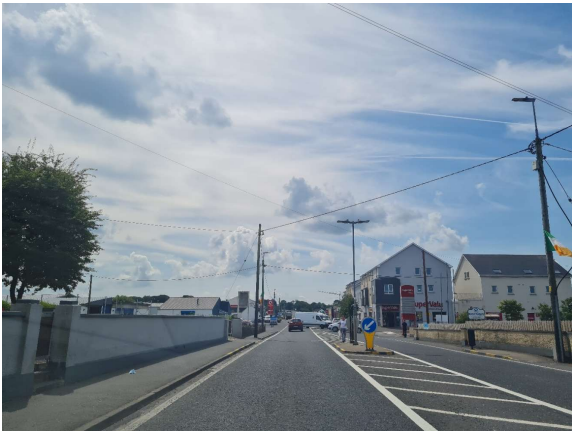
### **Location 34 - Spitter Island On N15 In Grange**

Visual inspection indicates that the street furniture on the splitter island is to be removed.

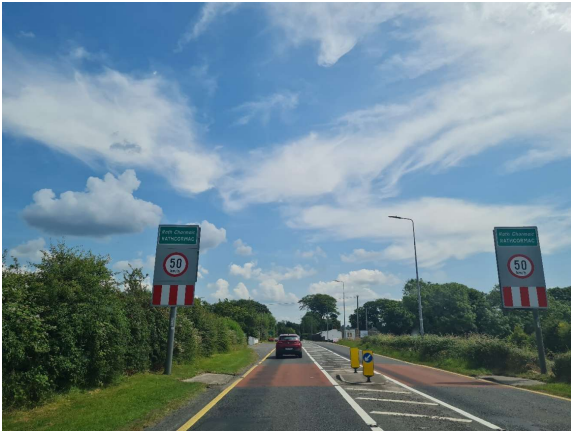
### **Location 36 - Exit Splitter Island On N15 At Grange**

Visual inspection indicates that the street furniture on the splitter island is to be removed.

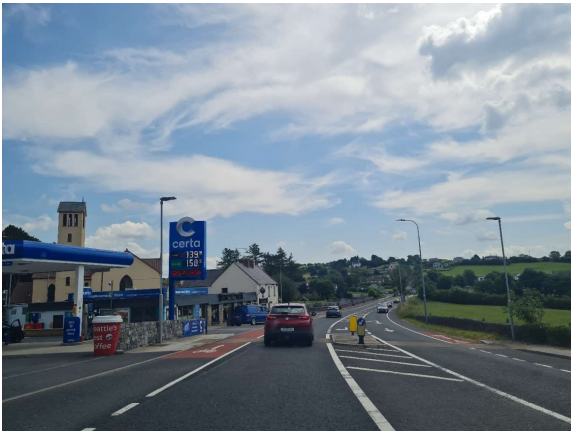
**Location 37 - Entry Splitter Island On N15 At Rathcormac**

Visual inspection indicates that the street furniture on the splitter island is to be removed.

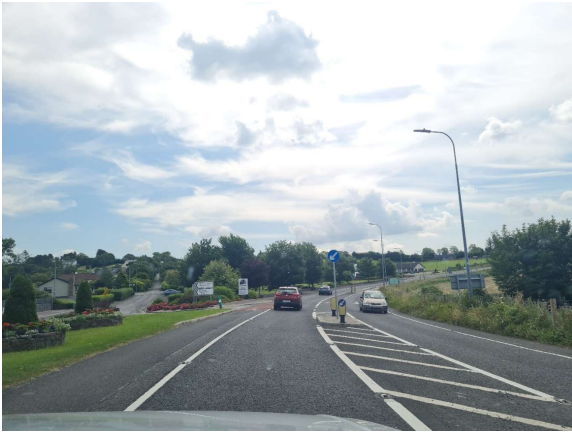
**Location 39 - Splitter Island On N15 At Rathcormac**

Visual inspection indicates that the street furniture on the splitter island is to be removed.

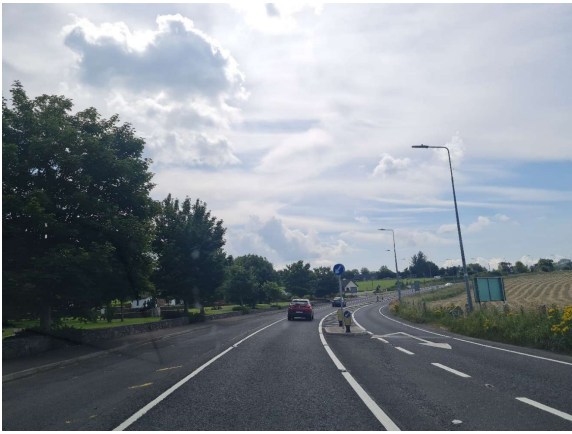
**Location 40 - Splitter Island On N15 In Rathcormac**

Visual inspection indicates that the street furniture on the splitter island is to be removed.

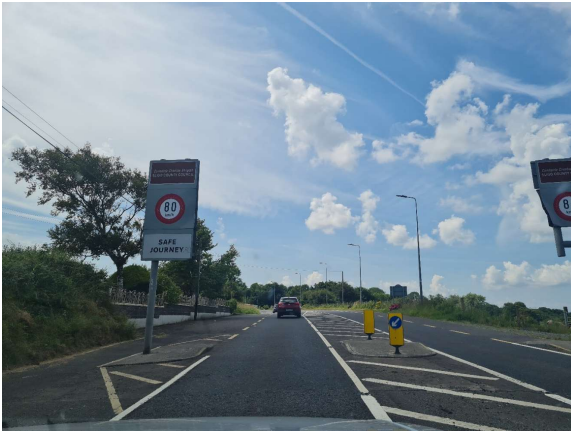
**Location 42 - Splitter Island On N15 At Rathcormac**

Visual inspection indicates that the street furniture on the splitter island is to be removed.

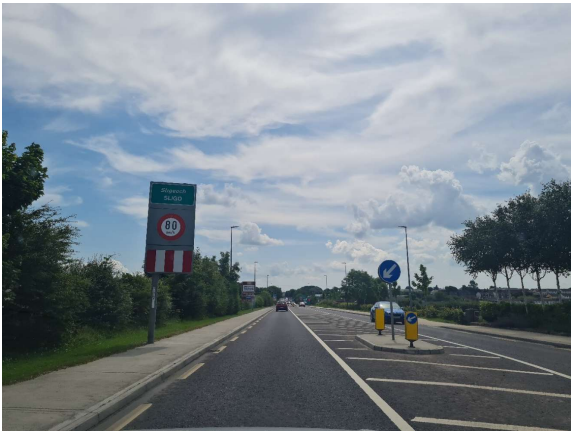
**Location 43 - Exit Splitter Island On N15 At Rathcormac**

Visual inspection indicates that the street furniture on the splitter island is to be removed.

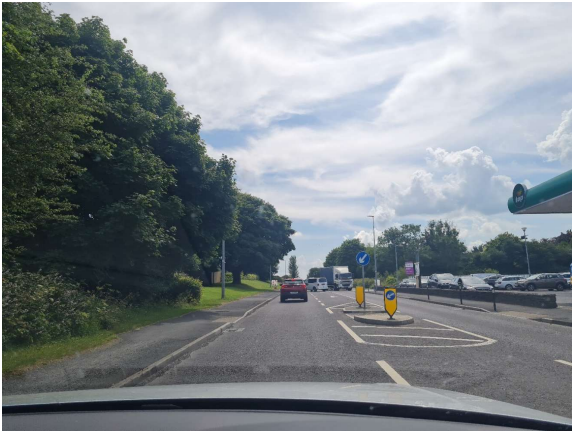
**Location 45 - Splitter Island On N15 At Sligo**

Visual inspection indicates that the street furniture on the splitter island is to be removed.

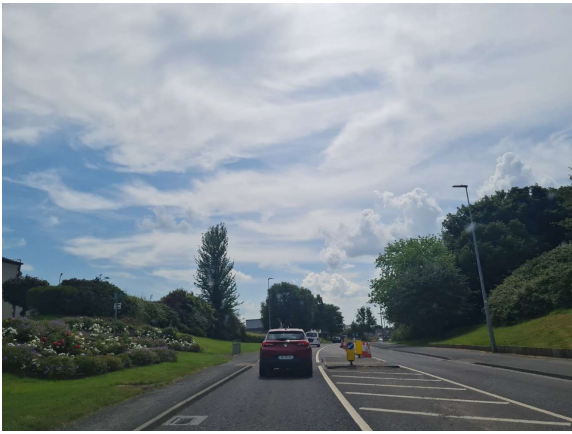
**Location 46 - Splitter Island On N15 At Sligo**

Visual inspection indicates that there are no issues at this location.

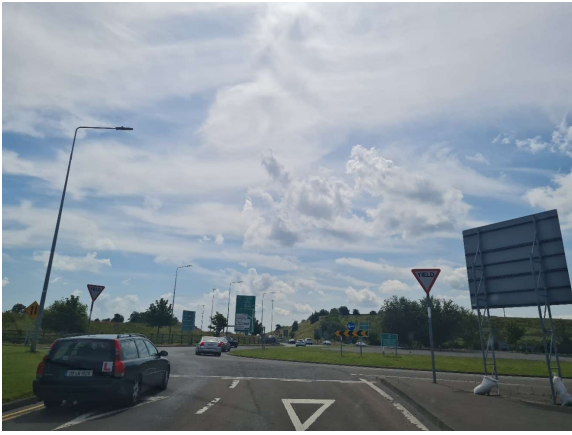
**Location 48 - Splitter Island On N15 At Sligo**

Visual inspection indicates that the street furniture on the splitter island is to be removed.

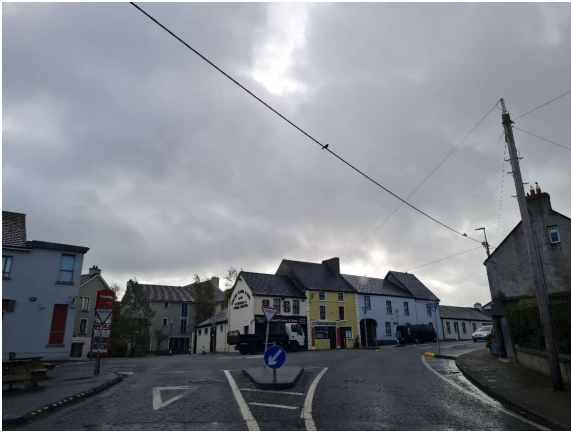
### **Location 54 - Splitter Island On N59**

Visual inspection indicates that the street furniture on the splitter island is to be removed.

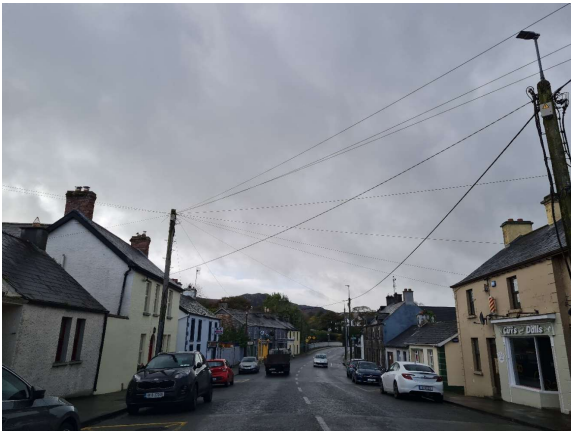
### **Location 55 - Mini Roundabout On N59 In Ballysadare**

Visual inspection indicates that the blade will overfaisl third party land on the nearside.

Any overhead obstructions to be removed.

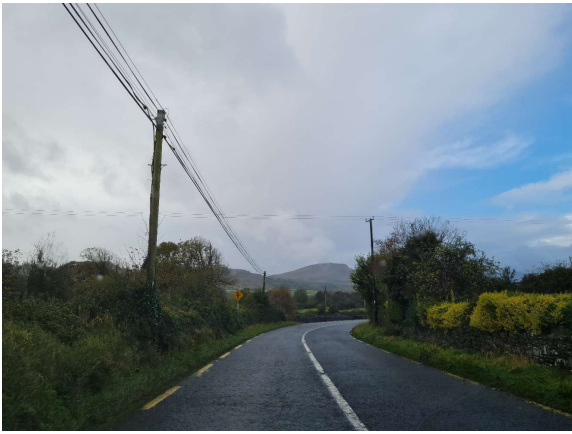
### **Location 61 - Left Bend On N59**

Visual inspection indicates that the blade will navigate utilise manual steering.

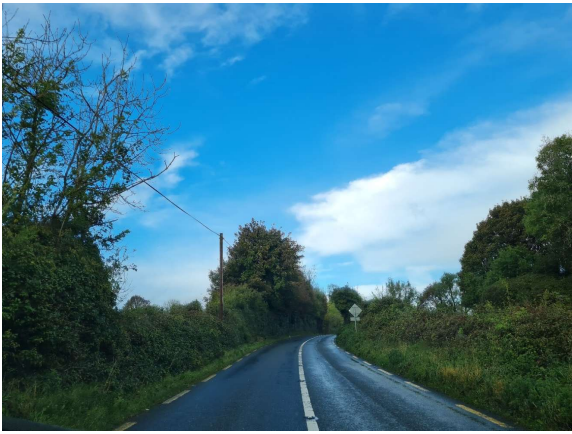
### **Location 64 - Right Bend On N59**

Visual inspection indicates that pruning is required on both sides of the road.

Manual steering required.

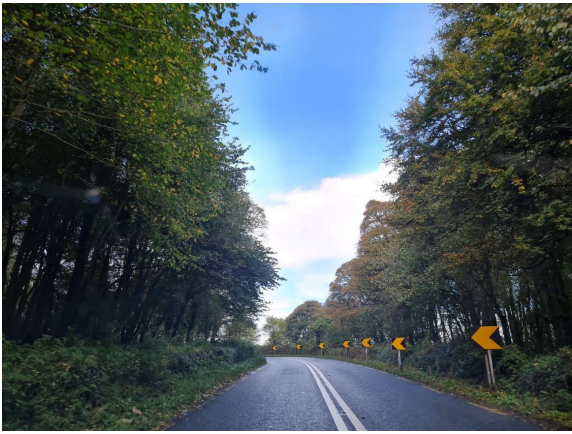
### **Location 67 - Crest On N59**

Visual inspection indicates that vertical analysis is required to determine whether grounding occurs at this location.

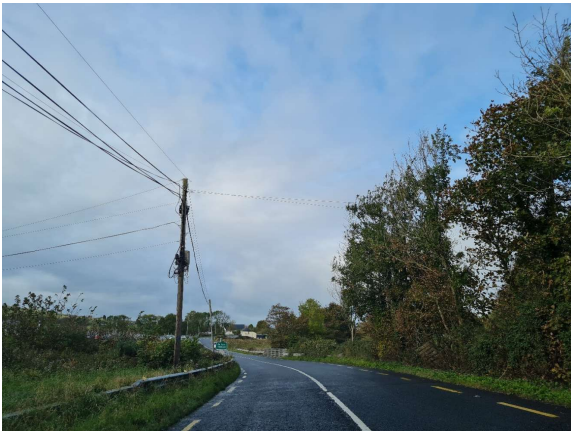
### **Location 70 - Crest On N59**

Visual inspection indicates that vertical analysis is required to determine whether grounding will occur at this location.

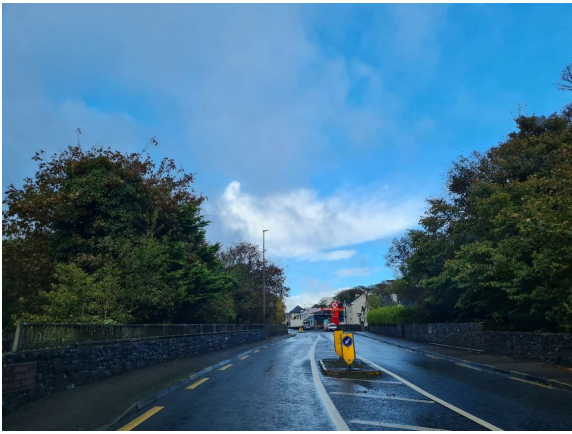
**Location 73 - Entry Splitter Island On N59 At Dromore West**

Visual inspection indicates that the street furniture on the splitter island to be removed.

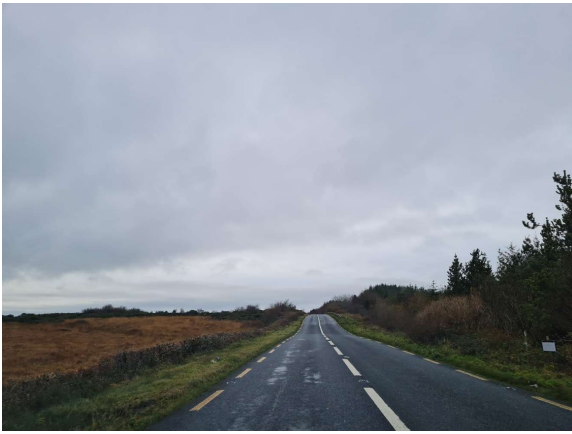
### **Location 76 - Spitter Island On N59 At Dromore West**

Visual inspection indicates that the street furniture on the splitter island to be removed.

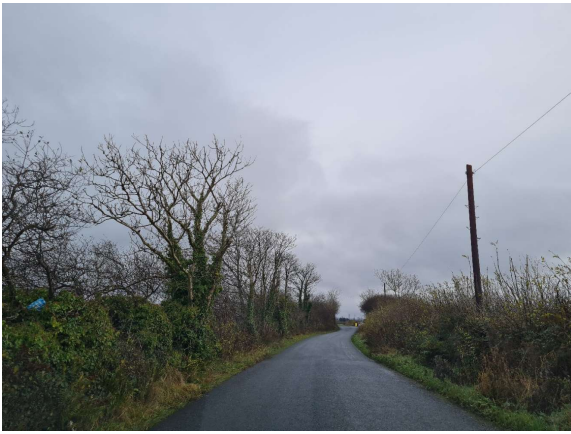
### **Location 79 - Left Bend On L2604**

Visual inspection indicates that road widening is required on the offside of the road.

Tree Pruning required on both sides of the road.

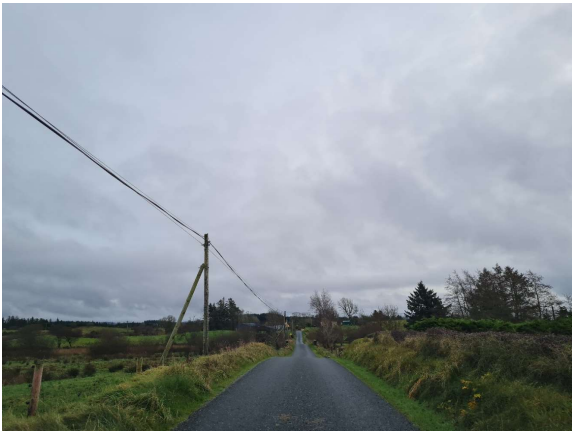
### **Location 88 - Road Signs On L2604**

Visual inspection indicates that road widening will be required on both sides of the road.

Road signs to be removed.

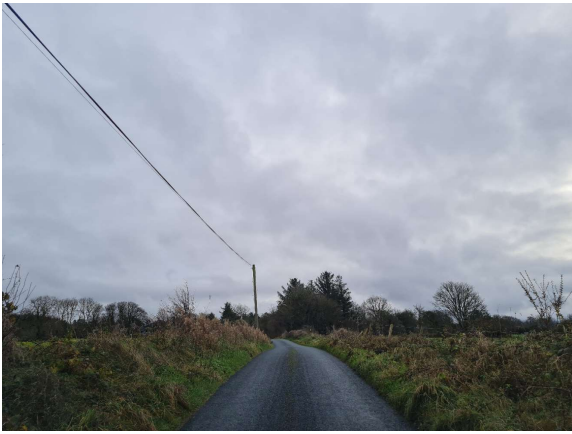
### **Location 91 - Right Bend On L2604**

Visual inspection indicates that third party land will be required at this location.

Street furniture will require removal.

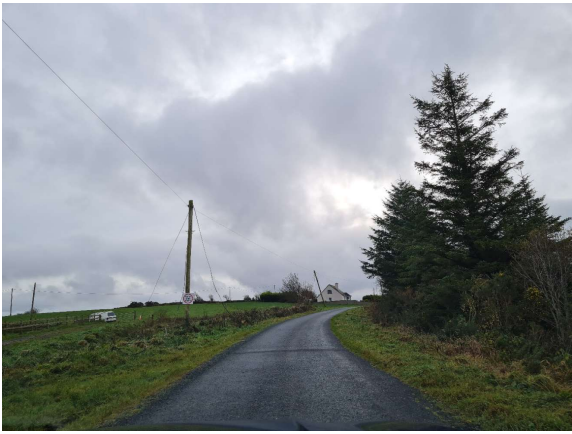
### **Location 94 - Right Bend On L2604**

Visual inspection indicates that road widening is required on the offside of the road.

Pruning required on both sides of the road.

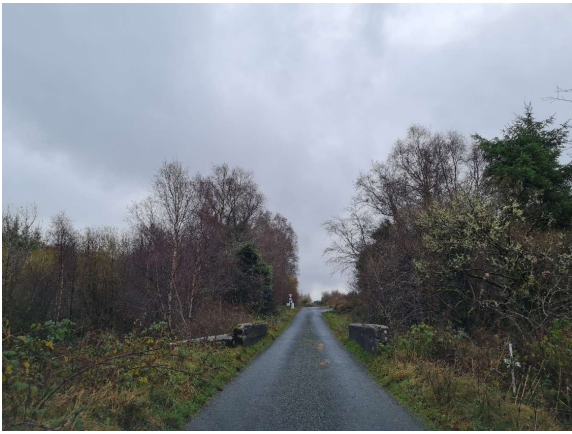
### **Location 103 - Crest On L2604**

Visual inspection indicates that vertical analysis is required to determine whether any grounding issues will occur during navigation.
