## Primary Route Assessment - Firlough Wind Farm, County Mayo, Ireland - Charlestown Route

381311

Wednesday, 29 March 2023

Prepared For Jennings O Donovan

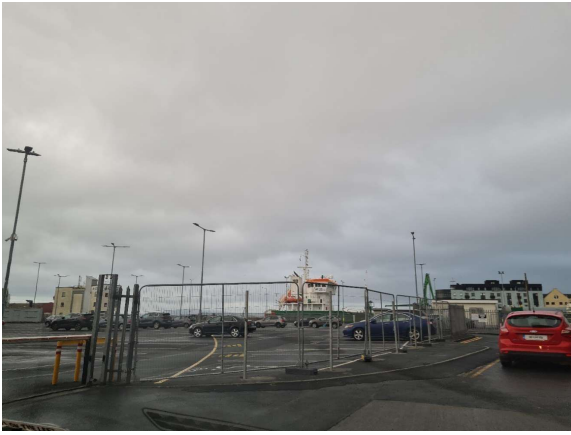
### **Location 1 - Exit From The Port Of Galway**

Visual inspection indicates that the loaded components will navigate out of the port.

The Port has been upgraded to accept larger blade components.

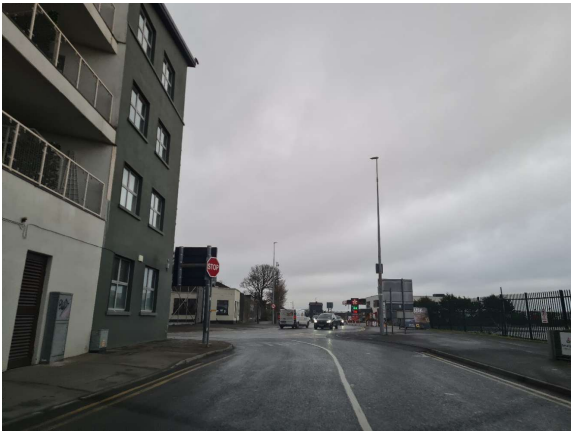
### **Location 2 - Dock Street/Lough Atalia Road Junction**

Visual inspection indicates that the street furniture on the offside of the junction is to be removed.

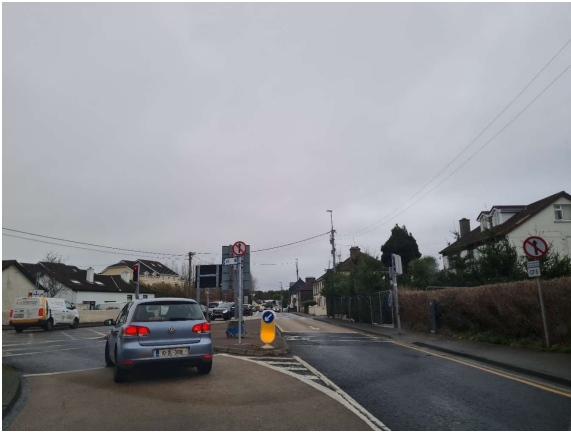
#### **Location 4 - Lough Atalia Road/R339 Junction**

Visual inspection indicates that a contraflow manoeuvre will be required at this junction.

Inspection indicates that a road sign, bollard, and traffic signal on the splitter island is to be removed.

Traffic signal on the offside to be removed.

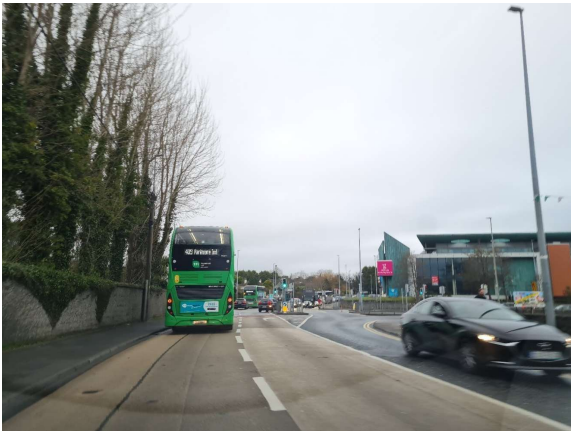
#### **Location 5 - R339/R338 Junction**

Visual inspection indicates that a contraflow manoeuvre will be required at this location.

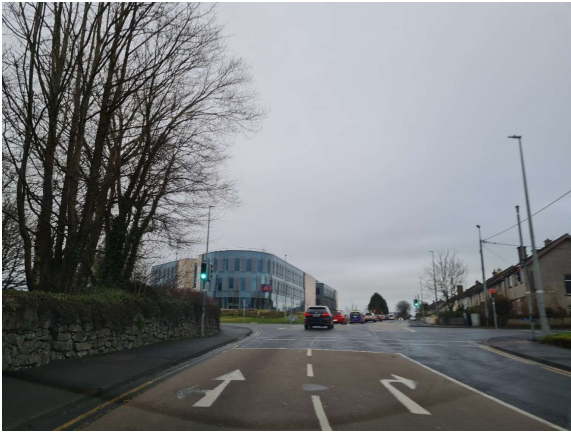
### **Location 7 - R339/Connolly Avenue Junction**

Swept Path Analysis indicates that the traffic signal on the nearside of the junction is to be removed.

Manual steering required to assist navigation.

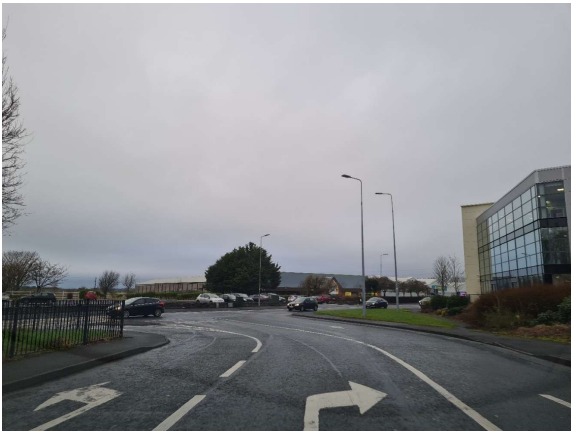
### **Location 8 - R336 Junction**

Swept Path Analysis indicates that road widening will be required on the offside of the junction. 2 lamp posts on the offside are required to be removed.

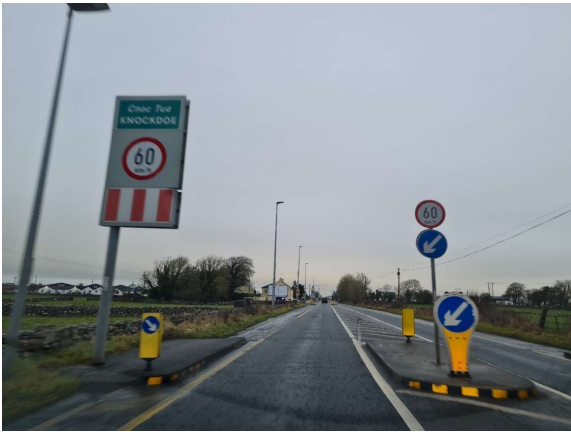
### Location 11 - Splitter Island On N83 At Knockdoe

Visual inspection indicates that the street furniture on the splitter island is to be removed.

Sign is socketed.

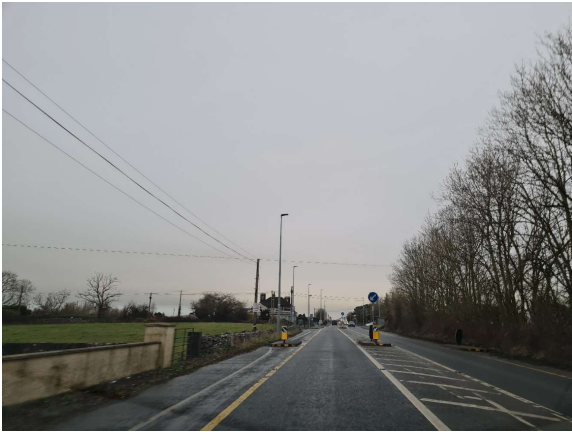
**Location 13 - Splitter Island On N83 At Knockdoe**

Visual inspection indicates that the street furniture on the splitter island is to be removed.

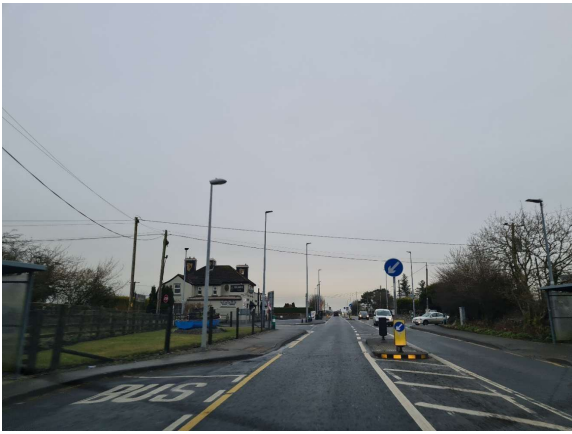
**Location 14 - Splitter Island On N83 At Knockdoe**

Visual inspection indicates that the street furniture on the splitter island is to be removed.

Sign is socketed.

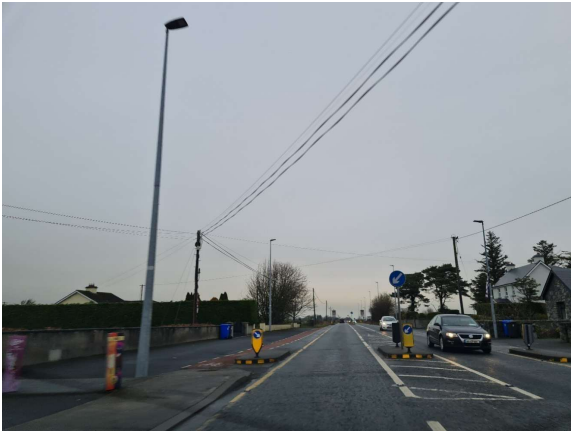
### **Location 16 - Splitter Island On N83 At Knockdoe**

Visual inspection indicates that the street furniture on the splitter island is to be removed.

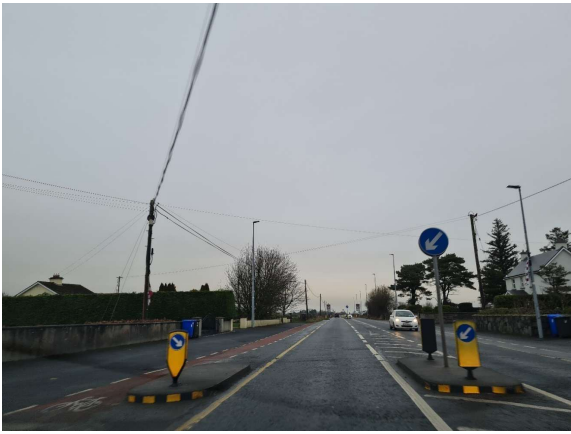
### **Location 17 - Splitter Island On N83 At Knockdoe**

Visual inspection indicates that the street furniture on the splitter island is to be removed.

Sign is socketed.

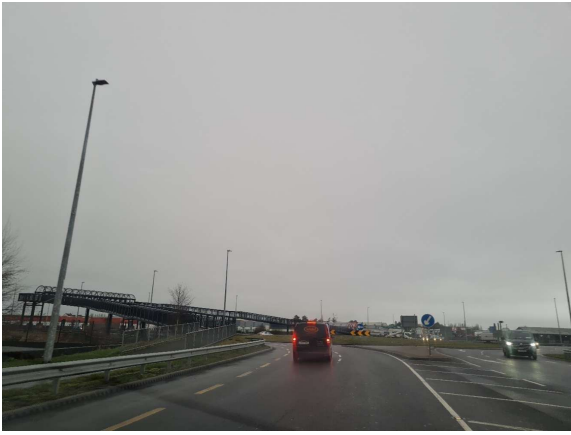
### **Location 19 - N83/N17/M17 Roundabout**

Swept Path Analysis indicates that road widening is required on the entry splitter island. Road signs on the offside splitter island to be removed due to rear projection on the blade. Road signs on the nearside to be removed due to blade oversail.

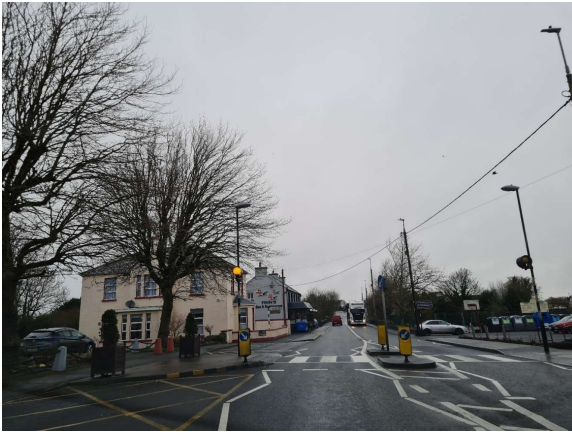
### **Location 22 - Splitter Island On N17 In Milltown**

Visual inspection indicates that the street furniture on the splitter island is to be removed.

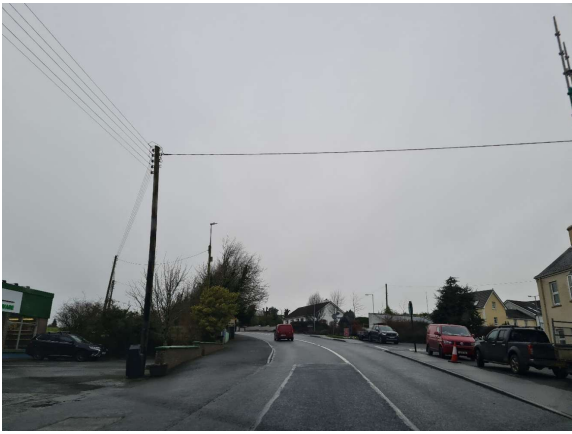
### **Location 23 - Left Bend On N17 In Milltown**

Swept path analysis indicates that the road sign on the nearside is required to be removed. Tree pruning is required on the nearside due to blade oversail.

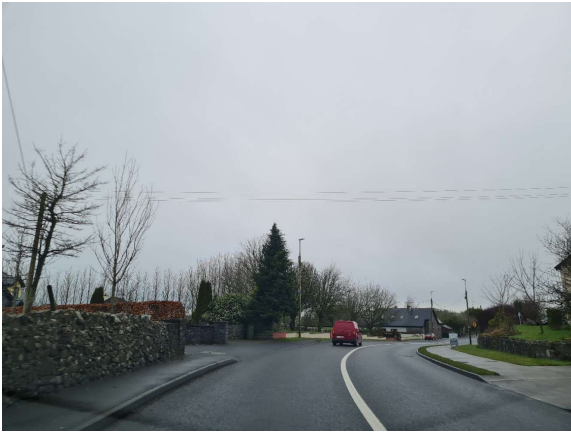
**Location 25 - Right Bend On N17 In Milltown**

Swept Path Analysis indicates that the loaded vehicle will navigate utilising manual steering.

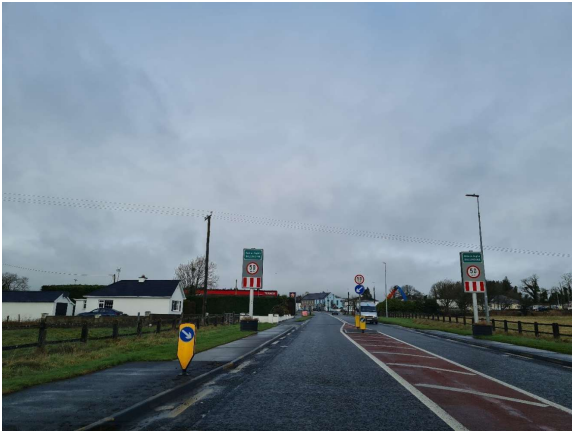
### **Location 28 - Splitter Island On N17 At Ballindine**

Visual inspection indicates that the street furniture on the splitter island is to be removed.

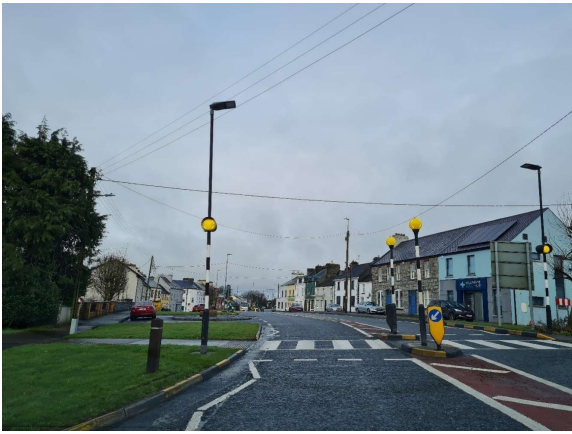
### **Location 29 - Splitter Island On N17 In Ballindine**

Visual inspection indicates that the street furniture on the splitter island is to be removed.

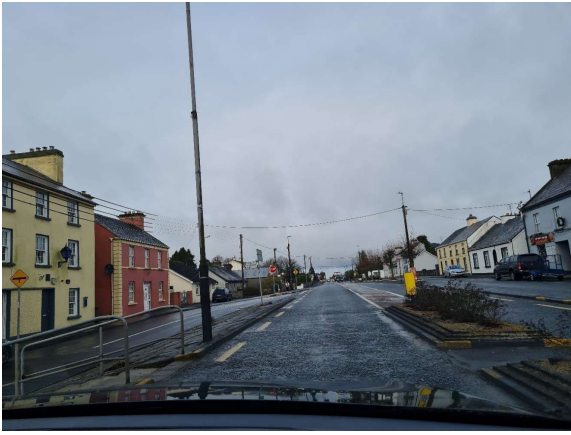
**Location 31 - Splitter Island On N17 In Ballindine**

Visual inspection indicates that the flexi bollards are to be removed to allow for oversail.

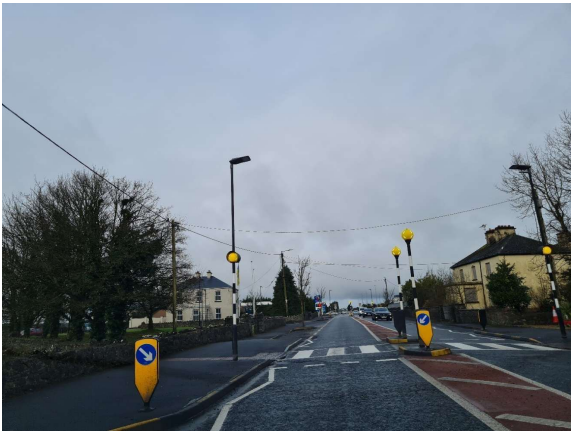
**Location 32 - Splitter Island On N17 In Ballindine**

Visual inspection indicates that the street furniture on the splitter island is to be removed.

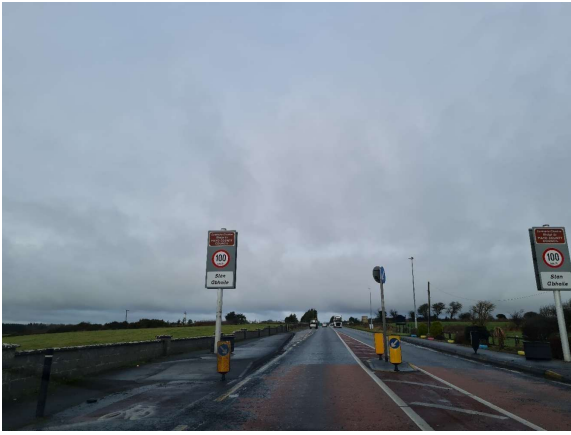
### **Location 34 - Splitter Island On N17 In Ballindine**

Visual inspection indicates that the street furniture on the splitter island is to be removed.

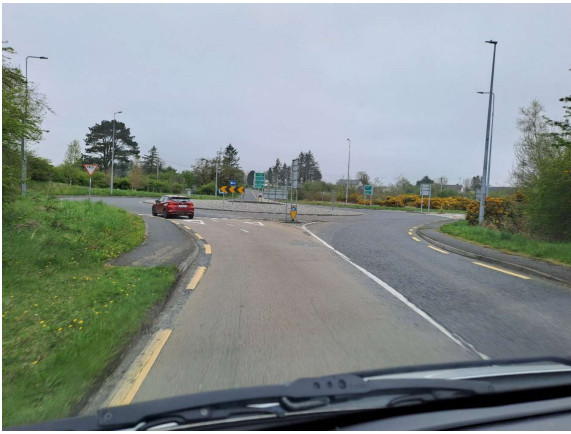
### **Location 35 - N17 / N5 Roundabout Charlestown**

Swept Path Analysis indicates a contraflow manoeuvre is required to reduce the modifications required.

Third-party land is required on the offside.

Road widening is required on the offside. Street furniture to be removed on the offside and entry Splitter Island.

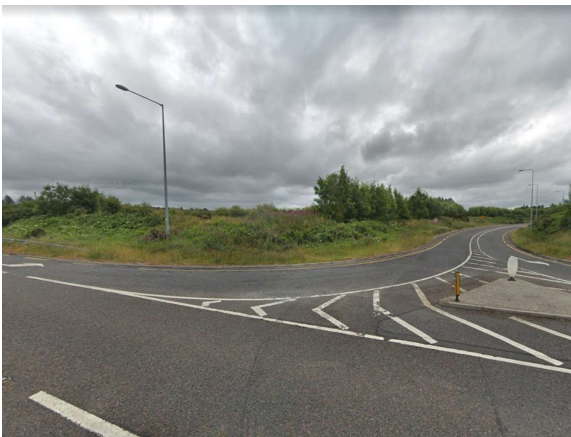
### **Location 36 - N5 / Unnamed Road Junction**

Swept Path Analysis indicates that road widening is required on the offside of the junction. Lamp posts on both sides of the junction to be removed.

Tree pruning is required on both sides of the junction.

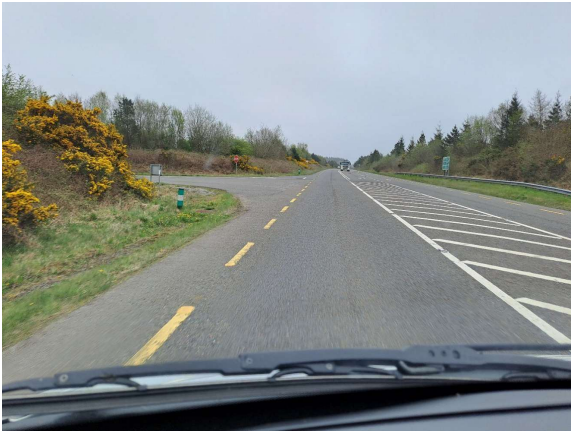
### **Location 37 - N5 Junction With Unnamed Road**

Swept Path Analysis indicates that earthworks are required on the nearside to allow the trailer to navigate.

Tree removal required on the nearside.

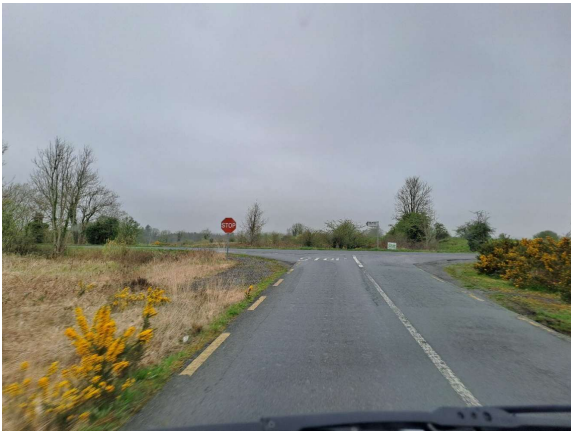
### **Location 38 - Unnamed Road Junction With L1331**

Swept Path Analysis indicates the telegraph pole and signpost on the offside are to be removed.

Signpost on the nearside required to be removed.

Tree pruning required both sides of the junction.

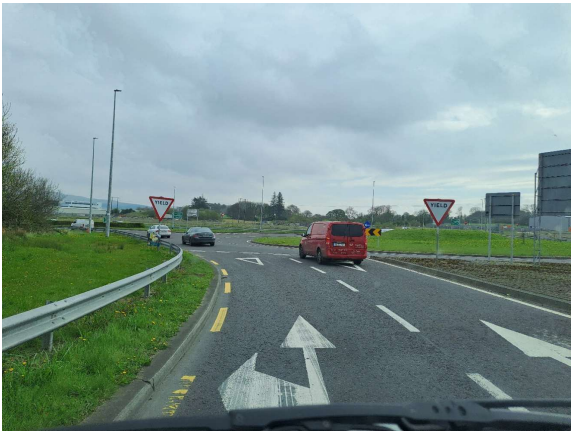
### **Location 44 - N17 / N4 Roundabout In Collooney**

Swept Path Analysis indicates that the loaded vehicle will navigate this location utilising manual steering.

After taking the 1st Exit, the loaded vehicle is required to contraflow onto the exiting dual carriageway.

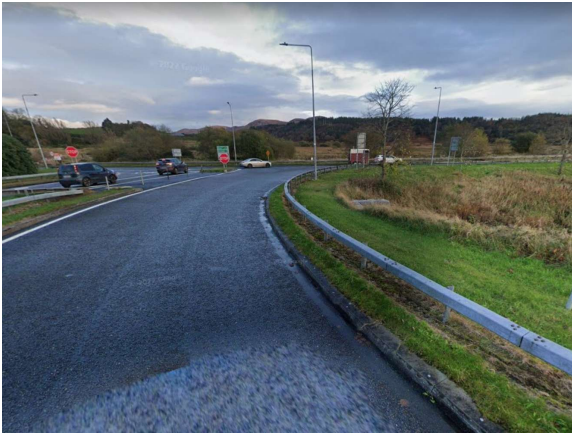
### **Location 46 - N4 / N59 Slip Road**

Swept Path Analysis indicates that the 4 lamp posts on the offside of the bend are required to be removed to allow the blade and trailer to oversail. The signposts on the offside are required to be removed to allow the rear projection to oversail.

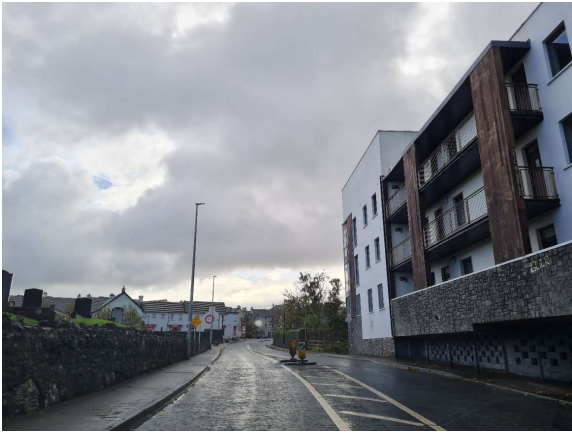
### **Location 50 - Splitter Island On N59**

Visual inspection indicates that the street furniture on the splitter island is to be removed.

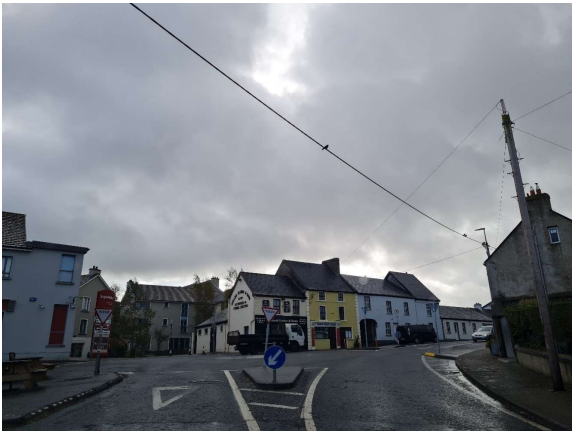
### **Location 51 - Mini Roundabout On N59 In Ballysadare**

Visual inspection indicates that the blade will oversail third party land on the nearside.

Any overhead obstructions to be removed.

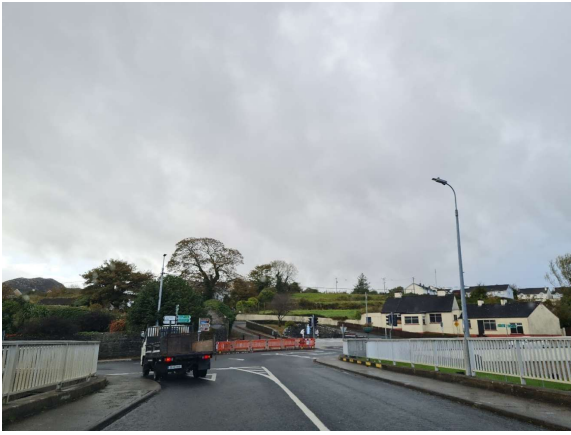
### **Location 53 - N59/R290 Mini Roundabout**

Visual inspection indicates that the raised blade in the lift adapter will oversail beyond the bridge parapet on the offside.

Any overhead obstructions to be removed.

Manual steering required.

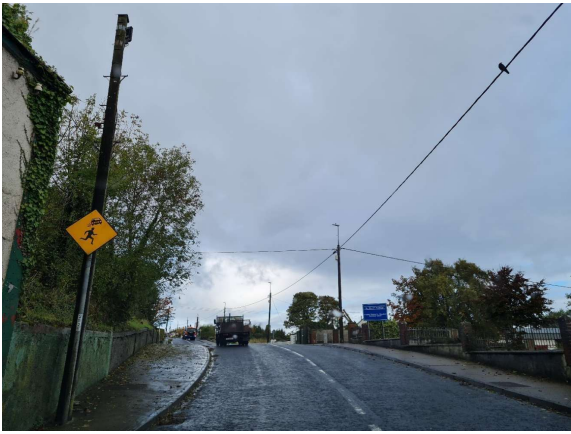
### **Location 54 - Left Bend And Crest On N59 At Ballysadare**

Visual inspection indicates that the overhead cables are to be removed.

Vertical Analysis of the Crest required to determine whether there are any issues.

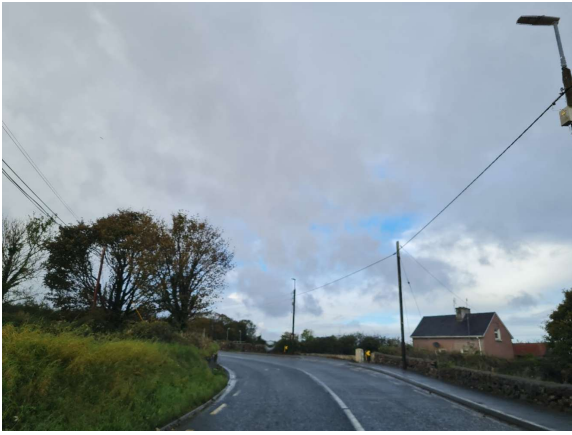
### **Location 56 - Left Bend On N59**

Visual inspection indicates that third party land is required on the nearside if the blade is transhipped back to the standard loading prior to this location. If not, it is recommended to be transhipped immediately following this location if land agreements allow.

Wall, trees, and fence on the nearside to be removed.

If blade is still on lift adapter, overhead cables to be removed.

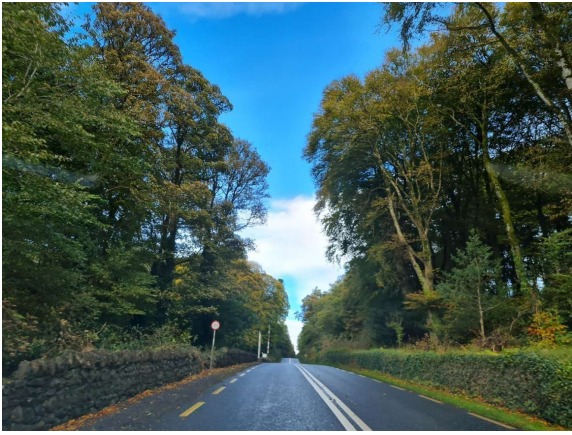
### **Location 62 - Crest On N59**

Visual inspection indicates that vertical analysis will be required to determine whether grounding occurs at this location.

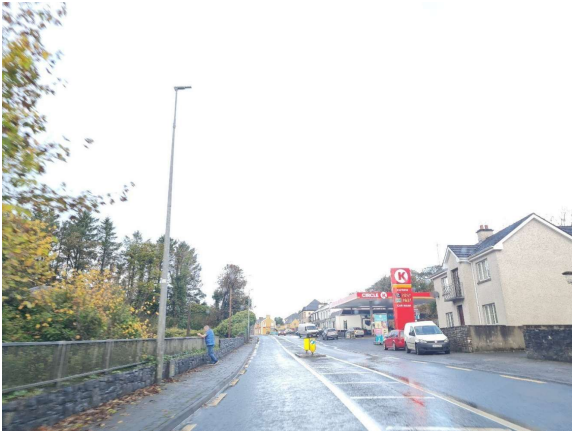
### **Location 71 - Splitter Island On N59 At Dromore West**

Visual inspection indicates that the street furniture on the splitter island to be removed.

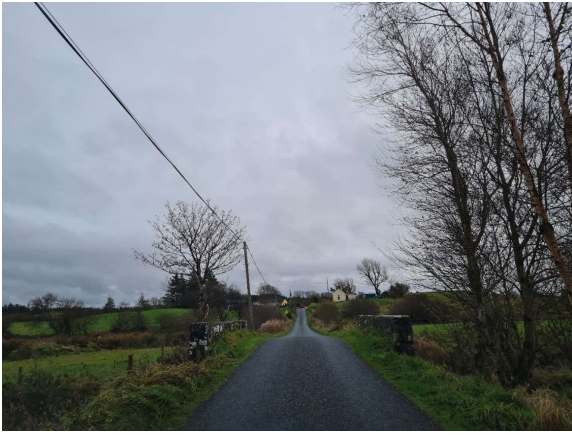
### **Location 86 - Crest On L2604**

Visual inspection indicates that vertical analysis is required to determine whether any grounding issues will occur during navigation.

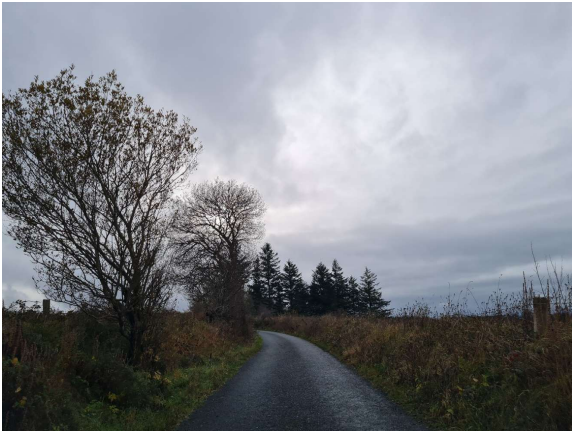
### **Location 92 - Left Bend On L2604**

Visual inspection indicates that third party land will be required on the nearside of the road.

Trees and vegetation on the nearside to be removed.

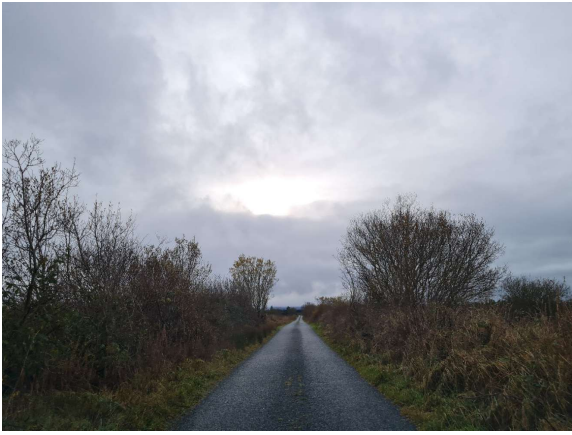
### **Location 95 - L2604**

Visual inspection indicates that the road will require upgrading to the turbine manufacturers specification.

Pruning will be required to provide a clear envelope as stipulated in the manufacturer's specification.
