## **Stage 1 Road Safety Audit**

**Firlough Wind Farm & Hydrogen Production Facility at  
Carrowleagh Bog, nr Ballina, Co Mayo**

On behalf of Mercury Renewables

**June 2023**

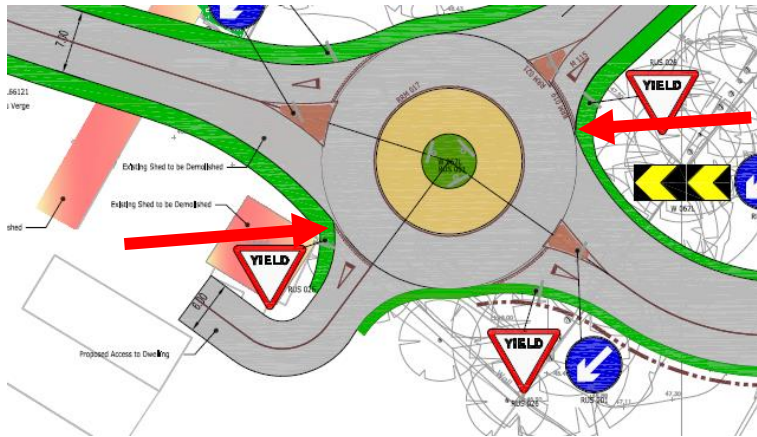
**Problem:** The entry / exit curves do not have a uniform radius. Trailing wheels of long vehicles may over-run the verge and drag detritus onto the carriageway surface.

**Hazard:** Following vehicles may skid / lose control on this detritus.

**Recommendation:** Provide a uniform radius from the roundabout entry to the exit.

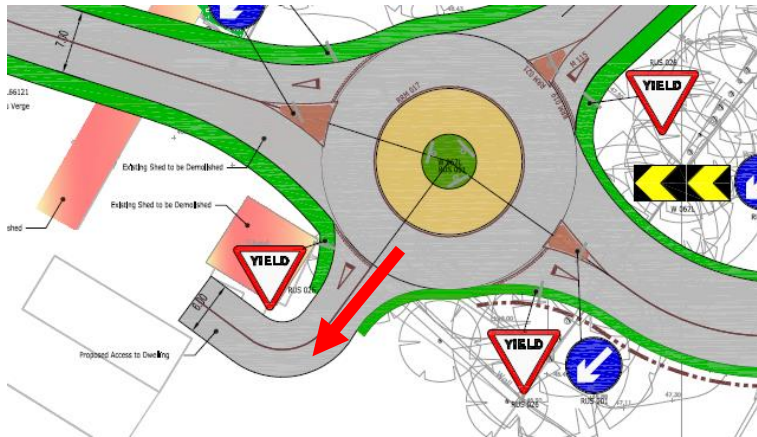
**Problem:** The access to the dwelling house off the roundabout has a similar look to all the other exits. There is a risk that general public vehicles will errantly depart the roundabout on this arm.

**Hazard:** Vehicles entering this arm may not expect the very tight bend immediately within the property lands. Vehicle loss of control may result.

**Recommendation:** Redesign this arm or roadside treatment to enable road users to differentiate this private access from the public ones.
