# Appendix I

## Accessibility Audit Report

# Ringsend to City Centre Core Bus Corridor Scheme

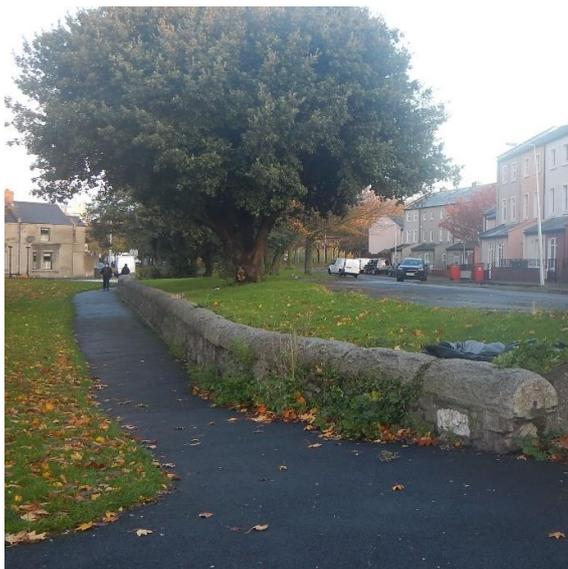
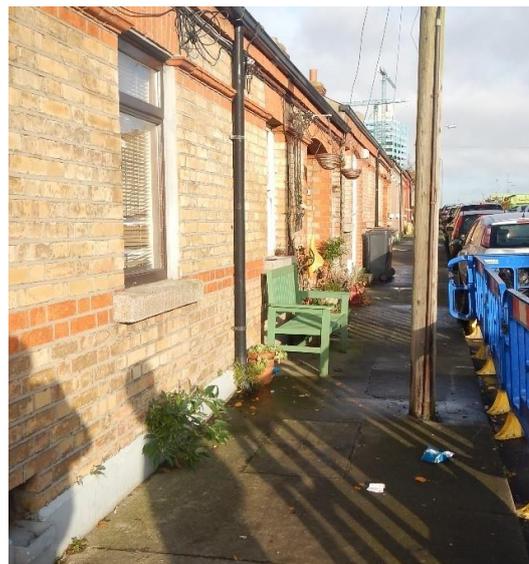
Overall, the existing footpath width provision is sufficient to cater for disabled users. However, the design should seek to maximise the width provision by providing, as a minimum, what already exists.

**Effective width of footpath reduced due a) to vegetation [left] and b) planter pots and benches [right]**

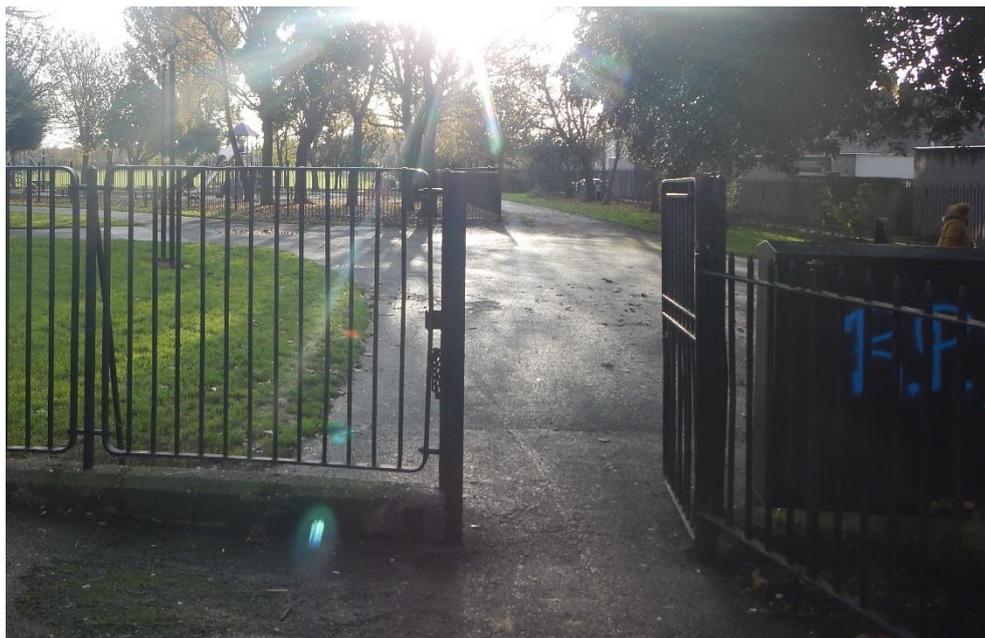
The width of the path through Ringsend Park is also insufficient for shared pedestrian and cycle use. A narrow shared path can lead to conflict between vulnerable pedestrians and fast moving cyclists and should be avoided where possible. Full segregation should be considered with careful consideration of any resultant criss-crossing manoeuvres that may manifest from the implementation of full segregation of cyclists and pedestrians.

**Ringsend Park Access Arrangement**

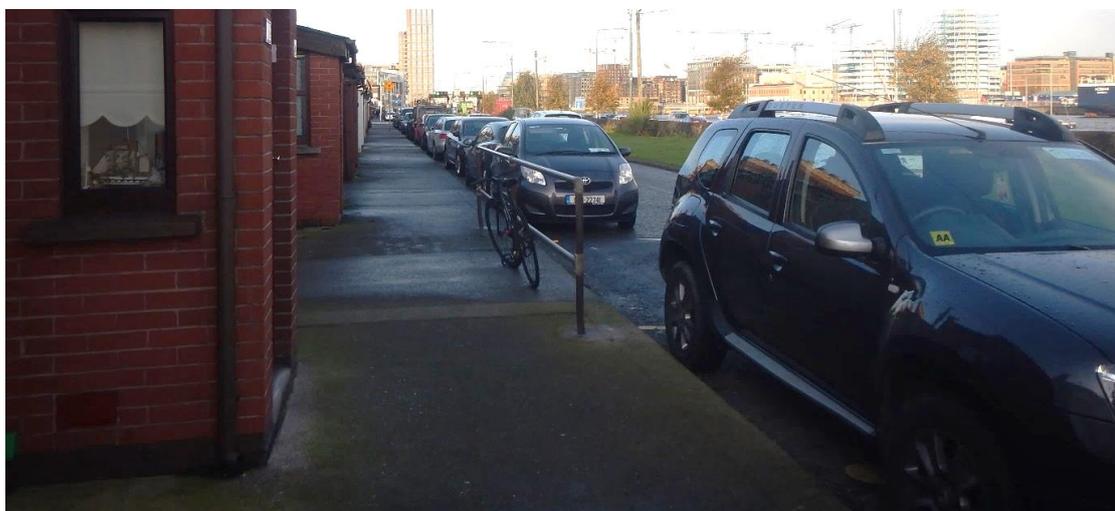
Some guardrails were noted in certain locations along this section of the route, primarily on Pigeon House Road at the pedestrian links to Ringsend Park [parallel to Pigeon House Road]. The traffic calming ramps on Pigeon House Road are located at these pedestrian links, and the guardrails prevent visually impaired users from interpreting the ramps as crossing locations.

**Pedestrian Guardrails on Pigeon House Road**

Where works are taking place on the footpath of Pigeon House Road these guardrails should be replaced. Alternatively, the traffic calming may be relocated away from the locations of the pedestrian links, and the guardrails removed to maximise the effective width of the footpath.

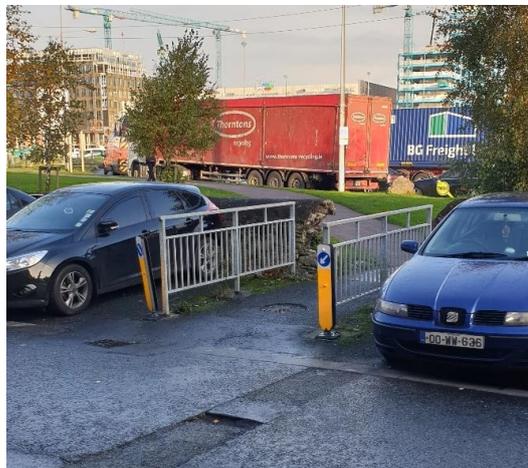
Guardrails were also recorded on York Road at the pedestrian / cycle access to the Tom Clarke Bridge [see adjacent image]. These guardrails are strategic in preventing any vehicles from parking in this location, maintaining free and unobstructed access for both pedestrians and cyclists. Their presence points to a problem of high demand for parking in the area. Any proposed works in this area should consider the accessibility requirements of all users between Ringsend Park and the river quays, and the effect unsolicited parking will have on this accessibility.

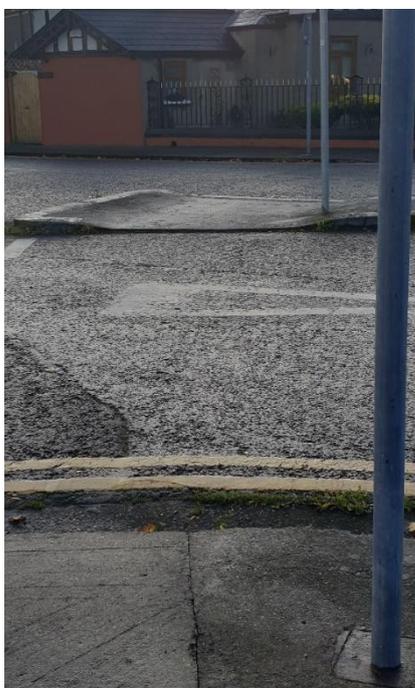
The standard of existing pedestrian crossing points through this section of the scheme varies with no dropped kerbs provided in some locations and dropped kerbs with inadequate width preventing wheelchair users and pushchairs from navigating the crossings comfortably. Drainage issues were also noted in the road carriageway within crossing locations, caused by flat or collapsed spots in the road surface.

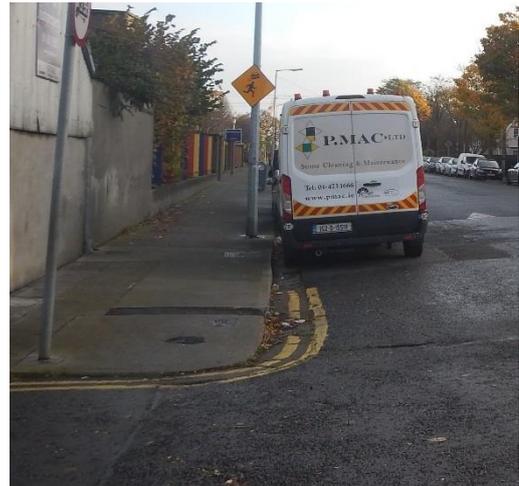
The crossing facilities at junctions are of poor standard particularly when catering for the mobility and visually impaired. For instance, on Cambridge Road the dropped kerbs at the uncontrolled crossings are located on the curve of the road and not in the direct line of travel at any of junctions with Pembroke Cottages and Cambridge Park. Locating the dropped kerbs on the curve of a road can cause a risk of visually impaired users being misdirected by the orientation of the kerb.

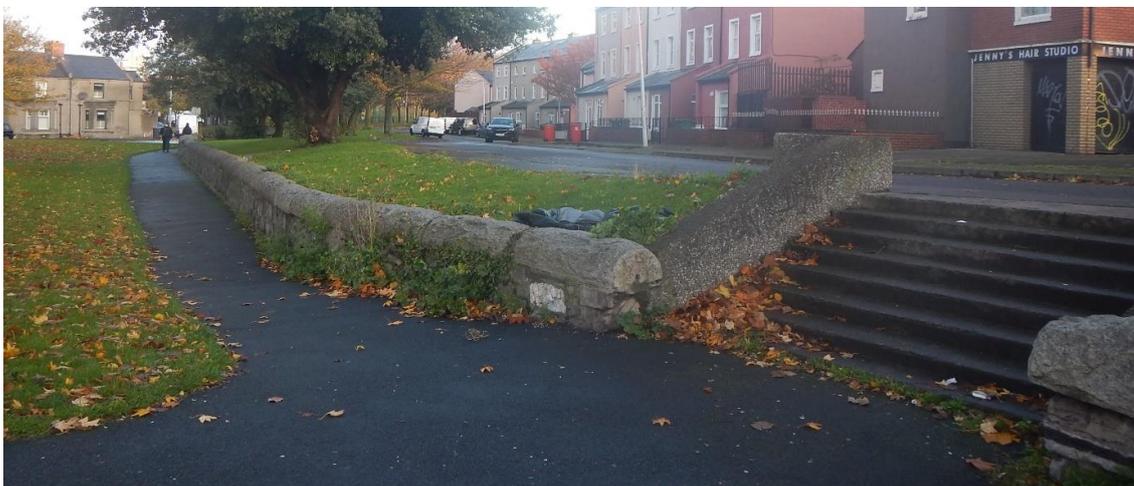
There are existing steps between Kerlogue Road and the footpath that runs parallel to Pembroke Street and Kerlogue Road. There is no tactile paving provided to warn visually impaired pedestrians of the presence of the hazard and should be included as part of the proposed scheme.

**Steps Located at Kerlogue Road / Pembroke Street**

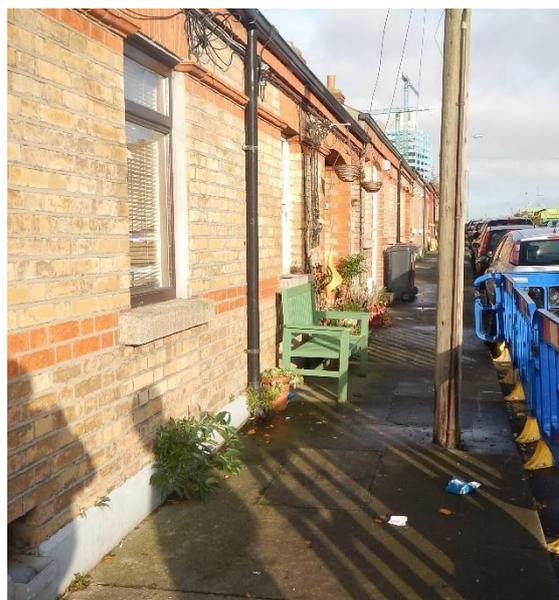
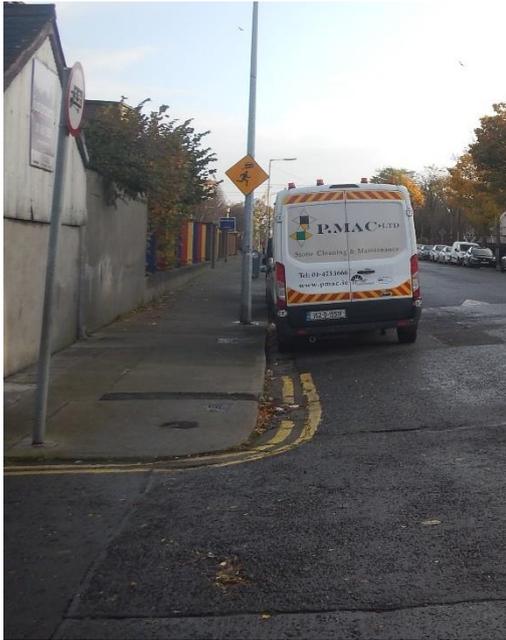
Varying aspects of street furniture were recorded during the walking audit of this section of the scheme. Junction boxes, benches and planter pots, where present, were generally located to the back of footpaths while public lighting and electricity poles were generally located to the front of the footpath. Only one such instance of conflict between the locations of the benches to the back of the footpath and public lighting posts to the front of the footpath arose on Pembroke Cottages [northbound] [see adjacent picture]. The placement of the bench and planter pot restricts the effective width of the footpath and has the potential to force awkward weaving manoeuvres for wheelchair users and visually impaired pedestrians with guide dogs or canes. These planter pots and benches shall be relocated during construction to prevent such conflicts occurring again.

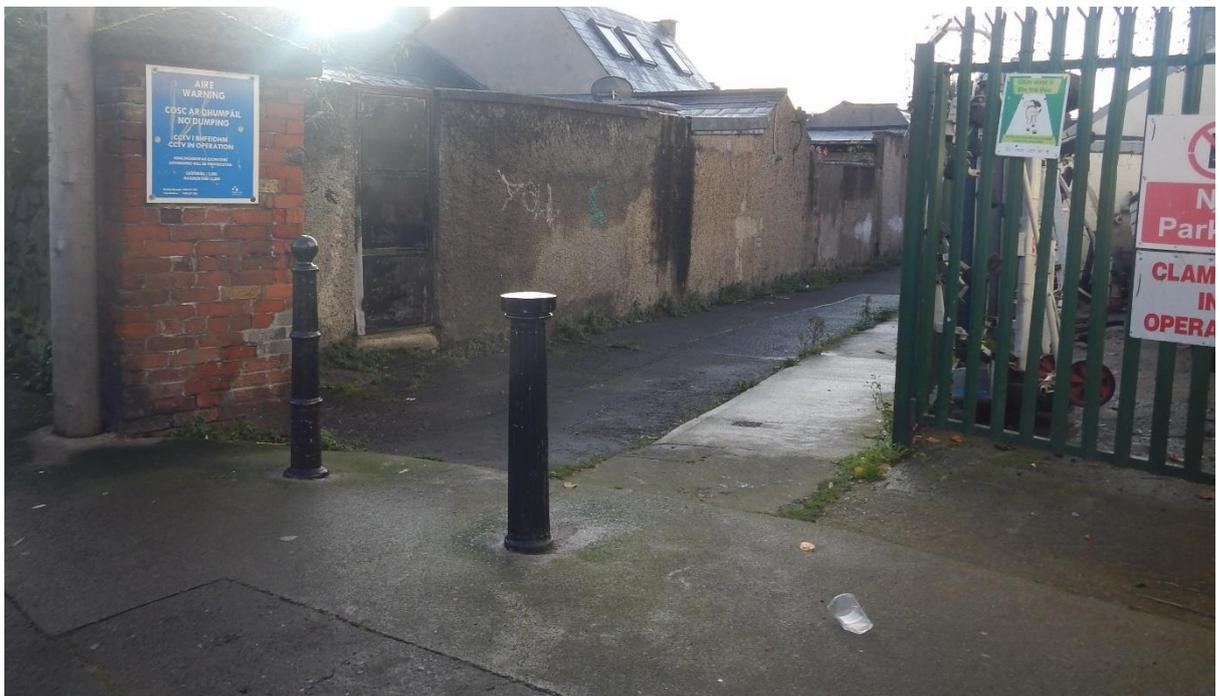
Similarly on York Road, the bollards to Pembroke Cottages are tightly spaced and placed in such a manner that a wheelchair user travelling from the east is forced to make what appears to be a 180 degree turn to access the footpath on Pembroke Cottages [southbound]. The use of bollards to restrict vehicular access should be reconfigured to provide easier access by all mobility impaired pedestrians, with minimum spacing of 1.2m between bollards.

**Bollard location affecting wheelchair accessibility**

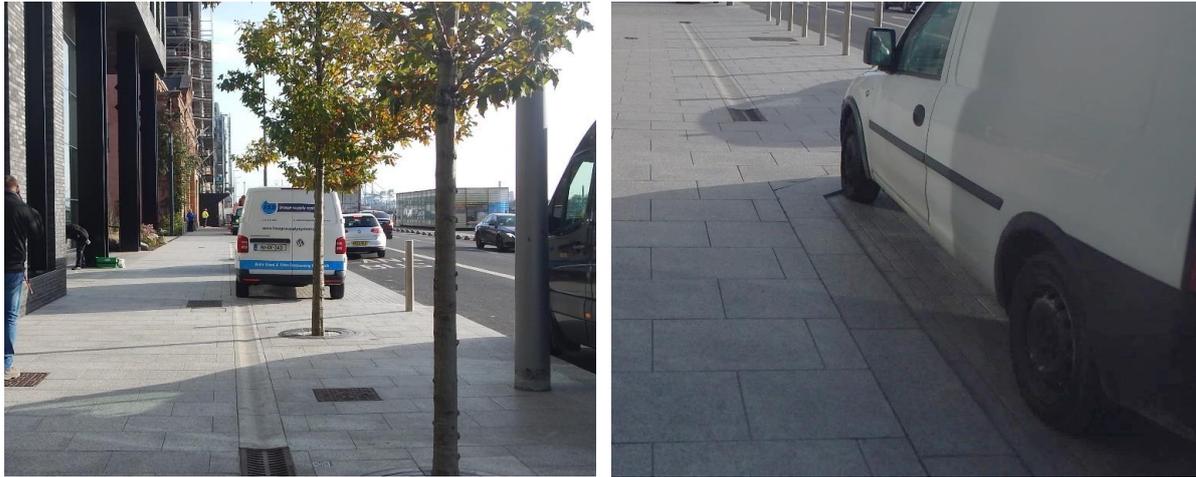
In one particular instance [see image over], outside the recently completed building east of the Central Bank, the set down area has been constructed with a shallow kerb level difference. The kerb height was not measured during the walking audit however it was observed that it was not sufficient to ensure the vehicle does not encroach on the footpath space. The shallow height, if less than 50mm, could present as a trip hazard since the paving colour did not sufficiently contrast with the footpath to ensure visually impaired pedestrians could identify and avoid the set-down area.

**Shallow kerb height a potential trip hazard**

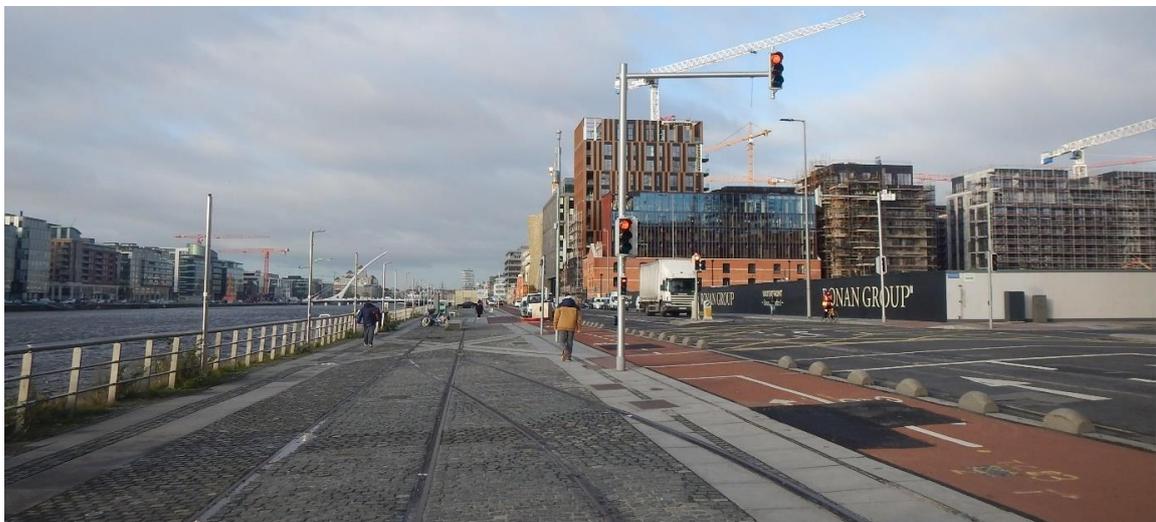
**Northern Campshires [eastern end]**

The northern campshire is a wide 10.5m wide area made up of various elements, including a two-way cycle track, heritage railway tracks [opposite the Point Depot], Dublin Bikes stations, landscaping and pedestrian amenities. The landscape architecture of the area however constrains pedestrians along two apparent routes at approximately 1.6m each. Given the wide expanse along the northern campshires, improvements to the pedestrian route should be improved to provide, as a minimum, a single 2m wide clear pedestrian route.

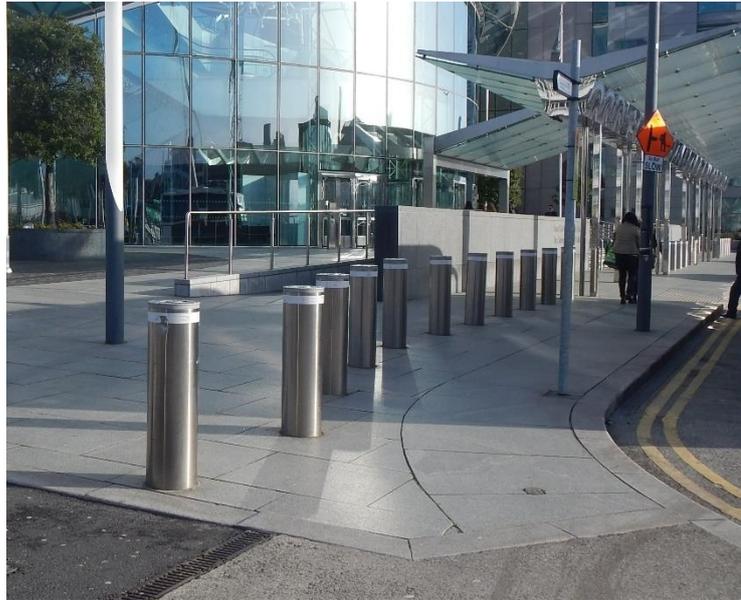
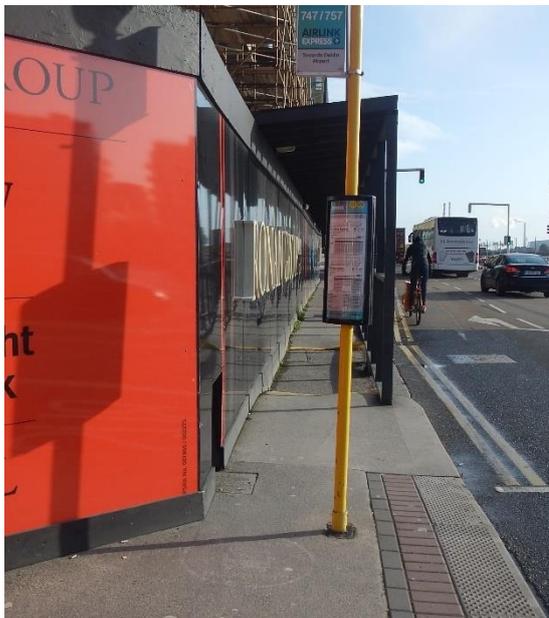
The width of the northern footpath along the North Quays varies between 2.2m and 4m, however the effective width of the footpath is lower when the impact of the street furniture is taken into consideration. Cognisance of the extent of existing street furniture is required to allow the provision of 2m wide clear width to be provided where possible in the proposed design, and local widths of 1.5m minimum where obstacles cannot be avoided.

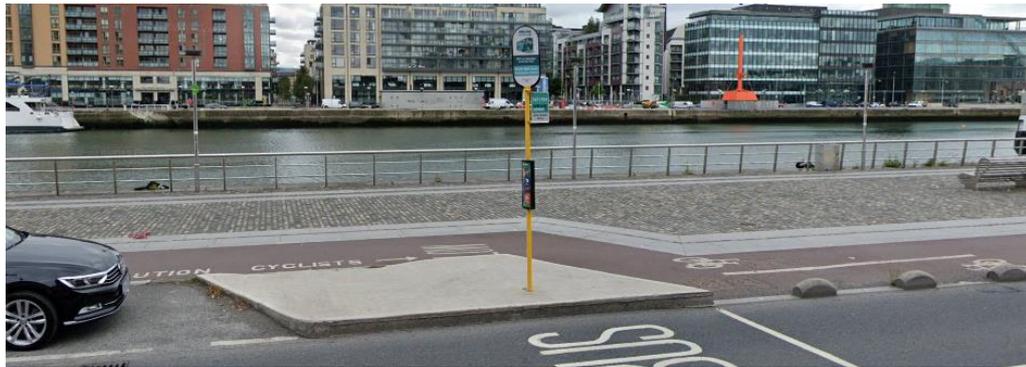
Access to an island bus stop on North Wall Quay near the Central Bank is poor, particularly for mobility and visually impaired pedestrians. Pedestrians are forced to cross a two-way cycle track without any visual aid, such as buff tactile paving to indicate the crossing. The dwell area is also insufficient for wheelchair users. Where such island bus stops are proposed there shall be clear indicators of its presence for all users, and increased dwell space to accommodate the expected volume of users. Facilities for crossing any cycle infrastructure shall also be included where necessary.

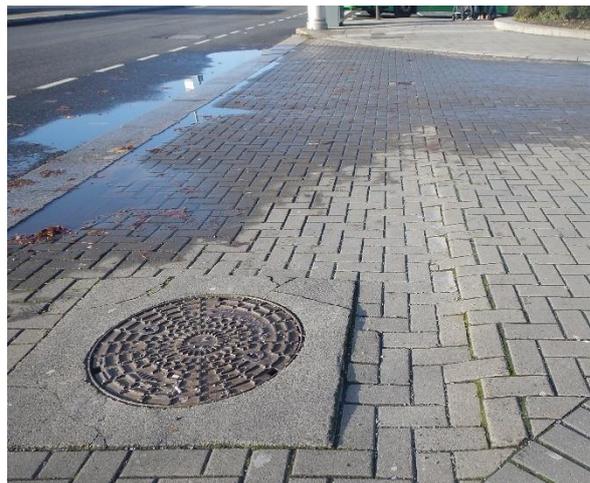
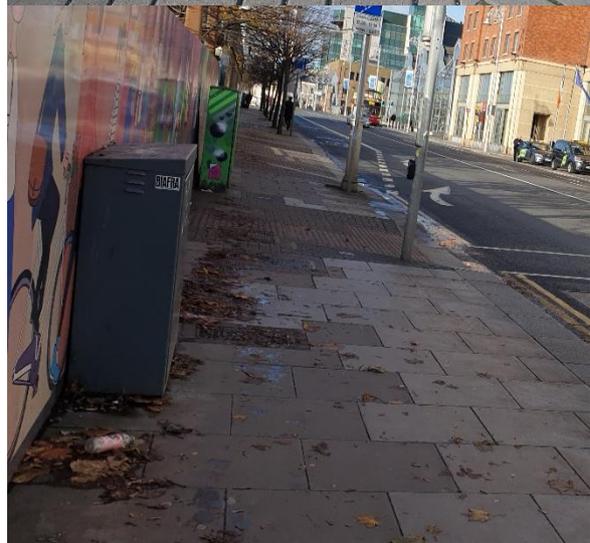
Some drainage channels were noted in certain areas along both sides of the North Quays. These channels are generally located out of the direct line of travel. Drainage channels, where required by the scheme, shall remain out of the direct line of travel.

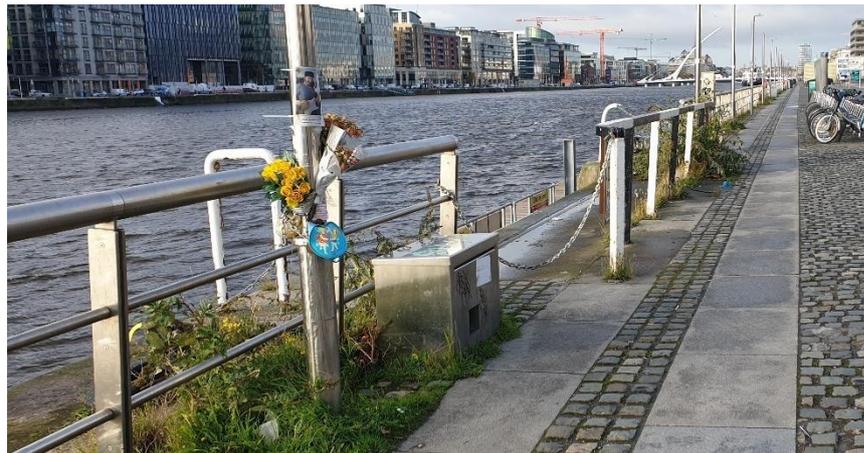
reaching the quay wall. These sections of railing should be replaced to match the three rail guardrail type either side.

**Protective Railing along the River Liffey**

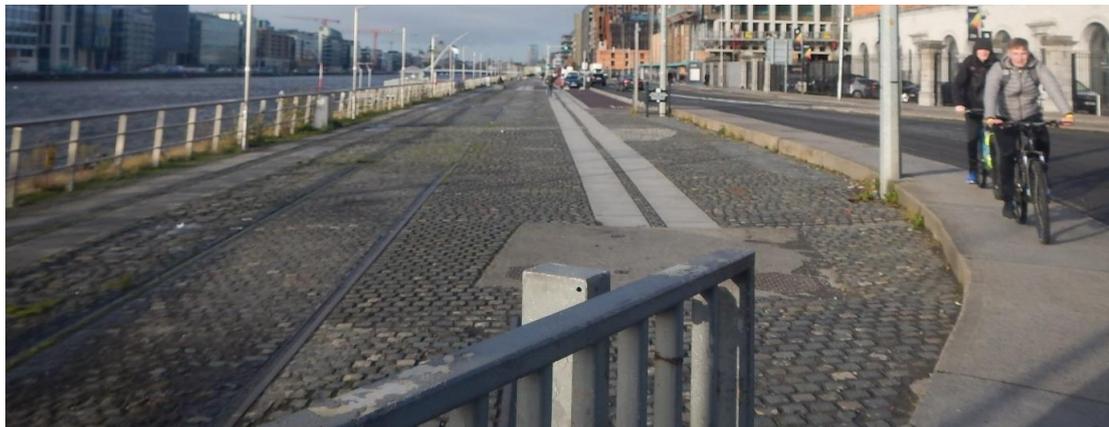
Guardrails were only noted in one other location along the North Quays, along the footpath from the Tom Clarke Bridge to the northern campshires. The guardrails are required due to the significant change in level between the footpath and the campshires at this location. Any proposals to this area should consider the need for the guardrail if the change in level is to be retained, or the change in level should be designed out to improve permeability to the campshires.

**Tom Clarke Bridge footpath and Northern Campshires interface**

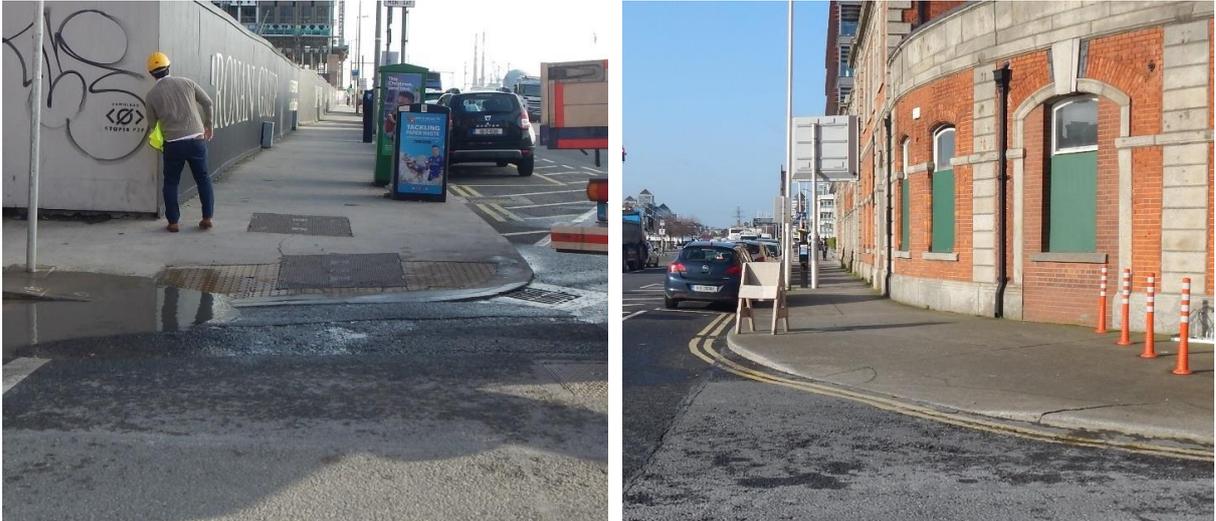
Crossing points have been provided along the North Quays at every junction. All but one of these pedestrian crossings are controlled. Crossing between the campshire and the northern footpath is also readily provided at all junctions except at Castleforbes Road and a controlled pedestrian crossing point should be provided at this junction to ensure all pedestrian desire lines are met.

**Poor Crossing facilities on North Wall Quay**

Poor drainage at some crossing points were also noted, such as at Castleforbes Road shown above, and on the minor street between the Conference Centre and Kilmore House (PWC Building). The gradients of the road carriageway at the crossing points shall be designed to ensure water drains away from the line of travel. Drainage issues had previously been noted at the North Wall Avenue crossing point however this issue appears to have been overcome through the post-construction of a mastic channel to drain water towards the gullies, and the dished kerbs modified to compensate for the subsequent level difference between the road. The mastic channel however may cause a difficulty for wheelchair users and buggies where the wheels may get caught.

It may be preferable to provide raised platforms at crossing points, as part of the design, to provide greater flexibility with road levels to ensure water drains away from the direct line of travel.

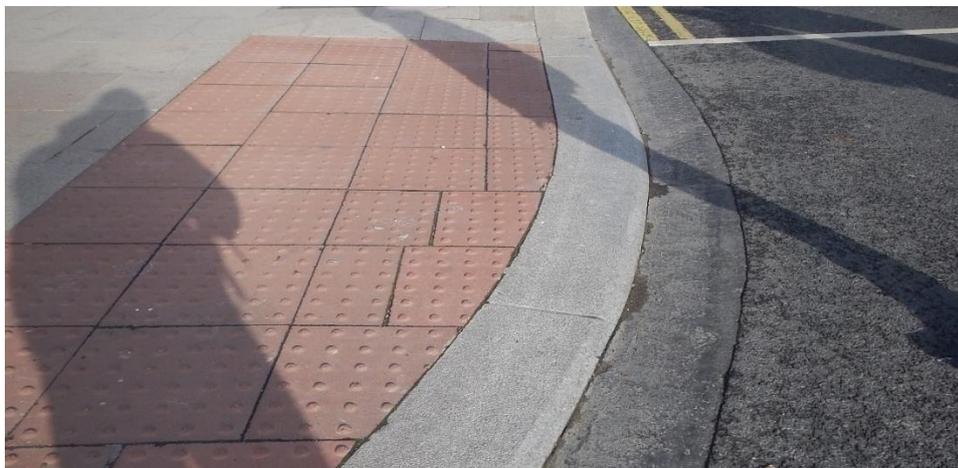
**Retrofitted drainage solution on North Wall Avenue**

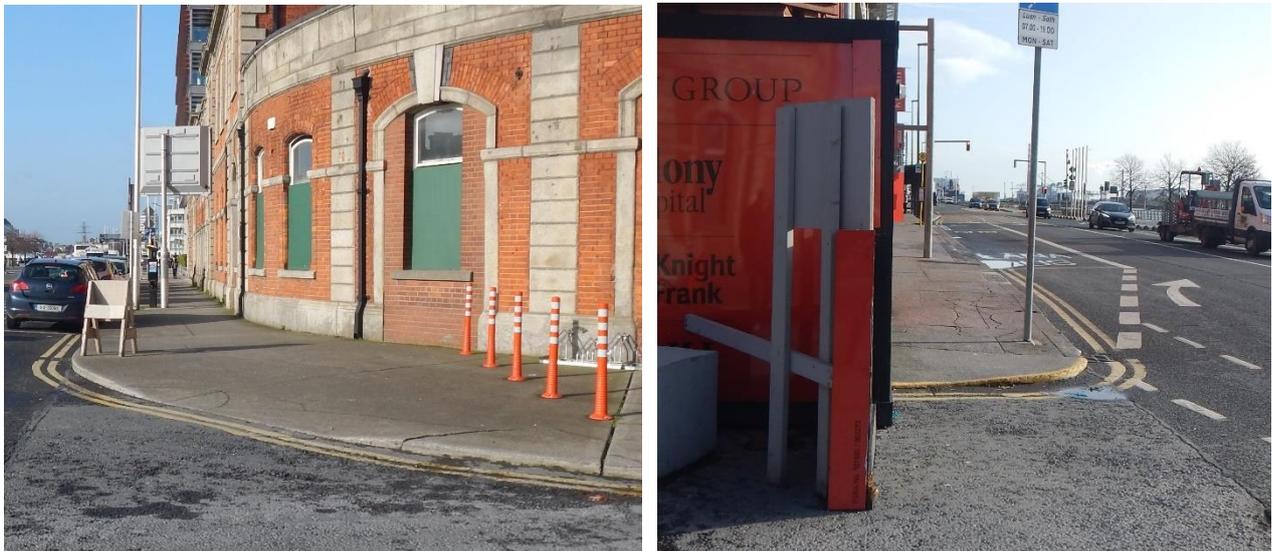
Blister tactile paving has been provided at all crossing points along the North Quays except where crossing is required at the access to the development between Park Lane and New Wapping Street, pictured over. Tactile paving shall be provided as required by the proposed crossing type, whether controlled [red blister] or uncontrolled [buff]. Red blister tactile paving has been provided at all controlled crossings, as is required, and buff provided on the uncontrolled crossing on Castleforbes Street.

**Missing tactile paving**

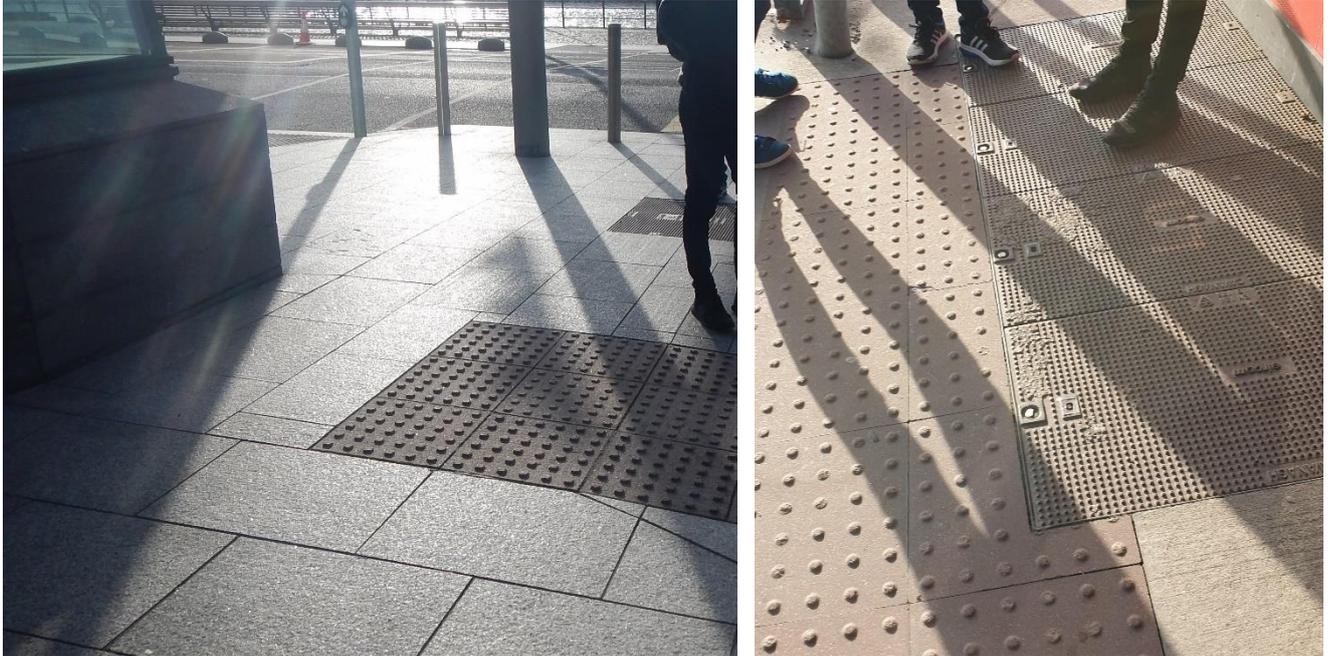
The layout of the tactile paving at some crossing points did not meet the requirements or recommendations of the NDA guidance, by not extending to the rear of the footpath or to building lines. In other instances where services chambers were located within the tactile paving, stick-on tactile paving was not applied. The number of rows of tactile paving required across the full width of the dropped kerbs in some instances do not follow the required standards.

**Incomplete tactile paving provision**

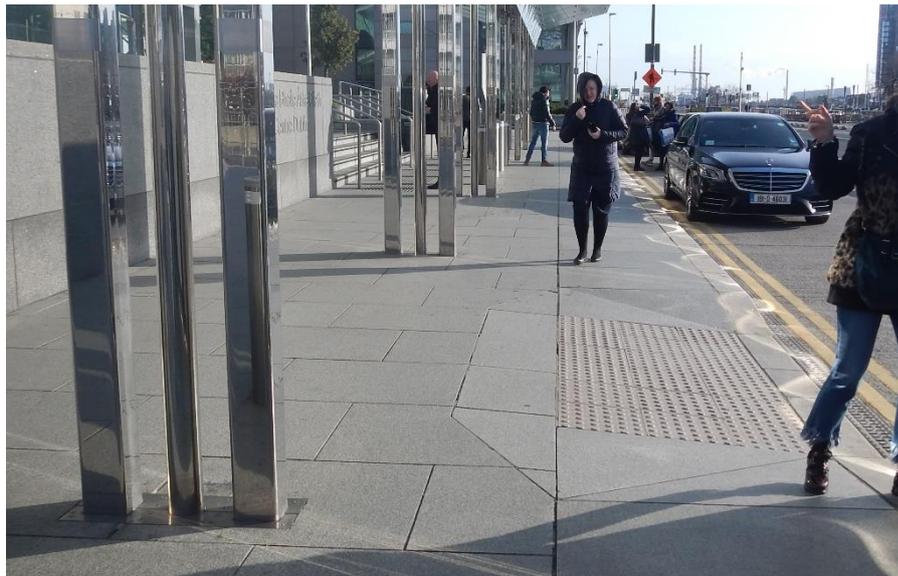
Outside the Conference Centre [pictured above] buff coloured blister tactile paving was provided adjacent to a dropped-kerb at the set-down area. This blister tactile paving should be removed since there is a chance that a visually impaired person may interpret this location as a crossing point, given that it is placed in the direct line of travel. Corduroy tactile paving should be installed where a kerb adjacent to a set-down point is dished in the direct line of pedestrian travel.

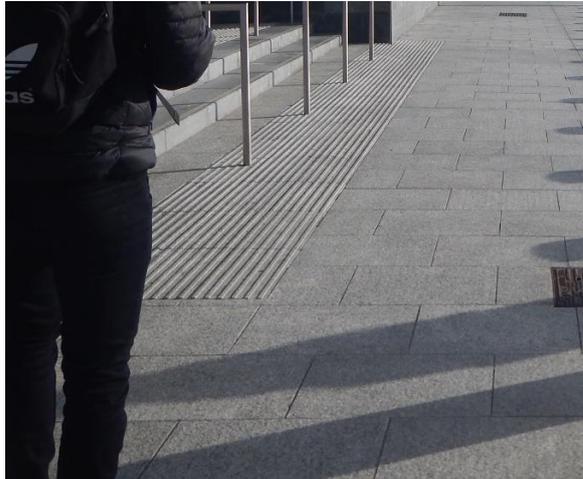
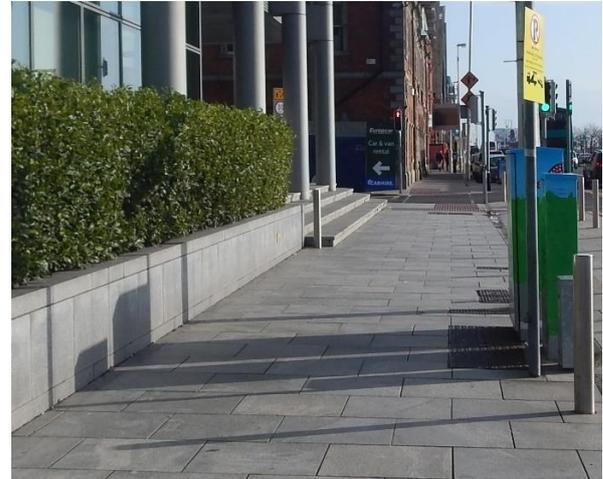
located at a higher level to the public footpath, hazard tactile paving has been provided at the top and bottom of the access steps. At older buildings, where there is a level change and steps, hazard tactile paving has not been provided. A review of the need for hazard tactile paving at all steps to buildings shall be carried out and included in the design where necessary.

### Discrepancies in Hazard Tactile Paving provision

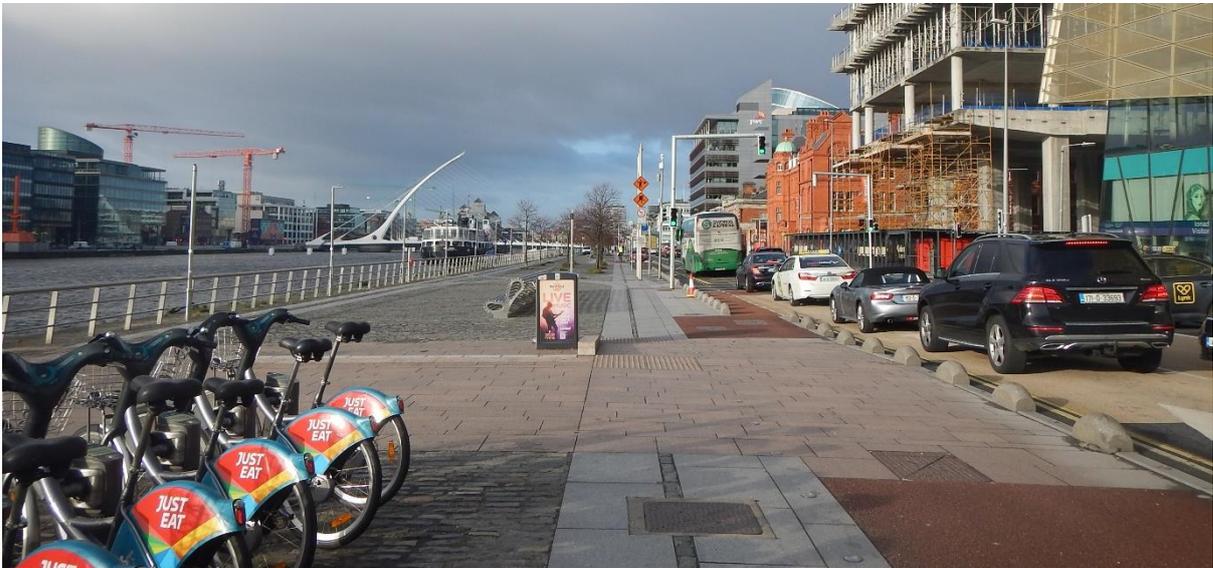
A short ramp and 3 steps are provided opposite the Central Bank [pictured below]. A handrail has not been provided between the ramp and steps at this location. The NDA guidance document states that where the clear width of a flight of steps is greater than 2m, additional handrails should be provided to divide the steps into channels. At over 8m wide, these steps should have multiple channels of handrails. In both instances however, where possible, these changes in level should be designed out since the changes in level do not appear significant.

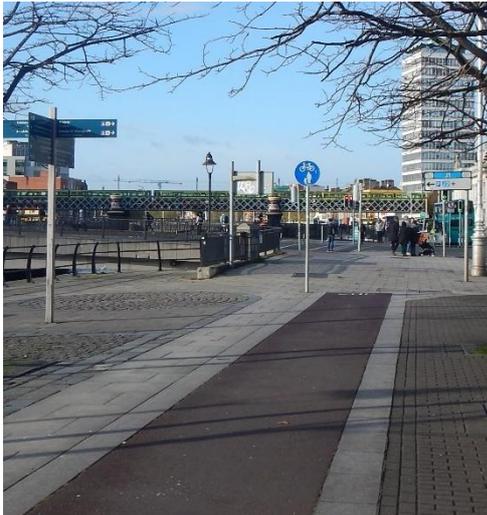
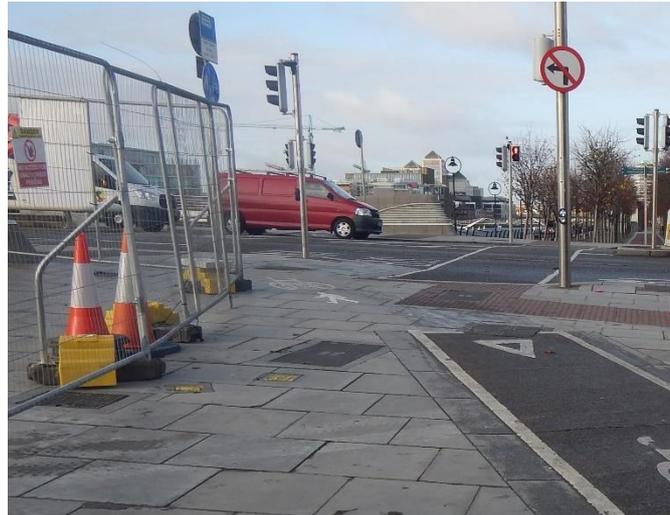
There are no public shared spaces between vehicles and pedestrians along this section of the route, except for emergency access [on Excise Walk]. Shared areas between cyclists and pedestrians are predominantly found at significant junctions, such as at Talbot Memorial Bridge and Samuel Beckett Bridge, and adjacent to the Scherzer Bridges at George's Dock and Spencer Dock. The shared space at the Samuel Beckett Bridge junction is insufficient for the volumes of both pedestrians and cyclists that are forced to interact with each other. Similarly, the campshire's path adjacent to the Scherzer bridge at Spencer Dock is inappropriate for the existing volumes of pedestrians and cyclists. It is noted that an alternative bridge crossing was under construction during the walking audit.

**Shared Pedestrian / Cyclist Areas along with North Quays**

The design should seek to maximise separation between cyclists and pedestrians where possible.

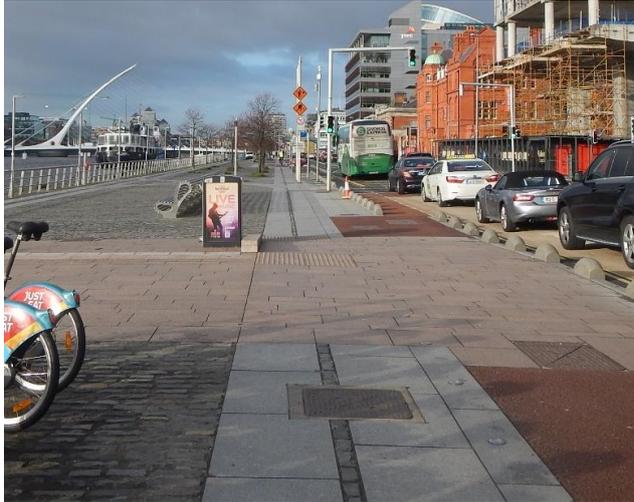
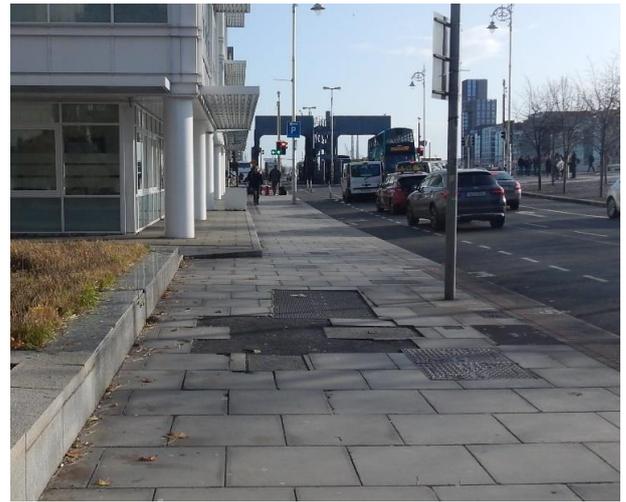
The northern footpath on the north quays is predominantly constructed with silver grey granite flags. In some locations asphalt was used for footpath repair, in lieu of replacing removed flagstones, creating undulations in the surface and potential trip hazards due to poor finishing. Where such paving flags have been removed and patch repaired with asphalt, the asphalt shall be broken out and the flags replaced. At the CHQ building in particular there is an extensive use of setts on both footpaths. These setts shall be removed within the direct line of travel and replaced with flags. Setts, similar to cobbles are difficult for wheelchair users and buggies to cross, create an uncomfortable surface to walk on, and may present a trip hazard.

**Cobbles and red paving on the campshire [left] and poor asphalt repairs [right]**

East of the Conference Centre on the northern footpath where sites have not been redeveloped to date, or are currently under construction, the footpaths comprise solid concrete. Due to construction activities, certain sections of these footpaths have been subjected to patch repairs [due to the extensive redevelopment taking place]. Where these footpaths will not ultimately be completely reconstructed as part of the overall redevelopment of the various sites, full sections of the footpaths shall be broken out and replaced to provide a smooth finish along the footpath.

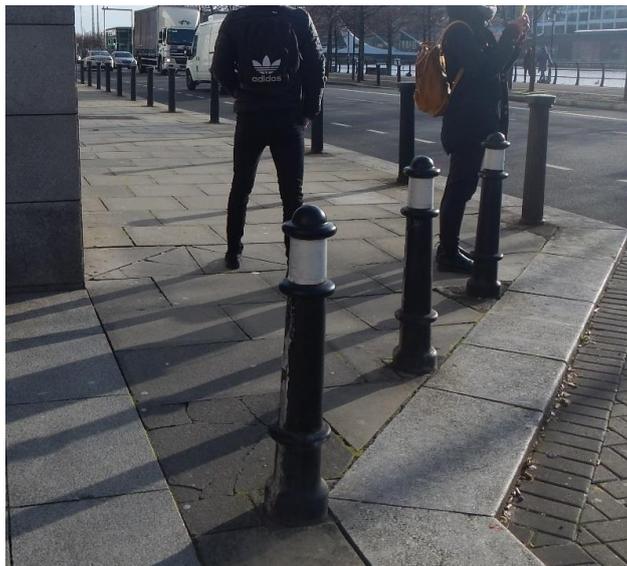
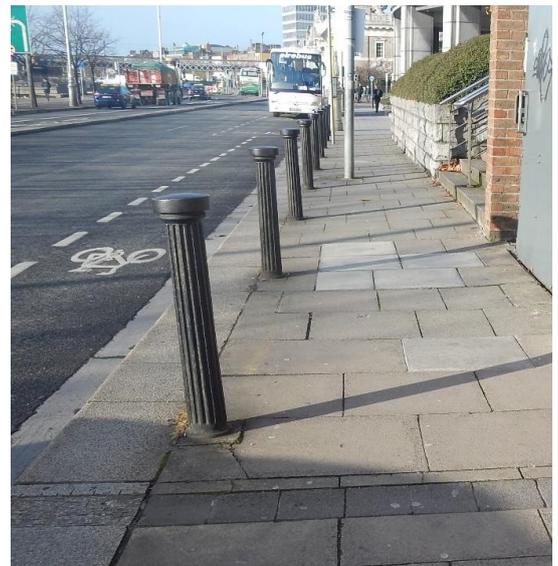
Street furniture was considered to be prolific throughout the north quays, particularly through a potential overuse of bollards in certain areas and a significant number of traffic signs. The bollards installed along the North Quays vary from black in colour to stainless steel. Stainless steel bollards may potentially lead to glare in bright sunshine and may not be sufficiently contrasted in colour with the pavement to alert visually impaired pedestrians of their presence. The inconsistency in the use of bollards along footpath edges and at set-down areas suggests a problem with either parking on footpaths or an issue with poor distinction in paving materials. The use of and need for the extent of bollards along the quays should be reviewed, and only used where there is an overwhelming reason to do so.

**Examples of the overuse of street furniture constraining the footpath width**

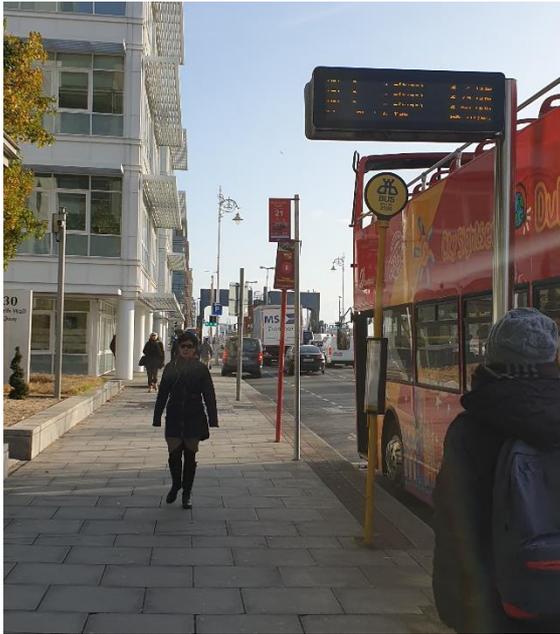
The extent of existing traffic signs and posts shall be reviewed to identify those that can be removed or relocated to lighting columns or other signposts. The need for new traffic signs shall be done with a view to only providing those that are statutorily required. Similarly, rationalisation of the Bus Stop infrastructure should be carried out along the north quays. All bus stops along the route were observed with multiple Bus Stop signs for individual bus companies, closely spaced within the bus stop cage. In some instances, Real Time Passenger Information (RTPI) signs were also present, creating a mass of unwanted street clutter. This clutter creates boarding difficulties by limiting the space available for wheelchair ramps to be extended to the

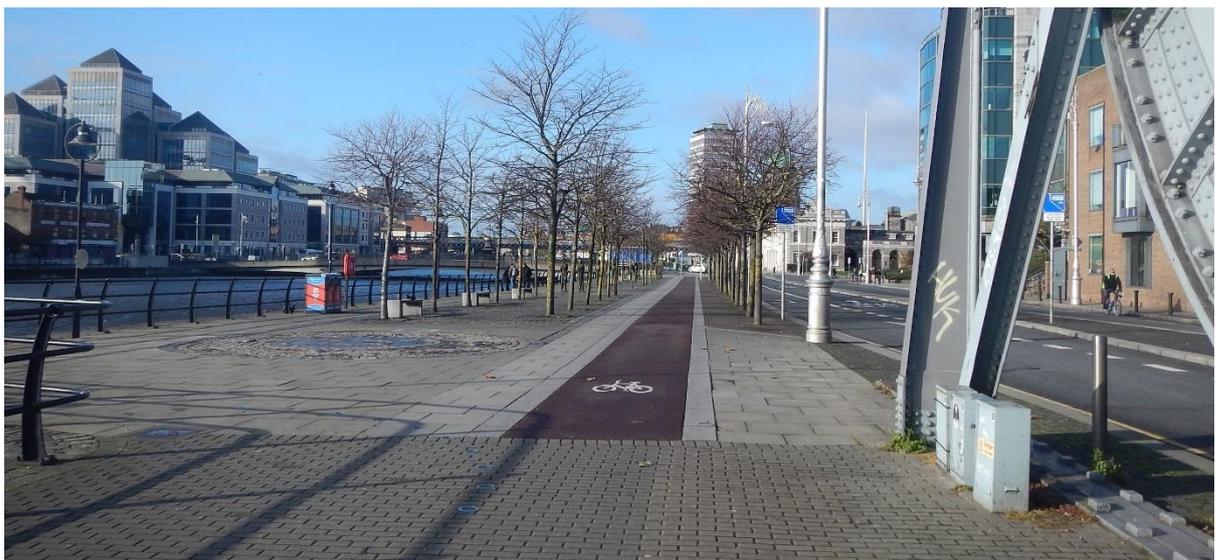
Various other forms of street furniture were noted, particularly along the campshires. These comprised, inter alia, benches, electricity supply boxes, advertising and information panels, memorial sites, trees, wayfinding signage and bins. These forms of street furniture were generally placed outside the line of travel, and careful consideration of their relocation during construction shall ensure a clear, tidy path is provided to pedestrians once the scheme is complete.

**Various forms of Street Furniture along the North Quays**

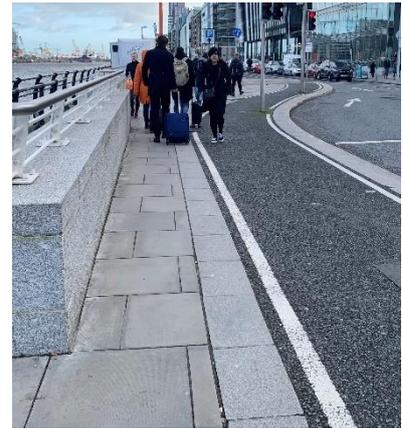
The footpath widths along the south quays vary considerably between 2m and 3m along the southern footpath on Sir John Rogerson's Quay east of the Samuel Beckett Bridge, and between approximately 1m to 3m west of the Bridge. The severe constraint in footpaths was due to construction works taking place on sites. Some of the effective width of these footpaths were also severely compromised due to various forms of street furniture placed in the direct line of travel.

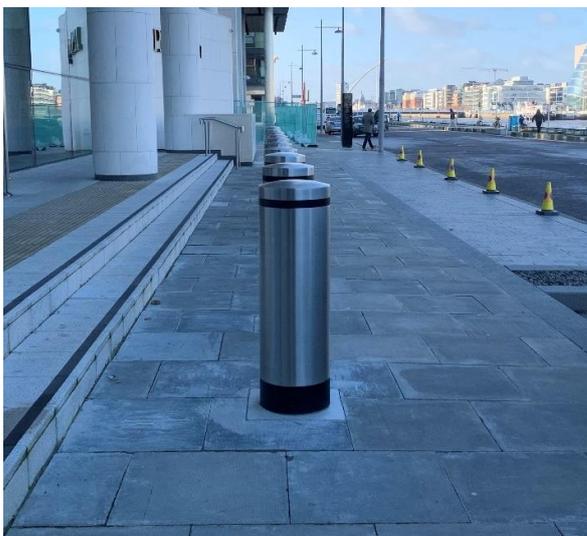
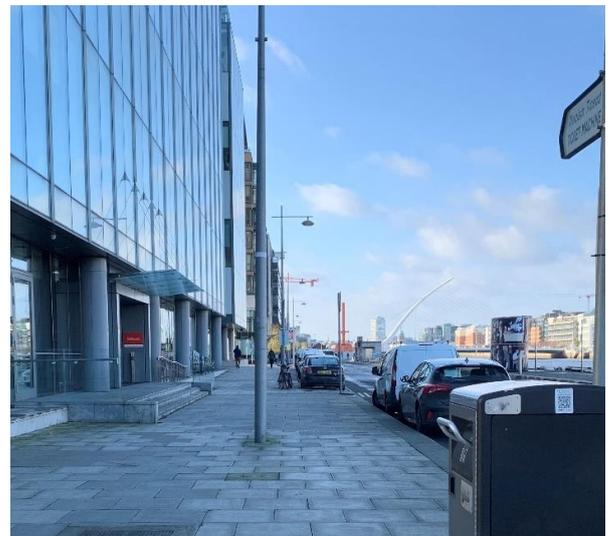
The southern campfires east of the Samuel Beckett Bridge, despite being over 10m wide, allocates two narrow paths of no more than 1.3m each to pedestrians. The recently constructed flood wall also creates a pinch point in the footpath and two-way cycle track at the bridge creating a severe point of conflict between fast moving two-way cycle traffic in an area of high pedestrian volumes.

#### Poorly placed street furniture affecting the effective width of the footpaths

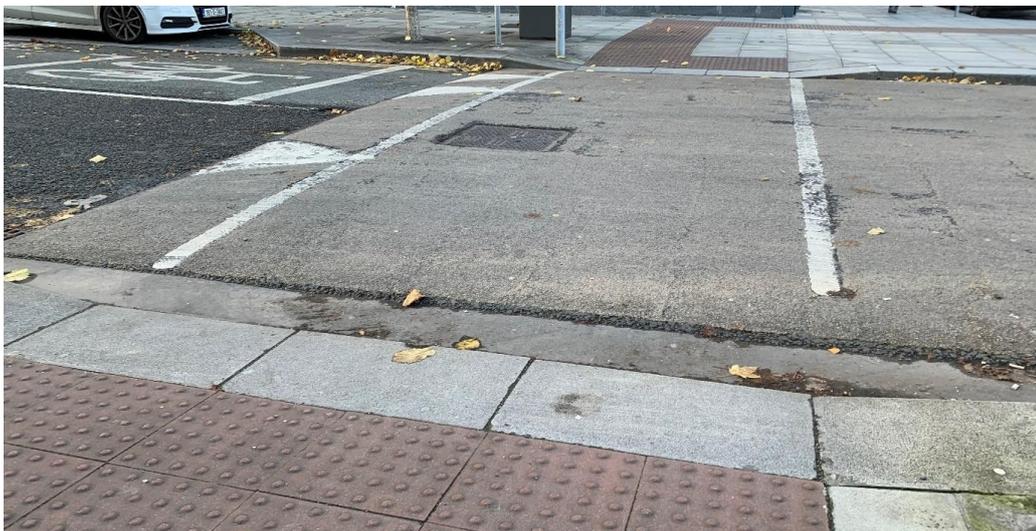
**Ramps at crossing points with dished kerbs**

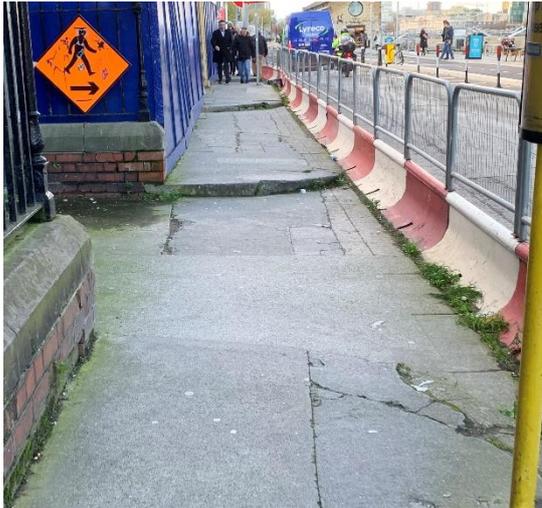
West of the Samuel Beckett Bridge the footpaths have generally been upgraded over time and dished crossings provided. The most recent public realm upgrade has taken place on Windmill Lane and Creighton Street where the road has been raised as a platform to meet the kerb level and tactile paving provided. This creates a smooth travel experience for all pedestrians and should be replicated where possible throughout the scheme. In one location however, between Lime Street and the Samuel Beckett Bridge, the footpath does not have any dished kerbs or tactile paving to warn of the step hazard. The site fronting this footpath is currently under
