# Appendix I

## Accessibility Audit Report

# Ringsend to City Centre Core Bus Corridor Scheme

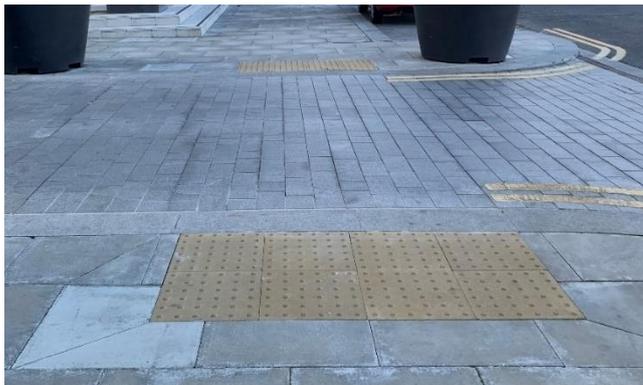
Only one minor access street was noted on the south quays where pedestrians have not been given crossing priority over it. This is reinforced through the presence of tactile paving despite the continuation of pavement materials. It is recommended that priority be given to pedestrians across all accesses to reduce the level of uncertainty over priority on what appears to be footpath.

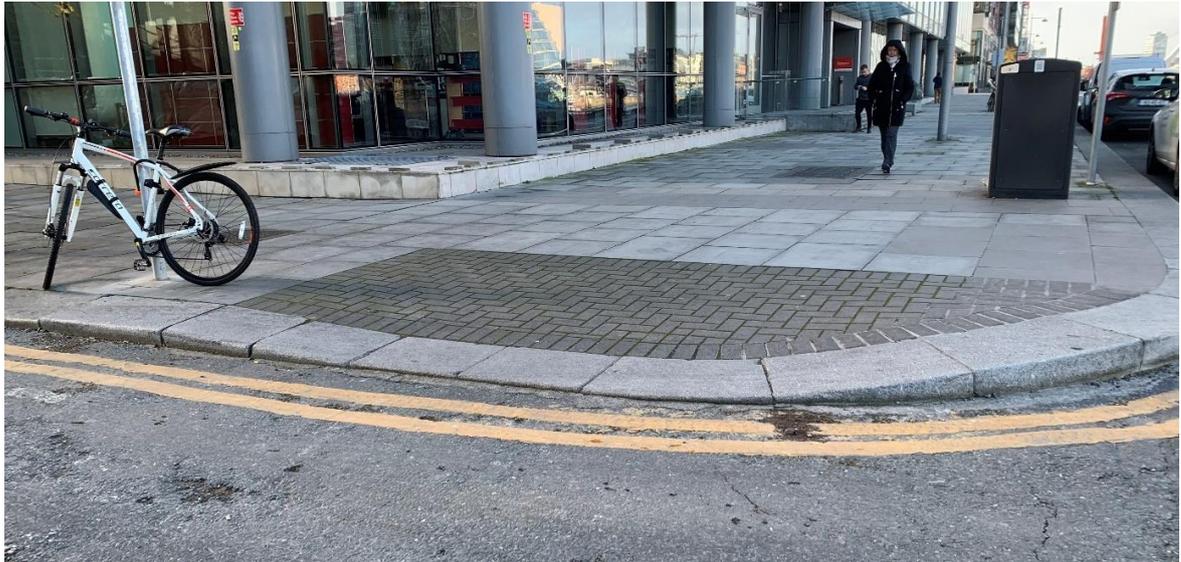
Red blister tactile paving has been provided at all controlled crossing points along the south quays, as is required. A significant number uncontrolled crossings do not have tactile paving at the dished kerbs. The existing buff coloured cobble lock used at these crossings should be replaced with buff colour blister tactile paving. Tactile paving shall be provided at all crossings as required by the crossing type, whether controlled [red blister] or uncontrolled [buff].

**Cobble lock used in lieu of blister tactile paving at uncontrolled crossings**

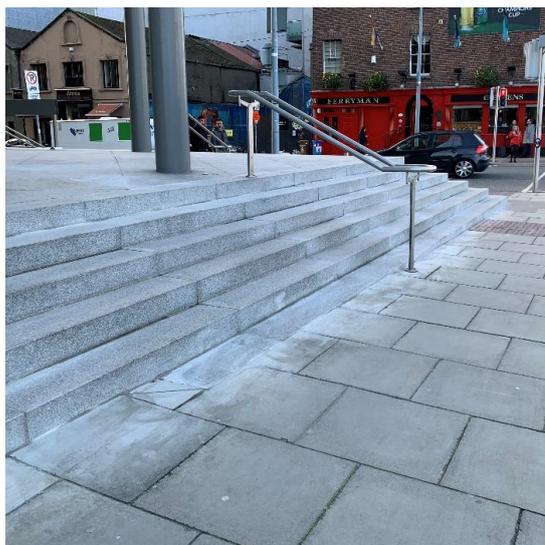
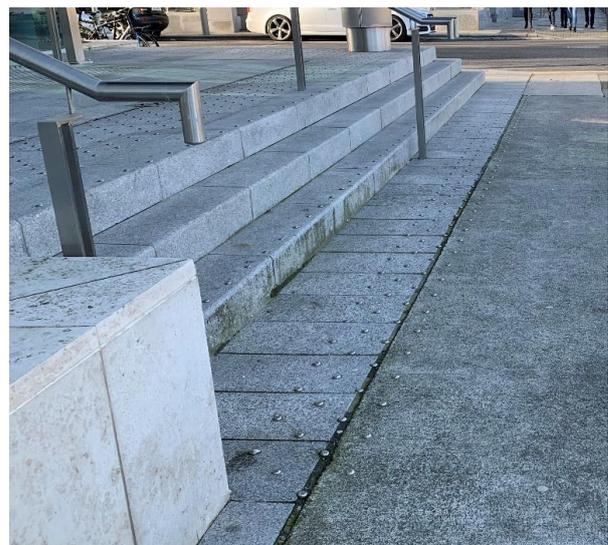
**Poor Step Hazard Identification**

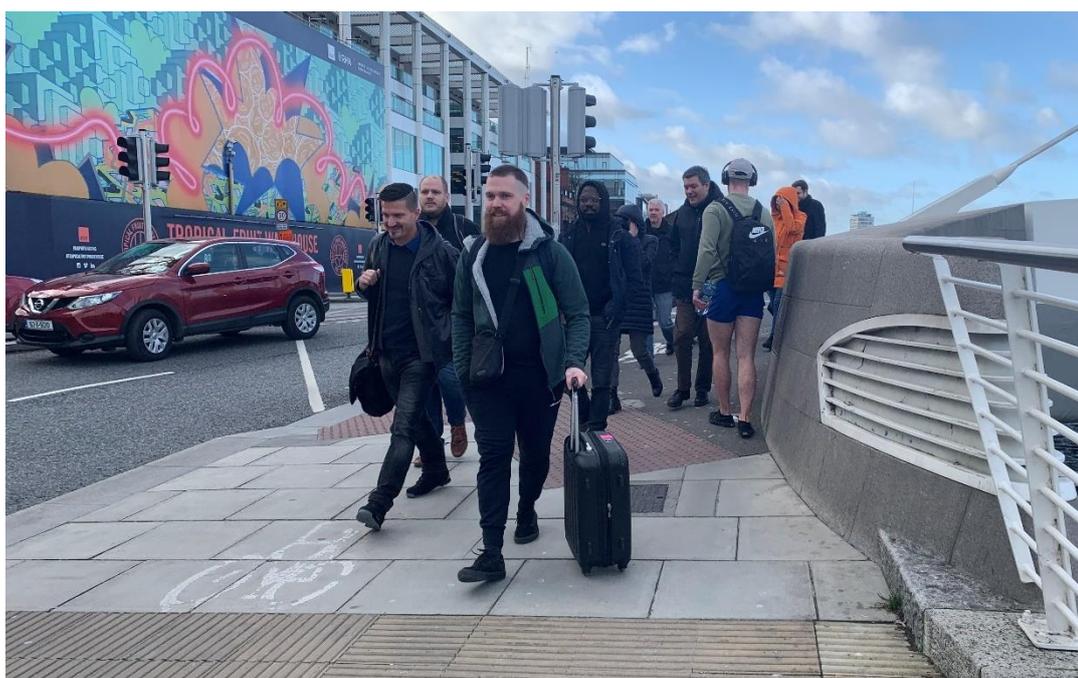
**Shared Space at Samuel Beckett Bridge**

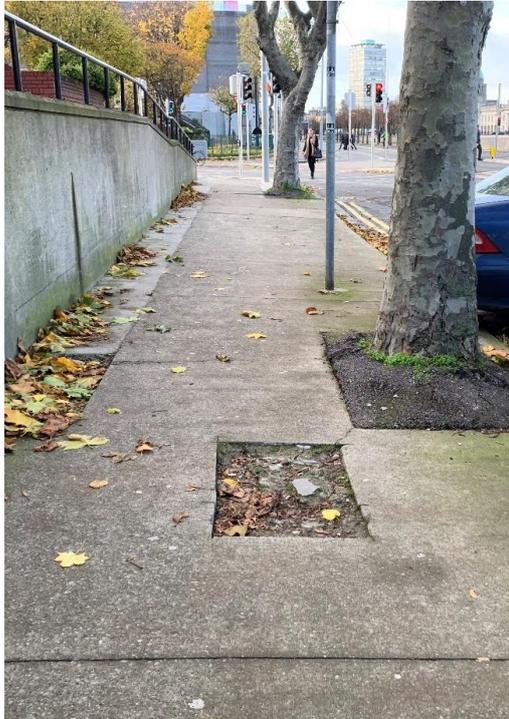
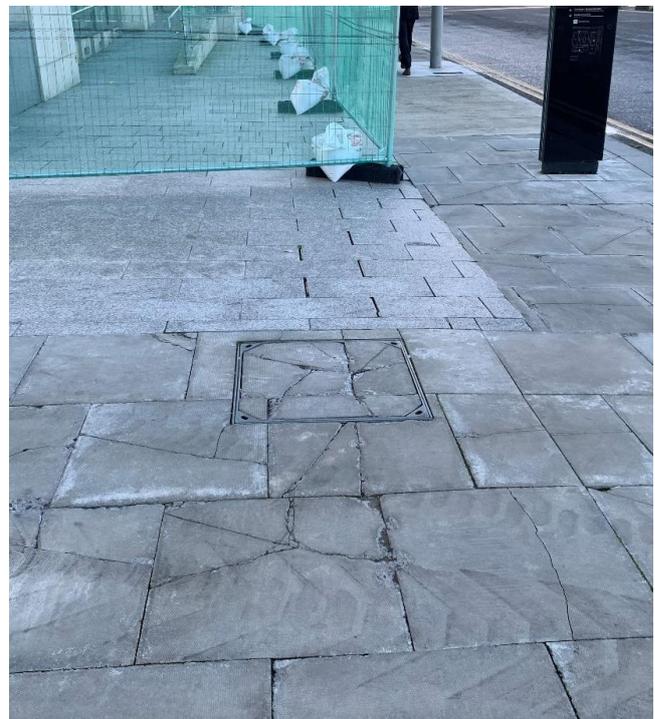
**Poor Footpath surfaces**

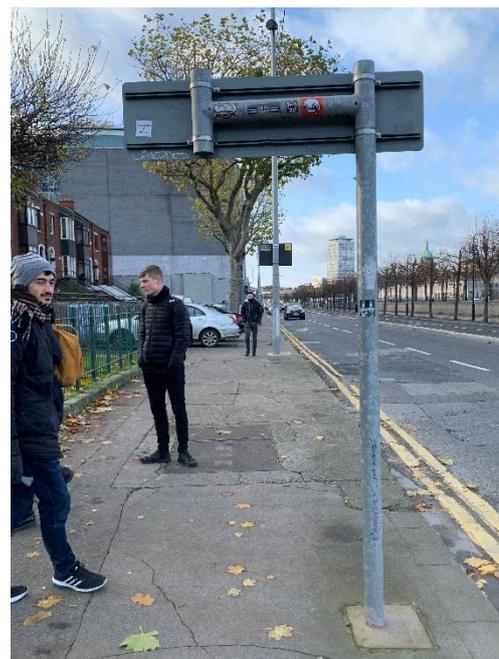
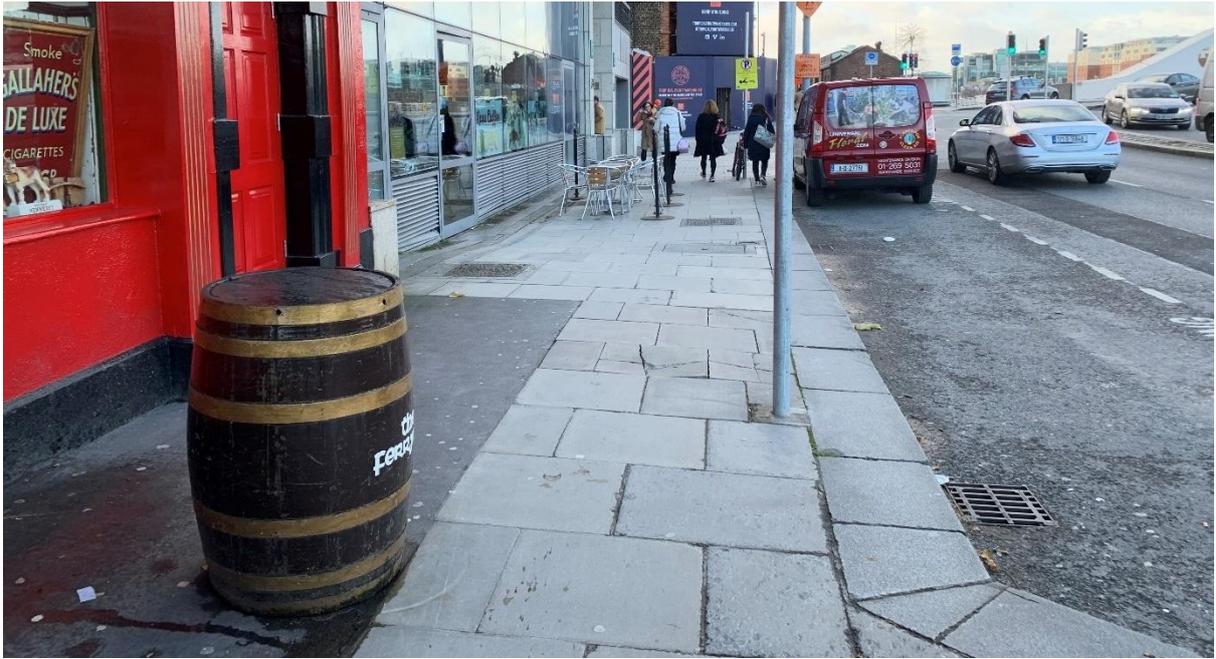
**Negative interaction of Street Furniture on Private Landings**
