Road Safety Audit

BusConnects Core Bus Corridors

Ringsend to City Centre Core
Bus Corridor

Stage 1 Road Safety Audit

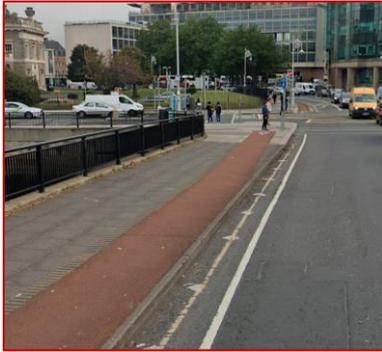
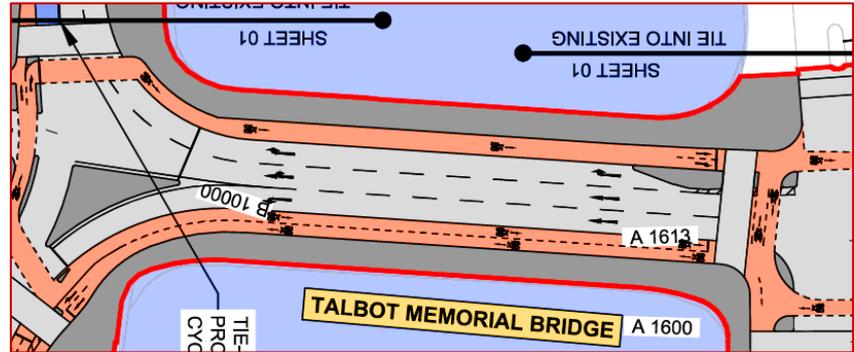
Summary: Lack of physical separation between the cycle tracks and general traffic on Talbot Memorial Bridge may increase the risk of a cyclist being struck by an errant vehicle.

There is a lack of separation (vertical or kerb/bollard) indicated between the proposed two-way cycleway on the eastern side of the Talbot Memorial Bridge. Insufficient separation between the proposed cycle tracks and general traffic on Talbot Memorial Bridge could increase the risk of cyclists being struck by an errant vehicle, particularly turning left onto City Quay.

The existing northbound cycle lane on the western side of Talbot Memorial Bridge is located adjacent to the footpath and separated from the trafficked carriageway by a kerb. It is unclear from the drawing provided if this arrangement is to be retained, and if not, insufficient separation between the proposed cycle track and general traffic could increase risk of cyclists being struck by an errant vehicle.

The cycle tracks on Talbot Memorial Bridge should be physically separated from general traffic, and if possible from the footway also.

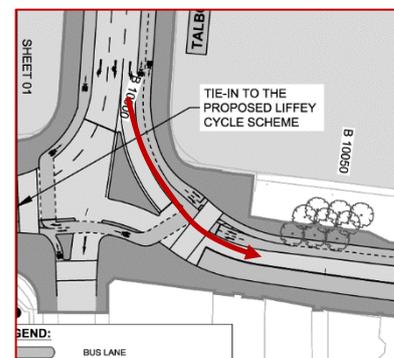
Summary: Potential for large vehicles to encroach onto cycle track.

It is unclear if the left-turn lane from Talbot Memorial Bridge onto City Quay can accommodate the swept path of a large vehicle without encroachment into the adjacent two-way cycle track.

Vehicles encroaching upon the two-way cycle track could increase the likelihood of a vehicle/cyclist collision.

It is recommended that separation be provided between the carriageway and the cycle track, and that a swept-path analysis is undertaken to ensure that all vehicles can complete this turn within the proposed road layout.

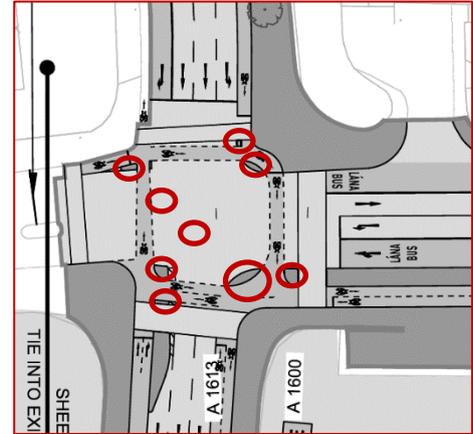
Summary: Small islands proposed at signalised junctions may be impractical to sign, and lead to these islands being struck.

Small islands have been indicated within signalised junctions to separate vehicle, cyclist, and pedestrian movements. The relatively small size of the islands, and their number within a junction, may be impractical to sign, and lead to these signs being struck by vehicles and cyclists, leading to material damage and loss of control collisions.

Ensure physical islands can accommodate traffic signs and provide at least 450mm between the carriageway edge and the sign.

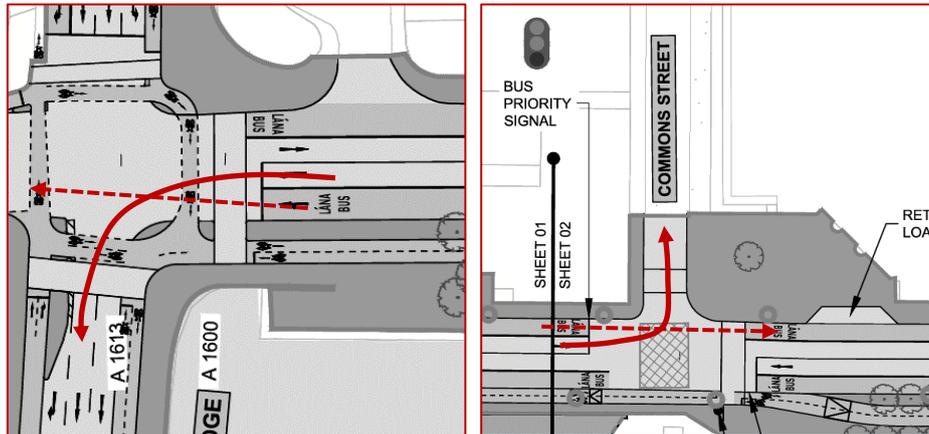
Summary: Risk of general traffic turning left across straight-ahead bus movements, resulting in side-on collisions.

Details of the proposed signal phasing have not been provided at this stage in the design process. Where “Bus Priority Signals” are proposed, it is unclear if the general traffic lane will be held while buses proceed, and conversely that buses will be held while general traffic proceeds.

Should all traffic proceed on the same signal phase, there is an increased risk of side-on collisions between left turning traffic and straight-ahead buses/cyclists, resulting in side-on and vehicle/cyclist collisions.

Ensure that the general traffic lane operates on a separate signal phase to the bus and cycle lane(s).

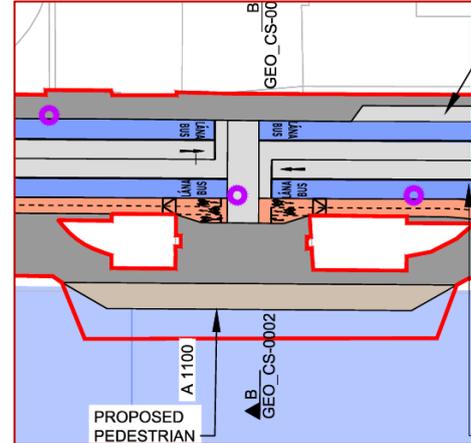
Summary: Drivers may have limited visibility to some signals at the signalised crossing on North Wall Quay, leading to an increased risk of overshoot and vehicle/pedestrian collisions.

It is unclear what type of signal supports (e.g. standard height, high mast, cantilever, etc) are proposed at the signalised crossing located on the North Wall Quay. There is a risk that the traffic signal location on the southern footway, which is offset from the carriageway, may be outside a driver's eyeline on approach to the signalised crossing, and possibly blocked by the nearby buildings either side of the crossing. This could increase the likelihood of overshoot and vehicle/pedestrian collisions.

In addition, a bus within the bus lane at the crossing stop line may obscure visibility towards the signals for an approaching driver in the general traffic lane, which may also result in overshoot and vehicle/pedestrian collisions.

Ensure that approaching drivers have adequate visibility to the upcoming signals. This may require the provision of high-mast or cantilever-type signal supports.

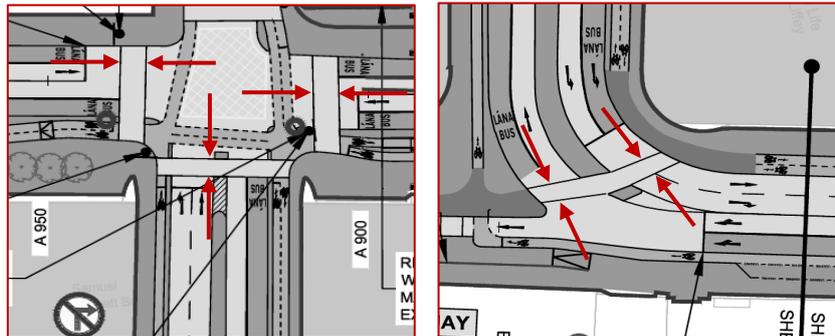
Summary: Proposed crossing widths at signalised pedestrian crossings may be insufficient for the anticipated high pedestrian volumes.

The pedestrian crossing widths indicated appear to be relatively narrow given the likely volumes of pedestrians during peak times, particularly near the Convention Centre (e.g. on the northern & southern side of the Samuel Beckett Bridge). This may be of increased concern on the southern side of the Samuel Beckett Bridge, which is a Toucan crossing.

Provide signalised crossings at least 4m wide (Ref: DMURS section 4.3.2, page 92).

3.1	Yes	Yes		
3.2	Yes	Yes		
3.3	Yes	Yes		
3.4	Yes	Yes		
3.5	Yes	Yes		
3.6	Yes	No	Space constraints prevent a blanket provision of 4m wide crossings everywhere within the scheme. Where space allows we have widened all crossings to up to 4m. At Beckett Bridge south however, the design is especially constrained by levels and opening bridge paraphernalia and the layout as constructed is the most that can be achieved at this location. The existing crossing layout is being retained with enhancements to the footpaths and cycle facilities on each side where practicable.	Yes

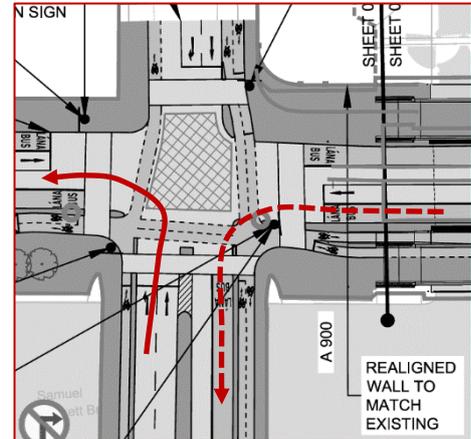
Summary: Large vehicles may fail to navigate left-turns without mounting the kerbs, leading to vehicle/pedestrian, vehicle/cyclist, and material damage collisions.

It is unclear if buses are intended to turn left from Spencer Dock onto the Samuel Beckett Bridge. If this manoeuvre is anticipated in the future, the proposed road layout may not accommodate the swept path of a bus undertaking this manoeuvre. Similarly, it is unclear if a large vehicle or a bus can undertake a left turn from Samuel Beckett Bridge onto the North Wall Quay without encroaching into the opposing traffic lane, or mounting the kerb on the inside of the turn.

Modifications to the existing junction radii may increase the risk of kerb strikes, vehicle/pedestrian, vehicle/cyclist, and material damage collisions.

A swept-path analysis should be undertaken at each junction to confirm that large vehicle movements can be accommodated safely within the proposed road layout.

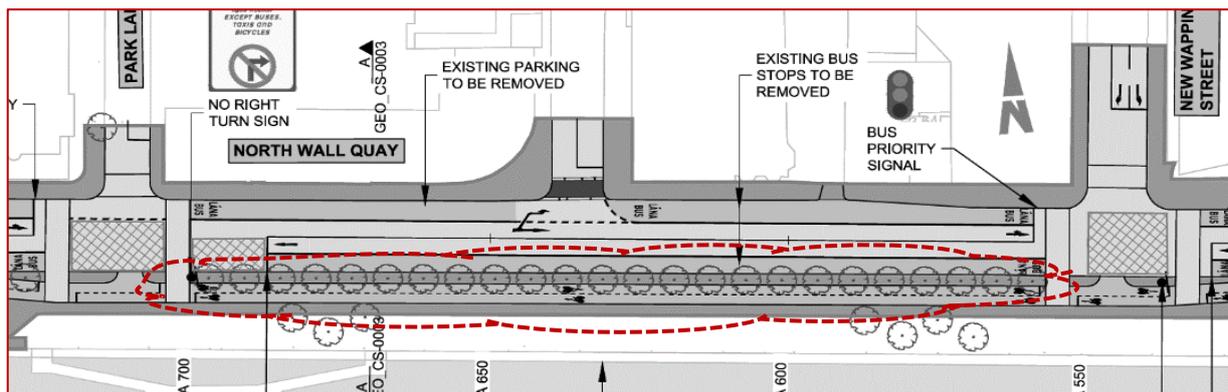
Summary: Trees and their canopies may increase the risk of bus strikes and reduced visibility, leading to material damage and side-on collisions, or present a hazard to cyclists on the adjacent cycle track.

Tree planting is indicated on North Wall Quay, between CH A550 and CH A700. The tree canopies may, as they mature, overhang the bus corridor, increasing the risk of bus strikes and material damage collisions.

Low hanging tree canopies may present a hazard to cyclists on the two-way cycle track, leading to personal injury collisions.

Care will be required during the subsequent Design Development phases to ensure that the tree species chosen have canopies, when mature, that will not present a hazard to vehicles travelling in the adjacent bus lane, or to cyclists on the two-way cycle track.

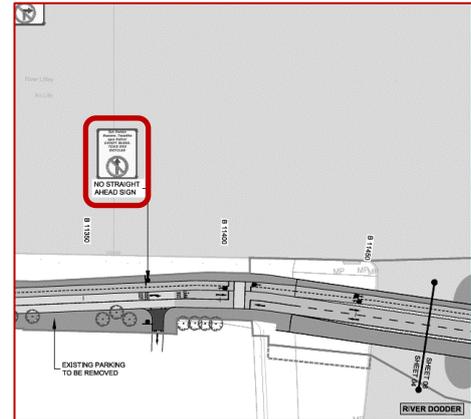
Summary: Insufficient advance warning of “No Straight Ahead Sign” restriction may lead to unsafe reversing manoeuvres, or potentially increased traffic along the adjacent narrow road network.

A sign has been indicated on the Sir John Rogerson’s Quay, which advises drivers that they cannot proceed east on the new Dodder Public Transport Bridge. The position of the sign may be too late to prevent some drivers inadvertently travelling this far east.

This could lead to unnecessary, and possibly unsafe, reversing manoeuvres or potentially increased traffic along the adjacent narrow road network, resulting in rear-end-shunt and material damage collisions.

Advance signage should be provided at a suitable junction further upstream (to the west) so that drivers can follow an appropriate alternate route.

3.7	Yes	Yes		
3.8	Yes	Yes		
3.9	No	No	Drivers can continue to turn right at the location of the sign via Steven's Walk and Green Street East. Larger HGVs that don't use Steven's Walk can continue to use Benson Street. It is noted that 5+ axle HGV's are not permitted to use Sir John Rogerson's Quay as a haul route and there are several 3.5T parking bans on the streets perpendicular to discourage such large vehicles from entering the area.	Yes

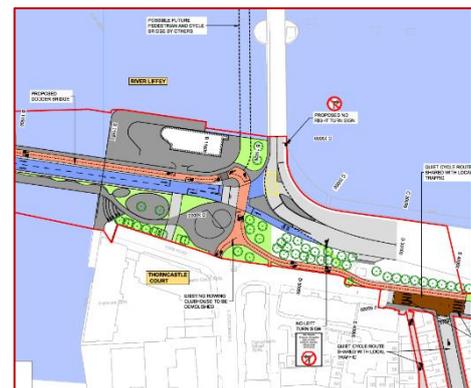
Summary: Lack of pedestrian facilities between Pembroke Cottages, the new Dodder Sustainable Transport Bridge, and the Tom Clarke Bridge may lead to vehicle/pedestrian and pedestrian/cyclist collisions.

No pedestrian facilities have been indicated between the Zebra crossings at Pembroke Cottages, the new Dodder Sustainable Transport Bridge, and the Tom Clarke Bridge. It is therefore unclear how pedestrians in the Ringsend and Irishtown residential catchment areas will access the footways on the new Dodder Sustainable Transport Bridge or the existing Tom Clarke Bridge.

The absence of appropriate pedestrian facilities may lead to pedestrians travelling within the two-way cycle track, or within the York Road carriageway, where there is an increased risk of pedestrian/cyclist and vehicle/pedestrian collisions.

A pedestrian footpath, which ties in with a controlled crossing of York Road, should be provided between Pembroke Cottages and the new Dodder Sustainable Transport Bridge/ Tom Clarke Bridge, ensuring that pedestrian/cyclist conflicts are minimised.

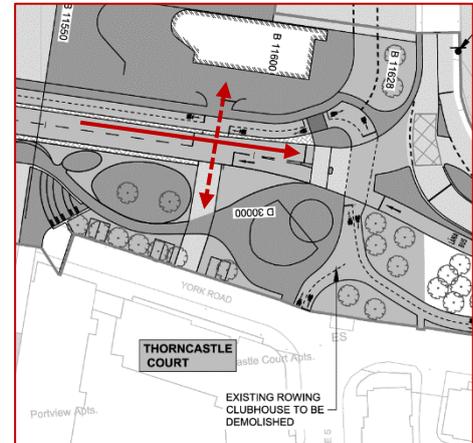
Summary: The close proximity of signals may lead to driver confusion, resulting in overshoot, rear-end-shunt and side-on collisions.

It is unclear if it is proposed to provide signals on the new Dodder Sustainable Transport Bridge for access to the rowing club. The road layout indicated implies that signals will be provided to facilitate access across the sustainable transport bridge carriageway and the two-way cycle track.

The proximity of the signals to the downstream junction signals could result in eastbound drivers misinterpreting the first set of signals as applying to the downstream junction, resulting in overshoot, rear-end-shunt and side-on collisions.

Provide measures at the rowing club signals to reduce the risk of eastbound drivers misinterpreting the first set of signals as applying to the downstream junction (e.g. both sets of signals operating in-phase).

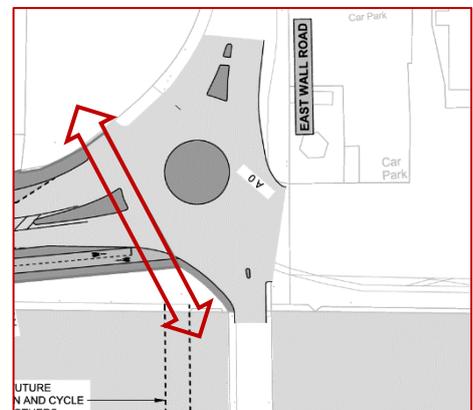
Summary: A lack of safe crossing facilities for pedestrians, particularly partially sighted or mobility impaired pedestrians, may lead to vehicle/pedestrian collisions at the North Wall Quay/Tom Clarke Bridge Roundabout junction.

There may be a likely pedestrian desire line to/from the narrow footpath on the western side of the Tom Clarke Bridge and the area around the 3-Arena on East Wall Road.

There are no existing, or proposed, pedestrian crossing facilities in the vicinity of the existing roundabout on the northern side of the Tom Clarke Bridge.

A lack of safe crossing facilities for pedestrians, particularly partially sighted or mobility impaired pedestrians, may lead to vehicle/pedestrian collisions.

Identify likely pedestrian desire lines and demand for vulnerable road users between Tom Clarke Bridge and East Wall Road and provide pedestrian facilities where necessary.

3.10	Yes	Yes		
3.11	Yes	Yes		
3.12	Yes	No	<p>This junction is outside the scope of this project and is being progressed separately by DCC. The issue will be brought to DCC's attention</p>	Yes

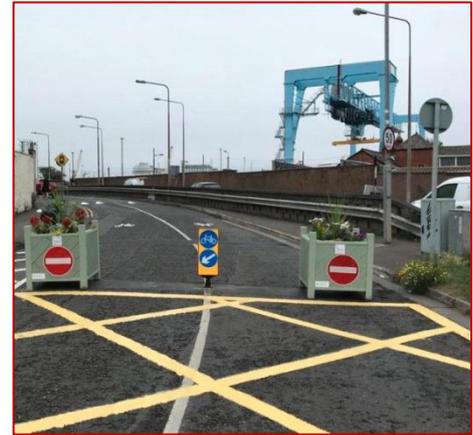
Summary: Removal of existing vehicle restriction on Pigeon House Road may lead to the re-introduction of high traffic volumes on a narrow residential street, increasing the risk of vehicle/cycle and material damage collisions.

Dublin City Council is currently (May 2021) trialling a vehicle restriction on Pigeon House Road. The restriction prevents motorists on Pigeon House Road from accessing the Sean Moore Road Roundabout, and vice versa. It is unclear if the Ringsend to City Centre Core Bus Corridor Scheme proposes to remove the restriction on through-traffic on the Pigeon House Road.

Removing any existing restrictions could result in a significant diversion of traffic through the relatively narrow local streets to the west of this location, along which is intended to route cyclists to/from the new facilities on Sir John Rogerson's Quay. This may lead to an increased risk of vehicle/cycle and material damage collisions.

The Design team should consult with Dublin City Council to understand the trial's conclusions before determining whether the restriction should be retained or removed.

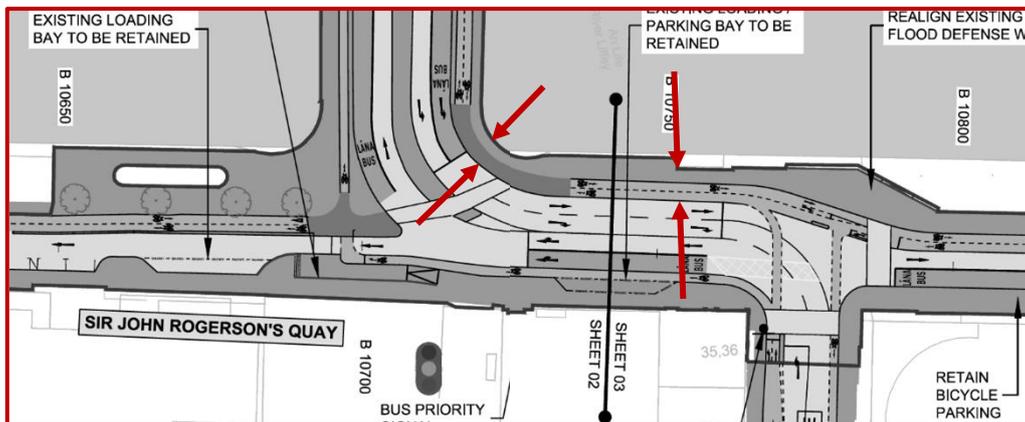
Summary: Insufficient footway width may lead to pedestrian/cyclist and vehicle/VRU collisions.

It is unclear if the proposed footway width at the junction between Samuel Beckett Bridge and Sir John Rogerson Quay can safely accommodate the likely volume of pedestrians and cyclists at this location, in particular during peak times. The existing footway width is constrained at this location, and insufficient width may lead to pedestrians and cyclists colliding on the bend, or to cyclists and/or pedestrians stepping into the carriageway to pass opposing users, leading to vehicle/VRU collisions.

Ensure the footway is wide enough to accommodate the expected volumes of Vulnerable Road Users.

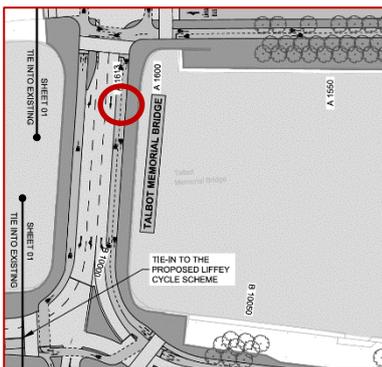
Observation 4.2

4.2 The Talbot Bridge nearside lane shows a straight-ahead arrow in a lane that can only turn left downstream. The straight-ahead arrow should be replaced by a left turn arrow.

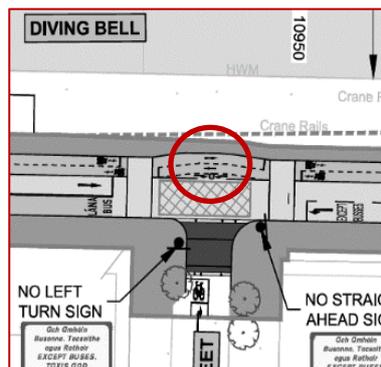
Observation 4.3

4.3 The proposed arrangement for cyclists to access side roads at a number of locations on the south quays (e.g. at Forbes Street) from the two-way cycle track appears unnecessarily complicated. Cyclists could use the adjacent toucan crossings to access the side roads at these locations.

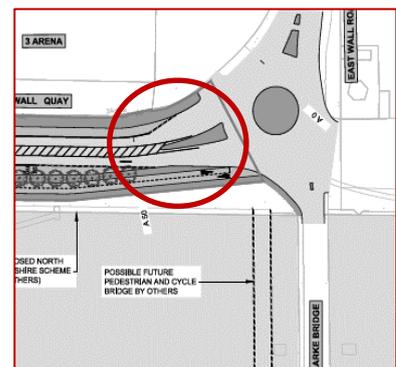
Observation 4.4

4.4 The eastbound approach to the existing roundabout on the northern side of the Tom Clarke Bridge is poorly defined. The existing arrangement has two lanes entering the roundabout, one for left-turning traffic and one for right-turning traffic. Vehicles in the general traffic lane on North Wall Quay will have to move left in order to turn left at the roundabout. The absence of appropriate guidance may result in late lane-change manoeuvres and possible side-swipe collisions. Provide guidance markings to support good lane discipline and clear direction for approaching drivers.
