Appendix A14.1
Scheme Walkover
Summary

Appendix A14.1: Scheme Walkover Summary

The following is a summary of the observations by the Land, Soils, Geology and Hydrogeology Environmental Impact Assessment Team following a physical walkover of the Bray to City Centre Core Bus Corridor Scheme (hereafter referred to as the Proposed Scheme). The walkovers occurred on 29 January 2020, 17 August 2022 and 23 March 2023. The drawings used to determine the type and extent of proposed works, and in turn, to inform the site walkovers were the General Arrangement drawings which are contained in Volume 3 of the Environmental Impact Assessment Report (EIAR).

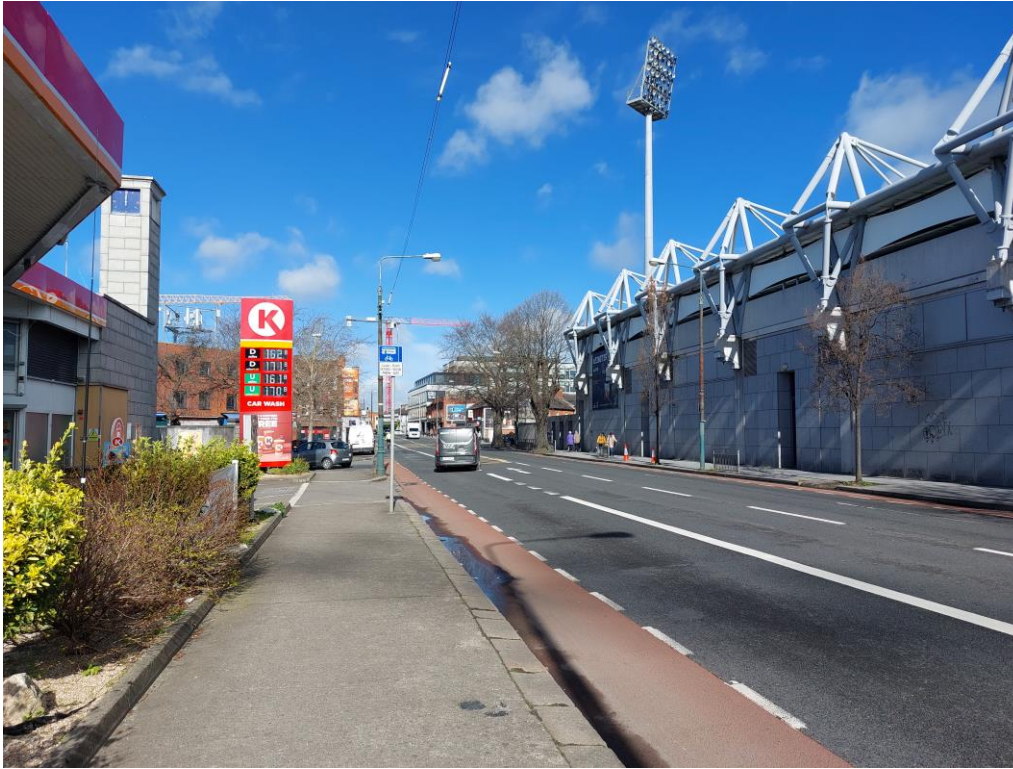
Observation	General Arrangement Drawing Sheet Number*	Description	Possible Impact	Photo Number
Petrol station	Sheet 08	Historic activities at petrol stations may have resulted in oil leaks into the surrounding soils and groundwater in the past.	This may pose an issue for the earthworks balance and waste assessment and mobilising contaminants into the groundwater.	Bray_Photo01
Donnybrook Junction – Dublin Bus Depot	Sheet 08	Historical maps indicate there used to be a train depot, Electricity Supply Board (ESB) electrical holding yard and a quarry at this location. Due to the historical land use at this location, it may be a source of contamination.	This may pose an issue for the earthworks balance and waste assessment and mobilising contaminants into the groundwater.	Bray_Photo02
UCD	Sheet 12 to 14	Upgrade works are noted at University College Dublin (UCD). Final details are to be confirmed after the completion of the UCD masterplan. Level changes are noted along the access ramp including mature trees and a perimeter wall.	This may pose an issue for the earthworks balance and waste assessment.	Bray_Photo03

Photo ID	Caption	Date Taken	Coordinates
Bray_Photo01	Photo showing petrol station in Donnybrook	23/03/2023	717660, 731481 (ITM)

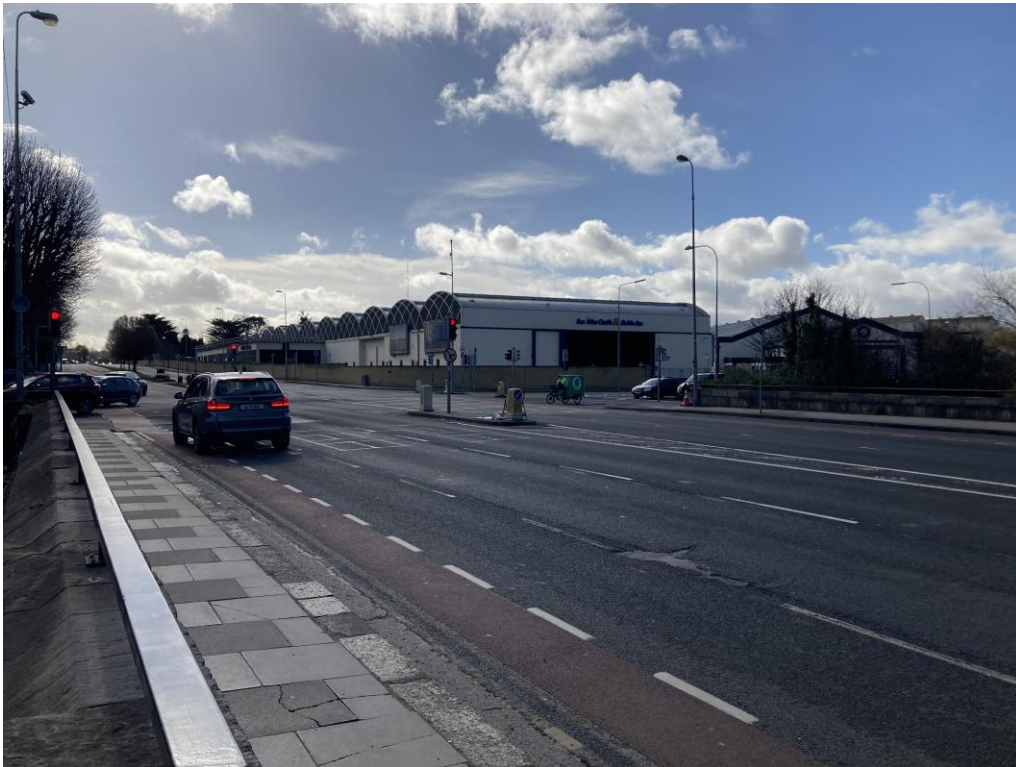
Photo ID	Caption	Date Taken	Coordinates
Bray_Photo02	Photo showing Dublin Bus depot	23/03/2023	717773, 731375 (ITM)

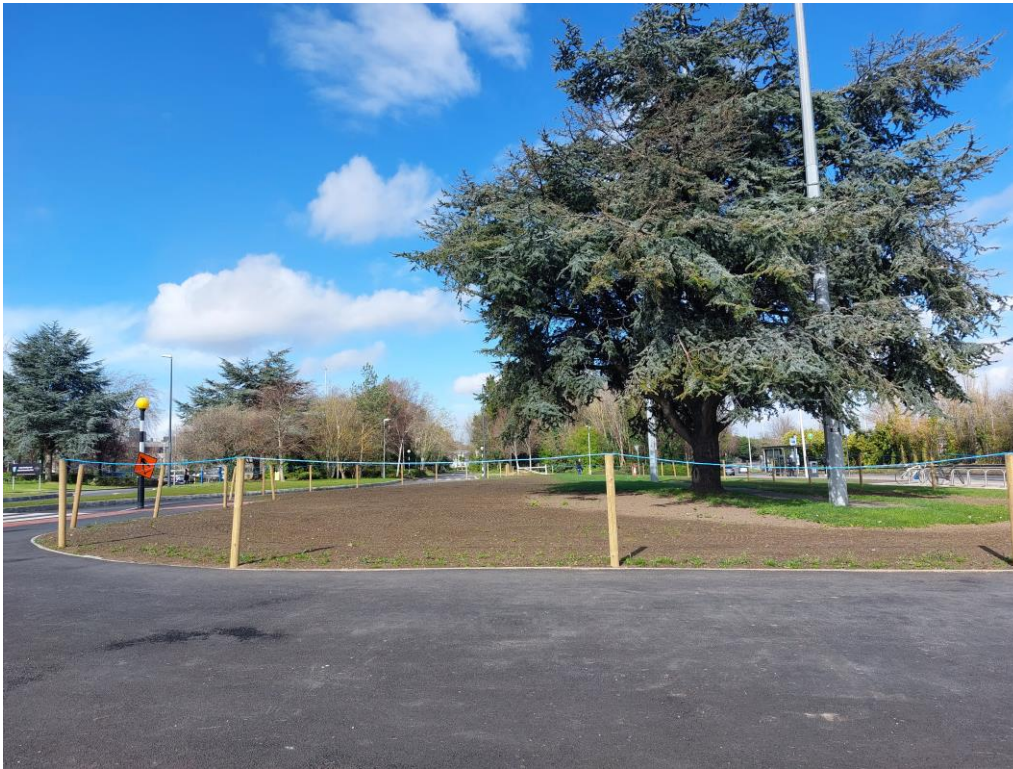
Photo ID	Caption	Date Taken	Coordinates
Bray_Photo03	Photo showing proposed area of UCD interchange	23/03/2023	718730, 730223 (ITM)

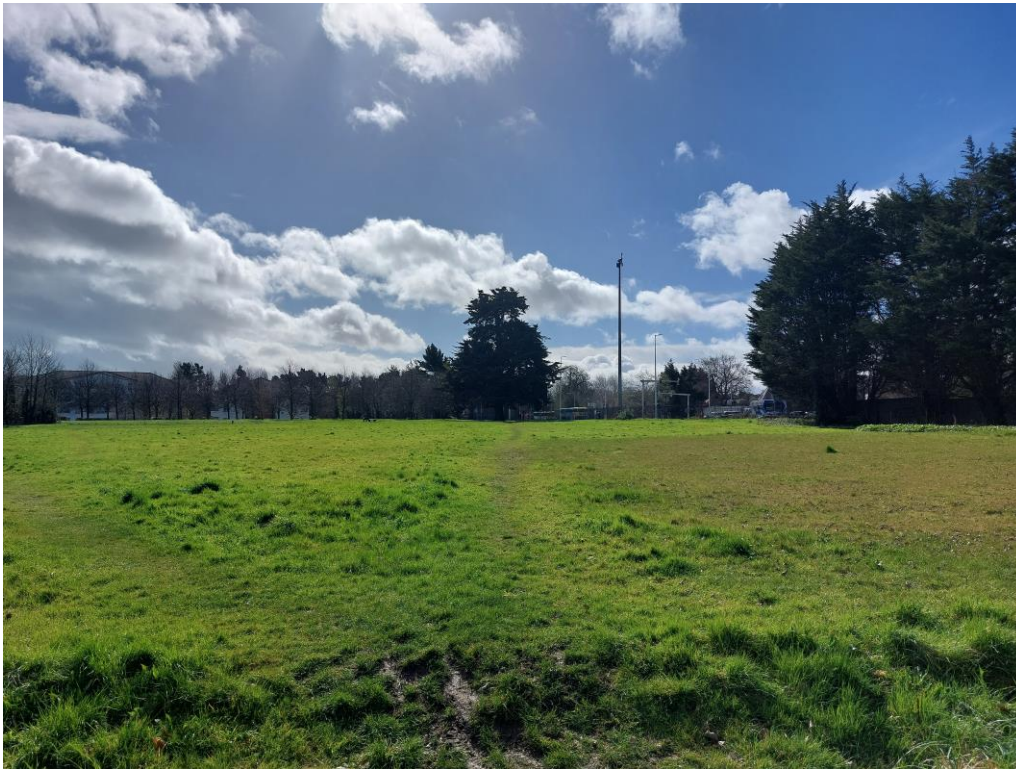
Fosterbrook Construction Compound (BR2)	Sheet 15	A construction compound is proposed at Fosterbrook estate. It is likely that the topsoil will be stripped, and level changes will be required at this location to accommodate the works.	This may pose an issue for the earthworks balance and waste assessment.	Bray_Photo04

Photo ID	Caption	Date Taken	Coordinates
Bray_Photo04	Fosterbrook Construction Compound (BR2)	23/03/2023	719381, 729781 (ITM)

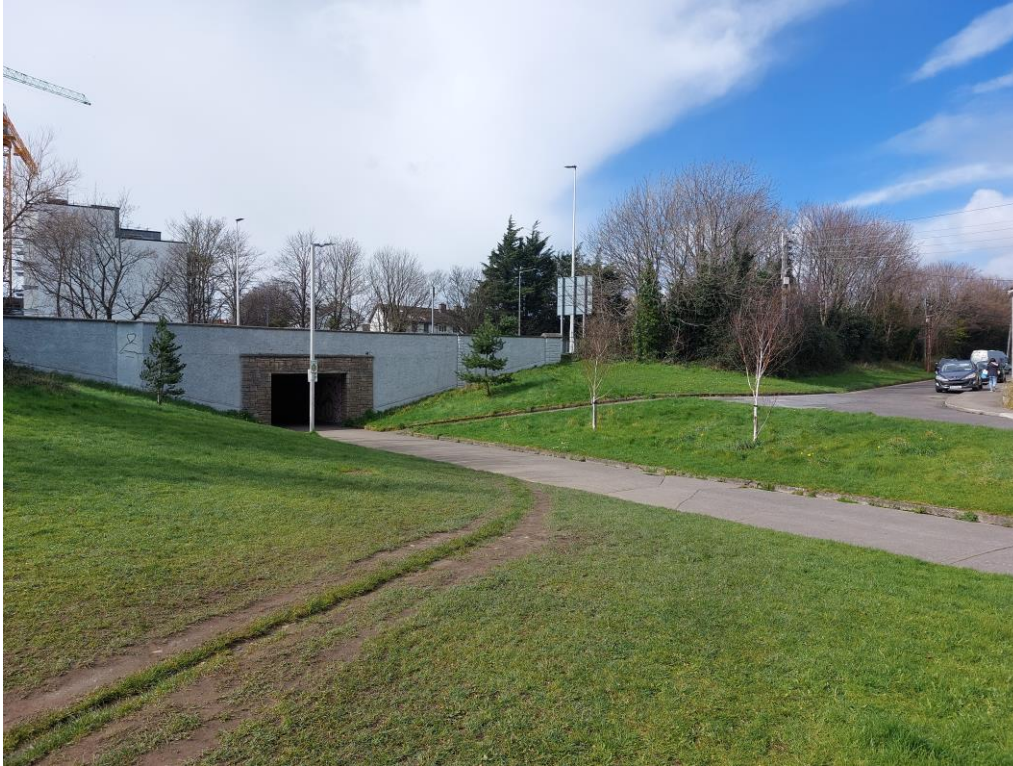
Photo ID	Caption	Date Taken	Coordinates
Bray_Photo05	St. Laurence's Subway	23/03/2023	720274, 728192 (ITM)

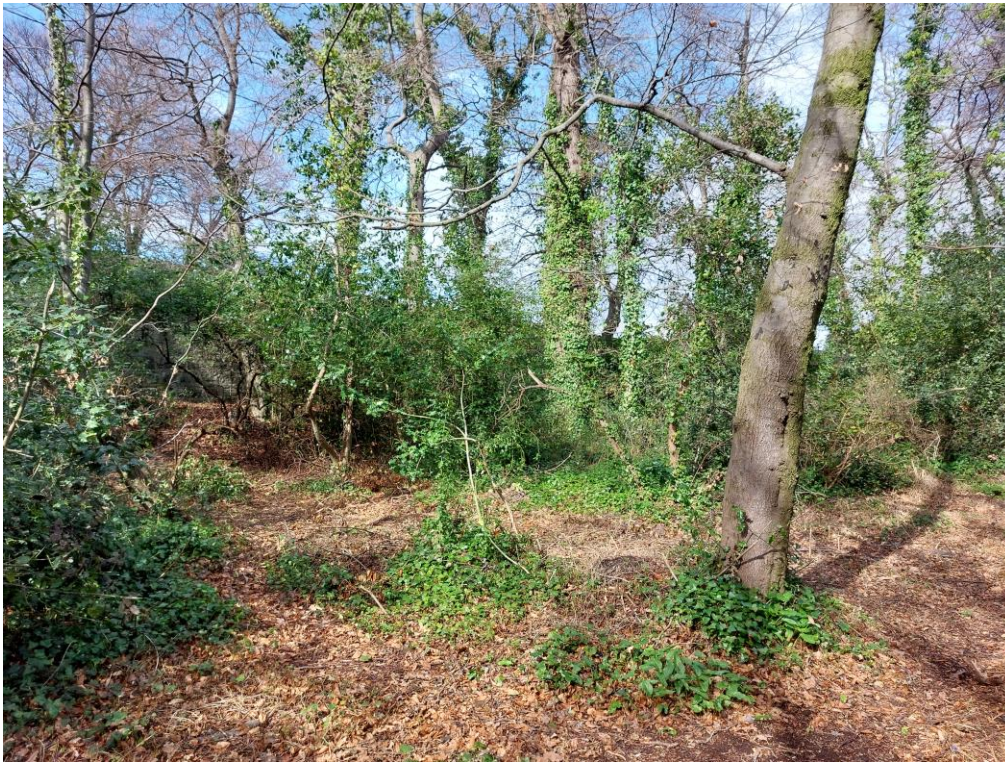
Photo ID	Caption	Date Taken	Coordinates
Bray_Photo06	Potential Retaining Wall Strengthening Works	23/03/2023	725275, 721910 (ITM)

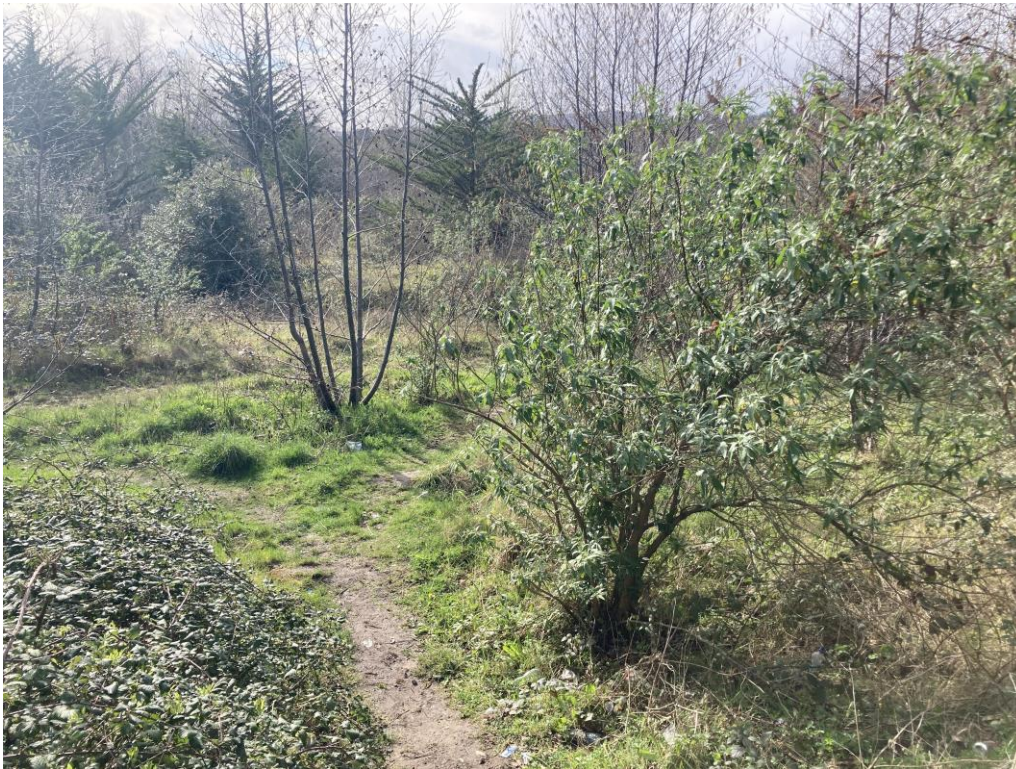
Photo ID	Caption	Date Taken	Coordinates
Bray_Photo08	Wilford Junction Construction Compound (BR1)	23/03/2023	725633, 719728 (ITM)

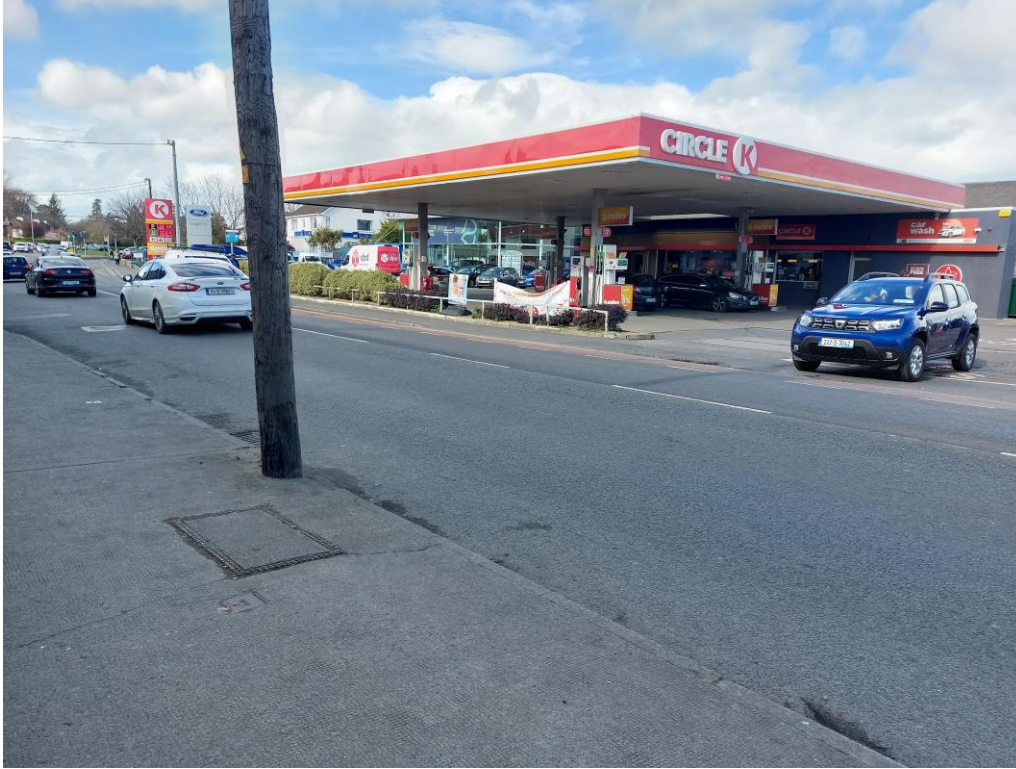
Wilford Junction Construction Compound (BR1)	Sheet 49	A construction compound is proposed to the south of Wilford Junction. It is likely that the topsoil will be stripped, and level changes will be required at this location to accommodate the works.	This may pose an issue for the earthworks balance and waste assessment	Bray_Photo08
Petrol station	Sheet 50 and 51	Decommissioning works are expected at an existing Circle K petrol station on the southbound side of the Dublin Road in Bray due to proposed widening works. Historic activities at petrol stations may have resulted in oil leaks into the surrounding soils and groundwater in the past. This will likely require land take, there is also possible presence of made ground. The area's build up is uncertain and may be overlying potentially contaminated soil, mitigation measures may need to be put in place. Ground Investigation will be required to confirm the ground conditions.	This may pose an issue for the earthworks balance and waste assessment and mobilising contaminants into the groundwater.	Bray_Photo09

Photo ID	Caption	Date Taken	Coordinates
Bray_Photo09	Petrol Station Bray town	23/03/2023	725841, 719357 (ITM)

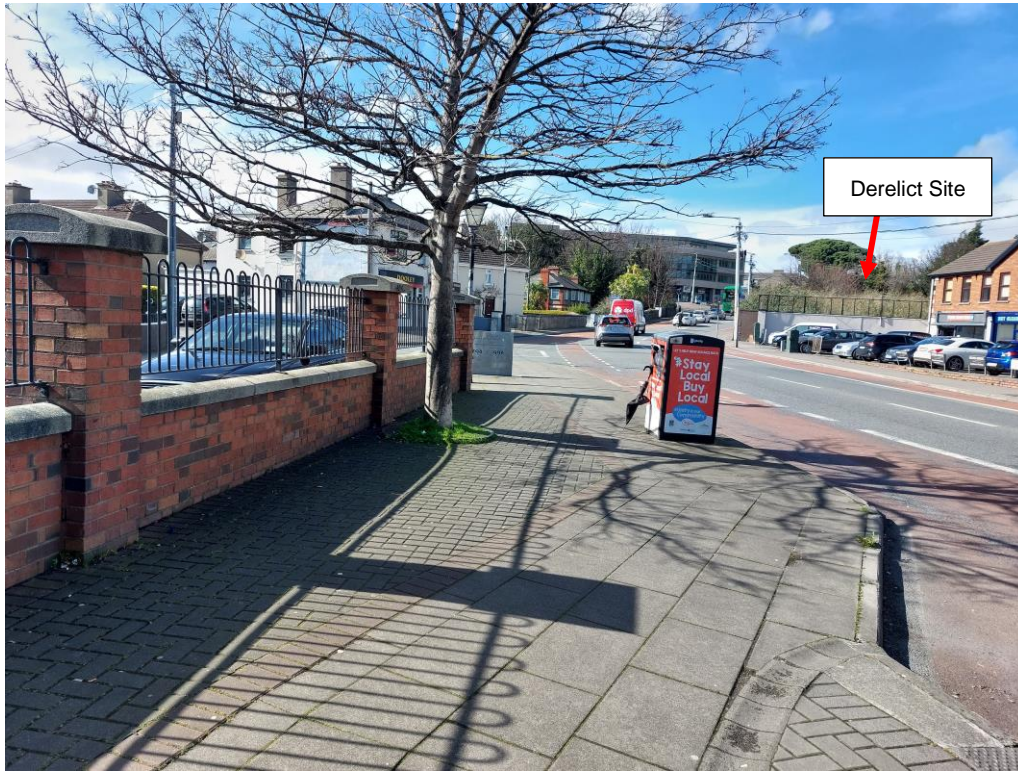
Derelict Site along Castle Street	Sheet 52	Due to potential historic land use and removal of buildings at this location, this site may be a source of contamination.	This may pose an issue for the earthworks balance and waste assessment	Bray_Photo10

Photo ID	Caption	Date Taken	Coordinates
Bray_Photo10	Derelict Site	23/03/2023	725247, 721885 (ITM)
