Proposed OCGT Development

Visual Assessment of Existing Road Pavement

EP Energy Developments

Project number: 60661667

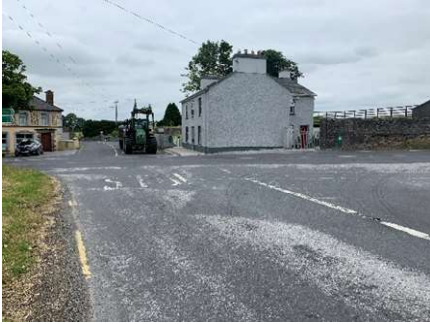
Chainage (km)	Condition Pavement Surface	Image
0.00-0.10	Road markings worn at junction and some oil staining of surfacing Pavement surface in good condition

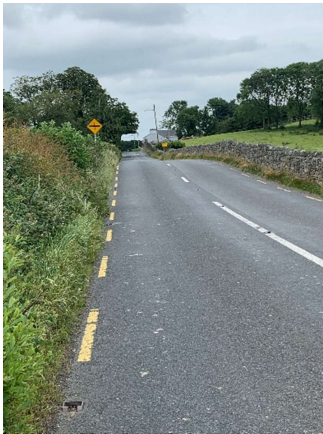
0.10-0.20	Pavement surface in good condition, slight surface deterioration	
0.20-0.30	Pavement surface in good condition, hump in road

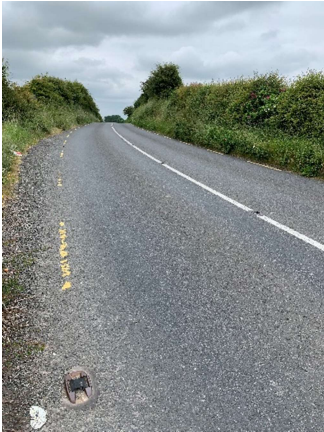
Chainage (km)	Condition Pavement Surface	Image
0.70-0.80	Pavement surface in good condition, slight fattening/ flushing parallel with centre line

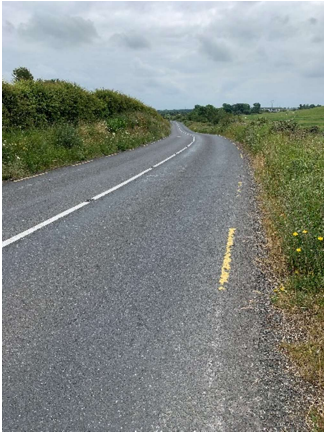
0.80-0.90	Pavement surface in good condition, slight fattening/ fretting parallel with yellow line

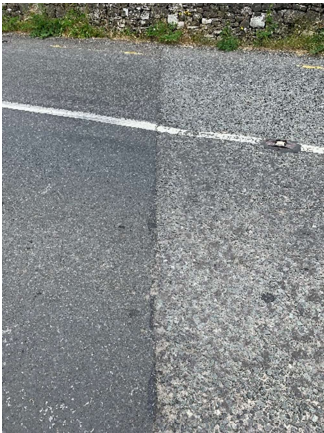
0.90-1.00 0.96	Pavement surface in good condition, slight surface deterioration on approach to bend Joint in Road – change in pavement surface

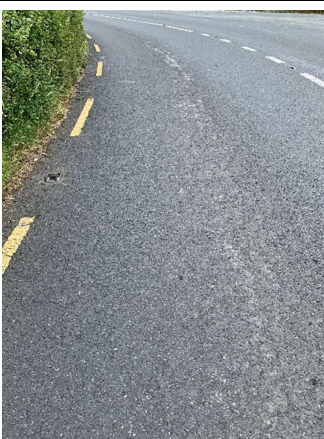
1.15	Joint in the road - change in pavement surface	
1.20-1.30	Pavement surface in good condition, slight surface deterioration	
1.30-1.40	Pavement surface in good condition, slight surface deterioration	
1.40-1.50	Pavement surface in good condition, slight surface deterioration	
1.50-1.60	Pavement surface in good condition, slight surface deterioration	
1.60-1.70	Pavement surface in good condition, slight surface deterioration	
1.70-1.80	Pavement surface in good condition, slight surface deterioration /rutting of surface

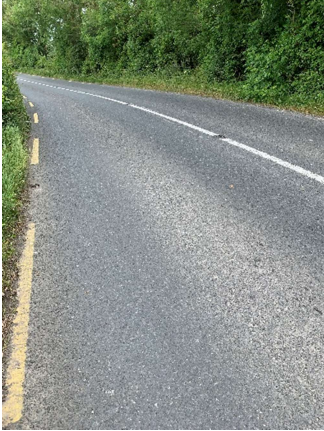
Chainage (km)	Condition Pavement Surface	Image
1.80-1.90	Pavement surface in good condition, surface deterioration at approach to bend

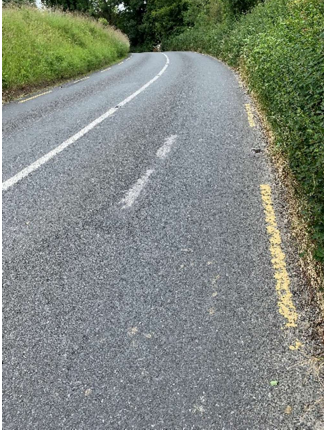
2.00-2.10	Pavement surface in good condition, slight surface deterioration

2.07	Localised increased surface deterioration	
2.10-2.20	Pavement surface in good condition, slight surface deterioration

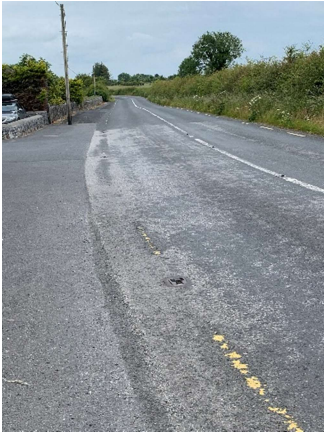
Chainage (km)	Condition Pavement Surface	Image
2.85-2.95	Extensive surface deterioration in front of Hodgins Architectural Glazing premises

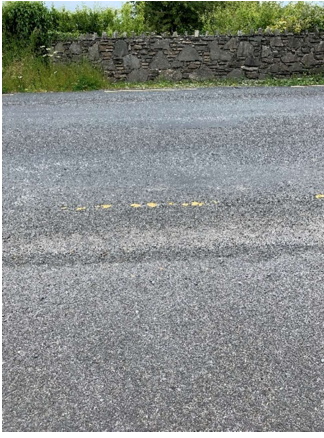
2.95-3.00	Pavement surface in good condition, slight surface deterioration

2.97	Small masonry bridge crossing – rutting of road & uneven pavement surface	
3.00-3.04	Pavement surface in good condition, slight surface deterioration	
3.03	Deterioration of road edge and pothole Property entrance southbound carriageway

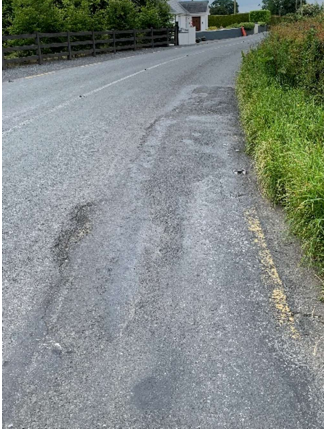
Chainage (km)	Condition Pavement Surface	Image
3.04-3.07	Patch repair, deterioration of road edge and uneven surface

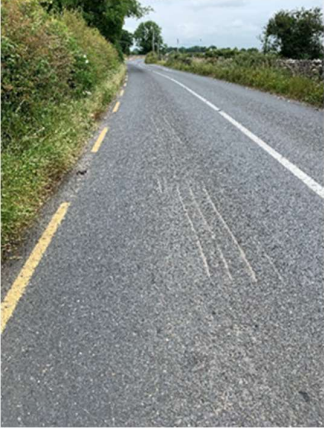
3.35-3.36	Scrape marks in the surfacing	
3.40-3.50	Pavement surface in good condition	
3.50-3.60	Pavement surface in good condition, slight surface deterioration	
3.60-3.70	Pavement surface in good condition	
3.70-3.80	Pavement surface in good condition, slight surface deterioration	
3.75	Scrape marks circa 1m long

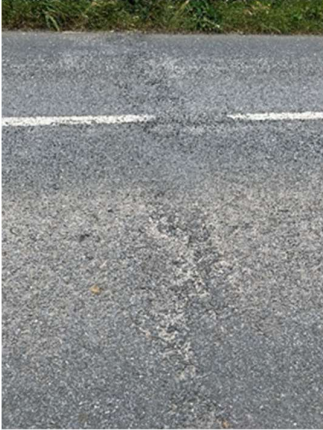
Chainage (km)	Condition Pavement Surface	Image
3.80-3.90	Pavement surface in good condition, slight surface deterioration

3.83	Slight deterioration in pavement surface across entire road	
3.90-4.00	Pavement surface in good condition, slight surface deterioration	
4.00-4.10	Pavement surface in good condition, slight surface deterioration	
4.10-4.20	Pavement surface in good condition, slight surface deterioration	
4.20-4.30	Wearing of surface opposite junction

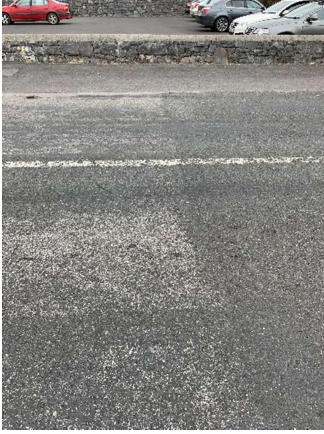
2.85-2.95	Extensive deterioration pavement surface in front of Hodgins Architectural Glazing premises

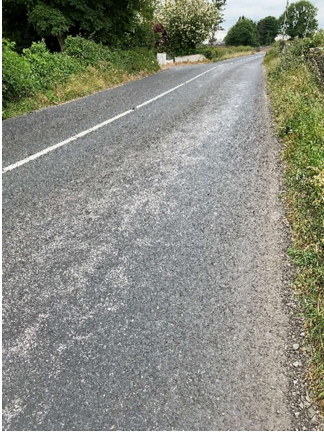
3.40-3.50 3.47-3.53	Pavement surface in reasonable condition Slightly more extensive surface deterioration

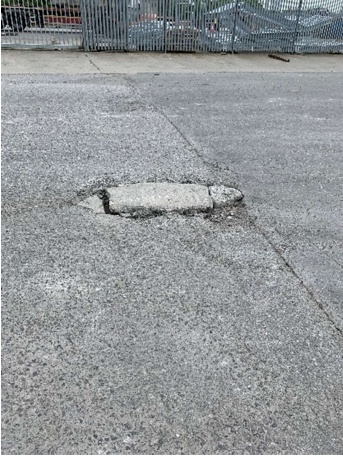
Chainage	Condition Pavement Surface	Image
0.00-0.01	Pavement surface in good condition	
0.01-0.20	Pavement surface in good condition	
0.20-entrance	Cracking and potholing around joint Surfacing appears to comprise a layer of asphalt / macadam over a concrete road surface

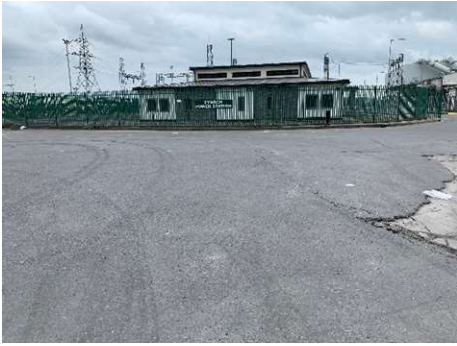
Edge surfacing ragged

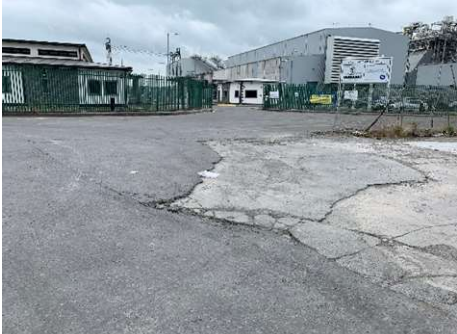
Edge surfacing ragged Surfacing appears to comprise a layer of asphalt / macadam over a concrete road surface
