Title: STAGE 1 ROAD SAFETY AUDIT

Office Innovation Campus, Moygaddy, Co. Meath.

Client: OCSC Consulting Engineers.

Report reference: 1388R01

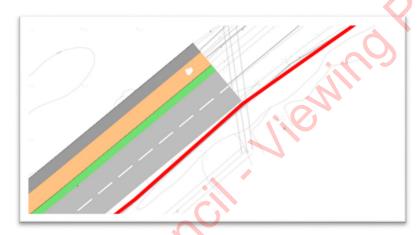
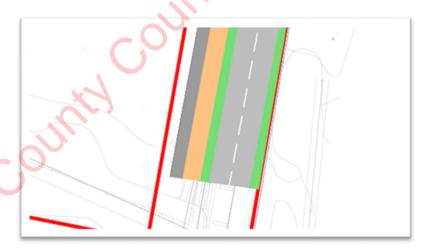
3.1 Problem

General Comment tie-in points

Details have not been provided of how the cycle track and footpaths will tie in at the scheme extents. Cyclists and pedestrians will have to cross the carriageway to access the facilities. Without suitable transitions from off road to on road and suitable crossing facilities there is a risk that pedestrians and cyclists will be struck by passing traffic.

It is recommended that suitable transitions and crossing facilities be provided.

3.1	Υ	Y	The proposed cycle lane along the R157 eastern arm will be updated to tie into the carriageway. A suitable Jug turn will be provided on the opposite side of the road to accommodate the cyclists' right turning movement towards the development	Yes

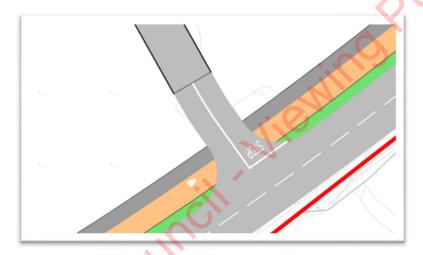
3.2 Problem

Drawing S665- OCSC-1A-MH-DR-C-0111 S2 P01 Sheet 2 of 3, cycle track across campus access road.

The proposed two way cycle track crosses the mouth of the campus access road. There is a risk that drivers exiting the campus may not expect two way cyclists as they approach the stop line.

It is recommended that a 'bend out crossing' be provided.

3.2	Y	N	It is proposed to provide a shared space and tactile for crossing before the cyclist and pedestrians approach the junction. A raised crossing will be provided to indicate priority for pedestrians and cyclists.	Yes

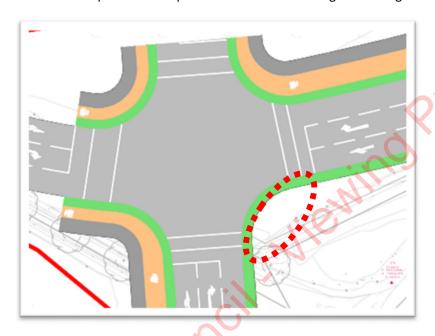
3.4 Problem

Drawing S665- OCSC-1A-MH-DR-C-0111 S2 P01 Sheet 2 of 3, campus access road.

There is a signalised pedestrian crossing of the R157 eastern section, however there is no footpath on that side. This could lead to slips and falls if pedestrians cross into the grassed verge.

It is recommended that a section of footpath be provided linking the north-south and east west pedestrian crossing areas. The crossing should be retained to be able to cater for potential future development.

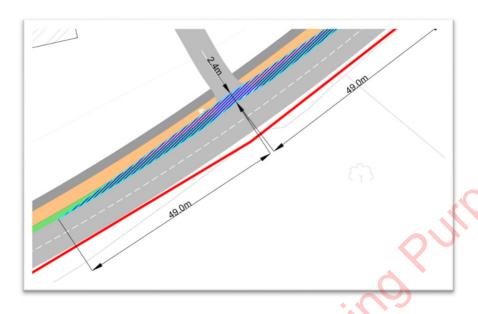
3.5 Problem

Drawing S665- OCSC-1A-MH-DR-C-0115 S2 P01, Visibility Splay at Campus junction.

The visibility splay is shown for a 50km/hr urban design speed. The posted speed is 80km/hr. There may be insufficient visibility to oncoming vehicles leading to side-impact or rear-end collisions.

It is recommended that visibility splays be provided to match the anticipated 85th percentile speed post opening.

3.5	N	N	The visibility splay is achieved for 50kph. The speed limited will be lowered to 50kph once the new	Yes

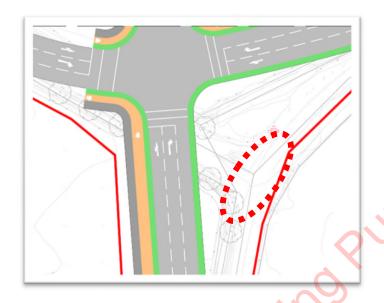
3.6 Problem

Drawing S665- OCSC-1A-MH-DR-C-0111 S2 P01 Sheet 2 of 3, Carton Estate gate.

There is an existing gate into the Carton estate close to the proposed signalised junction. It is unclear if this gate will be used in the future. If it is to be used movements into and out of it may lead to collisions at the junction.

It is recommended that the accommodation works relating to this gate be included in the design process.

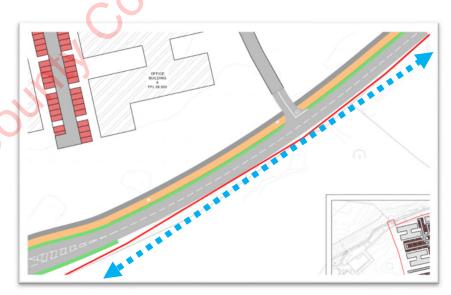
3.7 Problem

Drawing S665- OCSC-1A-MH-DR-C-0111 S2 P01 Sheet 2 of 3, Carton Estate boundary wall.

The realigned R157 eastern arm is very close to the stone wall of the Carton Estate. This is a hazard for an errant vehicle.

It is recommended that a suitable Clear Zone be provided between the boundary wall and the realigned carriageway.
