## INCHAMORE WIND FARM, CO. CORK

### **VOLUME IV APPENDICES**

## Inchamore Wind Farm, Co. Cork

Chapter 15 – Traffic & Transportation

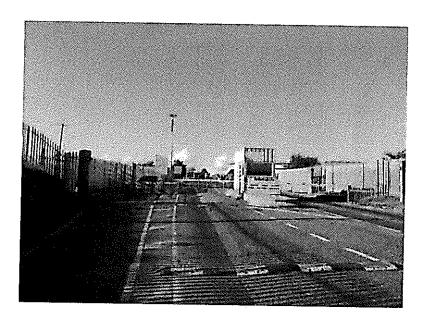
Location 1 - Port Exit

Visual inspection indicates that the
Loaded blade is required to
Contraflow the security gate house.

Swept path analysis recommended
to confirm.

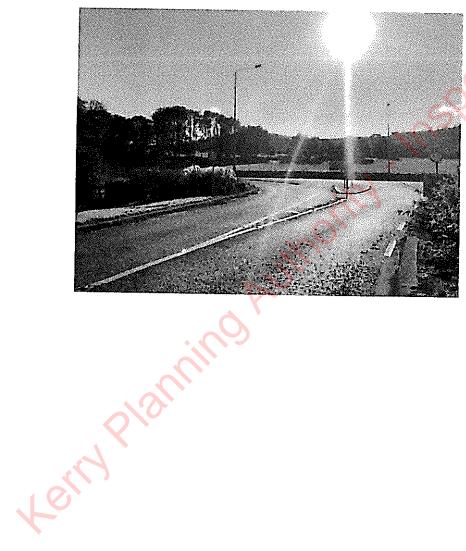
Location 2 - Exit From Port Of Foynes/N16 Junction

Direction Turn Left Onto N69 Visual inspection indicates that third party land will be required on the nearside. Modifications to street furniture will be required Walls and hedges to be removed. Swept path analysis recommended to confirm.

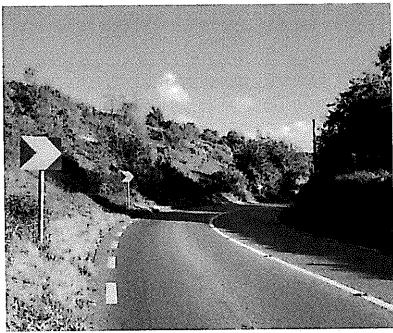
Direction Continue On N69 Option 1-Visual inspection indicates loaded blade will oversail third party land on nearside. Wall on nearside may be required to be removed.

Option 2 - Road signs, hedges and possible telegraph pole required to be removed offside to allow rear projection of blade to oversail. Swept path analysis recommended to confirm

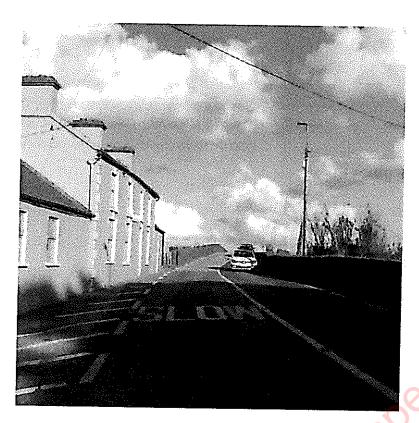
Location 5 - N69 Ferry Bridge
Direction Continue On N69
Visual inspection indicates that this
bridge is to be assessed both vertically
and horizontally Using Swept path
analysis and vertical analysis

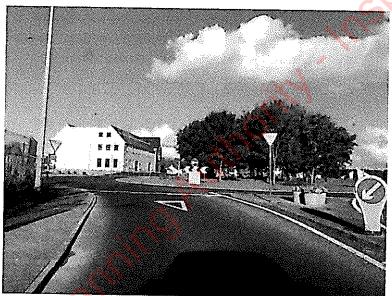
Location 6 - N69 Roundabout At Clarina

Direction Continue Straight On N69
Visual inspection indicates that
widening is required on the on
central island of roundabout and
street furniture to be removed at
this location. This is to avoid third
party land. Swept path analysis
recommended to confirm
modifications

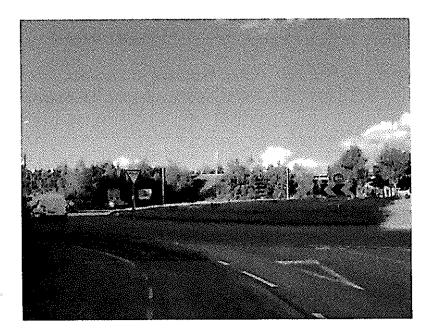
Location 7 - N69/N18 Roundabout Direction Turn Left Onto N18

Visual inspection indicates that road widening on central island is required. Road signs on central island also to be removed Swept path analysis recommended to confirm

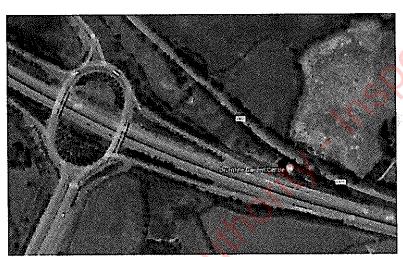
Location 8 - N18/N19 Roundabout Direction Circumnavigate Roundabout To Rejoin N18 Visual inspection indicates that modifiactions to street furniture will be required. Swept path analysis required to determine the extend of the modifications

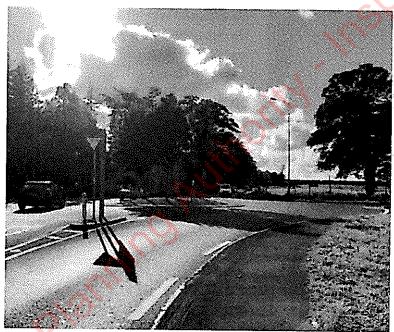
Location 10 - N21 L1420 L1424
Roundabout
Direction Continue Straight On N21
Visual inspection indicates Road
widening required on offside of
entering and exit of the roundabout
Swept path analysis recommended to
confirm this

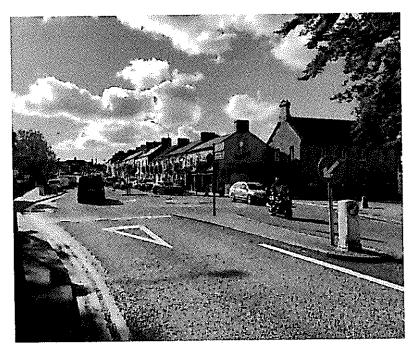
Location 12 - Splitter Island Before Left Bend On Adare

Visual inspection indicates that street furniture on splitter island is to be removed due to left hand bend afterwards. Topographical survey is required throughougt Adare to ascertain accurate mapping data

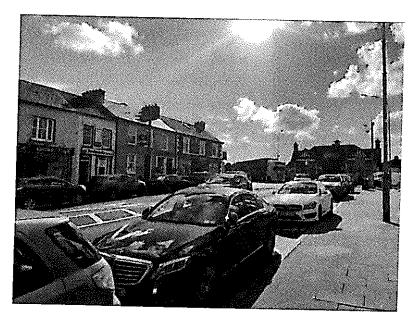
Location 13 - Left Bend On N21 At
Junction With L1422 In Adare
Direction Continue On N21
Parking restrictions on both side of the
road Lamp posts and road signs
required to be removed Topographical
survey is required throughougt Adare
to ascertain accurate mapping data

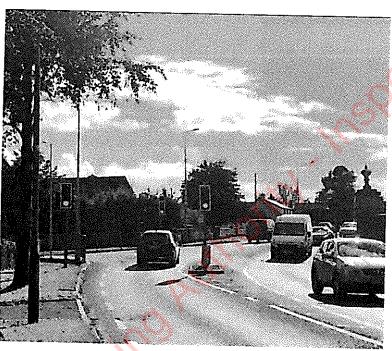
Location 14 - N21 Splitter Island And Right Bend At Rathkeale Road Junction

Direction Continue On N21 Visual inspection indicates that a contraflow manoeuvre will be required at this location as well as use of manual steering.

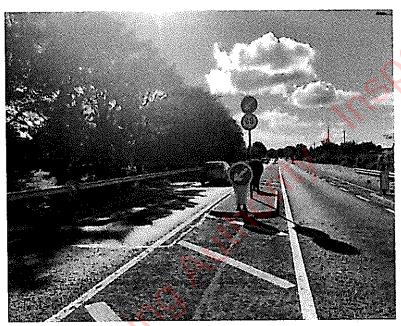
Location 16 - 8x Splitter Island On N21 In Croagh

Direction Continue On N21 Visual inspection indicates that road signs on all splitter islands to be removed as a precaution These road signs are removable \*Note\* 4.3m from nearside Kerb to road sign 4.7m from nearside bollard to sign

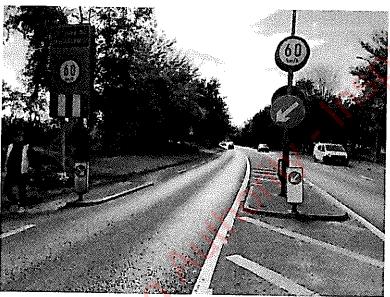
Location 18 - N21 Splitter Island At Entry To Newcastle West Direction Continue On N21 Visual inspection indicates that the

removable road sign may be required to be removed. \*Note\*

4.1m from nearside Splitter Kerb to road signs on lamppost. 4.5m to lamppost

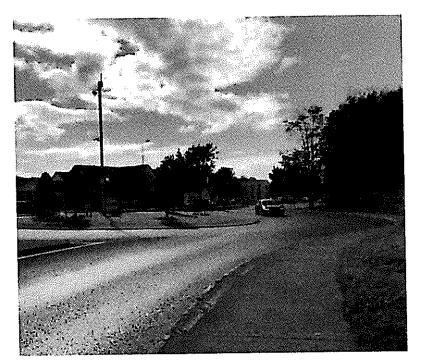
Location 19 - N21/R522
Roundabout In Newcastle West
Direction Continue Straight On N21
Visual inspection indicates that a
contraflow manoeuvre is required at
this location

Loaded vehicle to run on hard standing area of roundabout Tree and road sign on offside of exit are to be removed Swept path analysis required to determine extend of modifications

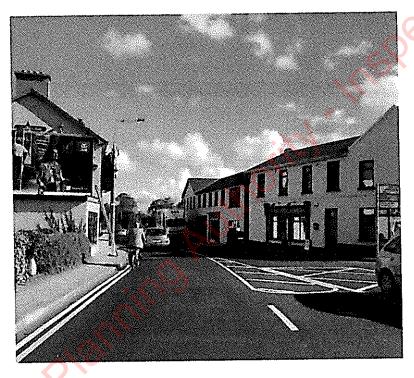
Location 20 - Newcastle West Centre

Topographical survey is required throughougt Newcastle west to ascertain accurate mapping data \*note\* photo in reverse view

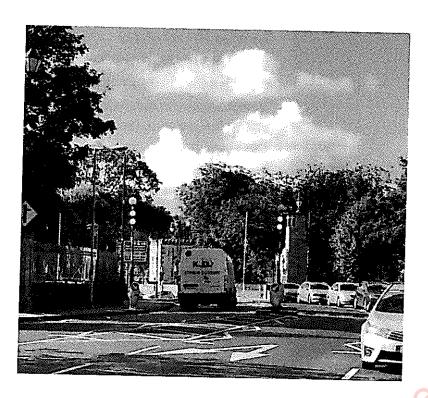
Location 21- Splitter islands On Left Bend In Newcastle West. Direction Continue On N21 Visual inspection indicates that street furniture on splitter island as well as

Visual inspection indicates that street furniture on splitter island as well as the next to be removed due to blade and trailer oversail Swept path analysis recommended to determine the extent of the modifications

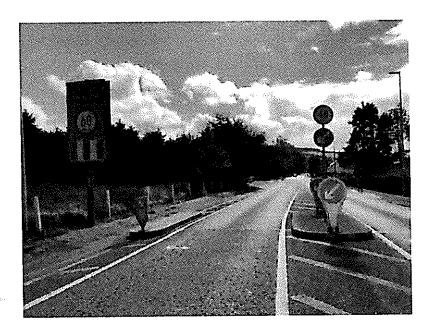
Location 23 - N21 Splutter Island
At Entry To Templeglantine
Direction Continue On N21 Visual
inspection indicates that removable
road sign is to be removed on splitter
island due to blade cord

Nearside kerb to road sign is 4.3m

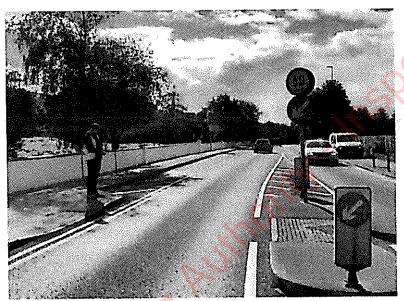
Location 24 - 4x Splitter Island On N21 At Templeglantine
Direction Continue On N21 Visual inspection indicates that loaded vehicle to contraflow splitter islands 1-3 to avoid modifications. Splitter

island 4 poses no issues

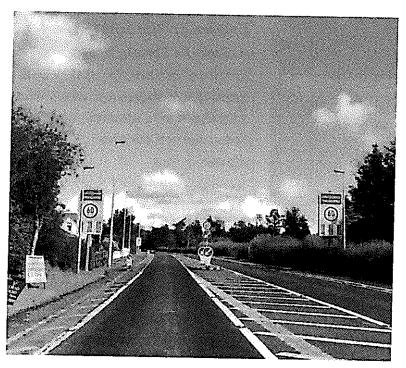
# Location 25 - N21 Splitter Island At Exit From Templeglantine

Direction Continue On N21 Visual inspection indicates that road signs to be removed on splitter island due to blade chord. Road sign is removable - once a manufacturer has been chosen this should be revisited

\*Note\* Width measured at 4.1m from nearside kerb to road sign on splitter island.

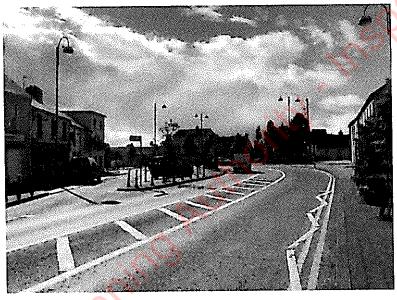
Location 28 - Left Bend On N21 In Abbeyfeale

Direction Continue On N21 Visual inspection indicates that trees, road signs lamp posts are required to be removed. Parking restriction will be required throughout Abbeyfeale to allow loaded blade to utilise the full width of the road. Topographical survey is required throughout Abbeyfeale to ascertain accurate mapping data Swept path analysis required to confirm modifications

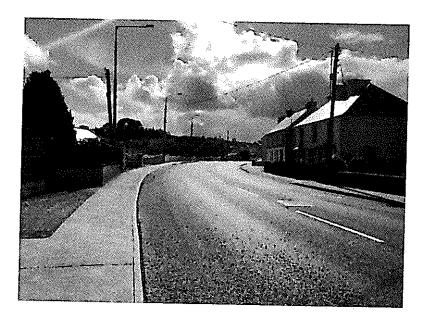
Location 29 - Right Bend In Abbeyfeale

Direction Continue On N21 Visual inspection indicates that loaded blade will require manual steering at this bed.

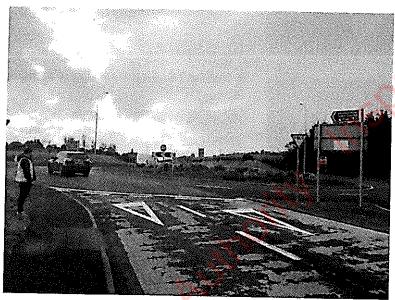
Location 30 - N21/L2041 Roundabout

Direction Continue On N21 Visual inspection indicates that widening and street furniture removal is required on central island. Swept path analysis recommended to confirm modifications

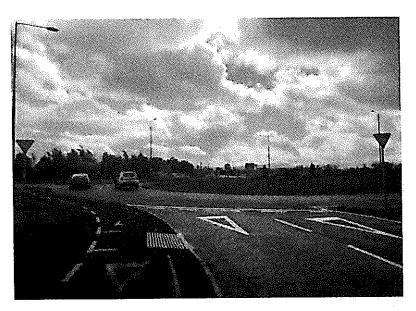
## Location 31 - N21 R577 N23 Roundabout

Direction Straight Onto N23 Visual inspection indicates that widening and street furniture removal is required on central island. Swept path analysis recommended to determine the extent of the modifications

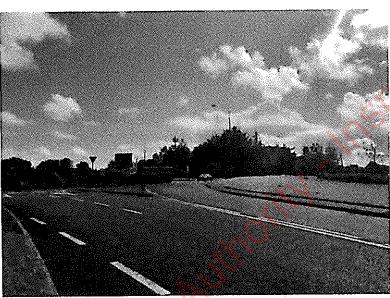
# Location 32 - N23/L2040

Direction Turn Right Onto N23
Visual inspection indicates that road widening and lamp post removal is required on the offside of the roundabout. Loaded blade is required to contraflow this roundabout. Swept path analysis recommended to confirm

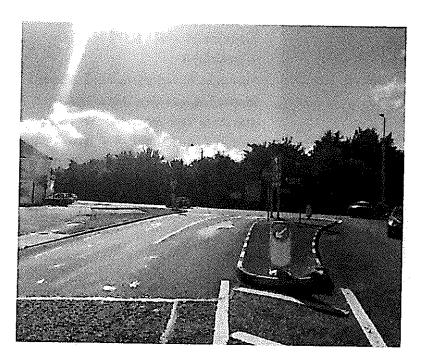
Location 33 - N23 / N22 Junction Direction Turn Left Onto N22 Visual inspection indicates that third party land is required on the nearside of the junction. Stop sign on nearside to be removed

Swept path analysis recommended to confirm modifications

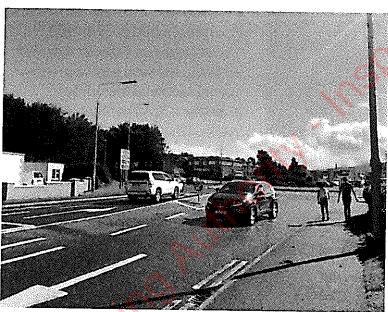
# Location 34 - N22/N71 Cleeny Roundabout

Direction Left Onto N22 Visual inspection indicates that widening and lamp posts, traffic lights and road sign removal is required. Street furniture on both the entry and exit splitter islands is to be cleared to allow blade and trailer to oversail.

Rear projection of blade will oversail 3rd party land on offside of entrance to roundabout Swept path analysis recommended to confirm this.

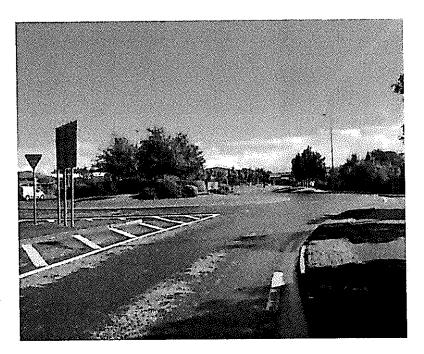
Location 35 - Micheal D'Oshea
Roundabout
Direction Continue On N22 Visual
inspection indicates that a contraflow
manoeuvre is required at this
roundabout. Blade vehicles to run on
central island hard standing

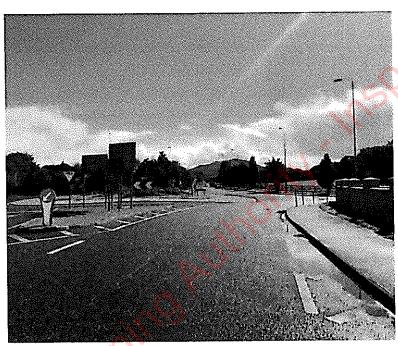
Location 40 - N22/N72 Roundabout

Visual inspection indicates that a Contraflow manoeuvre is required to allow navigation Swept path analysis recommended to confirm
