**APPENDIX 13.1:**

**AI BRIDGES TELECOMMUNICATIONS IMPACT STUDY**

## Inchamore Wind Farm Telecommunications Impact Study

Gortyrhilly, Inchamore and Cummeennabudoge (CMDC)  
Wind Farms  
Civil & Structural Due Diligence Report

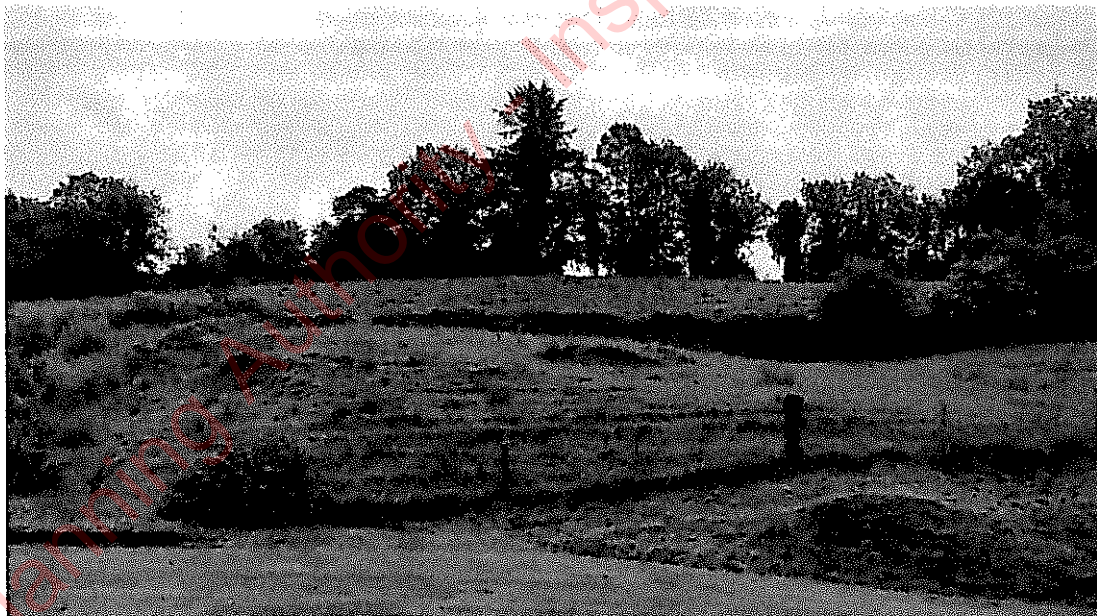
The existing topography to the south of Baile Bhuirne includes steep slopes (greater than 30°) sloping east to west/southeast to northwest (waypoints B-C). Some scarping of the steep slopes was noted on site as shown in Figure 6-2, although rock outcrops were noted in adjacent slopes and ditches, suggesting rock is likely shallow in the area. The vertical gradient of the road south of Baile Bhuirne (waypoints A-B-C) was observed to be generally acceptable. The cross slopes along the route to the north of Baile Bhuirne (waypoints C-D-E) are typically lesser than those to the south, however, the vertical gradients are typically greater in this section. The existing boreens have historically been levelled by constructing embankments along the cross slopes between waypoints C, D and E.

Figure 6-2: Evidence of overburden slope scarping along route A

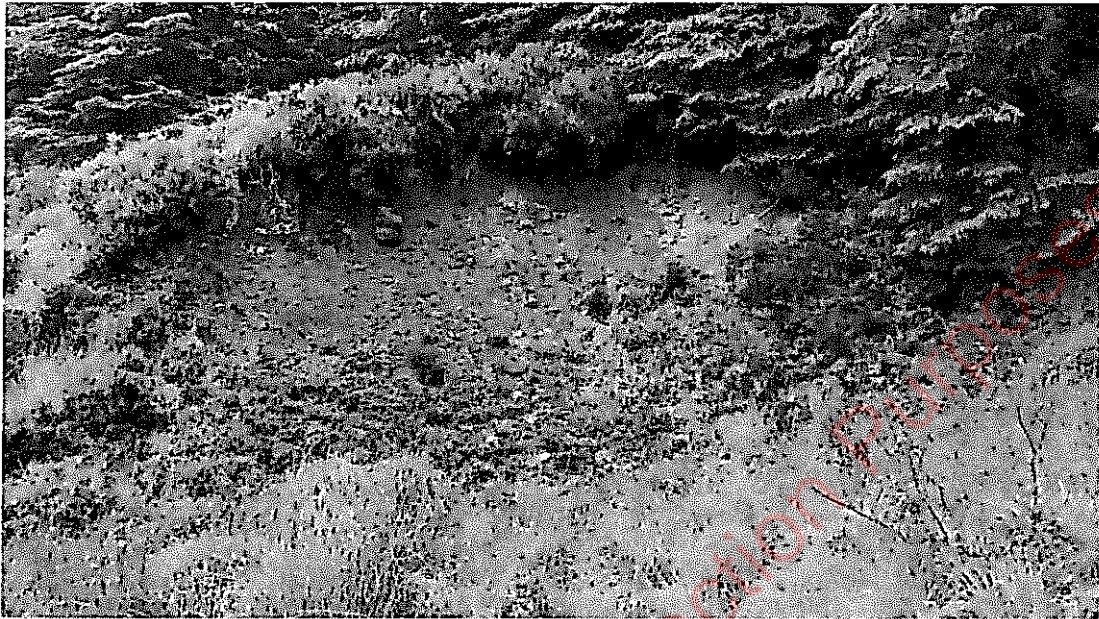
Figure 6-4: Exposed overburden cut with evidence of erosion/shallow slips (ITM 515852E, 582740N)

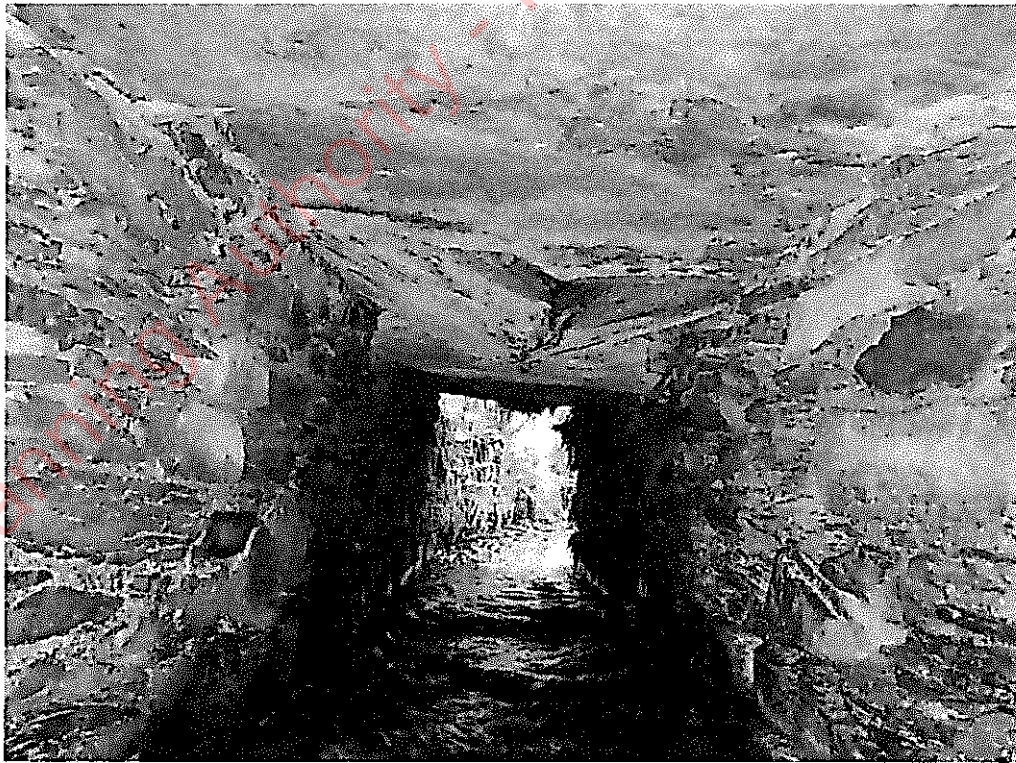
**Item 16 - Kiln.**

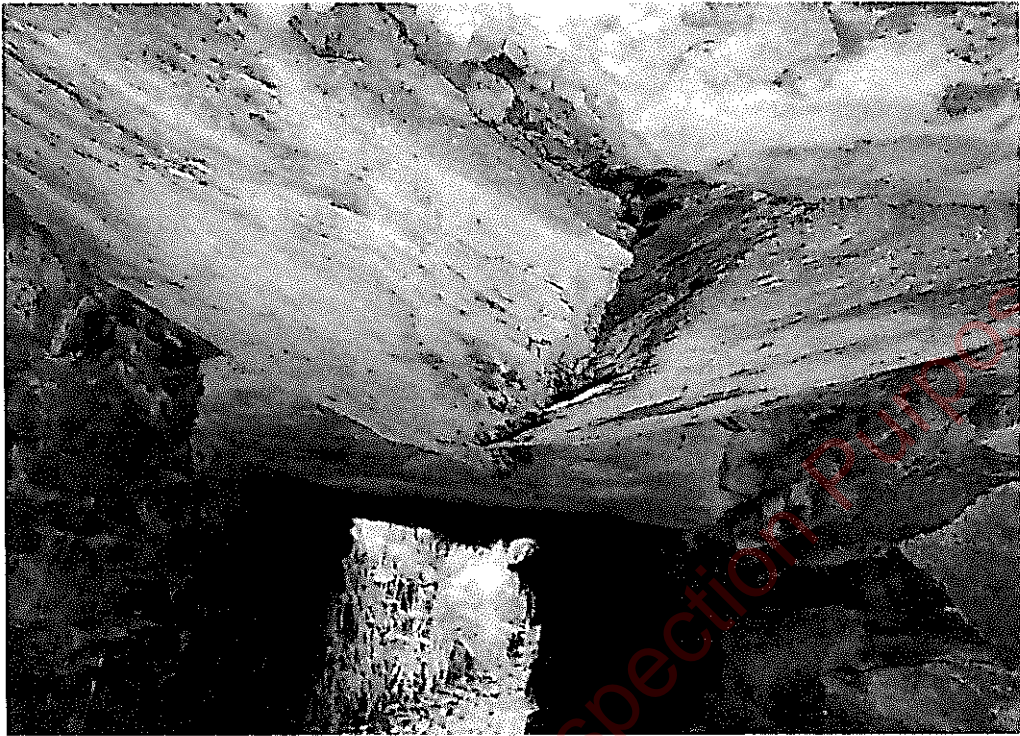
**Class:** Kiln - lime

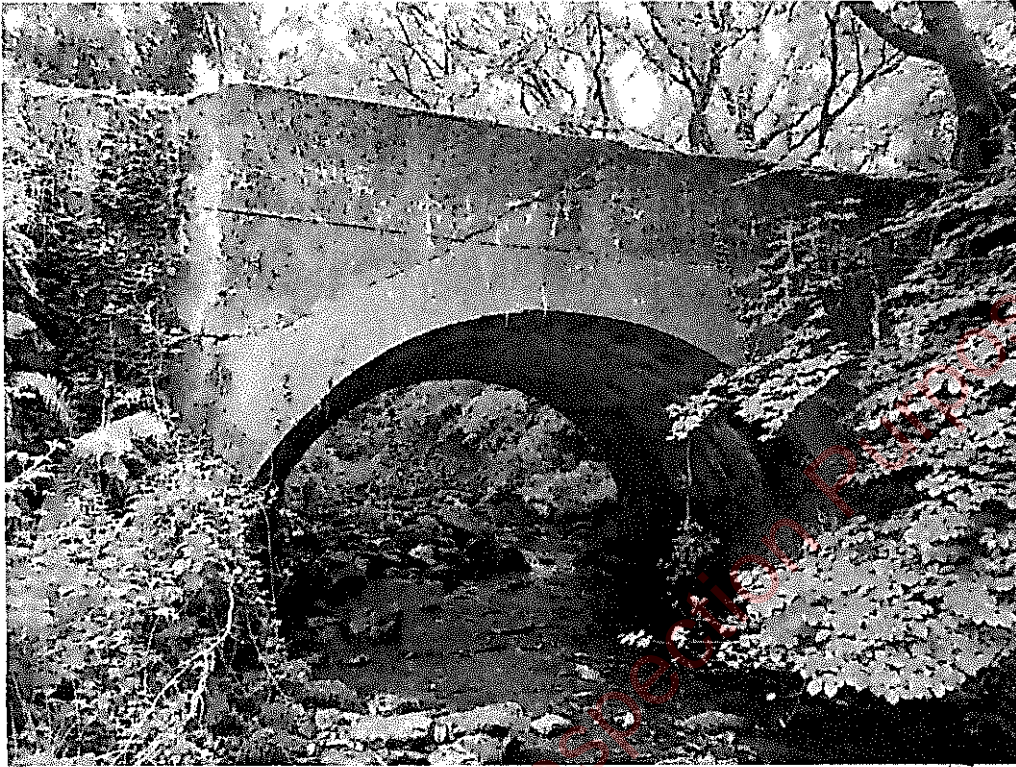
Both the Sullane and Foherish Rivers contain populations of the Annex II freshwater pearl mussel. The Route A bridge crossing at Ballyvourney bridge is also located on a stretch of the Sullane with known populations of freshwater pearl mussel albeit in low numbers. Specific pollution controls will be required here to ensure the fresh water pearl mussel are not impacted by works on the bridge or nearby road works when constructing the grid connection route. There were no freshwater pearl mussel recorded in the Bohill River (RPS, 2014) where the majority of crossings along Route A occur however a relatively high density of freshwater pearl mussel was recorded just downstream of the Bohill Stream confluence (Section 8) with the Sullane therefore works in and around watercourses will need to ensure adequate control measures are in place of sufficient standard to prevent any impact on the freshwater pearl mussel downstream of the confluence of the Bohill and Sullane rivers. Avoidance of instream works where possible and pollution control will be required at all stream, river and drainage ditch crossings, in particular where linked to the Sullane and Foherish Rivers due to the presence of freshwater pearl mussel populations. Detailed and potentially species-specific surveys will be required for aquatic fauna in order to inform specific mitigation measures (if required).

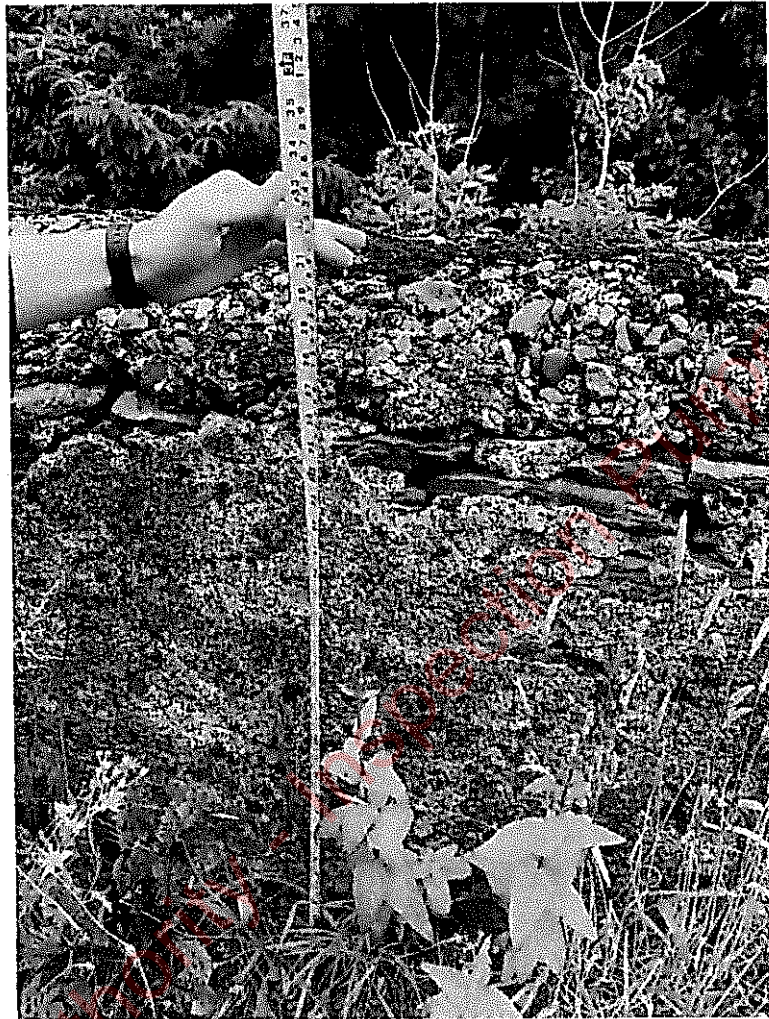
Parapet with concrete coping and repairs, open joints in exposed masonry

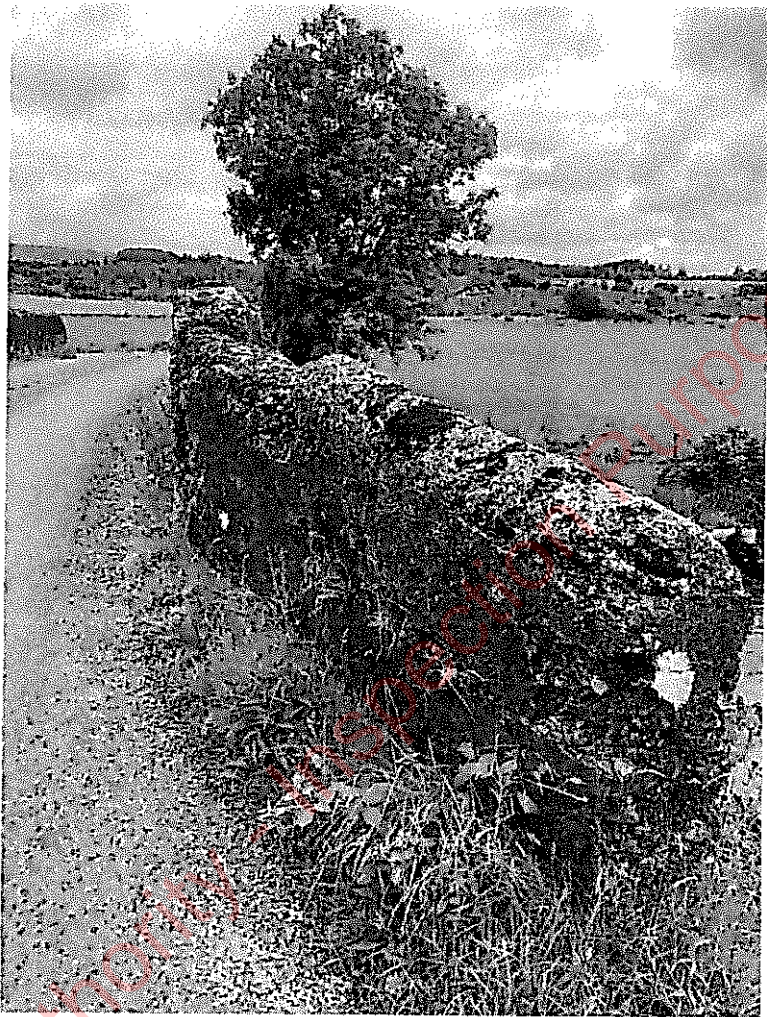
Close up of parapet showing concrete damage

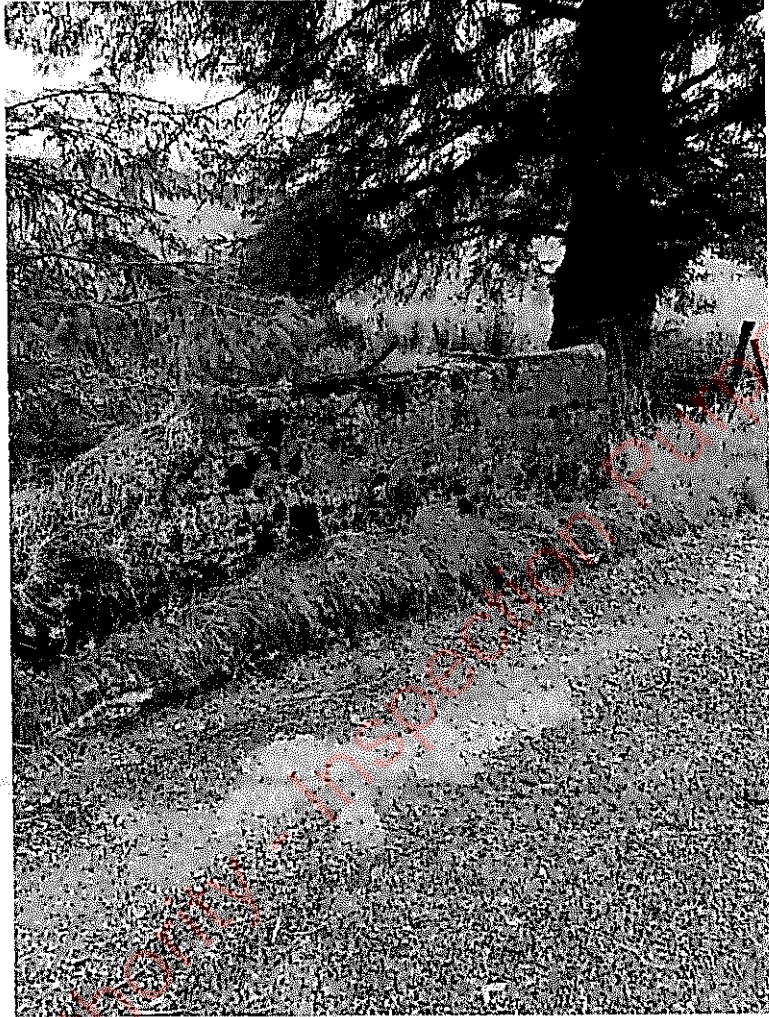
Upstream parapet with knocked section and structural cracking

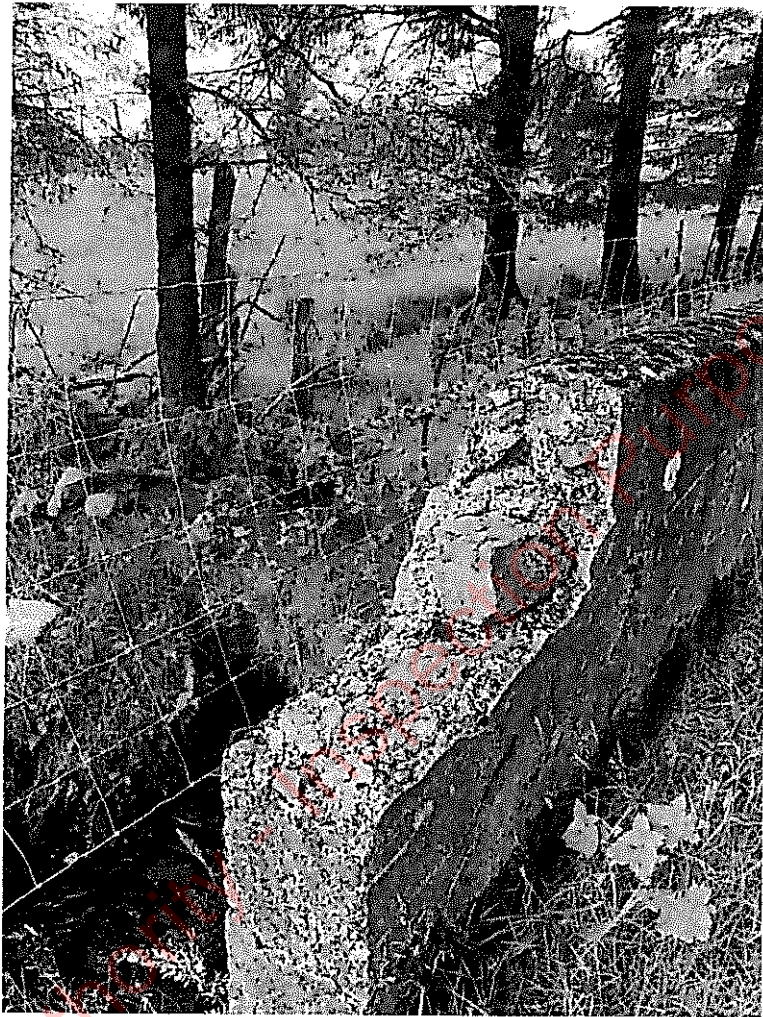
Knocked section of the downstream parapet
