APPENDIX A7.2.9

BUILDING A

MILLTOWN PARK HOUSE – INTERNAL IMAGES

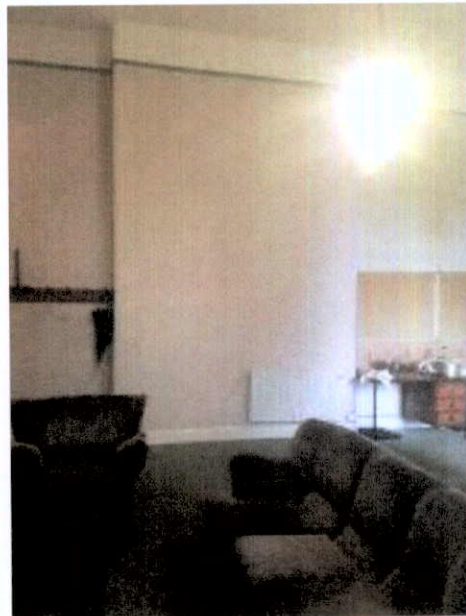
Plate 99: Historical features such as decorative plasterwork and fireplace removed.

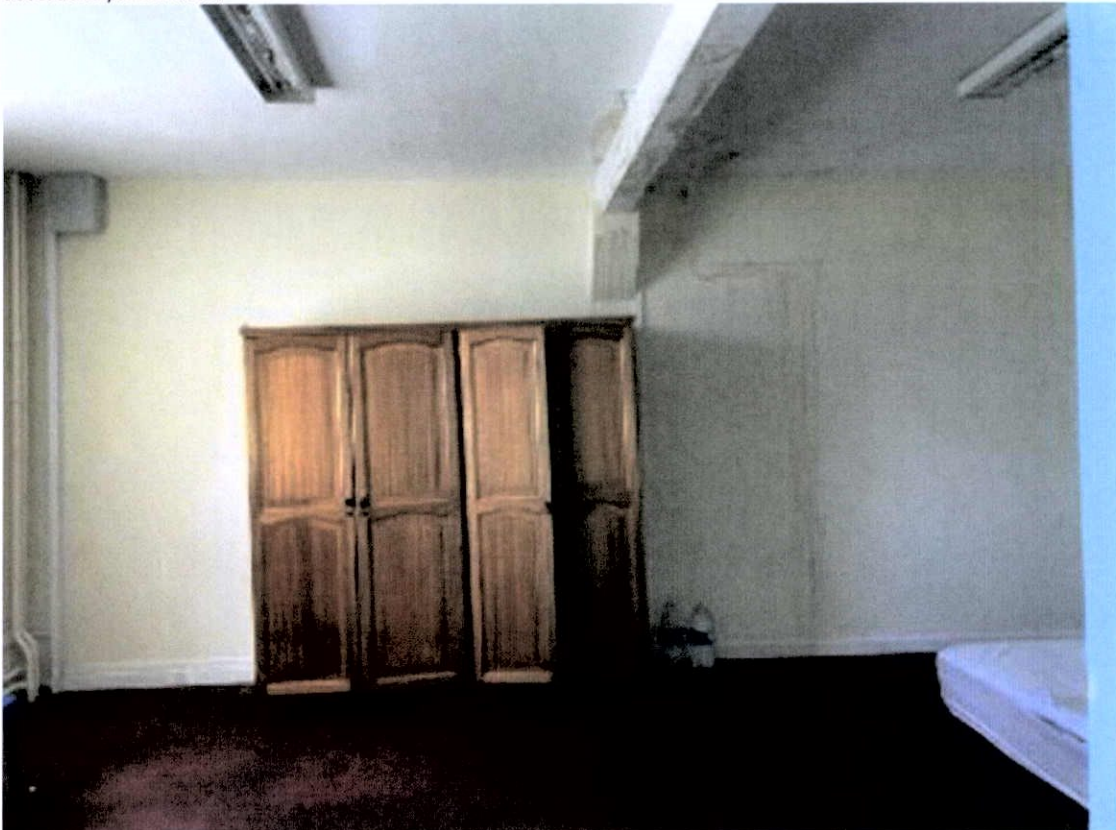
Plate 116: Amalgamated room, with beam supporting structure on level over. Evidence of water ingress. Exposed services. No chimneypiece or historic plasterwork.

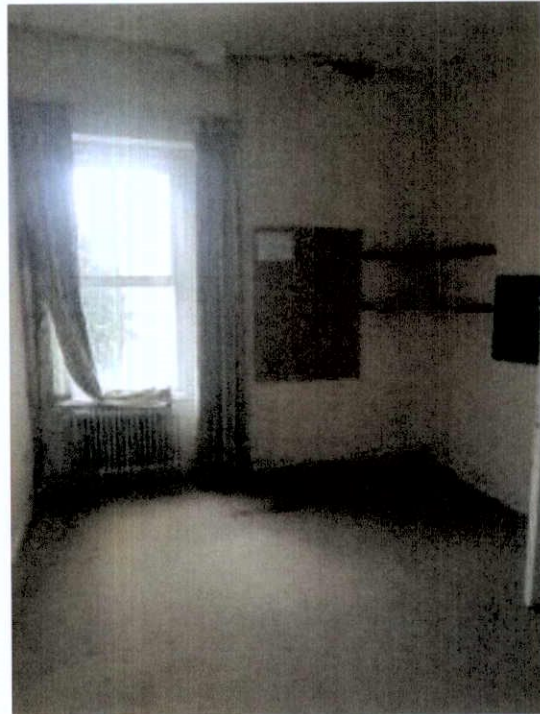
Plate 126: Sample room within vertical extension above main house. Note water ingress from breaches at roof level

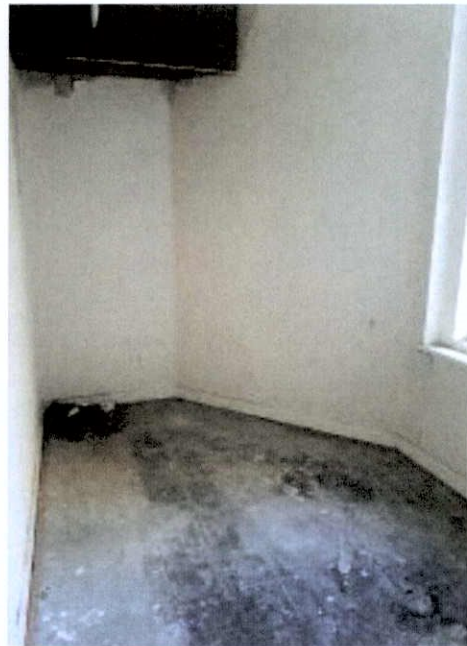
Plate 141: Small room with partitioned wall showing signs of water damage

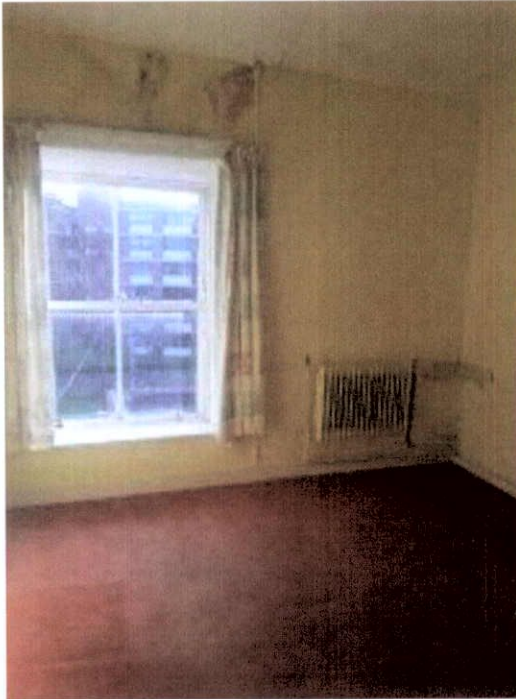
Plate 177: 2nd floor level typical study room to front (east) on first floor with signs of water damage

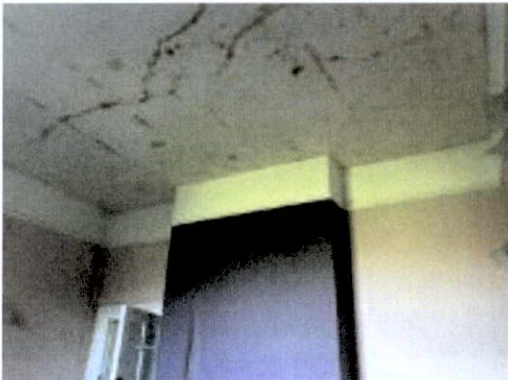
Plate 195: Evidence of water damage to ceiling fabric.

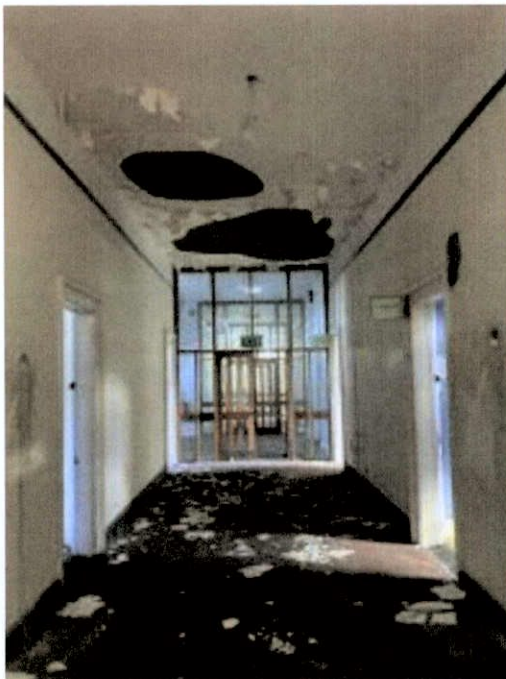
Plate 205: Entrance level corridor with later cross-corridor fire screens. Water ingress damage to ceiling fabric.

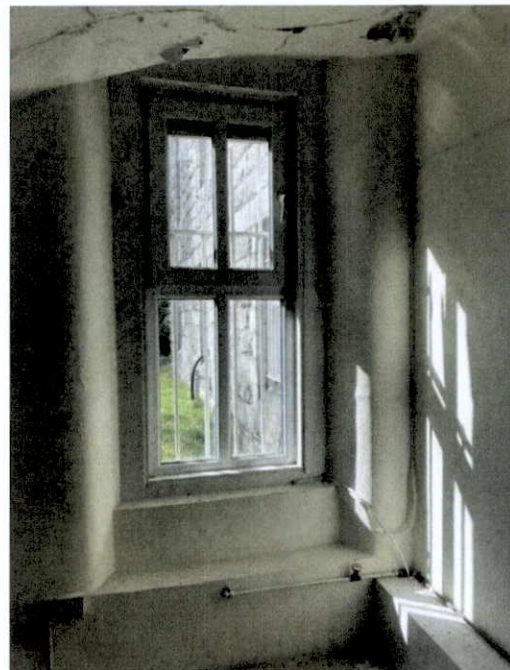
Plate 236: Contemporary uPVC window on lower ground floor. Beneath main entrance. Note deterioration of ceiling fabric indicative of water ingress through exterior steps.

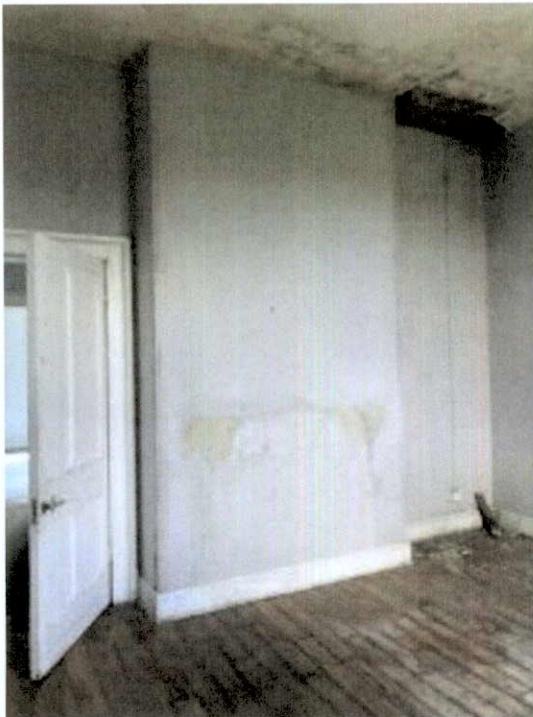
Plate 253: Chimneybreast with chimney piece removed. Evidence of water damage to ceilings and walls.

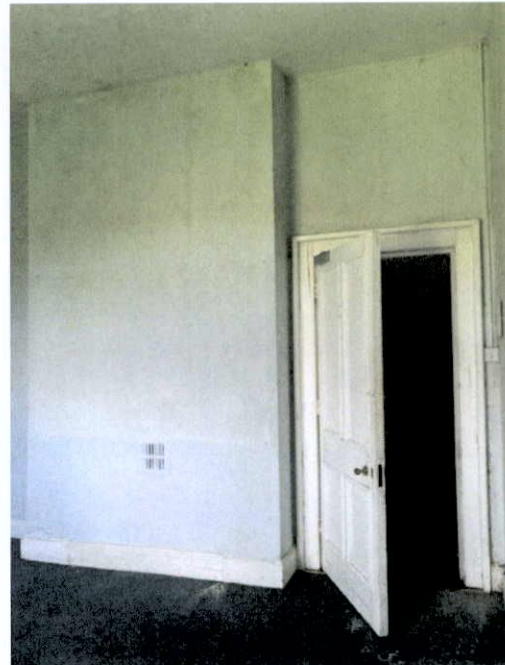
Plate 266: No chimney piece. Original joinery. Staining of ceiling suggestive of water ingress.

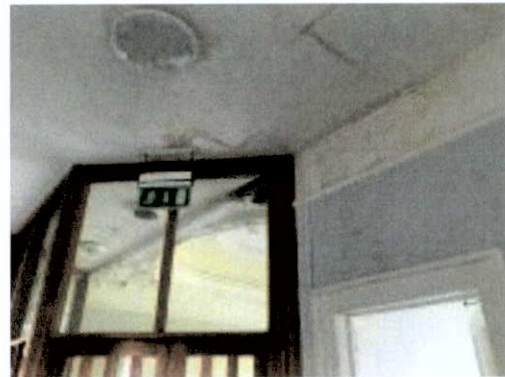
Plate 268: Water ingress damage from roof impacting second floor corridor ceiling

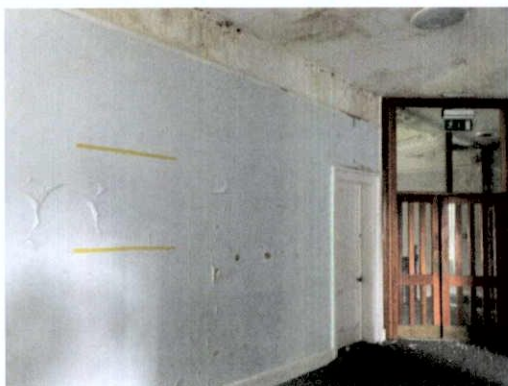
Plate 269: Central spine corridor with water staining evident to ceiling.

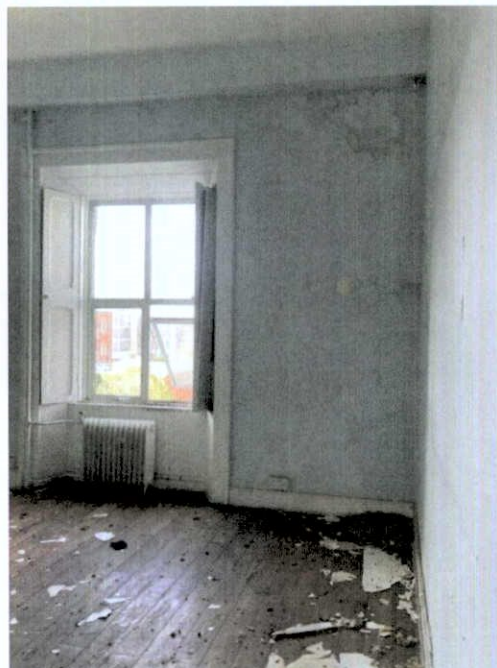
Plate 270: Damage to ceiling and wall fabric due to water ingress.

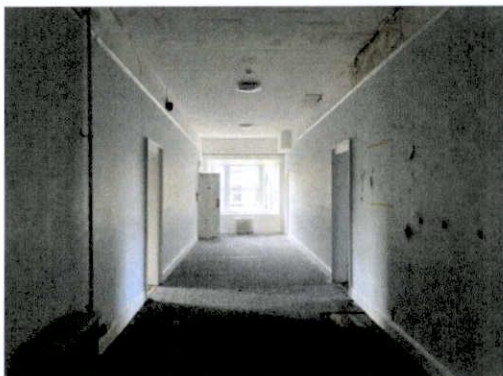
Plate 275: Central spine corridor. Original timber floor under carpet finish. Staining to ceiling evident.

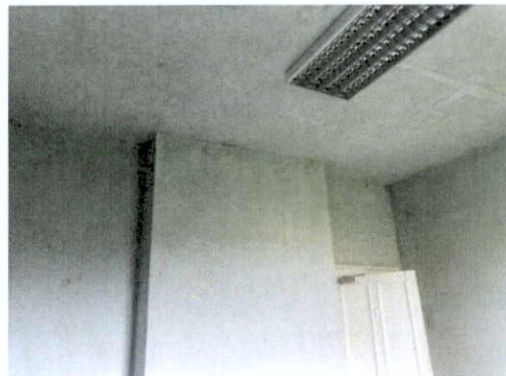
Plate 276: Mould growth evident on wall and ceiling surfaces.

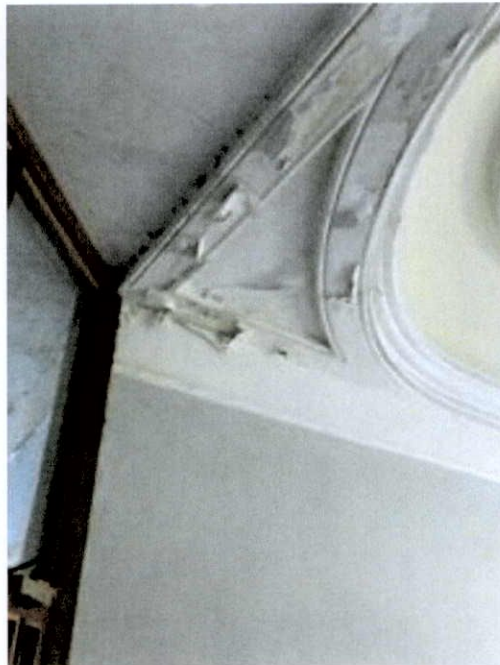
Plate 192: Flaking paint and staining of ceiling due to water ingress.

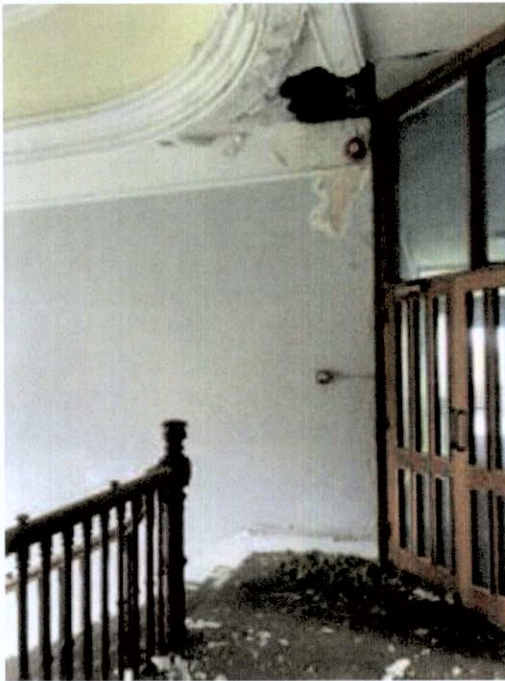
Plate 191: Damage to ceiling above main stairwell.

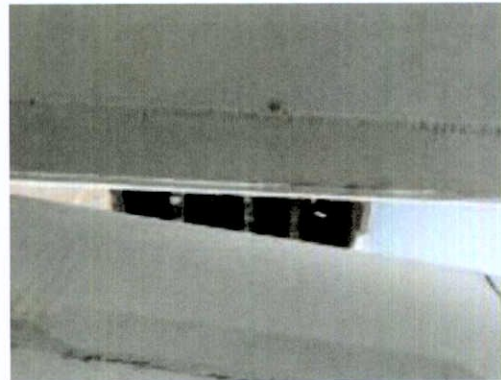
Plate 192: Breach in second floor ceiling with roof space exposed.

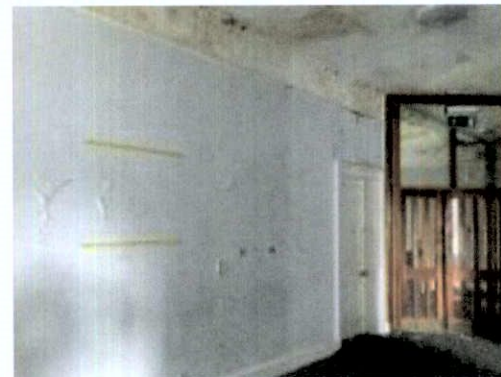
Plate 292: Central spine corridor with water damage evident on ceiling and top of walls.

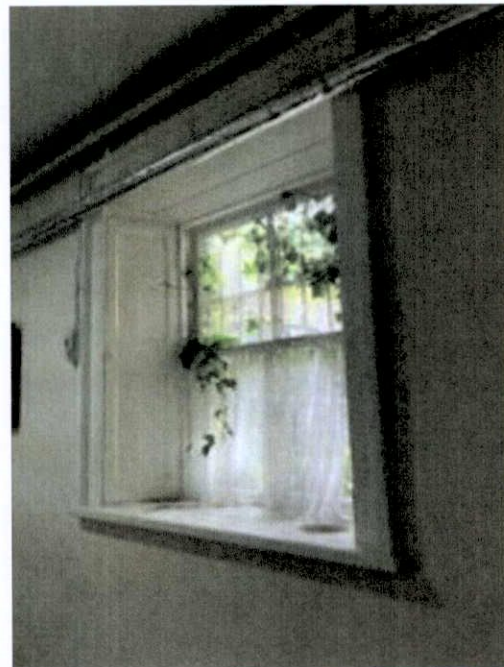
Plate 308: Detail of lower ground floor sash window and panelled shutters. Overgrown vegetation resulting in deterioration of fabric.
