Chapter 08

Landscape and Visual

Appendix 8.1

Arboricultural Impact Assessment

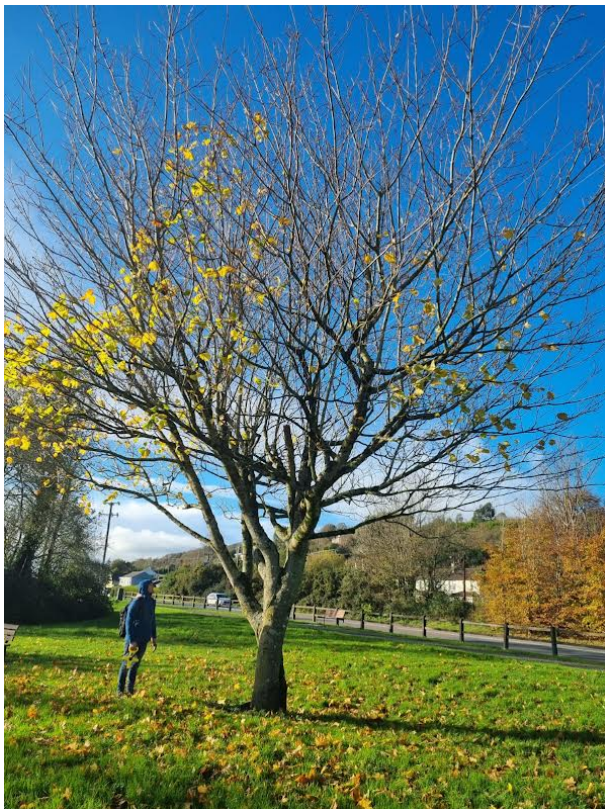
- II. These trees have suffered damage characteristic to trees located in public parks; including strimmer/mower damage above the root collar and soil compaction. These trees have predominantly Moderate to High retention values (87%), with life expectancies of over 40 years.

Fig.3 Example of Site A's decurrent deciduous parkland trees

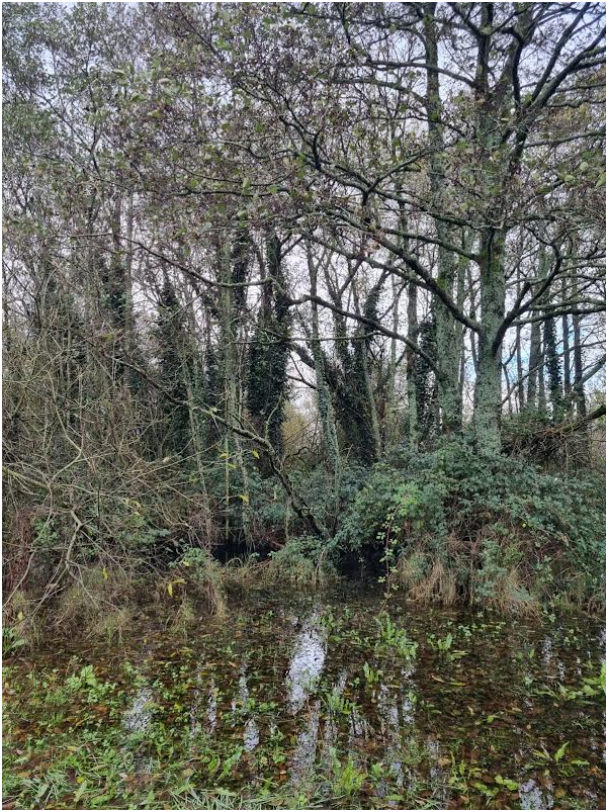
- V. The two (2) protruding water-logged wetland areas on Site A (see *Fig.2*) are surrounded/populated by alder and grey willow boscage (see *fig.5*). The grey willows have partially submerged trunks (see *fig.6*) sending up numerous vertical stems into the canopies. The field layers beneath the grey willow boscage were unable to be identified due to the submerged conditions, however characteristically dominant bramble and ivy were observable.

Fig.5 One of Site A's protruding wetland areas

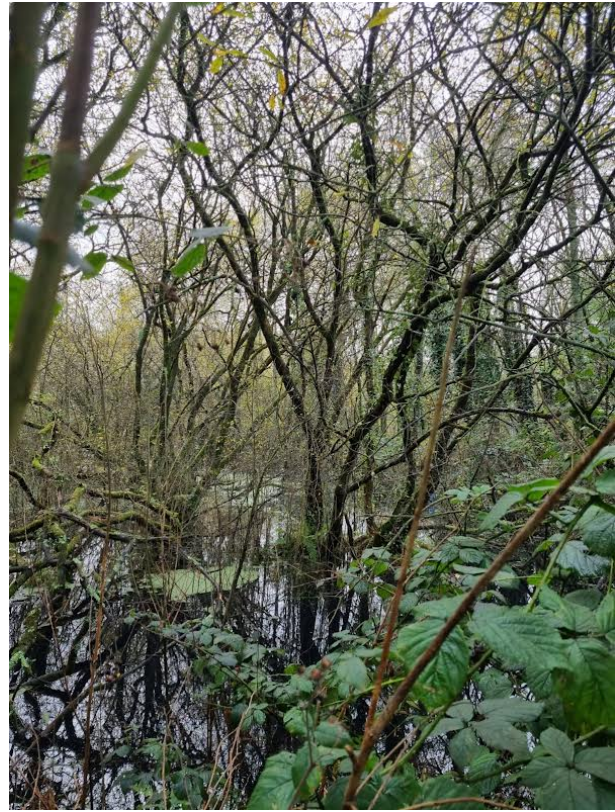
Fig.6 Example of Site A's grey-willow boscaige with partially submerged trunks

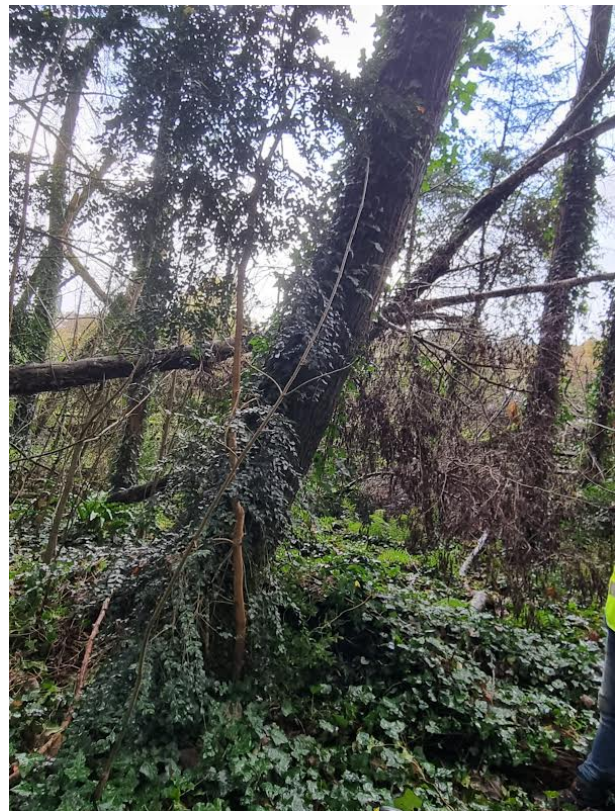
- III. Despite being planted, there appears to have been no woodland management in this area. Although woodlands are non-static entities that can usually be left without interference, the overall structure and composition of this woodland is poor; with 21% of the woodland classified as dead and/or hazardous (Byrnes, 2007b.) These trees have severe structural defects that are not remediable such that their failure is expected within 12 months (see fig.8). Only 2 alders (T713 and T714) have been categorised as high quality trees.

Fig.8 Example of spruce x poplar x alder woodland with 21% of trees in dead/hazardous condition

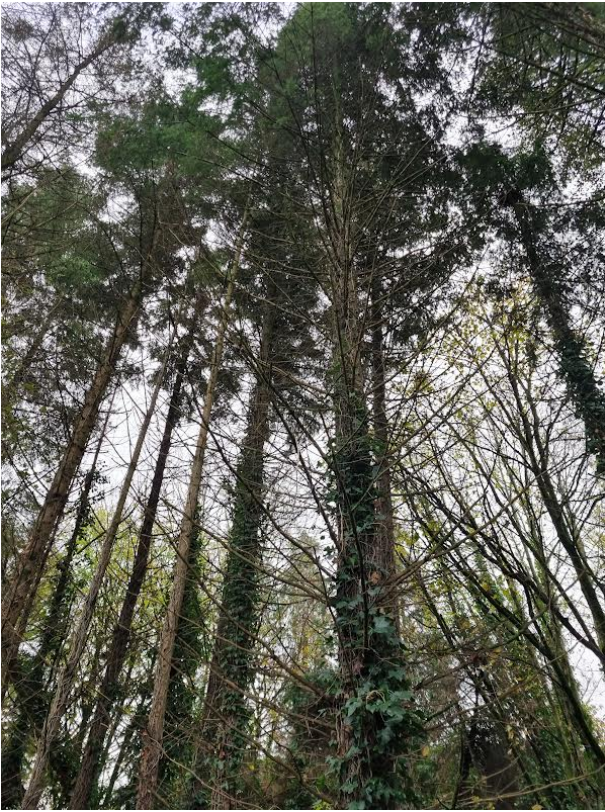
- II. The heavy shade-casting trees form a dense-canopied woodland, composed of blocks of similar size trees of varying age (from juvenile to mature) and condition (see fig.9). The species present are commonly found near streams, rivers and wetlands and play important roles in the dynamics of the riverine system (see fig.7). However despite their hydrological function, as a result of the shade the field layer is species-poor, dominated by ivy, broad leaved buckler-fern and hard fern (Forest Service, 2008).

Fig.9 Site B's dense-canopied spruce x poplar x alder woodland

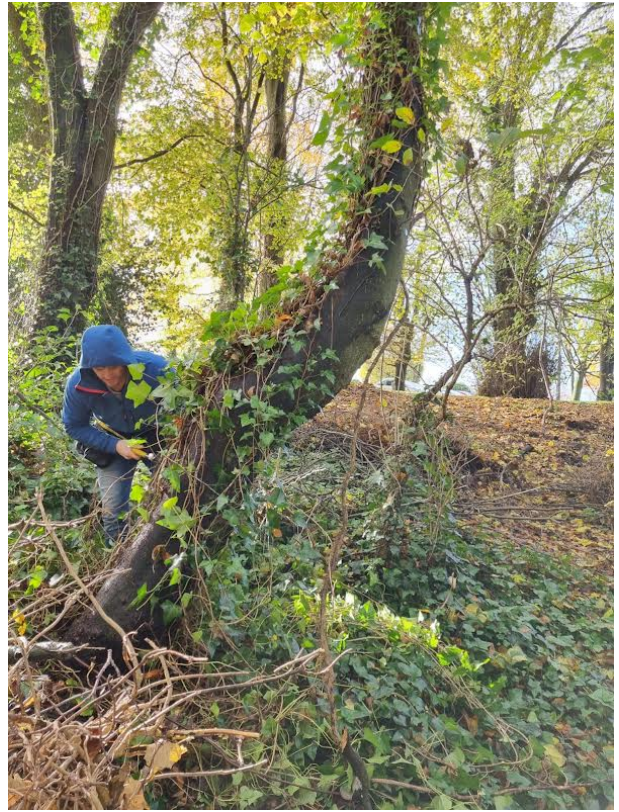
Fig.10 Example of a Northerly phototropic kink in a main stem in Site 's deciduous woodland

- X. Of the trees to be retained, three (3) have uncorrected leans/kinks due to phototropic competitive growth (see *fig.10*). It is thought that the removal of neighbouring trees to facilitate the proposed development, will force an alteration in the growth habit of these trees, and as such the majority of them have been recommended for re-assessment in the future (*Matteck 2015*).

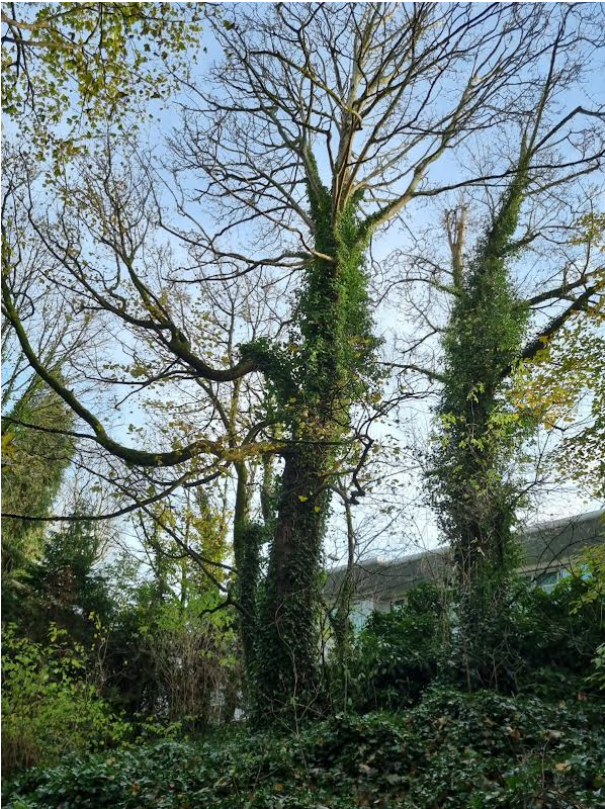
Fig.11 Site B's veteran sycamore (T578) which requires specialised management programme

- III. It must be noted that the proposed development will be elevated off the woodland floor, so these encroachments may be less invasive than customary building procedures. However, trees and tree groups will require specific root-safe protection measures during construction to ensure they are not subject to significant negative impact; and specialist working methods to ensure they remain viable following the completion of works (see guidelines in Sections 4.5 & 5.2). Specific regard and close monitoring of T578, is recommended due to its veteran status.

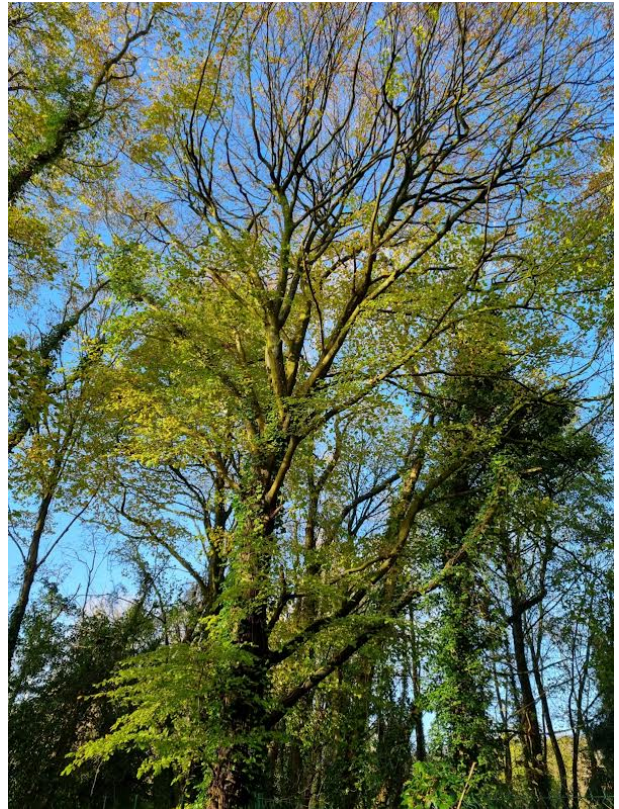
Fig.12 An example of a Category A high retention value mature beech in Site B's deciduous woodland
