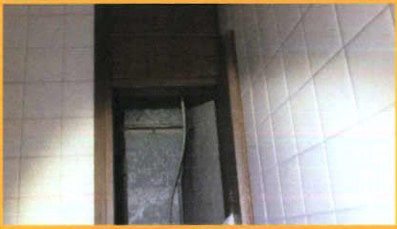
58	Fingal Co. Co. Office and Carpark Moore Lane	3 <sup>rd</sup> floor Gents WC Riser		Woven rope gaskets to air handling duct		Chrysotile	2	1	1	1	5	Removal and disposal as asbestos waste by a competent contractor prior to work likely to cause disturbance.

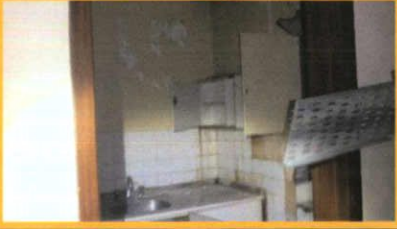
59	Fingal Co. Co. Office and Carpark Moore Lane	3 <sup>rd</sup> floor Kitchenette		Heat pads to sink unit		Chrysotile	1	0	0	1	2	Removal and disposal as asbestos waste by a competent contractor prior to work likely to cause disturbance.

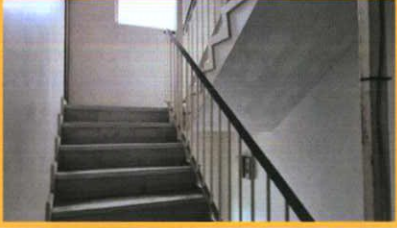
60	Fingal Co. Co. Office and Carpark Moore Lane	3 <sup>rd</sup> floor West stairway	2027325 2027326	VFT's and grey thread nosings		Chrysotile	1	0	0	1	2	Removal and disposal as asbestos waste by a competent contractor prior to work likely to cause disturbance.

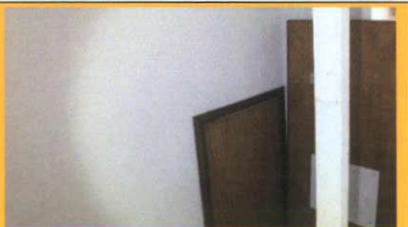
64	Fingal Co. Co. Office and Carpark Moore Lane	3 <sup>rd</sup> floor half landing	2027301	Insulation board to dry riser doors		Amosite	2	2	2	2	8	Removal and disposal as asbestos waste by a competent contractor prior to work likely to cause disturbance.

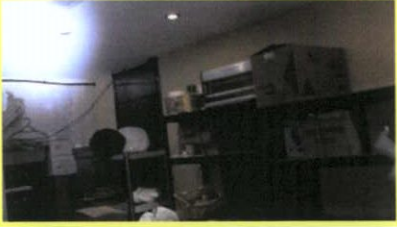
94	Fingal Co. Co. Office and Carpark Chinese Restaurant	1 <sup>st</sup> floor Lift lobby area		No access		VFT and adhesive presumed under fixed flooring						Investigation by a competent contractor prior to work likely to cause disturbance.

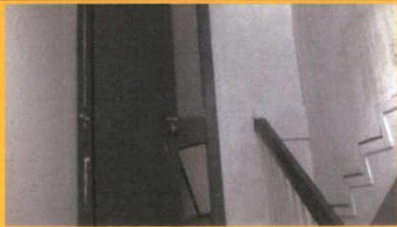
104	Fingal Co. Co. Office and Carpark Chinese Restaurant	2 <sup>nd</sup> floor Stairway to 3 <sup>rd</sup> floor of Fingal Co. Co.		VFT on stairway		Chrysotile	1	0	0	1	2	Removal and disposal as asbestos waste by a competent contractor prior to work likely to cause disturbance.

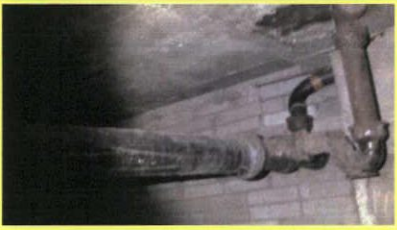
122	Fingal Co. Co. Office and Carpark	Basement		Lead sealed cast-iron pipework collars		Presumed to contain asbestos woven rope packing						Investigation by a competent prior to work likely to cause disturbance.

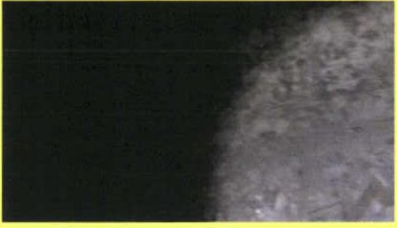
123	Fingal Co. Co. Office and Carpark	Basement Floors		Rubble heaps throughout the basement floors.		Presumed to contain asbestos						Investigation by a competent prior to work likely to cause disturbance.

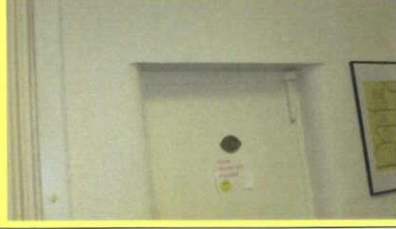
64	No. 59/60 O'Connell Street	Ground floor front office		Integral areas of strongroom and door		Presumed asbestos						investigation by a competent contractor prior to work likely to cause disturbance.
