# ABOUT SAFETY LTD.

**Client:** *Dublin Central GP Ltd*

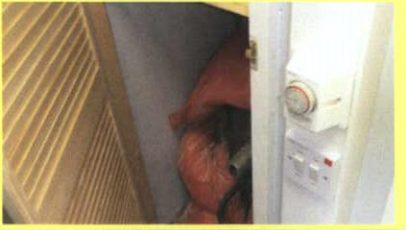
102	No. 59/60 O'Connell Street	3 <sup>rd</sup> floor Office				No visible asbestos containing materials identified

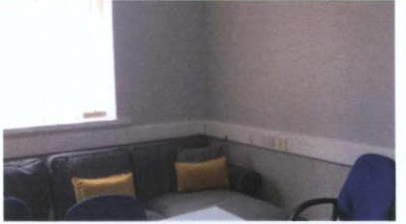
103	No. 59/60 O'Connell Street	3 <sup>rd</sup> floor Office				No visible asbestos containing materials identified

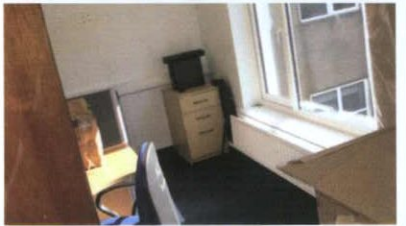
104	No. 59/60 O'Connell Street	1 <sup>st</sup> floor Office				No visible asbestos containing materials identified

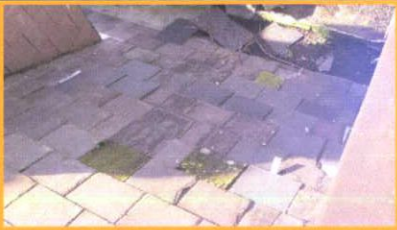
26	No. 58 O'Connell St.	Roof Flat roof	2028430	Substrate roofing felt		NAD

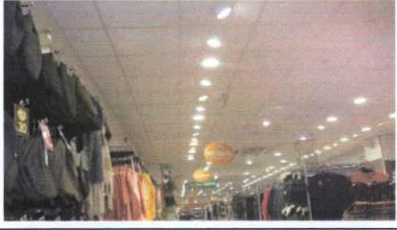
28	No. 58 O'Connell St.	Ground floor Back store room		Ceramic tiles to floor		No visible asbestos containing materials identified.

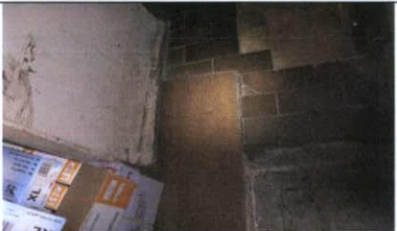
23	No. 43 O'Connell St. Ned Kellys	Basement Office				No visible asbestos containing materials identified.							 
24	No. 43 O'Connell St. Ned Kellys	Ground floor office up spiral stairway				No visible asbestos containing materials identified.

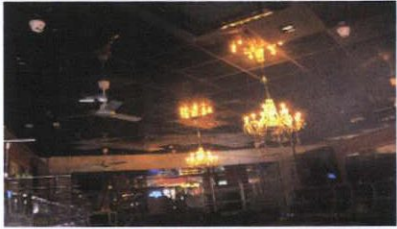
38	No. 43 O'Connell St. Ned Kellys	Ground floor Back gaming area		Lat and plaster ceilings		No visible asbestos containing materials identified.

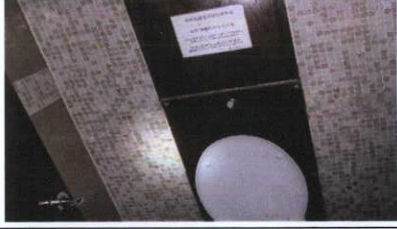
40	No. 43 O'Connell St. Ned Kellys	Ground floor Ladies WC Ceiling void				No visible asbestos containing materials identified.

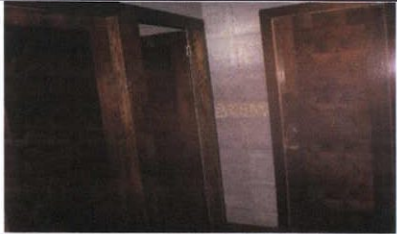
42	No. 43 O'Connell St. Ned Kellys	Ground floor Snooker room				No visible asbestos containing materials identified.							 
43	No. 43 O'Connell St. Ned Kellys	1st floor Front room				No visible asbestos containing materials identified.

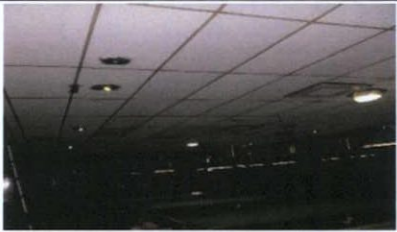
46	No. 43 O'Connell St. Ned Kellys	1 <sup>st</sup> floor Snooker room Ceiling void				No visible asbestos containing materials identified.

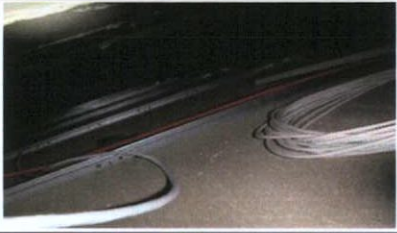
47	No. 43 O'Connell St. Ned Kellys	1 <sup>st</sup> floor Roofs				No visible asbestos containing materials identified.
