DDC PLAN NO 15432/22
 13/12/2022

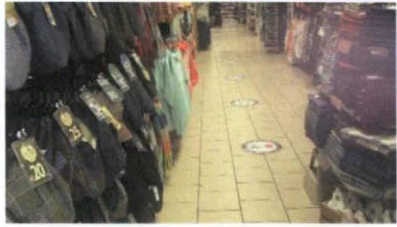
2	No. 57 O'Connell St.	Ground floor Shop.		Ceramic tiles		No visible asbestos containing materials identified.

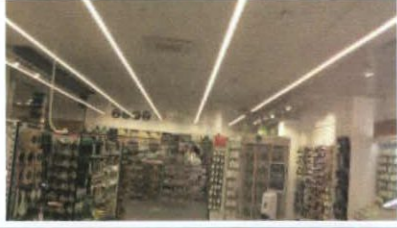
3	No. 57 O'Connell St.	Ground floor Shop.		Modern drop ceiling with lay-in ceiling tiles.		No visible asbestos containing materials identified.

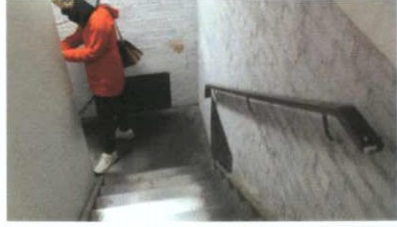
4	No. 57 O'Connell St.	Stairway to basement				No visible asbestos containing materials identified.

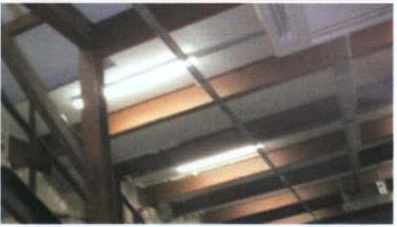
7	No. 57 O'Connell St.	Back store rooms		New insulated profile steel roof over back yard.		No visible asbestos containing materials identified.

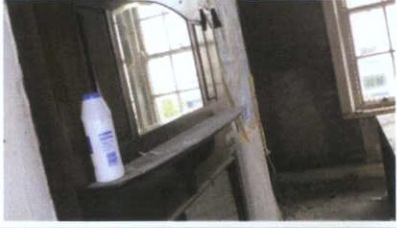
20	No. 57 O'Connell St.	2 nd floor Store room				No visible asbestos containing materials identified.

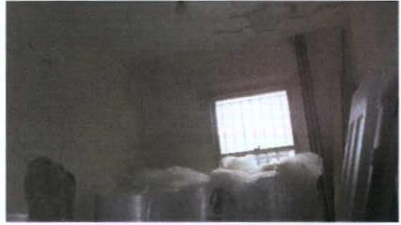
23	No. 57 O'Connell St.	2 nd floor Store room				No visible asbestos containing materials identified.

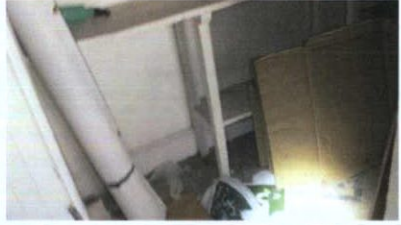
24	No. 57 O'Connell St.	3 rd floor Back room				No visible asbestos containing materials identified.

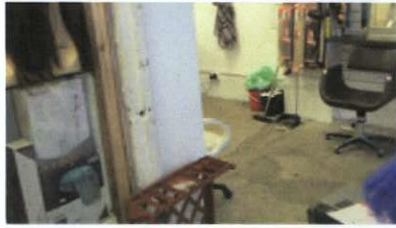
3	60A O'Connell St.	Ground floor Shop		Concrete floor		NAD

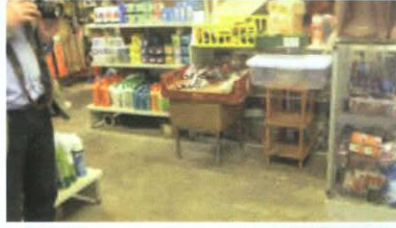
4	60A O'Connell St.	Ground floor		Plasterboard to ceilings		NAD

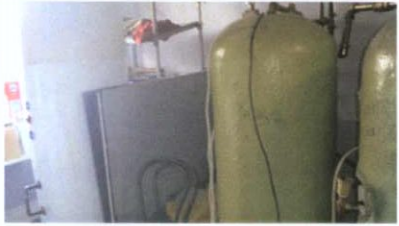
23	No. 61 O'Connell Street					No visible asbestos containing materials identified.

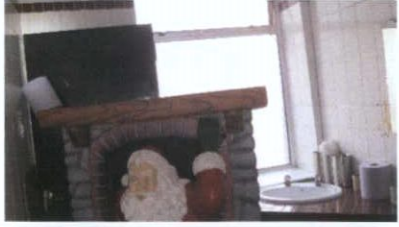
24	No. 61 O'Connell Street	2 nd floor		Softboard over drop ceiling		No visible asbestos containing materials identified.

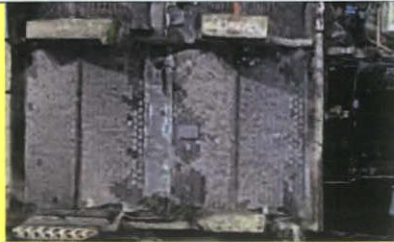
32	No. 61 O'Connell Street	External Roofs		No access to main roof pitched roof or flat extension roof.		Presumed to contain asbestos						Investigation by a competent contractor prior to work likely to cause disturbance.
