DPC PLAN NO 5432/22
 RECEIVED: 13/12/2022

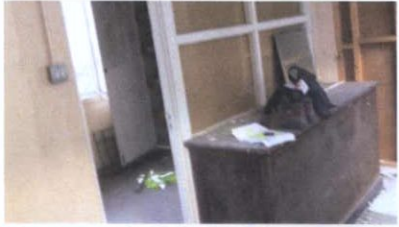
18	No. 44 O'Connell Street	1 st floor Front corridor				No visible asbestos containing materials identified.

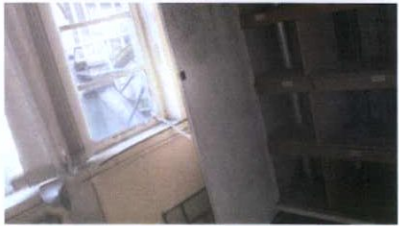
19	No. 44 O'Connell Street	1 st floor Front corridor		Bakelite cistern	1	Amosite	1	0	0	2	3	Removal and disposal as asbestos waste by a competent contractor prior to work likely to cause disturbance.

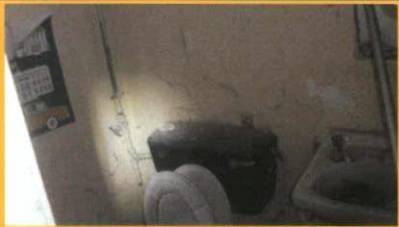
20	No. 44 O'Connell Street	1 st floor Front room				No visible asbestos containing materials identified.

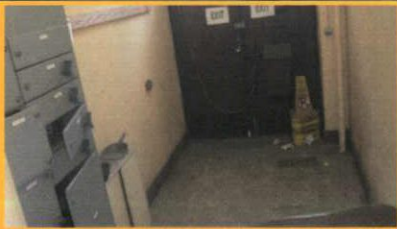
22	No. 44 O'Connell Street	Ground floor Old entrance lobby		Raised timber floor		VFT presumed to be under raised floors in corridor and main room						Investigation by a competent asbestos contractor prior to work likely to cause disturbance.

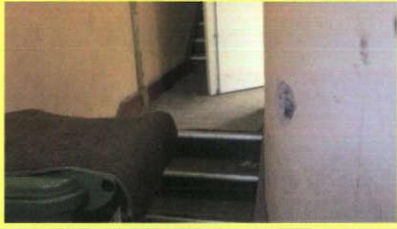
23	No. 44 O'Connell Street	Ground floor Old entrance lobby	2030428	Wall paint	NQ	Chrysotile	1	1	1	1	4	Removal and disposal as asbestos waste by a competent contractor prior to work likely to cause disturbance.

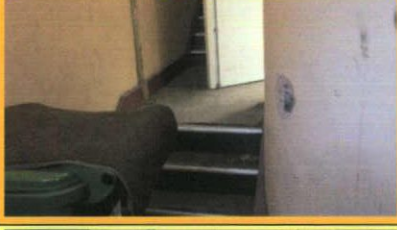
24	No. 44 O'Connell Street	Ground floor		Integral areas of fire doors in the building		Presumed to contain asbestos						Investigation of all fire doors by a competent contractor prior to work likely to cause disturbance.

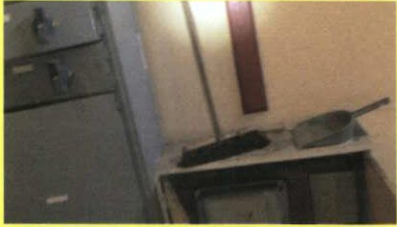
26	No. 44 O'Connell Street	Ground floor Reception area		Fixed floor not disturbed		Presumed asbestos						Investigation by a competent asbestos contractor prior to work likely to cause disturbance.

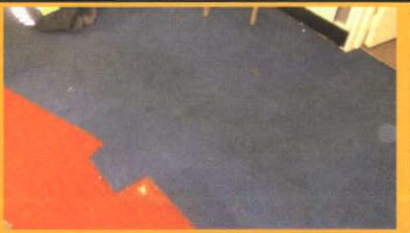
30	No. 44 O'Connell Street	Ground floor Locker room		Fixed floor not disturbed		Presumed to contain VFT and/or adhesive						Investigation by a competent asbestos contractor prior to work likely to cause disturbance.

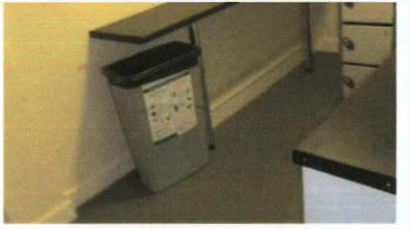
31	No. 44 O'Connell Street	Ground floor WC		Fixed floor not disturbed		Presumed to contain VFT and/or adhesive						Investigation by a competent asbestos contractor prior to work likely to cause disturbance.

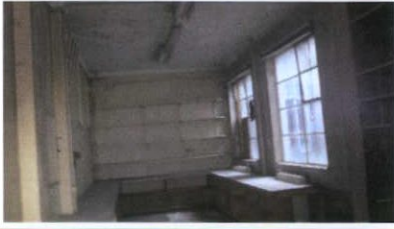
35	No. 44 O'Connell Street	Ground floor Back corridor		Integral areas of fire doors		Amosite						Removal and disposal as asbestos waste by a competent contractor prior to work likely to cause disturbance.

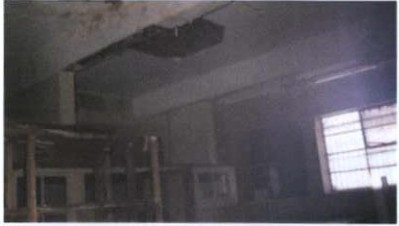
42	No. 44 O'Connell Street	Basement Locker rooms				No visible asbestos containing materials identified.

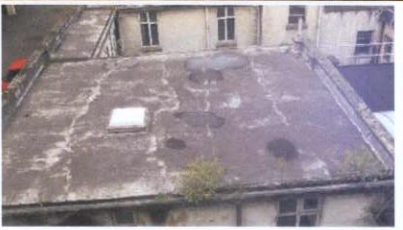
3	No. 45 O'Connell Street	Main roof	2030402	Putty to window bars.		NAD

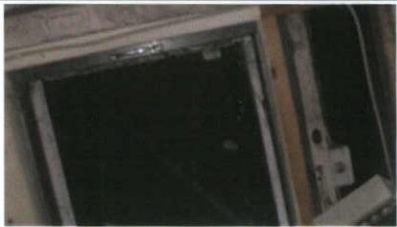
12	No. 45 O'Connell Street	2 nd floor Void		Georgian wire rooflight		Presumed asbestos in glazing bars						Investigation by a competent contractor prior to work likely to cause disturbance.

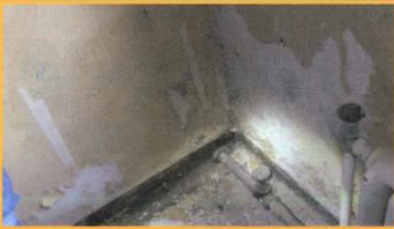
22	No. 45 O'Connell Street	1 st floor Side room between rooflights				No visible asbestos containing materials identified.

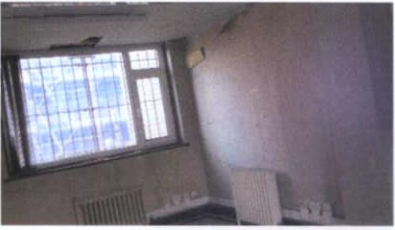
26	No. 45 O'Connell Street	Ground floor Reception		Aeroboard linings in radiator boxwork		NAD

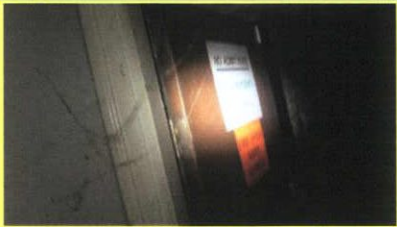
52	No. 45 O'Connell Street	Basement Boiler room		Integral areas of metal clad fire door.		Strongly presumed asbestos						Investigation by a competent contractor prior to work likely to cause disturbance.

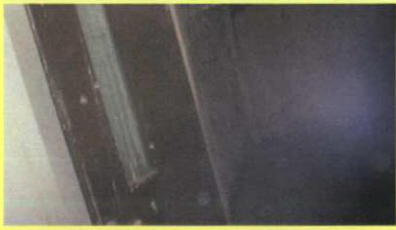
62	No. 45 O'Connell Street	Basement Back corridor WC	2030417	Common grey VFT and Evode		NAD

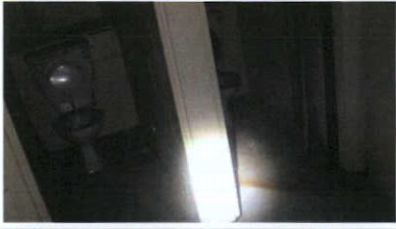
63	No. 45 O'Connell Street	Basement Back corridor Female shower		Common grey VFT and Evode		NAD

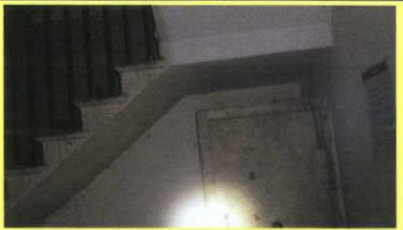
66	No. 45 O'Connell Street	Basement lobby Front of building	2030418	VFT and adhesive		NAD
