A4.7.3.2. Archival research describing the development on the site from 1916 to present

A4.7.3.3. Summary of forensic analysis findings

This report was prepared at the request of Molloy & Associates Conservation Architects to inform the Dublin Central Built Heritage Review for Hammerson Plc. The purpose of the work was to analyse the physical fabric of buildings on O'Connell Street, Parnell Street, Henry Street, Moore Street, Moore Lane and Henry Place; and to use the physical evidence gathered through study of the building materials to gain a better understanding of the significance and dating of each of the buildings. This report refers to buildings from Sites, 3,4 and 5 on Henry Street, Moore Street and Moore Lane¹.

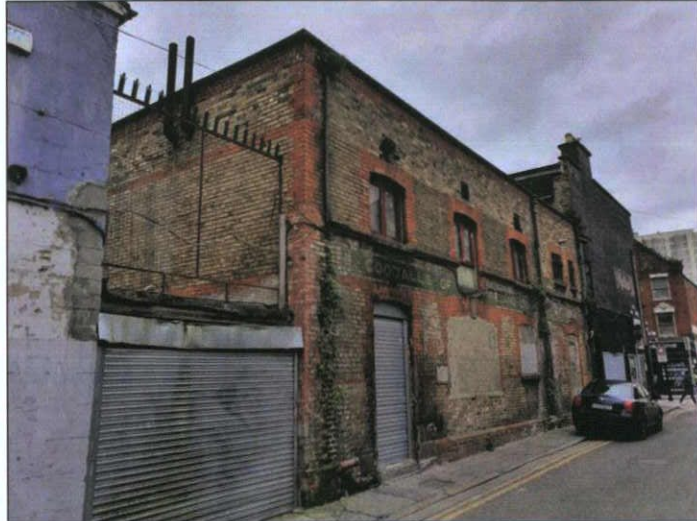
The lower part of the brick façade on Henry place may predate 1916. 'O'Briens' signage is visible under later Goodall's sign. Goodall's (Ireland) Ltd occupied the site in the 1940s.

P 27 Henry Place elevation of 11-13 Henry Place.

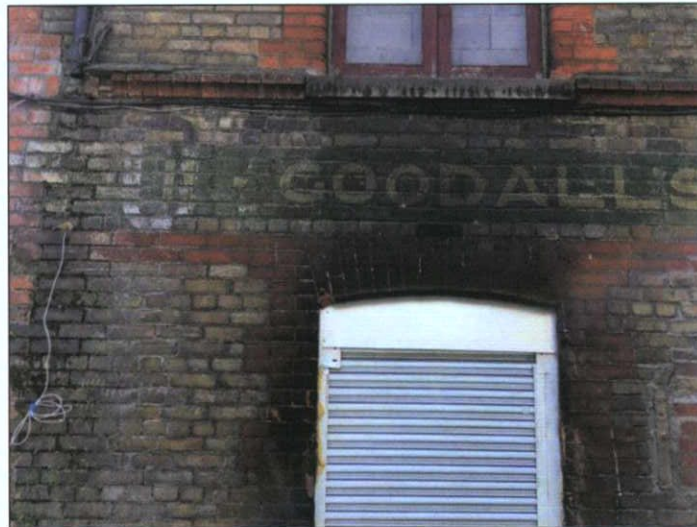
P 28 Detail of "O' BRIENS" painted sign beneath later "GOODALL'S" sign.

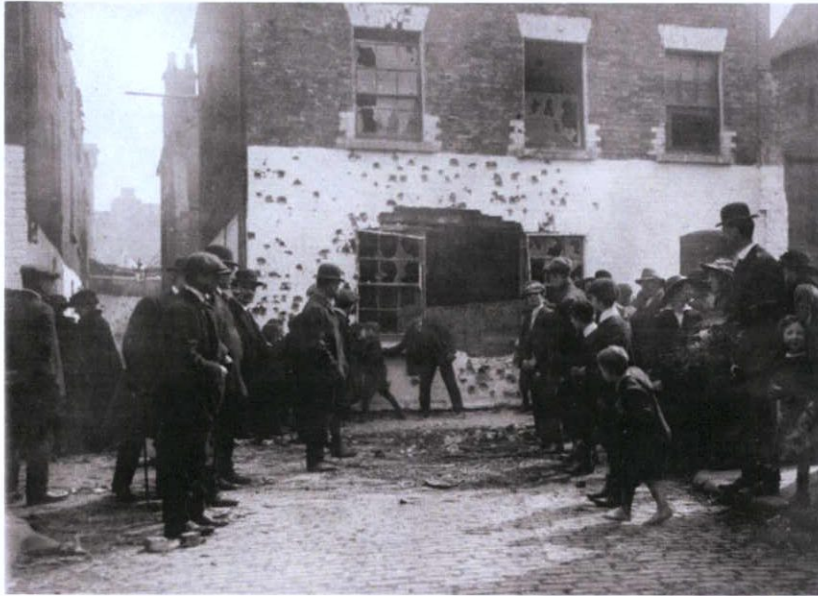
P 35 'Unknown building' damaged in 1916, thought be 10 Henry Place, at the junction of Moore Lane and Henry Place. Property Loss Archives describes the front of 10 Henry Place blown in by shell fire.

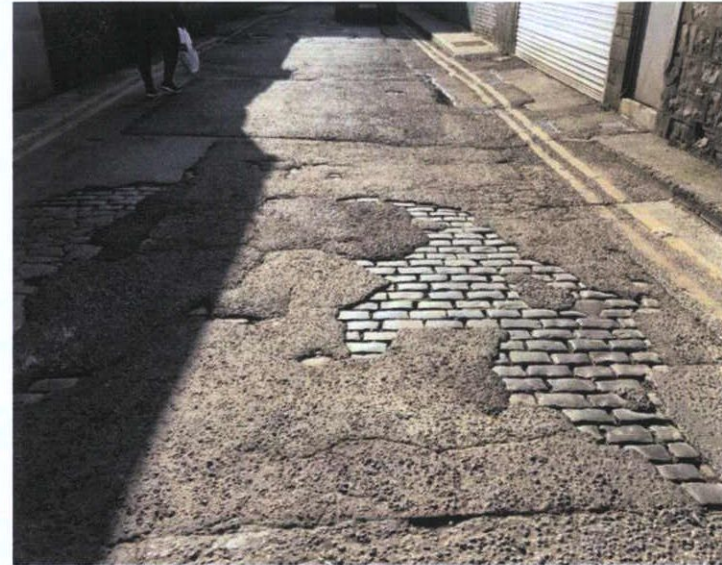
P 39 Original setts on Moore Lane visible under modern road surface.

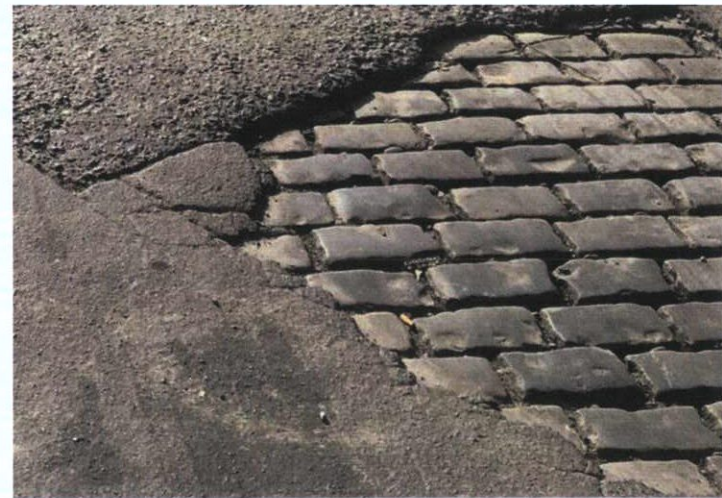
P 40 Detail of smoothly worn diorite setts on Moore Lane.

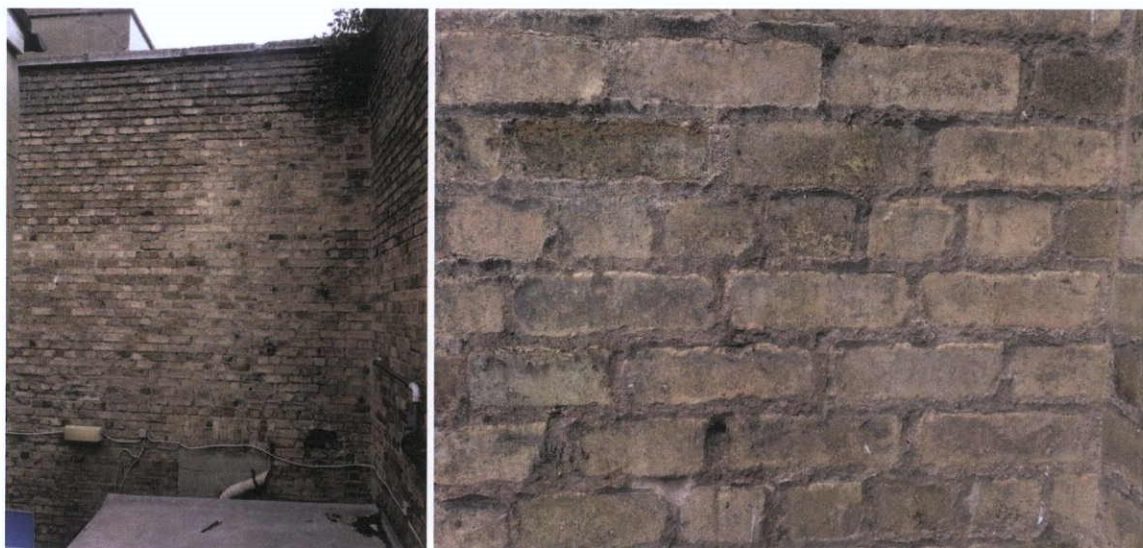
Fig.4.1.1: General view of the brickwork at the rear of 37 Henry Place adjacent to the alley separating Nos.9 and 10 Henry Place.

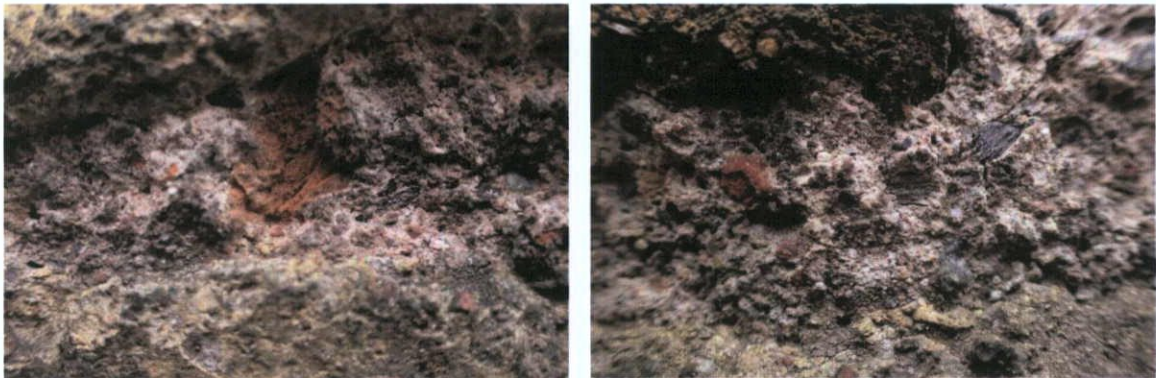
Fig.4.1.2: Coarse brick aggregate and fine brick dust in the bedding mortar of the 1920s yellow stock brick.

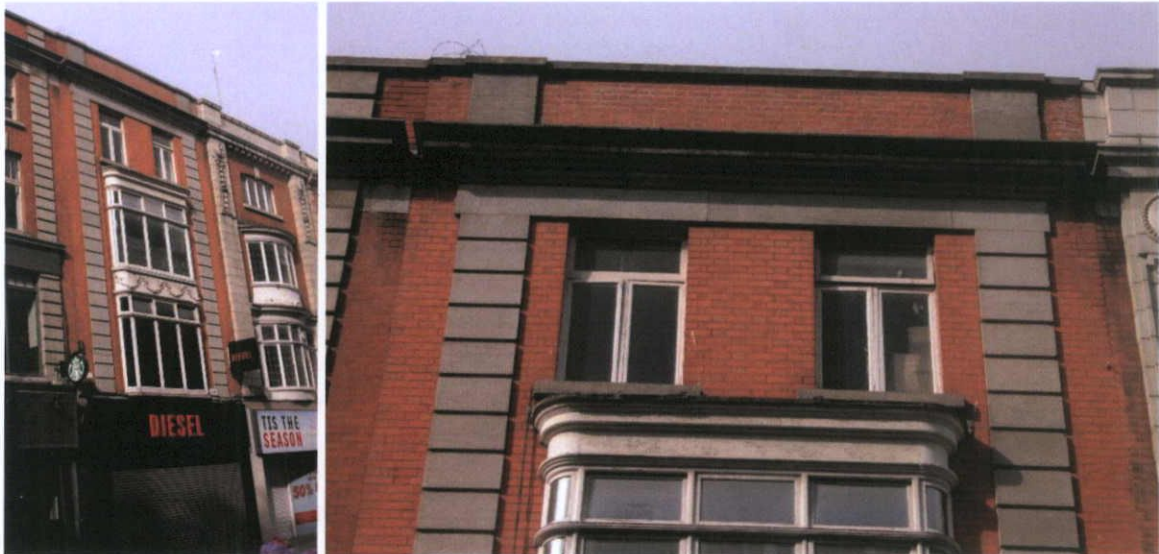
Fig.4.2.1: The façade of 38 Henry Street is of well-fired red brick with limestone detailing, with the parapet rebuilt in a different brick and heavier Portland Cement-based mortar.

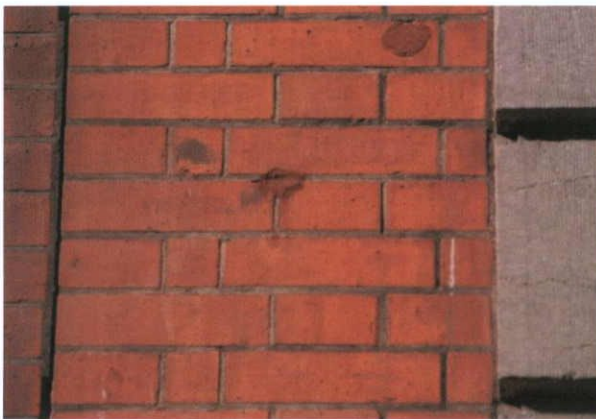
Fig.4.2.2: The brickwork and limestone detailing on the façade of 38 Henry Street has been cleaned and small 'plastic' mortar repairs (appearing dark red) seen.

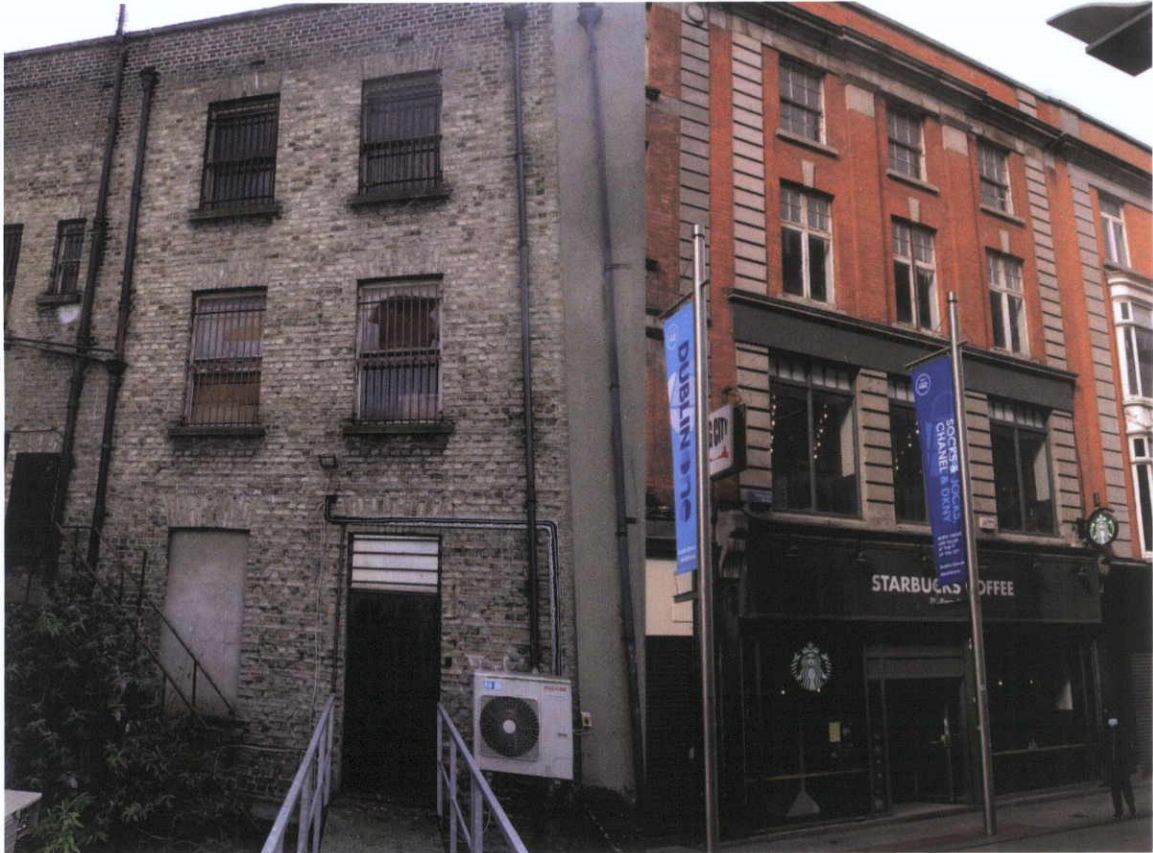
Fig.4.3.1: General views of the rear elevation (note rebuilt parapet) and façade of 39 Henry Street. The rear elevation brickwork matches that of No.38 and is contemporary with same.

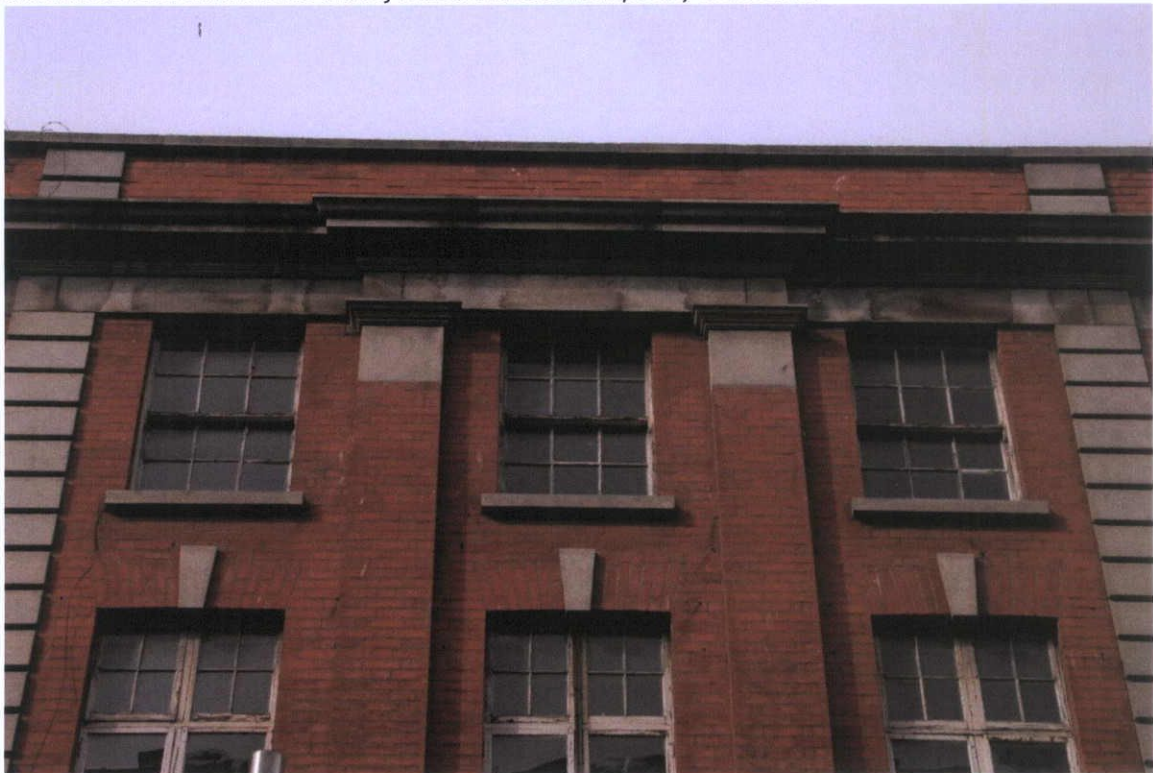
Fig.4.3.2: The superstructure is built with machine-cut red brick with granite used for architectural detailing. The granite shows brown staining, but the building surface is generally free from soiling and has been cleaned in the past.

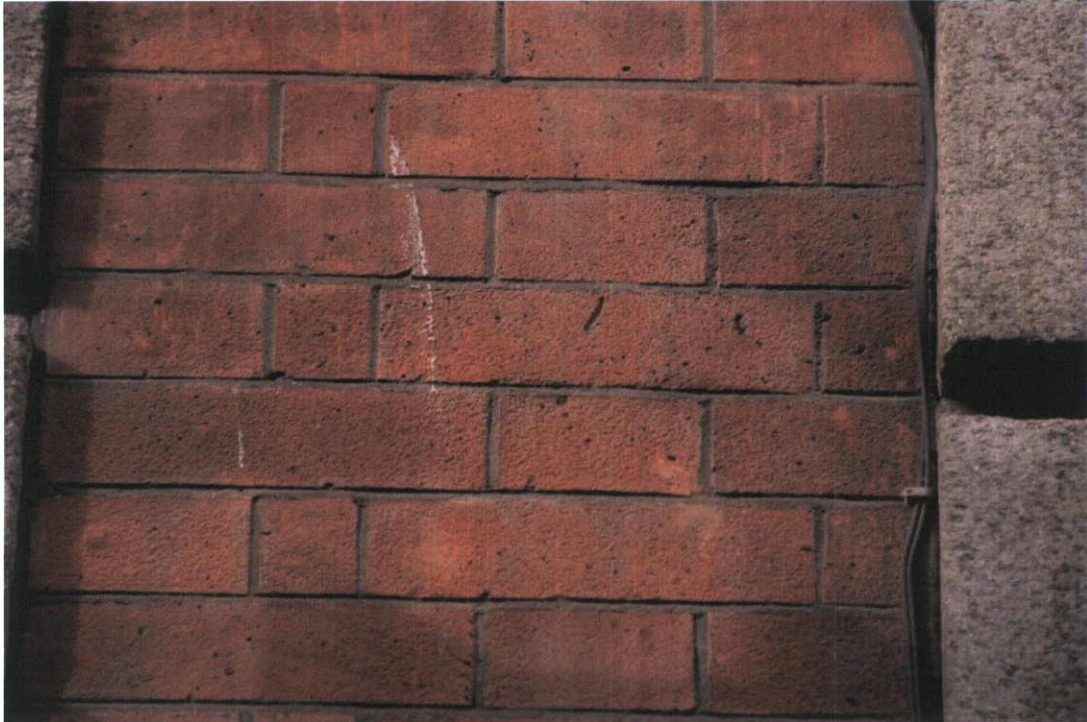
Fig.4.3.3: Detail of the brickwork on the façade of 39 Henry Street showing a damaged surface (probably from past cleaning) and the edge of the Leinster granite detail.

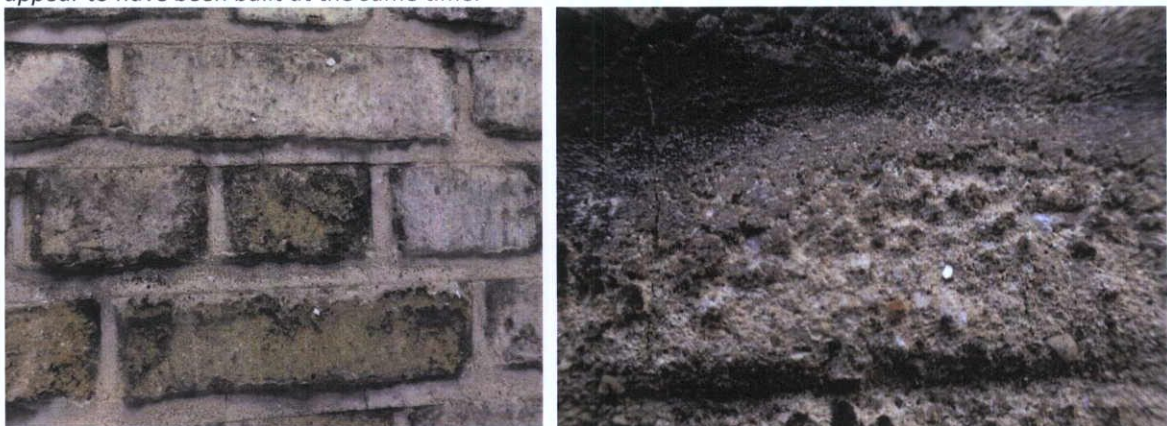
Fig.4.3.5: The rear elevation shows soiled Portland Cement pointing mortar.

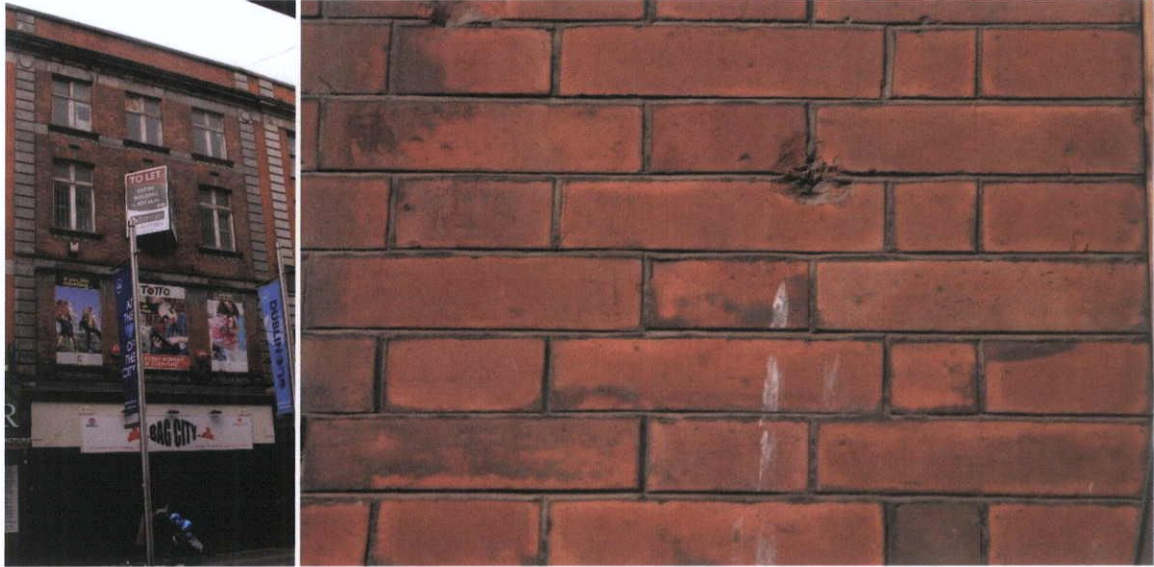
Fig.4.4.1: The brickwork on the soiled façade of No.40 Henry Street consists of well-fired machine-cut red clay brick with weatherstruck Portland Cement-based pointing mortars. Leinster granite was used for architectural detailing. The work probably dates to c.1917-1920.

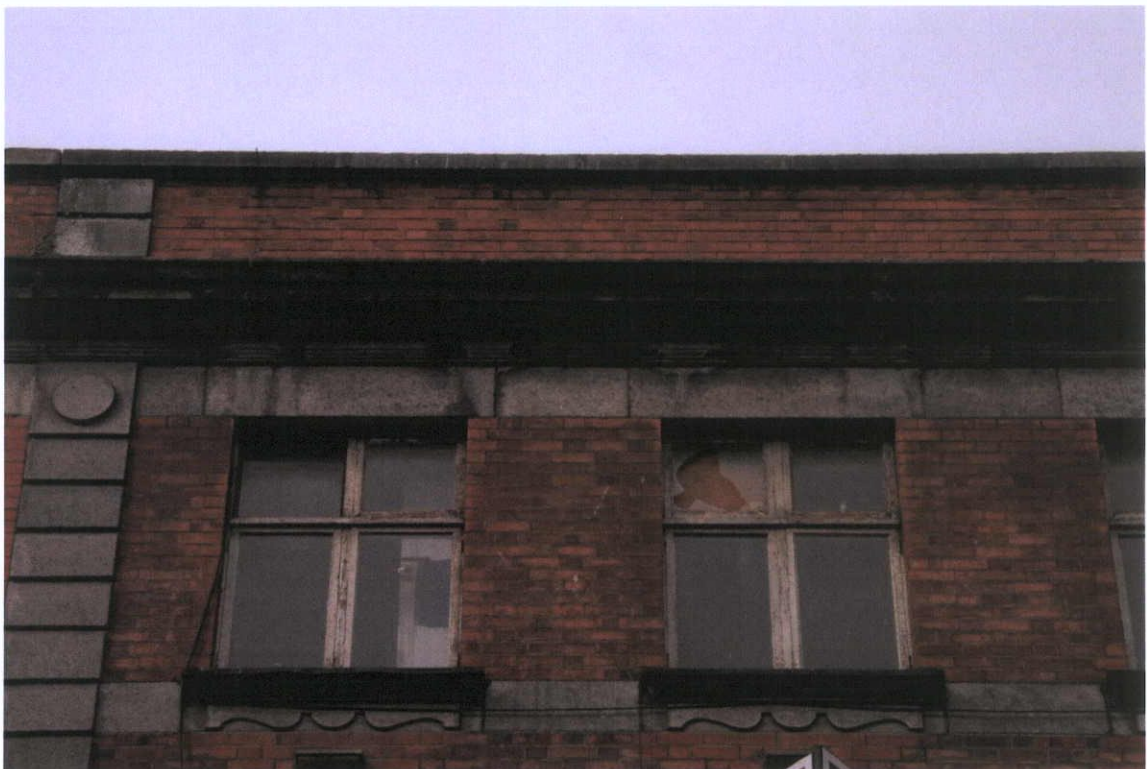
Fig.4.4.2: Soiled brick and granite detailing at upper floor level.

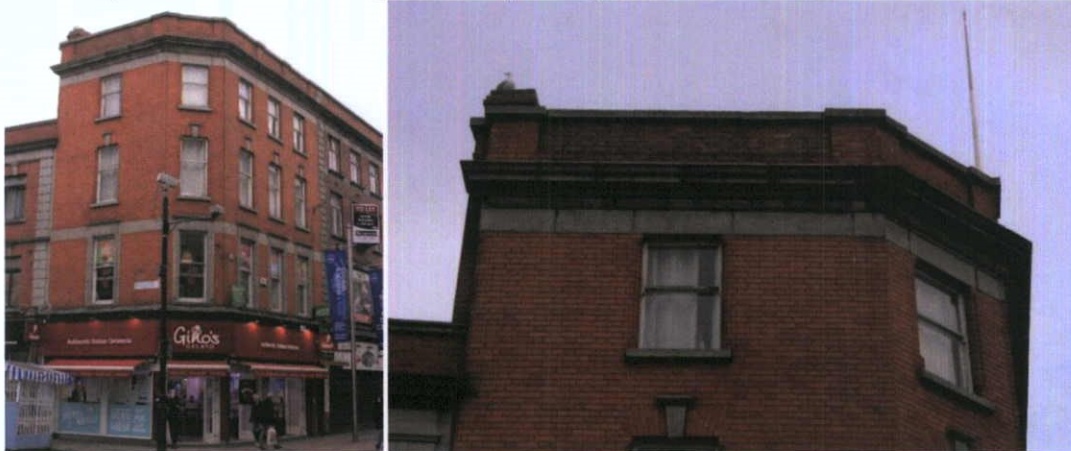
Fig.4.5.2: Soiled brick and granite detailing at upper floor level.

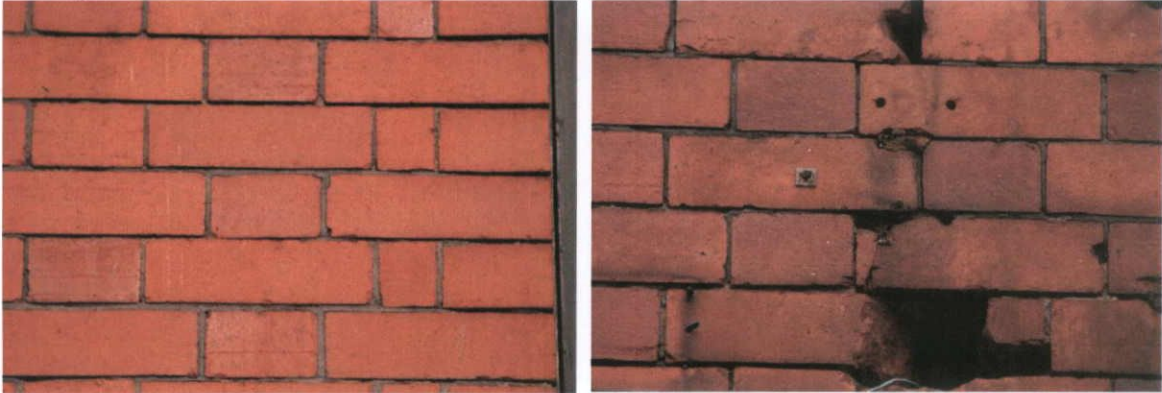
Fig.4.6.1: Homogenous red brickwork at first floor level of 1-2 Moore Street showing a grey-coloured Portland Cement-based pointing mortar (but also some joint recession suggesting this may be later repair work). The façade shows some minor damage exposing the bedding (right).

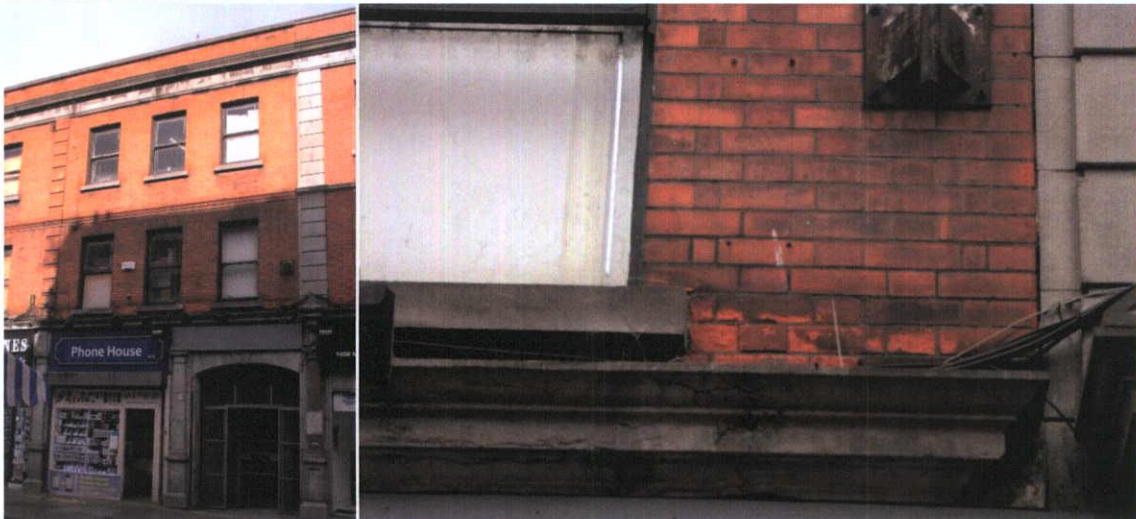
Fig.4.7.2: No.3 Moore Street built with machine-cut homogenous red brick with limestone used for window cills and architectural detail. The masonry is soiled, exaggerating certain stone features.

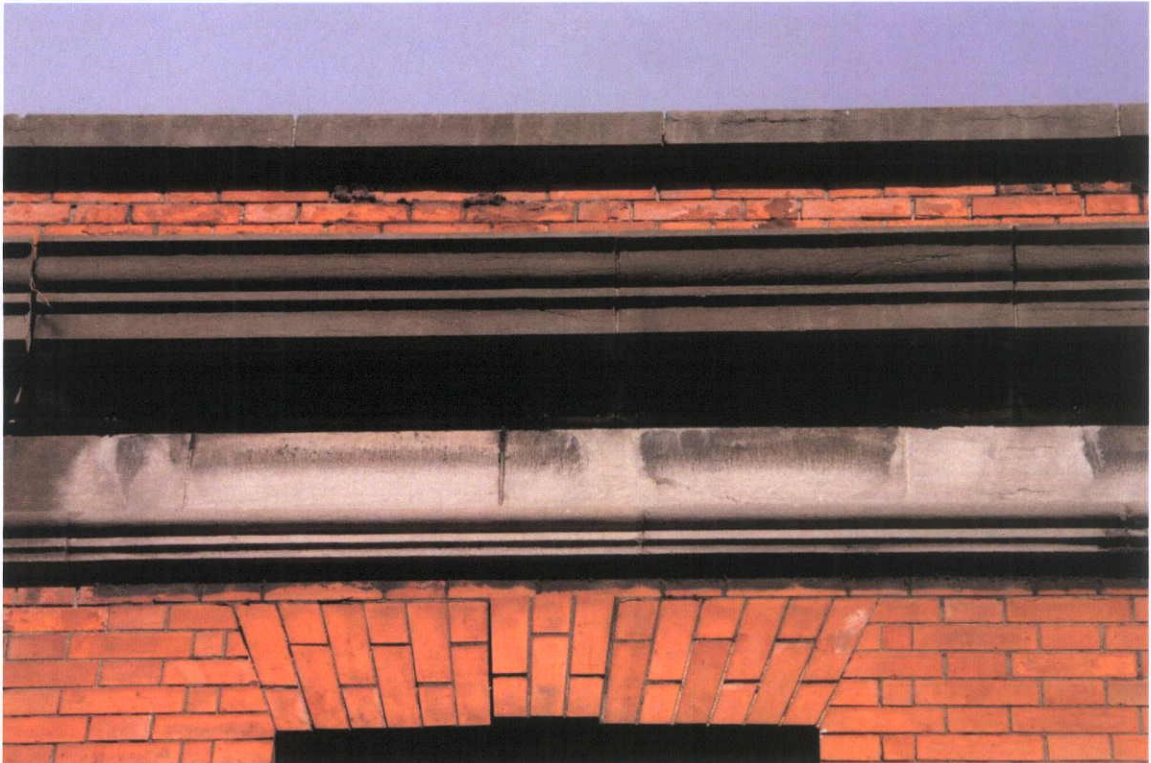
Fig.4.7.3: Detail showing the soiled limestone frieze and coping stones.

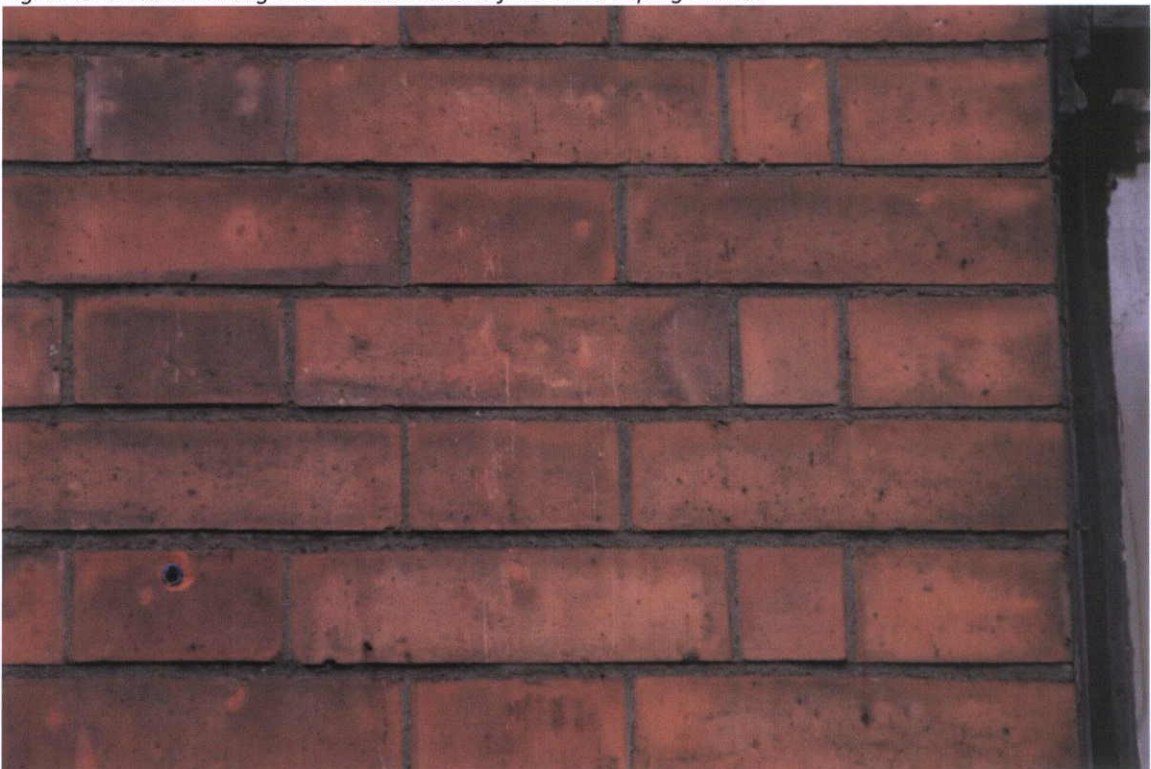
Fig.4.7.4: The soiled brickwork is machine-cut kiln-fired, consistent with c.1917 work.

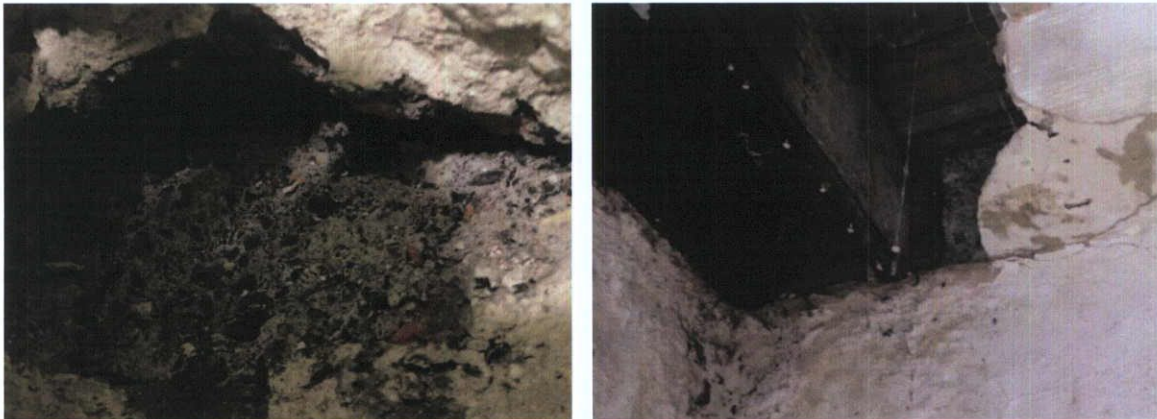
Fig.4.7.7: The clinker concrete used to form the rear, party and internal walls is a distinctive mix with coarse angular brick shards as aggregate; and this material was also used for the construction of Nos.4,5 and 6 Moore Street.
