4.9 5 Moore Street: The three-storey two-bay brick-fronted terraced building rising to a limestone frieze and cornice, built c.1917, has brick ‘soldier’ quoins and a modern shopfront at ground floor level. The architectural detail is uniform across the terrace, with identical limestone detailing at parapet and shopfront level, and with brick specials forming a string course between the first and second floor levels. The brickwork was finished with flush joints. No.5 was built c.1917 as part of a single build with Nos.3, 4 and 6 Moore Street.

4.10 6 Moore Street: The three-storey three-bay brick-fronted terraced building rising to a limestone frieze and cornice, built c.1917, has brick specials forming a string course between first and second floor levels, and with 'soldier' quoins farming the building, having a modern shopfront at ground floor level. The building forms part of a group with Nos.4,5,and 6 Moore Street.

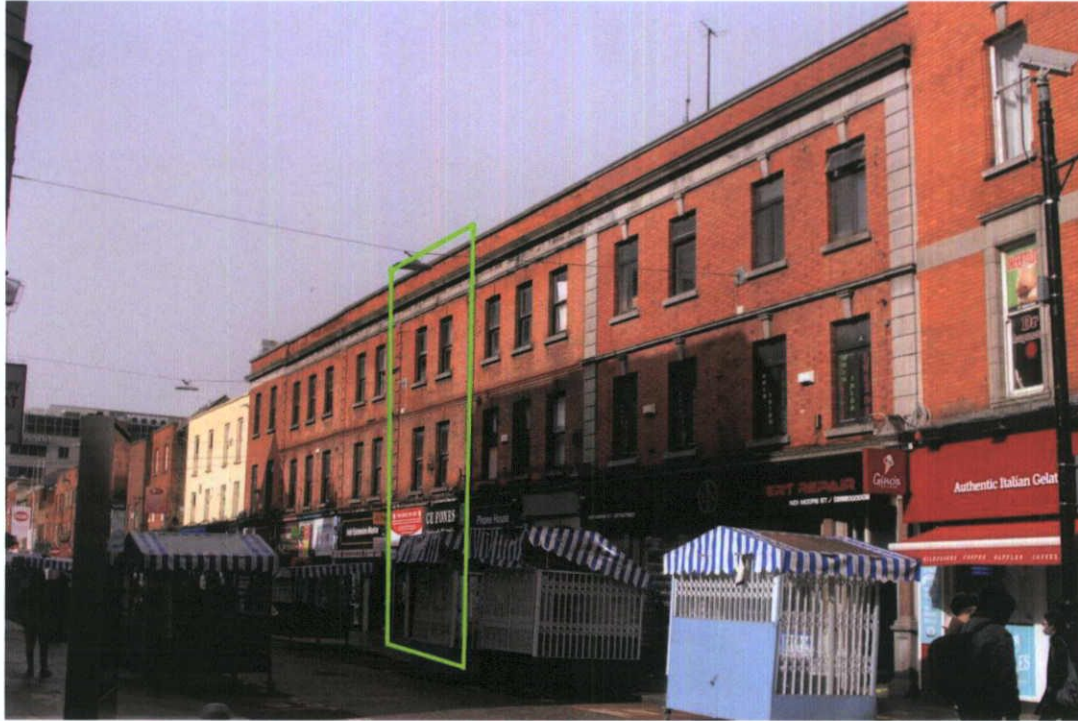
Fig.4.8.1: No.4 Moore Street, forming part of a terrace with Nos.3,5 and 6.

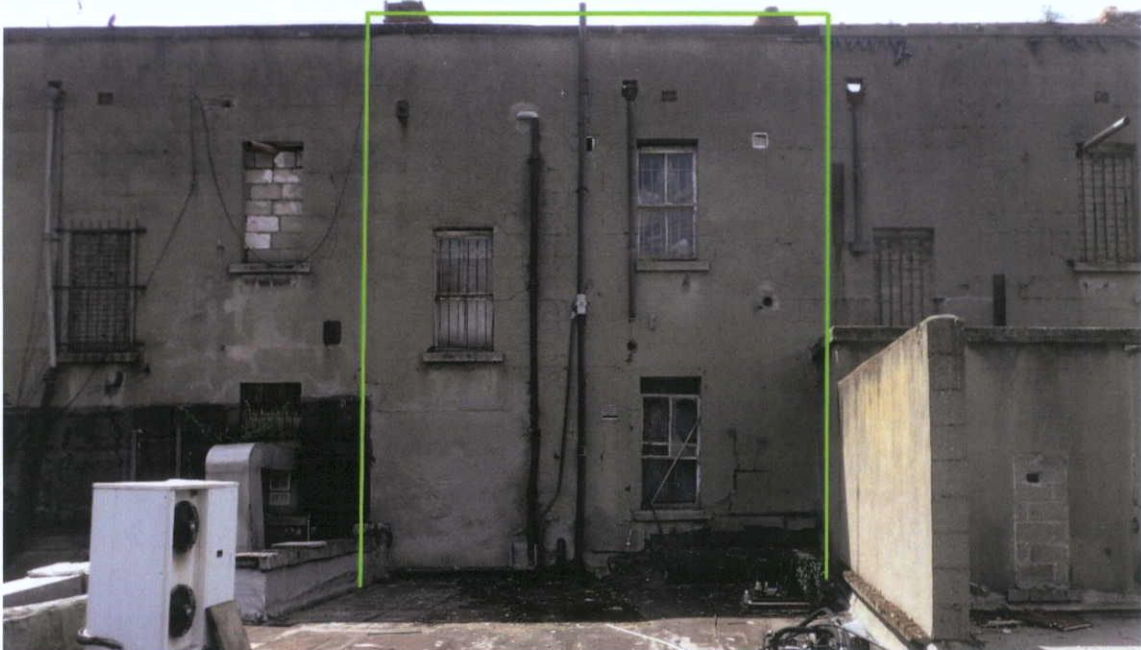
Fig.4.8.4: Note the rendered rear of No.4 mirrors the treatment of No.3 and 5.

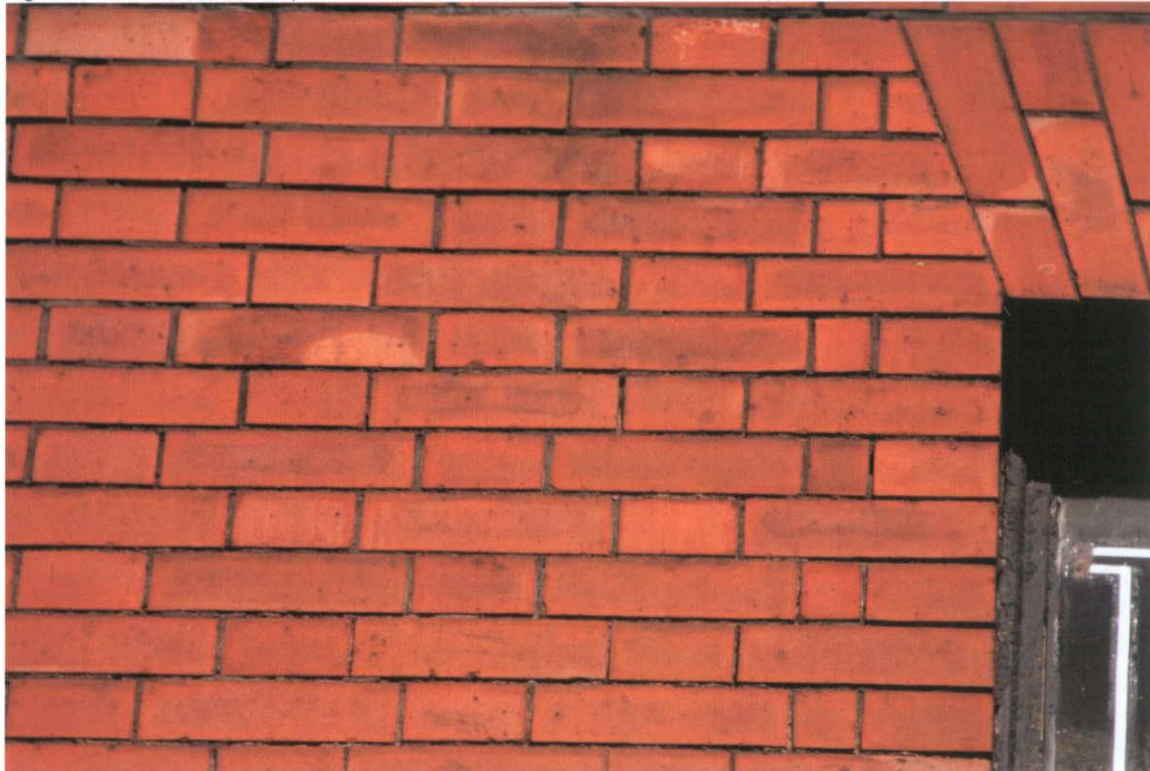
Fig.4.9.3: The surface of the brick shows subtle colour variations from the firing process.

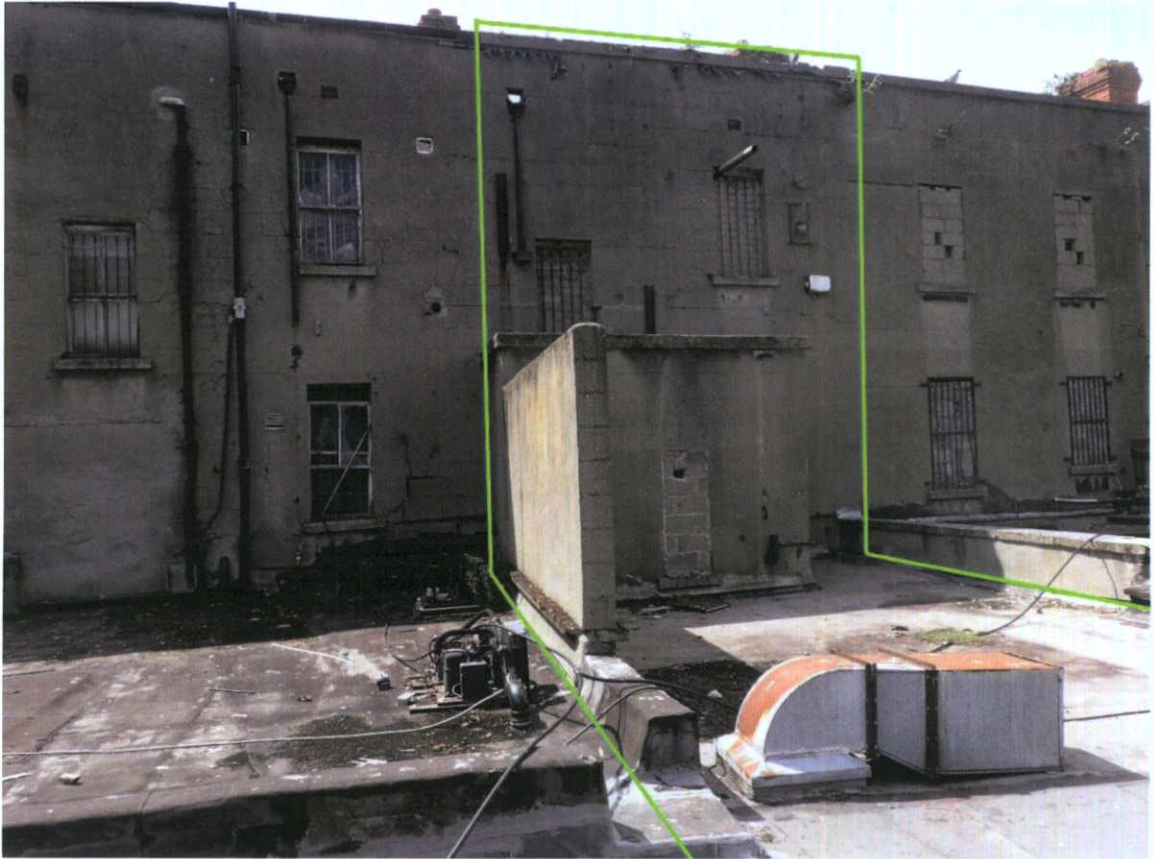
Fig.4.9.4: The rear elevation of No.5 Moore Street, built c.1917. Note that the colour and composition of the Portland Cement render and the configuration of the openings of Nos.5 and 4 matches; while the neighbouring No.6 Moore Street (right of image) was built using a slightly different Portland Cement render mix and with a different window arrangement.

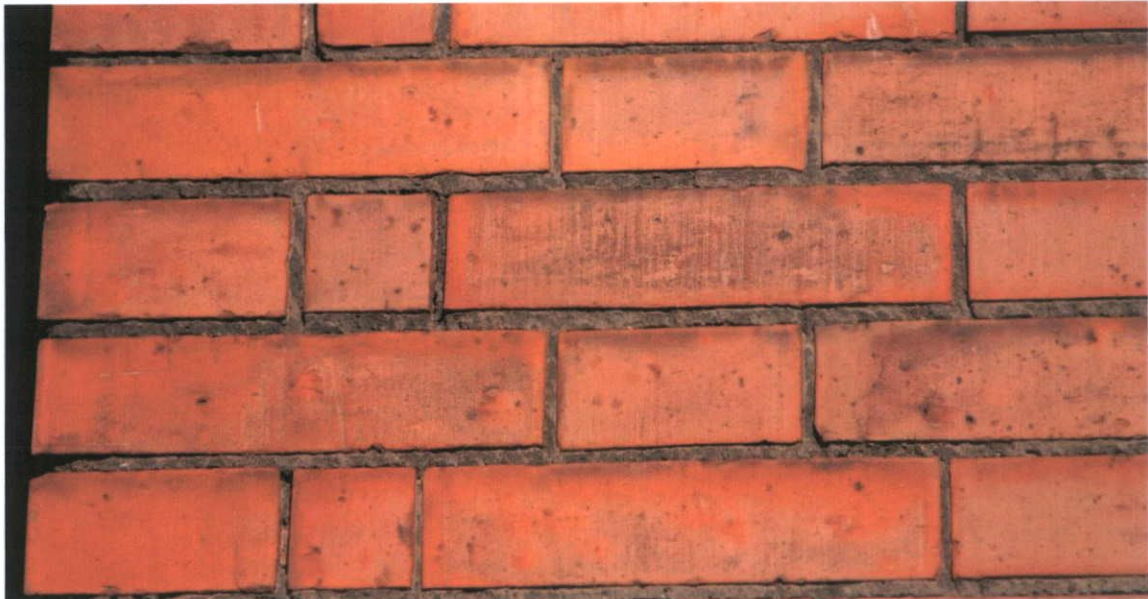
Fig.4.10.2: Machine-cut brick with subtle surface colour variations are characteristic of this brick.

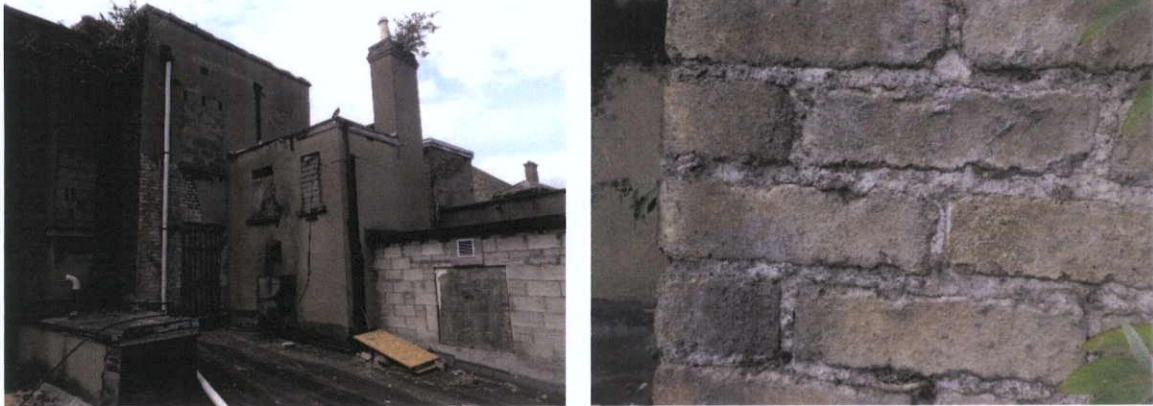
Fig.4.11.3: General view of the rear of No.7 Moore Street, which extends further than the terrace immediately to the south, and was constructed using a yellow stock brick (normally concealed beneath a Portland Cement render).

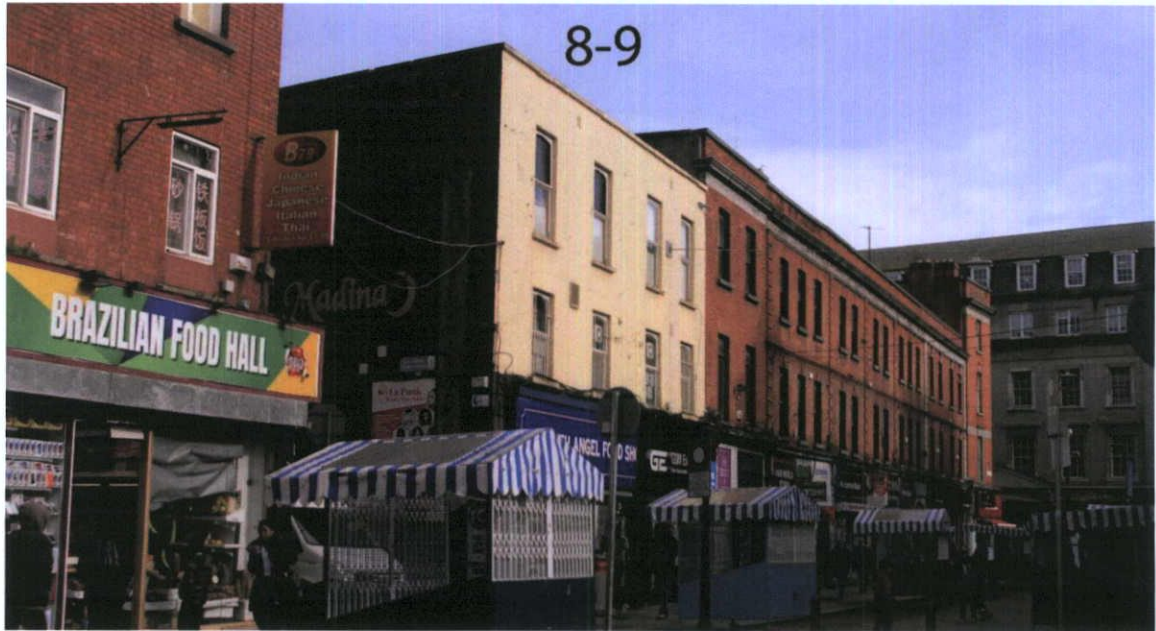
Fig.4.12.1: Nos.8-9 Moore Street forming the corner with Henry Place.

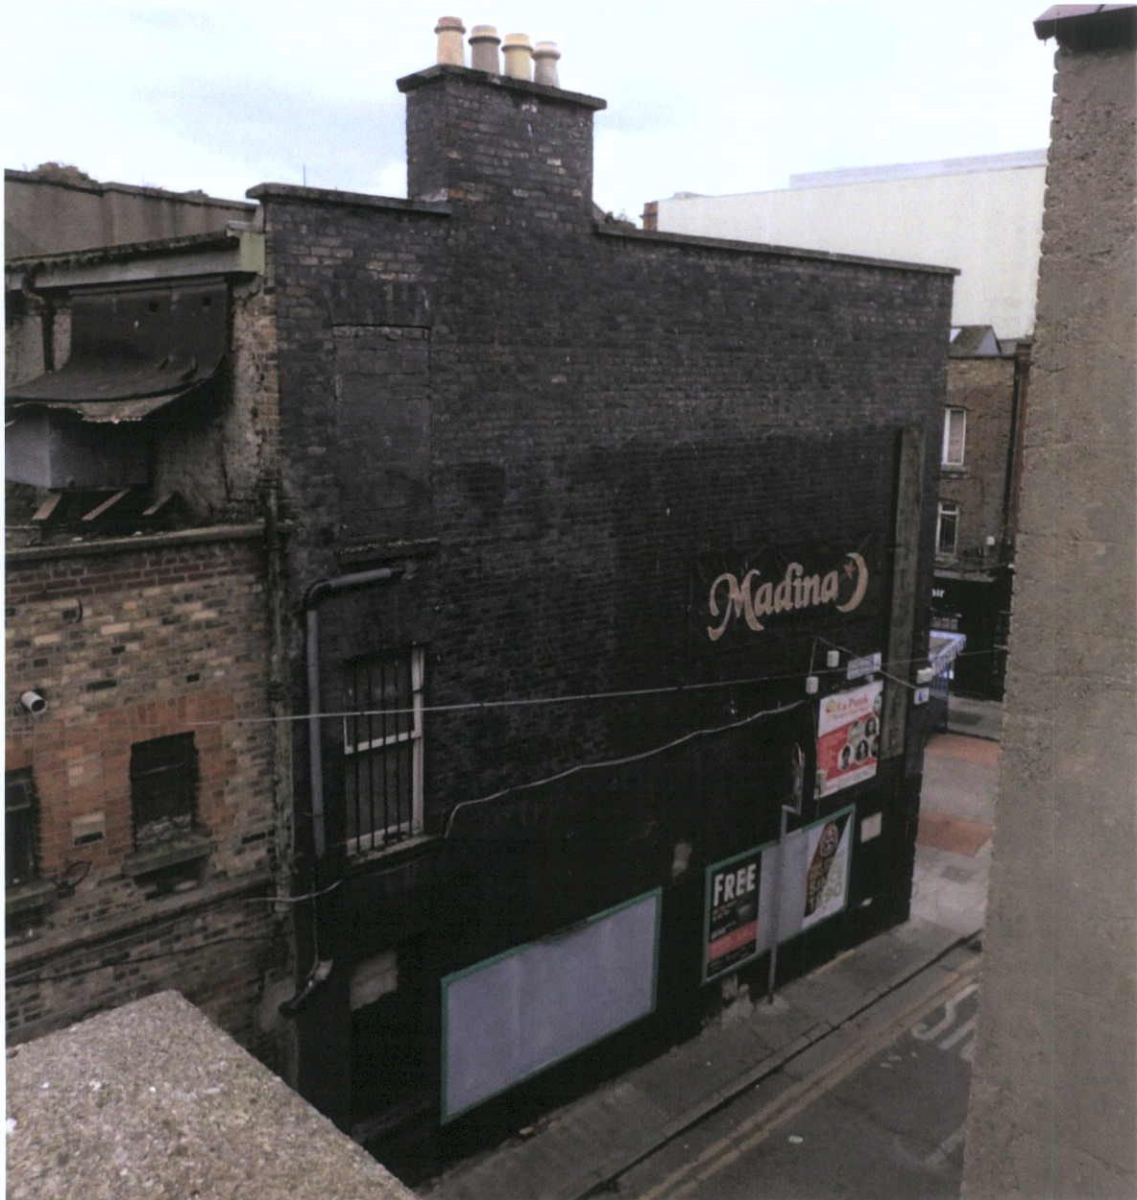
Fig.4.12.4: View of the painted north wall of No.9 Moore Street.

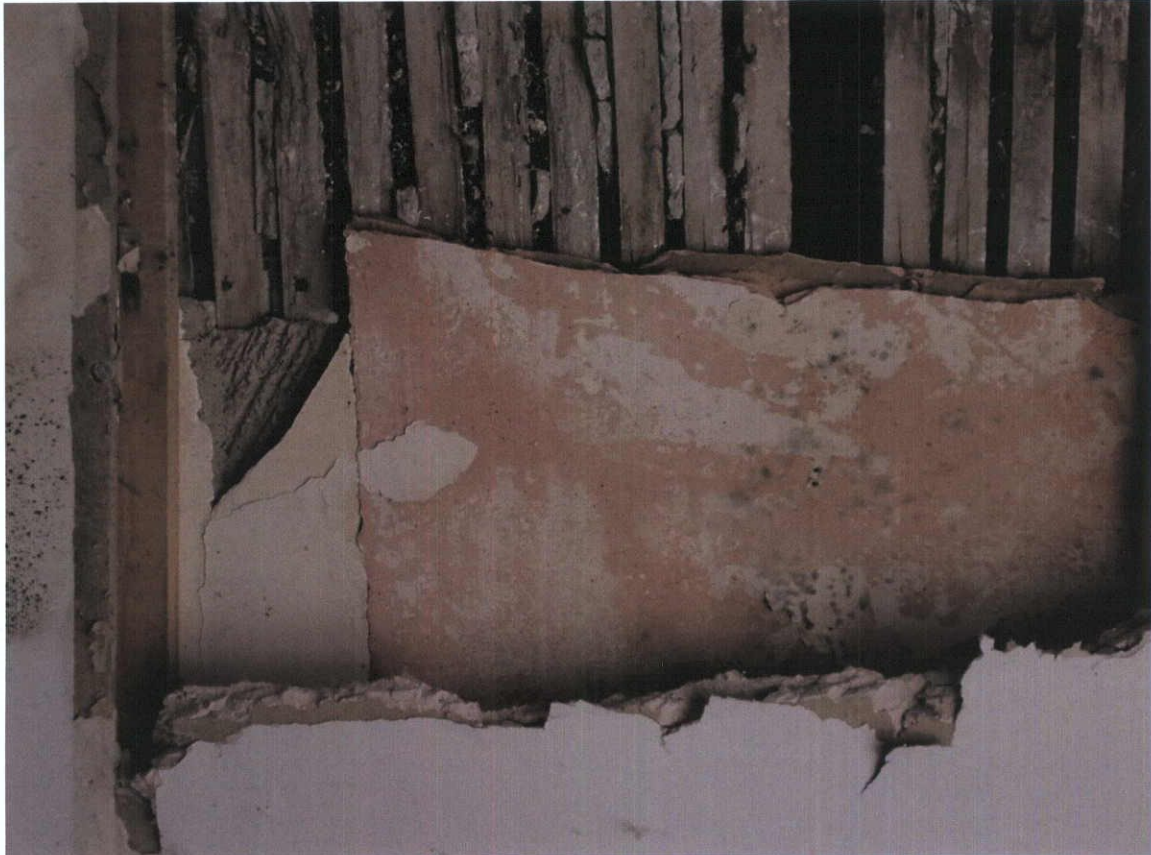
The ceiling plasterwork is pink gypsum applied on timber lath. However, the lathwork has the nibs of a lime-based keying surviving between the laths (Fig.4.12.6) which appear to be remnants of earlier lime-based plasterwork: this is at least of nineteenth century date, but may be earlier. The internal wall plaster contains burnt fuel fragments, abundant brick pozzolan and crushed brick aggregate.

Fig.4.12.6: Lime lath-and-plaster ceiling surviving at the first floor of Nos.8-9 Moore Street (concealed behind poorly-applied later ceiling plaster layers).

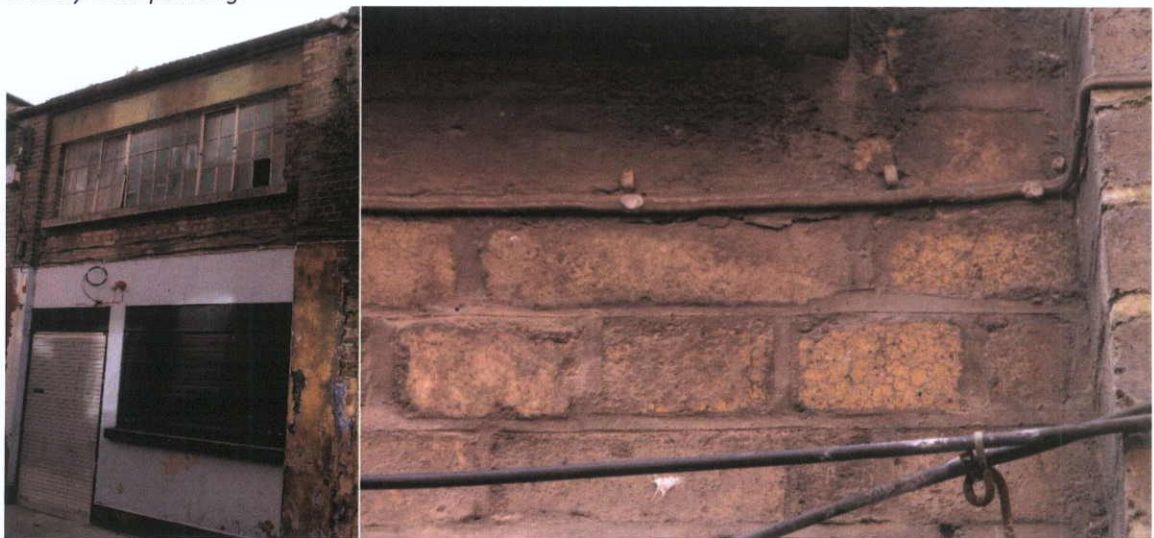
Fig.4.13.2: The brick is pointed in lined Portland Cement-based mortar, and the buff-coloured brick has crazele (network of minor cracks also called crack networks, termed 'crazing' for terracotta).

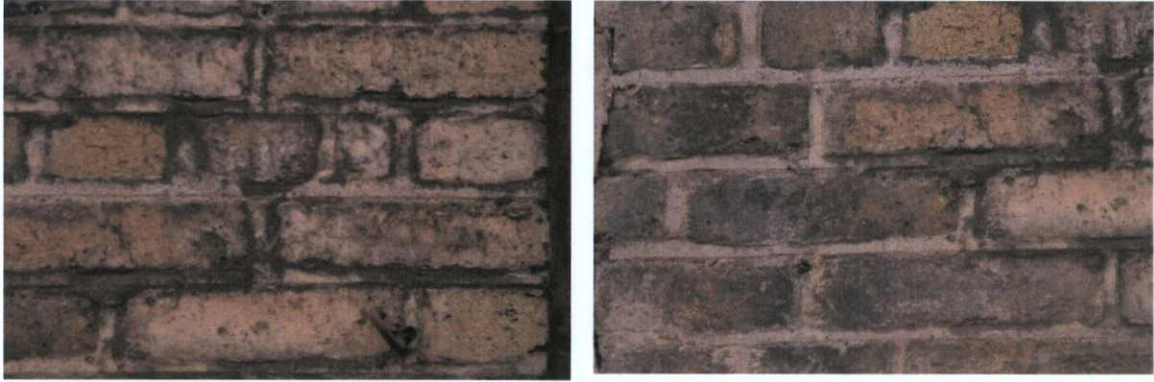
Fig.4.13.3: Soiled buff-coloured brick in lined flush pointing.

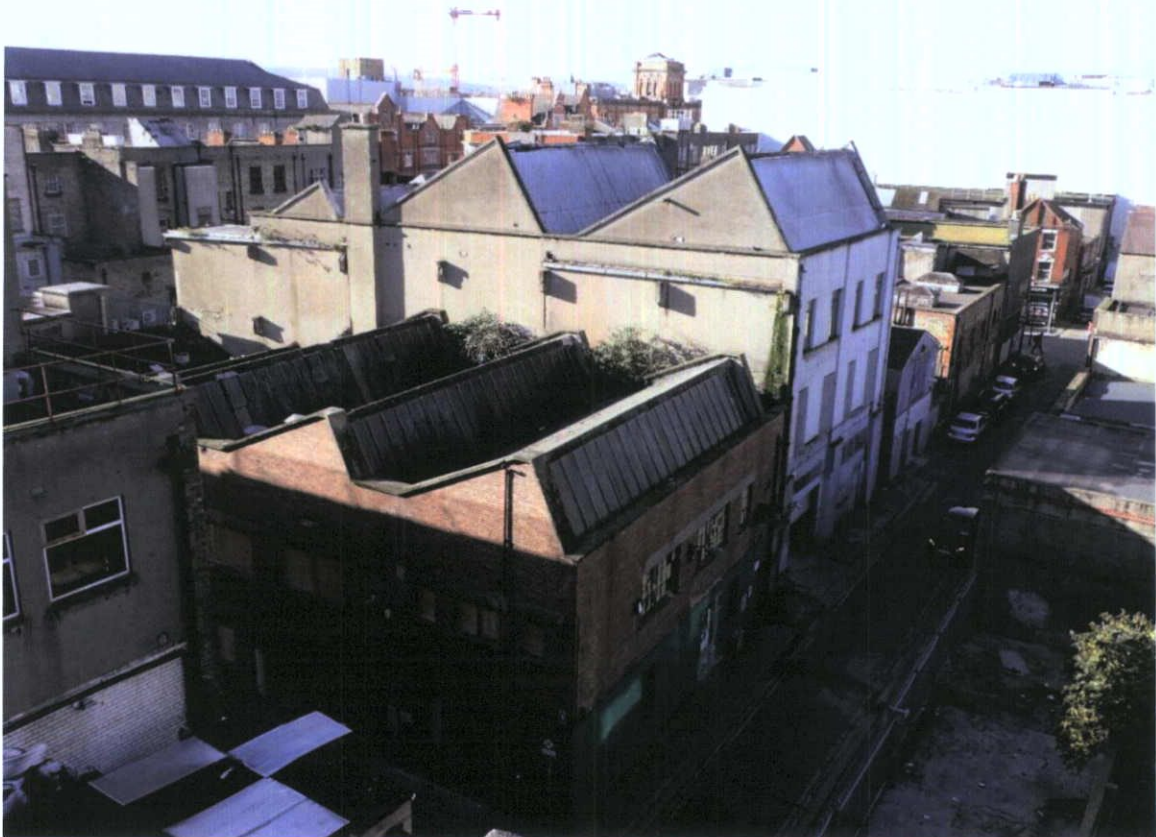
Fig.4.14.1: General view of the building showing a rendered and painted ground floor level, with a brick first floor rising to a sawtooth roof.

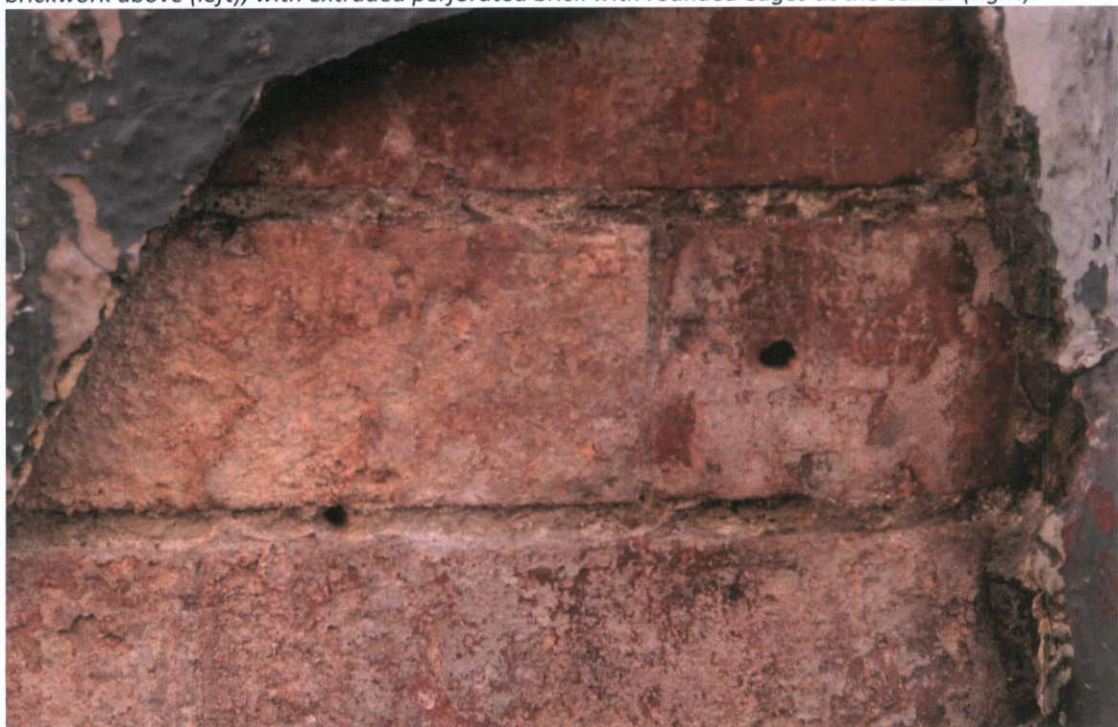
Fig.4.14.4: Detail of the curved brickwork at the north-east corner of the building.

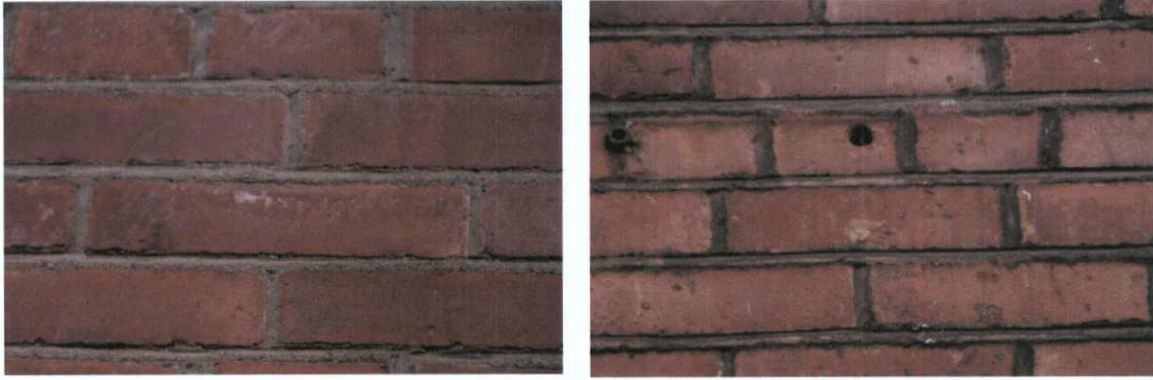
Fig.4.14.5: The brick at first floor level is remarkably free from airborne particulate soiling (which is commonly found on building surfaces which have not been previously cleaned in Dublin City). Some soiling is found on the weatherstruck joints – suggesting that the brickwork was either cleaned (or possibly built) not too long before the Air Pollution Act 1987.

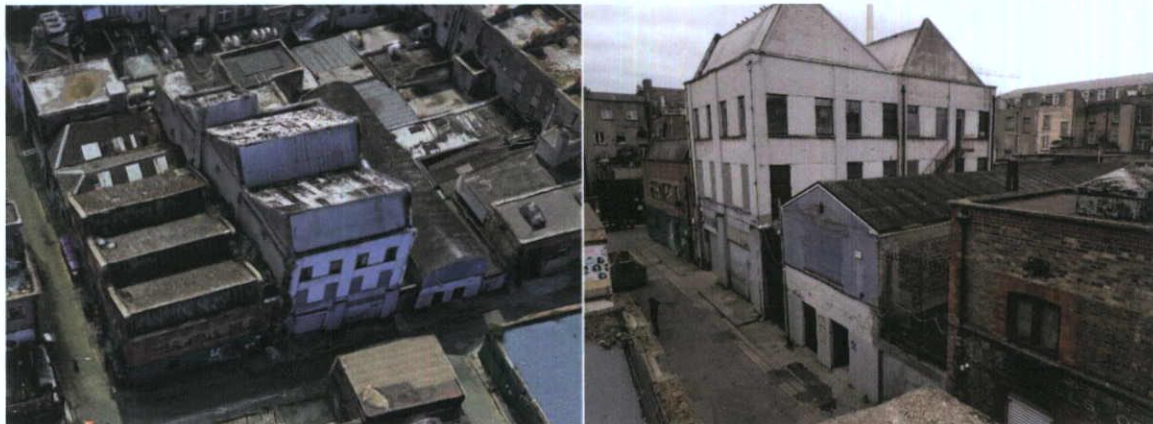
Fig.4.15.1: General view of No.9 Henry Place.

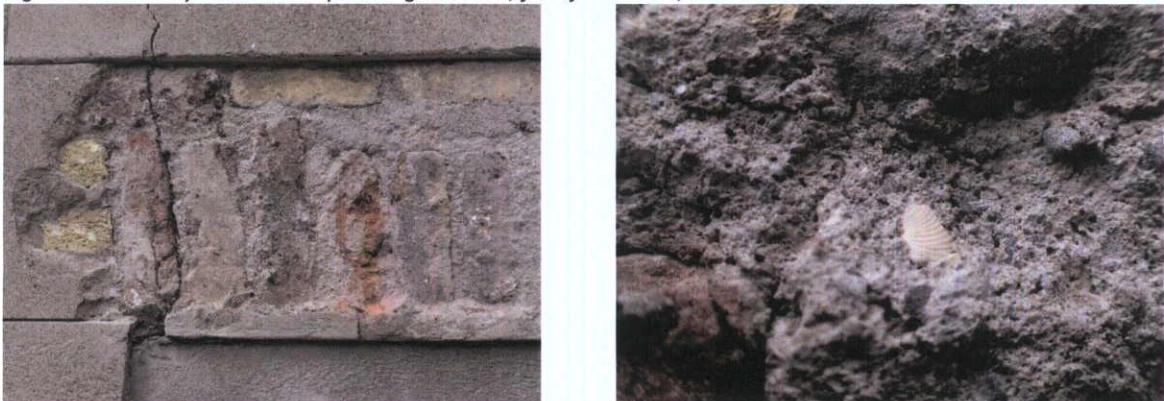
Fig.4.16.5: The first floor window head on the south elevation has a mix of 19th and c.1920s yellow stock brick (suggesting repair) bedded in a lime-cement mortar with shell included in the aggregate.

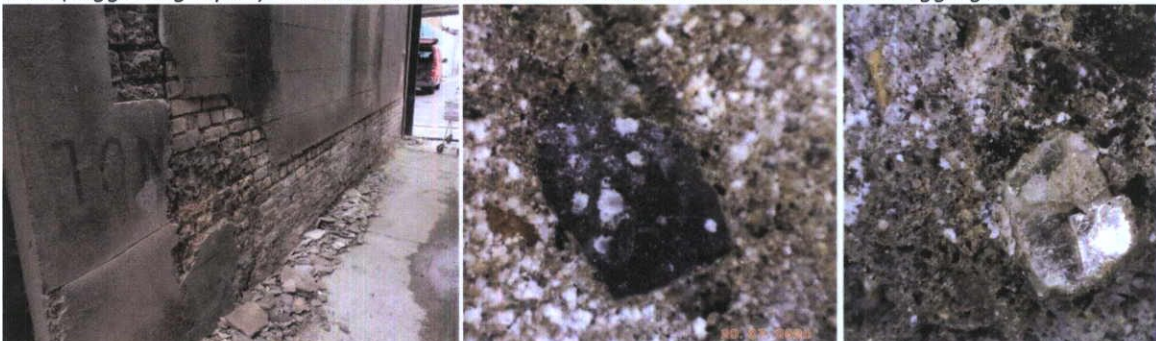
Fig.4.16.6: The north end of the east wall is coated with a Portland Cement render above a c.1920s yellow stock brick masonry substrate.

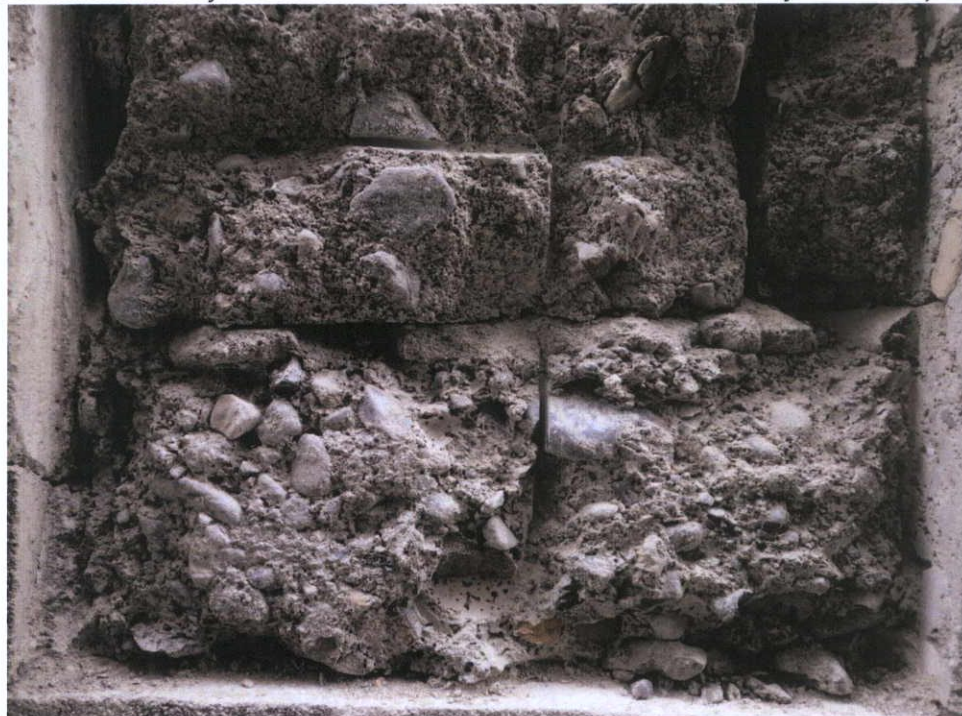
Fig.4.16.14: 1959 concrete repair, east elevation, ground floor level.

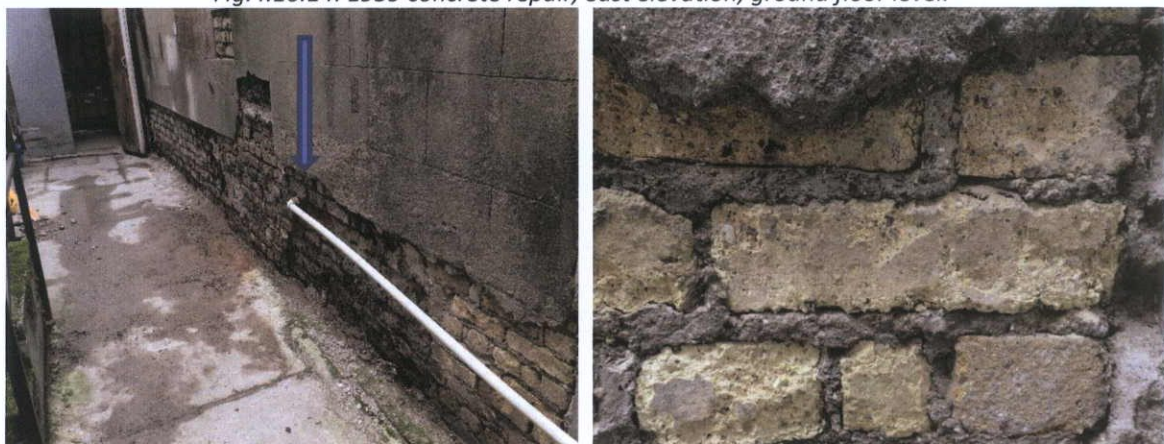
Fig.4.16.15: Junction (arrowed) between the c.1920 yellow stock brick in a cementitious bedding mortar and a section of probably nineteenth century stock brickwork in very poor condition.

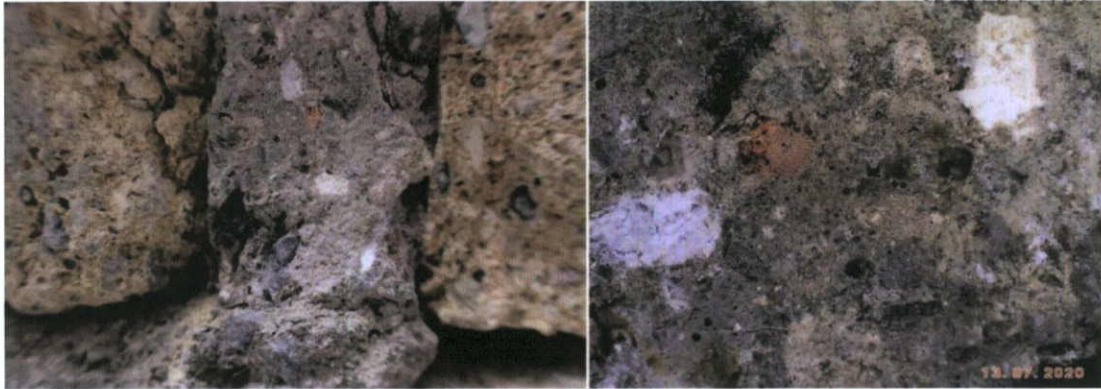
Fig.4.16.16: Detail of the cementitious bedding mortar of the c.1920s yellow stock brick.

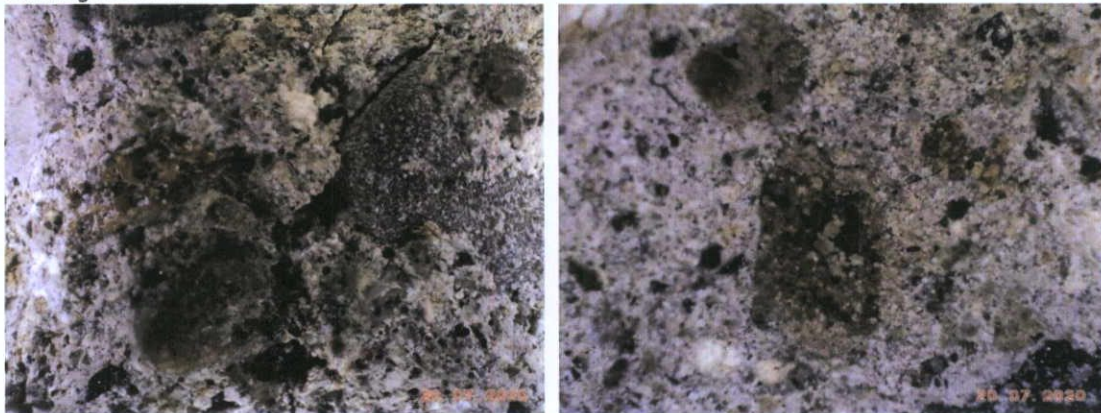
Fig.4.16.18: Crushed brick, timber and stone can be found in the cementitious bedding mortars.

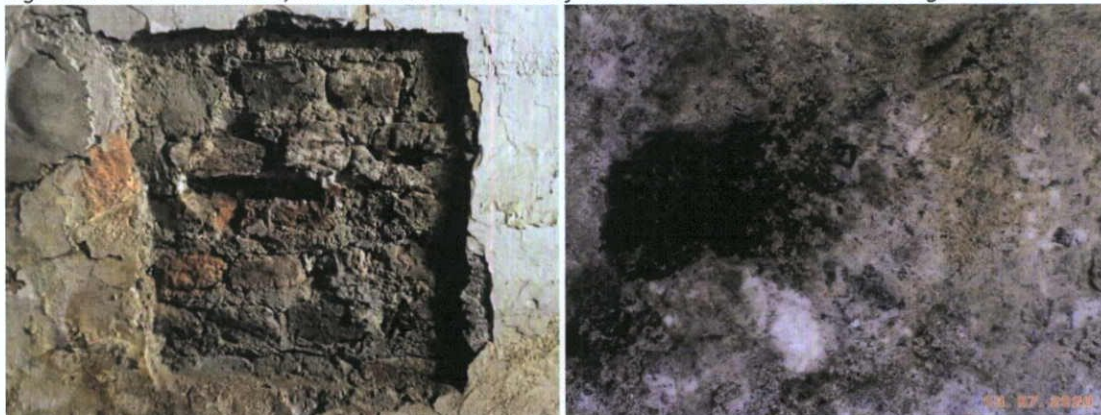
Fig.4.16.19: Nineteenth century stock brick and Calp limestone masonry at the south end of the west wall at ground floor level of No.10 Henry Place, coated with a cementitious internal plaster.

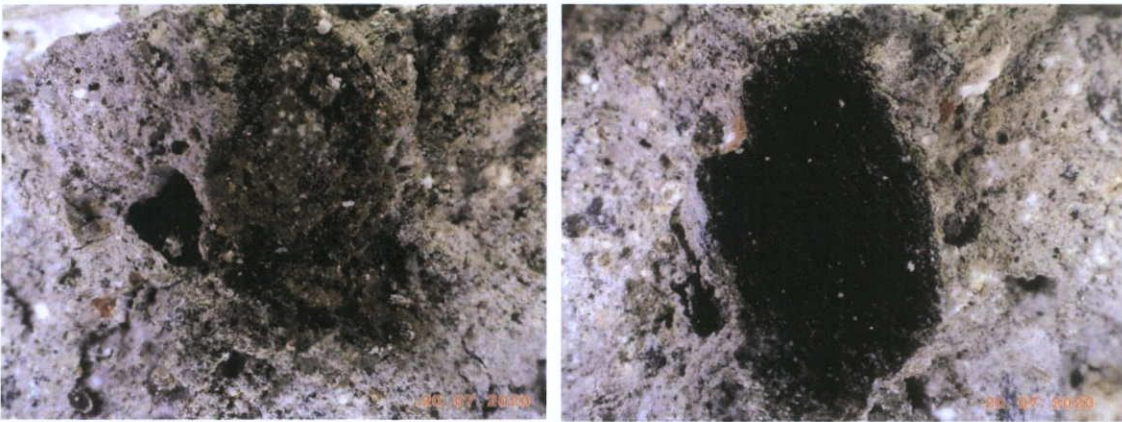
Fig.4.16.21: Crushed yellow, brown, beige, red and orange brick fragments are found in the plaster.

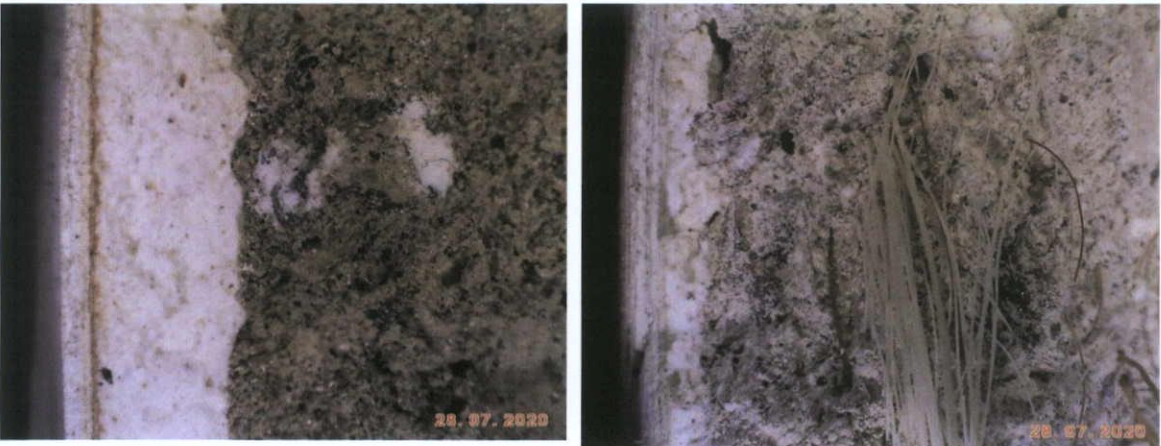
Fig.4.16.22: Detail of plaster, ground floor level, south end of the west wall. Some parts retain areas of haired lime, which were considered as trace remnants of the nineteenth century surface.

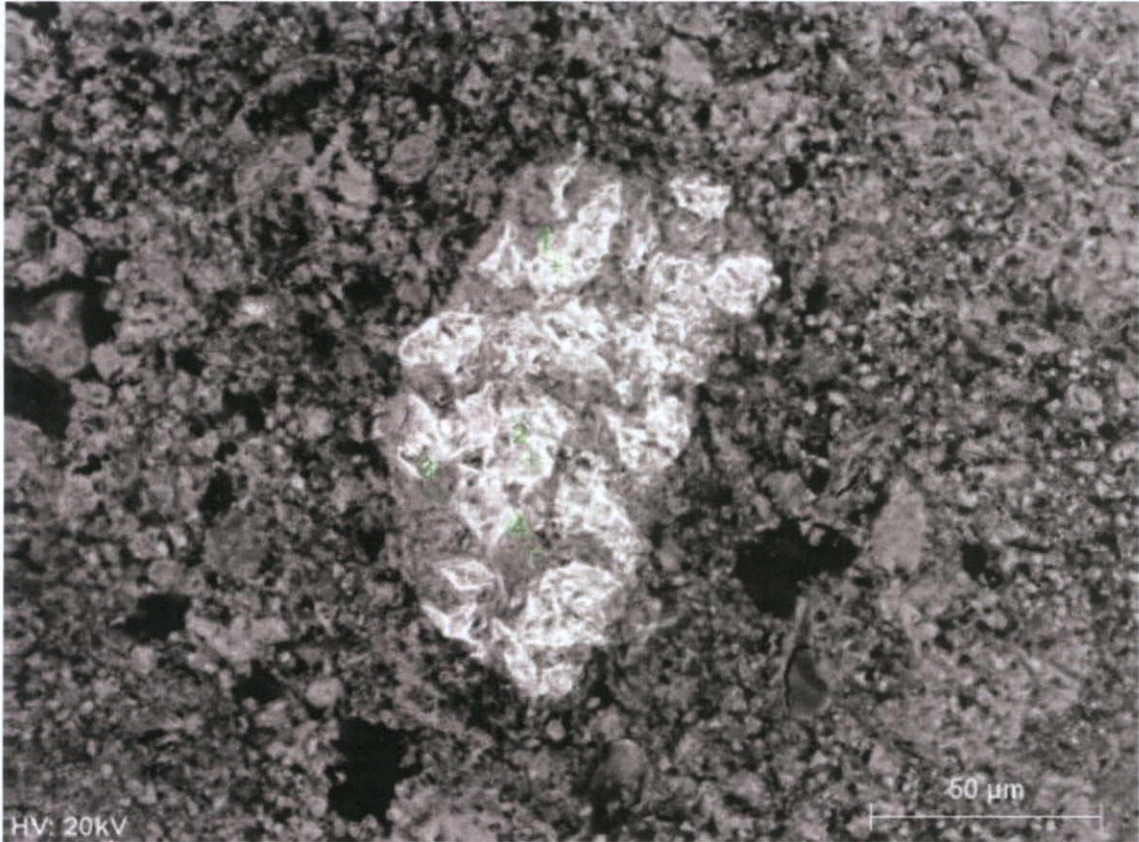
Fig.4.16.25: SEM-EDS analysis of the cementitious binder binding the 1920s yellow stock brick showing clinker phases

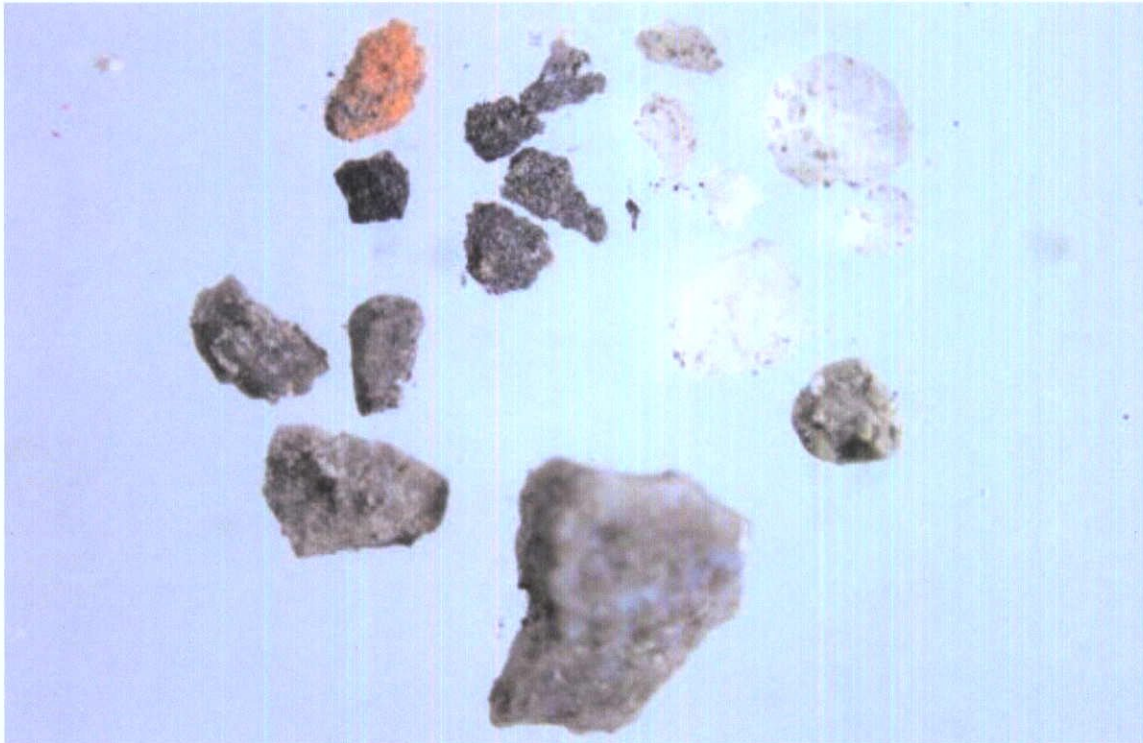
Fig.4.16.26: In contrast, the aggregate of the lime-based bedding mortars consists mainly of limestone, quartz, some chert and a fraction of brick aggregate.

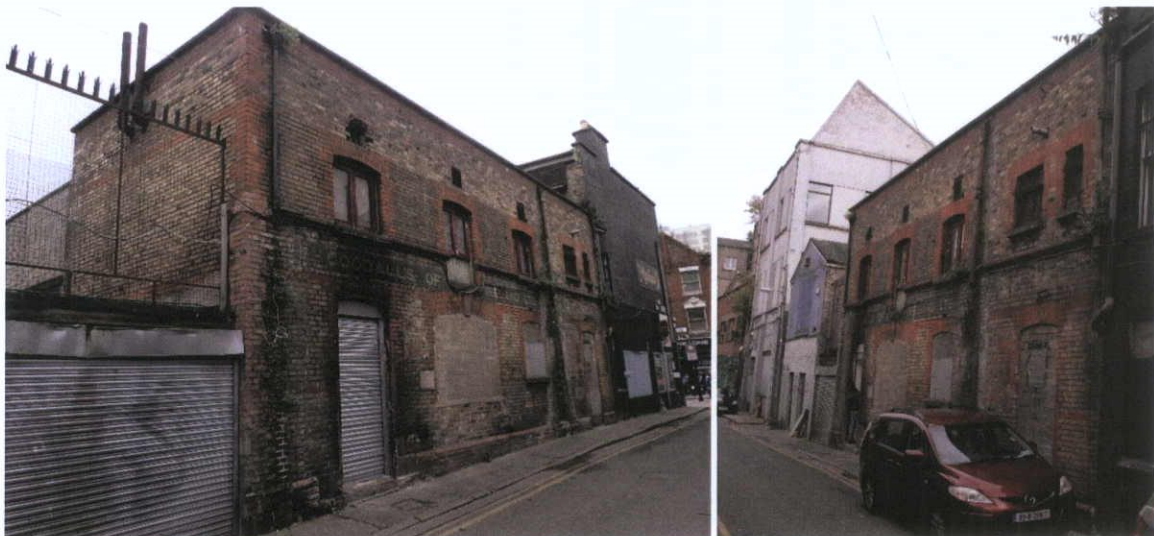
Fig.4.17.1: General view of Nos.11-13 Henry Place.

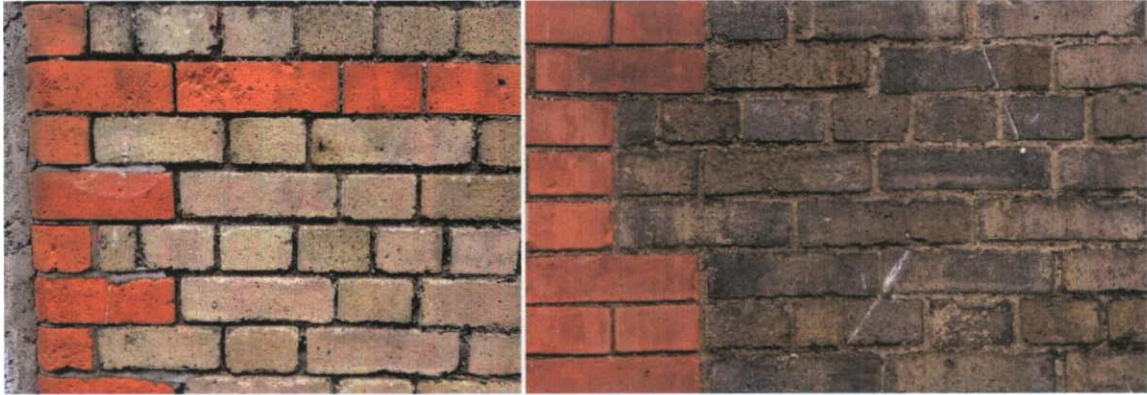
Fig.4.17.2: 'Cleaned' brickwork showing surface damage to the red and yellow brick with loss of fireskin and mortar from the bedding joints (left); soiled but intact original brick and mortar.

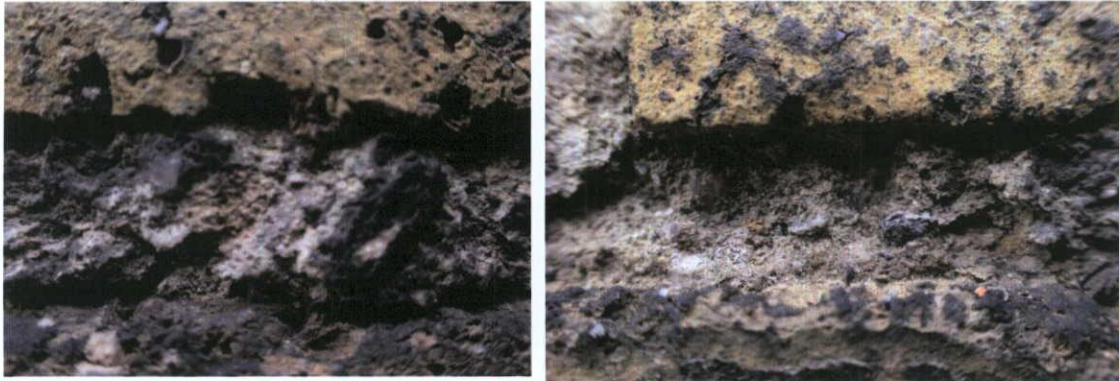
Fig. 4.17.3: Soiled, damaged surface of the bedding mortars.

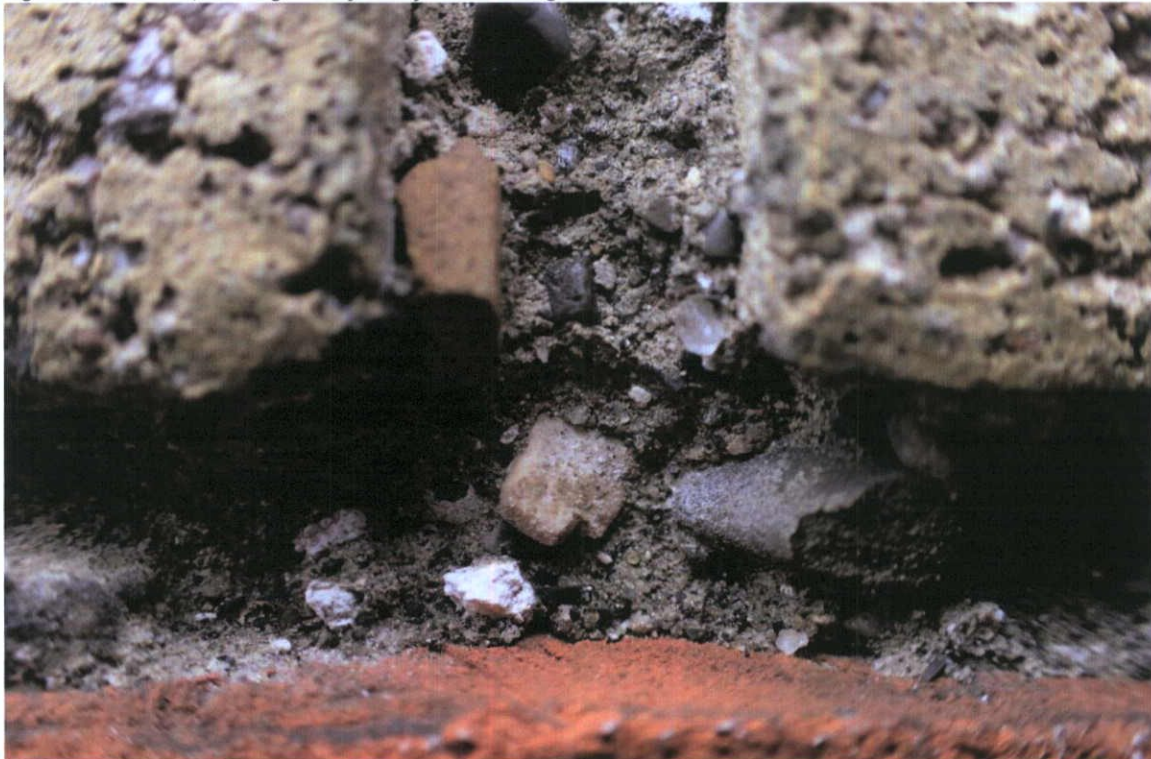
Fig. 4.17.4: Poorly sorted limestone, sandstone, quartz and chert aggregate with coarse lime lumps in a water-damaged lime binder.

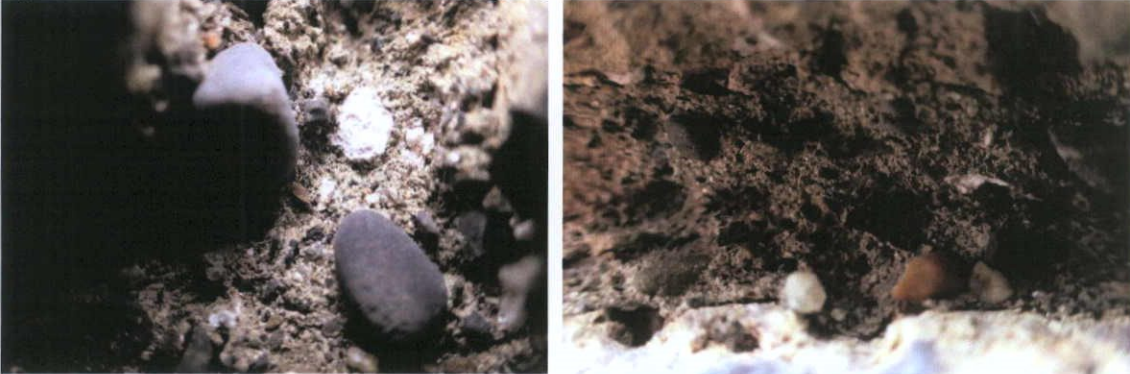
Fig. 4.17.7: Rounded limestone aggregate and sub-angular quartz with coarse burnt fuel fragments.

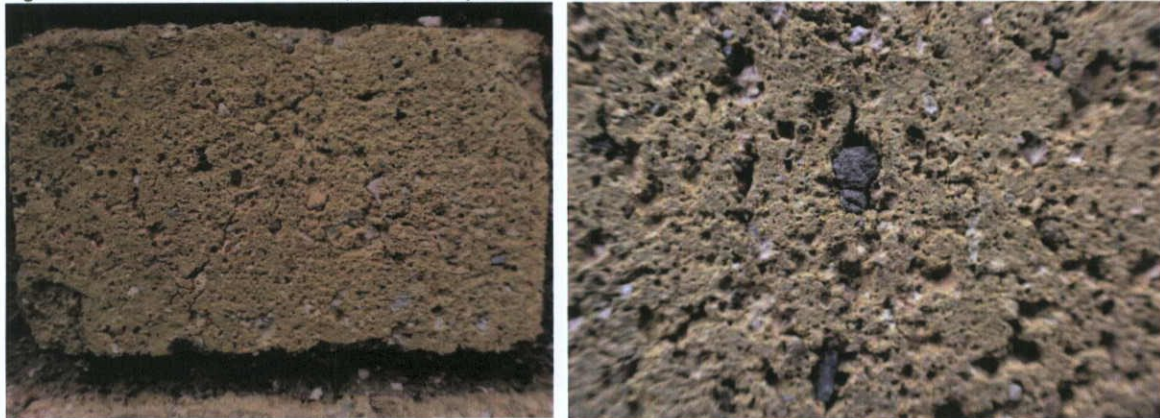
Fig. 4.17.11: Yellow brick damaged by abrasive cleaning showing the exposed brick core with abundant pebble inclusions from the unprocessed raw clay used to manufacture the brick.

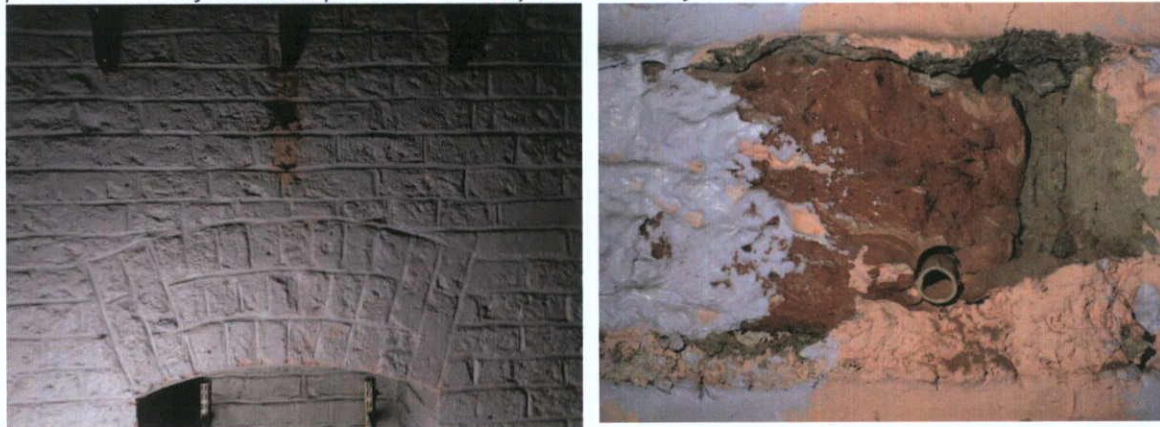
Fig. 4.17.12: The brick fireplace in the east wall at first floor level.
