4.9 5 Moore Street: The three-storey two-bay brick-fronted terraced building rising to a limestone frieze and cornice, built c.1917, has brick ‘soldier’ quoins and a modern shopfront at ground floor level. The architectural detail is uniform across the terrace, with identical limestone detailing at parapet and shopfront level, and with brick specials forming a string course between the first and second floor levels. The brickwork was finished with flush joints. No.5 was built c.1917 as part of a single build with Nos.3, 4 and 6 Moore Street.

4.10 6 Moore Street: The three-storey three-bay brick-fronted terraced building rising to a limestone frieze and cornice, built c.1917, has brick specials forming a string course between first and second floor levels, and with 'soldier' quoins farming the building, having a modern shopfront at ground floor level. The building forms part of a group with Nos.4,5,and 6 Moore Street.

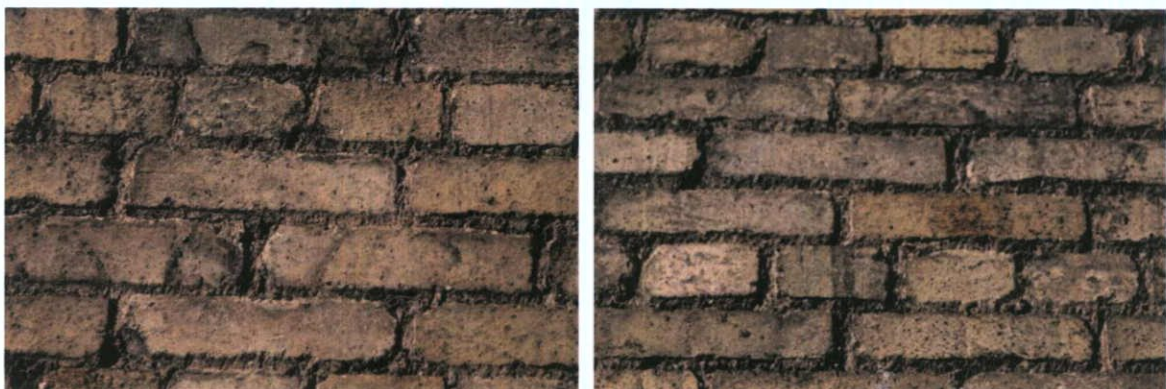
Fig.5.1.4: The south elevation is painted at ground floor level, and the upper parts are soiled and were not accessible. The yellow stock brick have some surface defects, and the soiled bedding mortars show flush finishes, weatherstruck finishes but are mostly disrupted (suggesting that the soiling is gypsum-based and the bedding contains lime). The brick appears broadly similar to that seen at Nos.17-18 Henry Place.

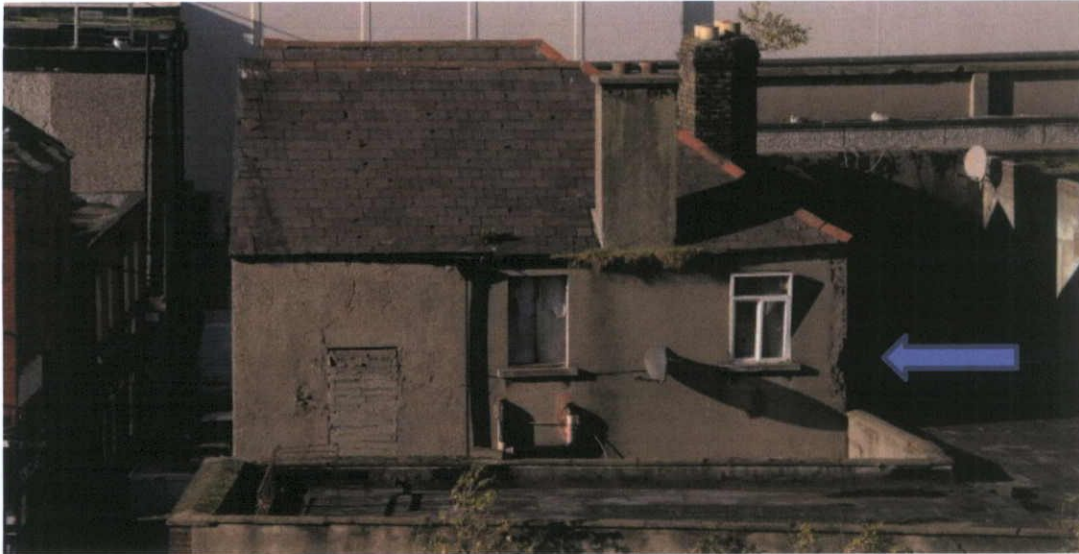
Fig.5.1.5: The rear of No.10 Moore Street is rendered. The north side (arrowed) was opened up.

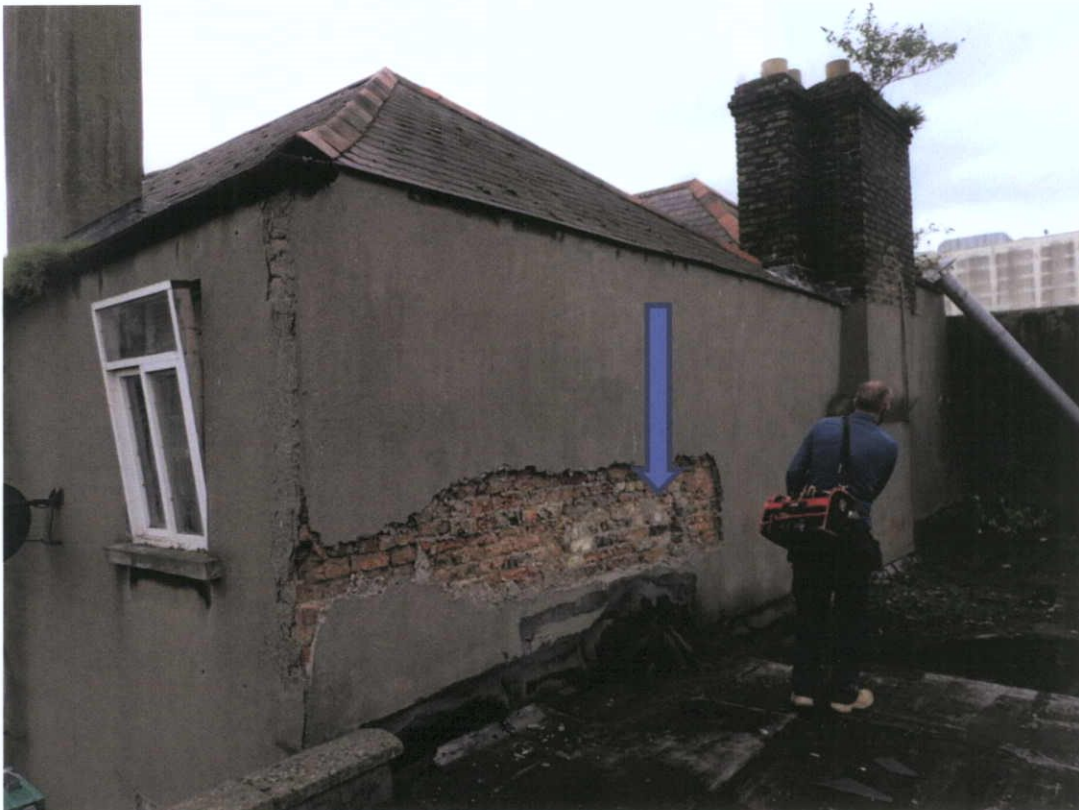
Fig.5.1.6: Exposed brickwork beneath Portland Cement render, north elevation, 10 Moore Street. The masonry has been disturbed and appears to be a 'creephole' (arrowed). See Fig.5.1.9 also.

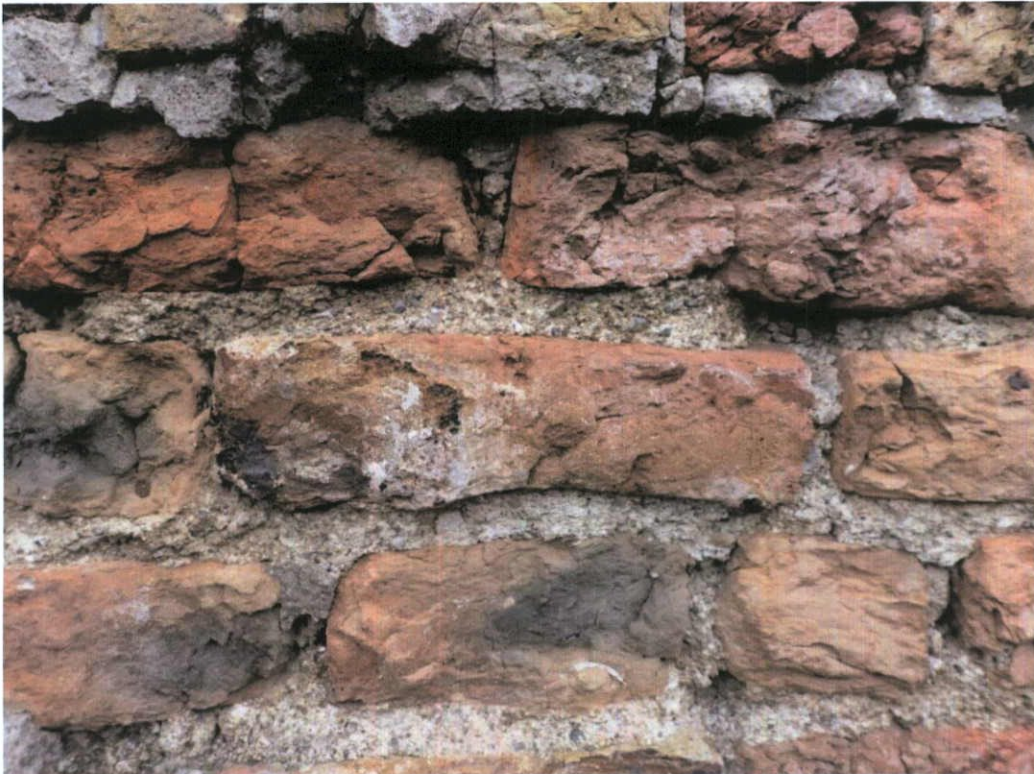
Fig.5.1.7: Detail of north elevation of No.10 Moore Street. The exposed brickwork consists of hand-made clamp-fired bricks showing a lack of sorting of the raw clay material, characteristic moulding and shaping defects, and both underfired and over-fired examples of brick. The bricks do not conform to standard imperial sizing.

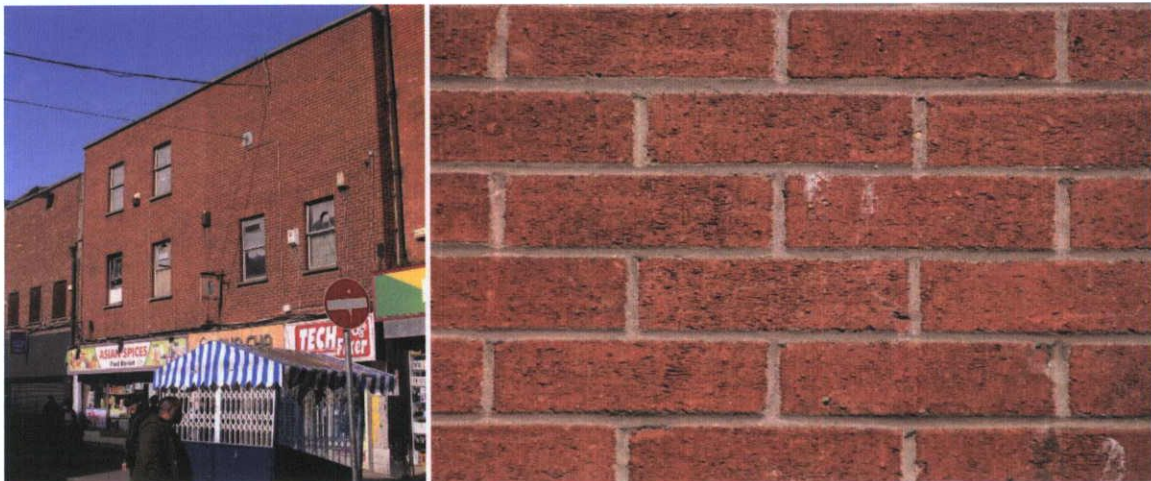
Fig.5.2.1: The façade of 11-12 Moore Street was built of machine-cut textured brick bedding in Portland Cement and finished with a 'bucket handle' joint, this finish is common from the late 1950s-1980s. The brick is widely used in the twentieth century, and this type of textured brick could date from anywhere from the 1930s to the 1990s.

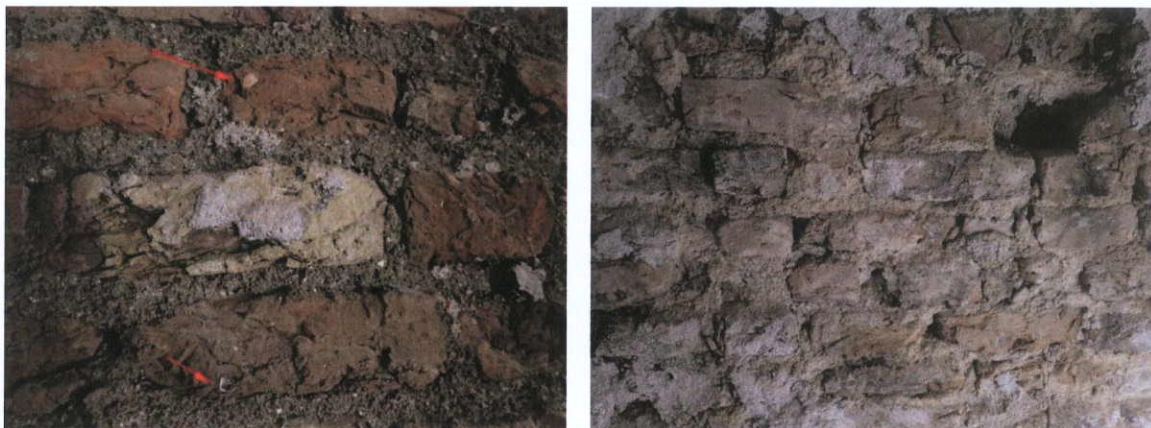
Fig.5.3.2: 13 Moore Street, Ground Floor, Rear Room, north face of south wall (party wall with No.12). Detail of handmade brickwork from the internal party wall between Nos.13 & 12 Moore Street with burnt shell inclusions (arrowed) within the fired clay matrix (left). The original brick at first floor level (right) is also hand-made and of varying dimensions and qualities, laid in deep lime mortar joints. These are ‘place’ bricks intended to be coated with a lime plaster.

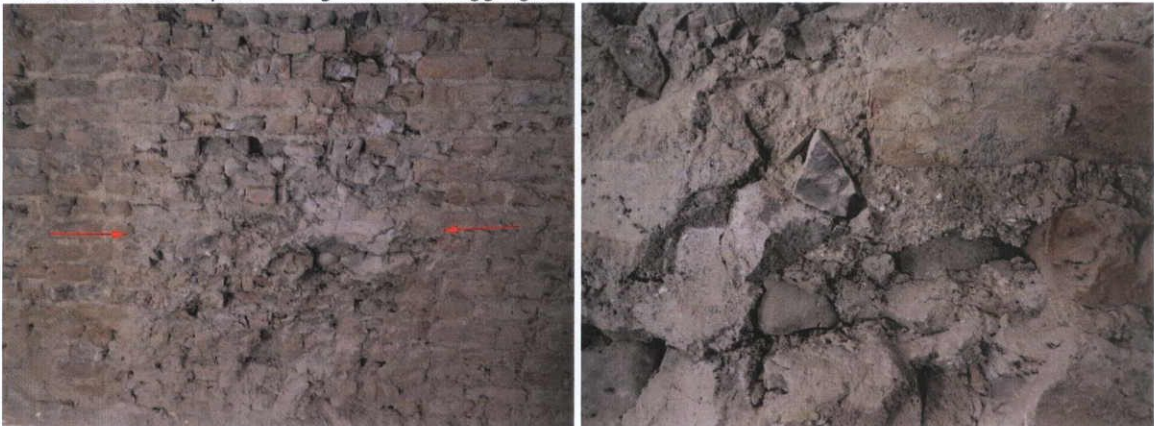
Fig.5.3.7: 'Creephole' at ground floor level, front room, south wall: showing a change in construction with the insertion of broken cobbles and other materials bonded in a cement-based mortar.

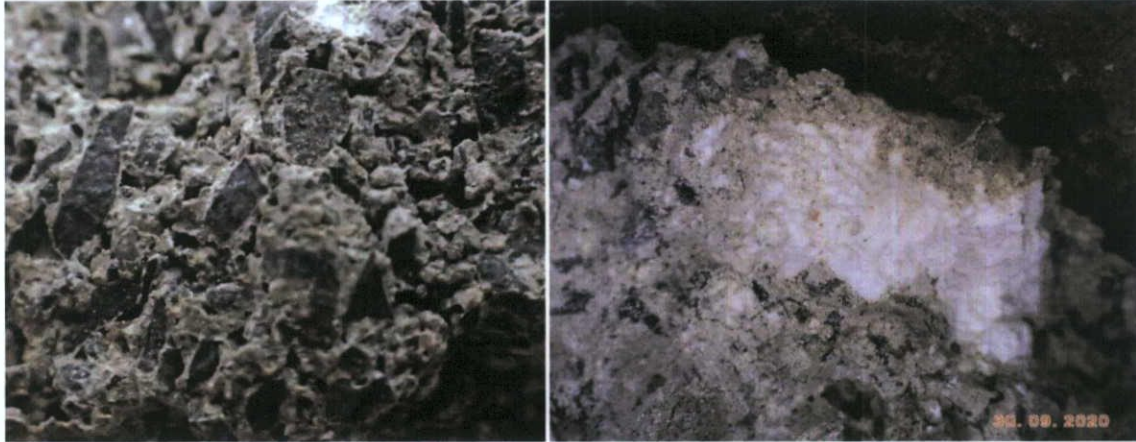
Fig.5.3.10: Detail of 20th century concrete repair to the south wall at ground floor level.

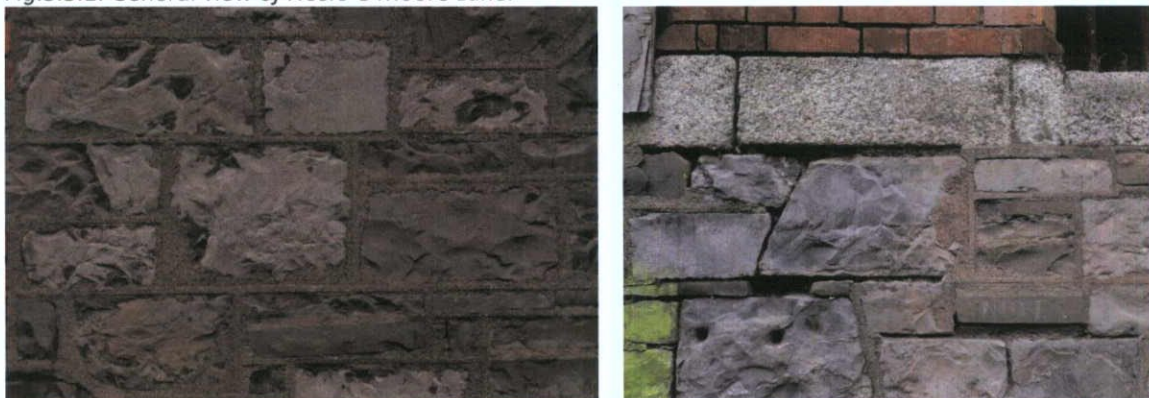
Fig.5.5.2: The coursed hewn Calp limestone masonry has been repointed with coarse-grained Portland Cement strapwork, which was also used as a repair mortar at the time of application.

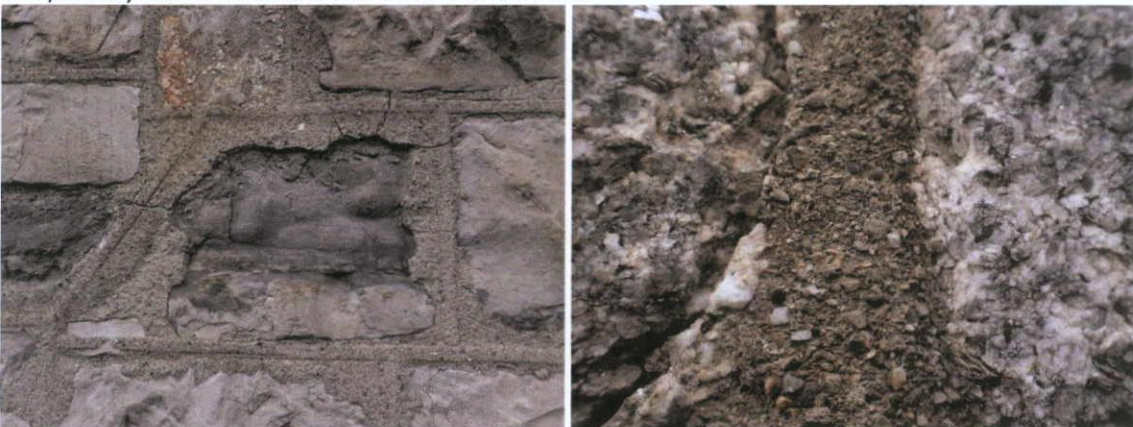
Fig.5.5.6: Mid-twentieth century Portland Cement-based repair and pointing mortar.

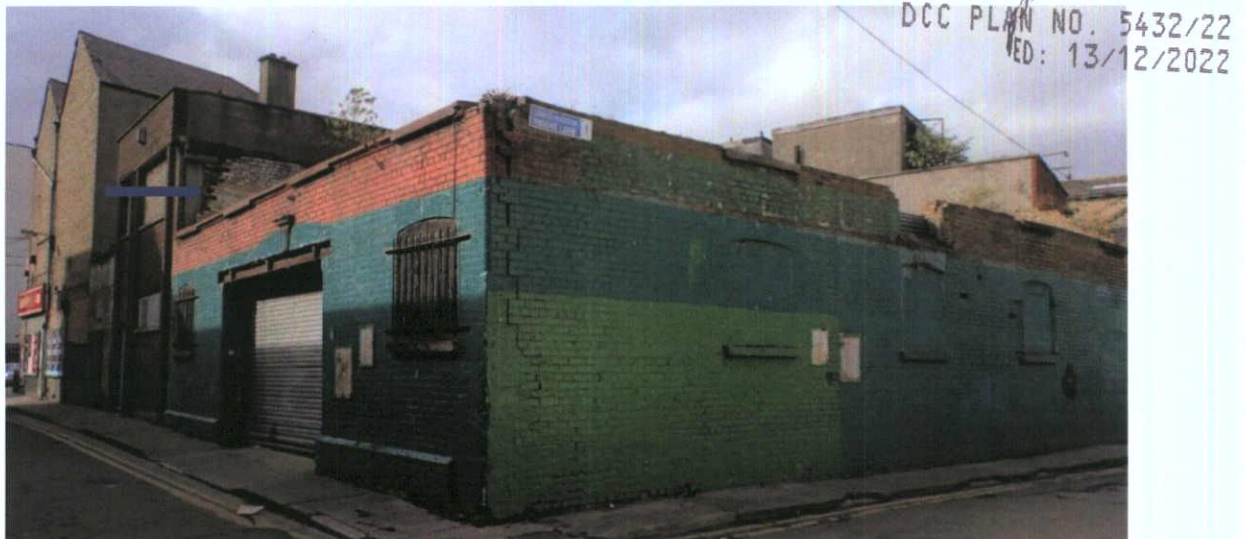
Fig.5.6.1: The building appears to have been cut down with upper floors removed. Part of the west wall at first floor level survives (arrowed). There is no wall-top, coping or other finish to the brick walls.

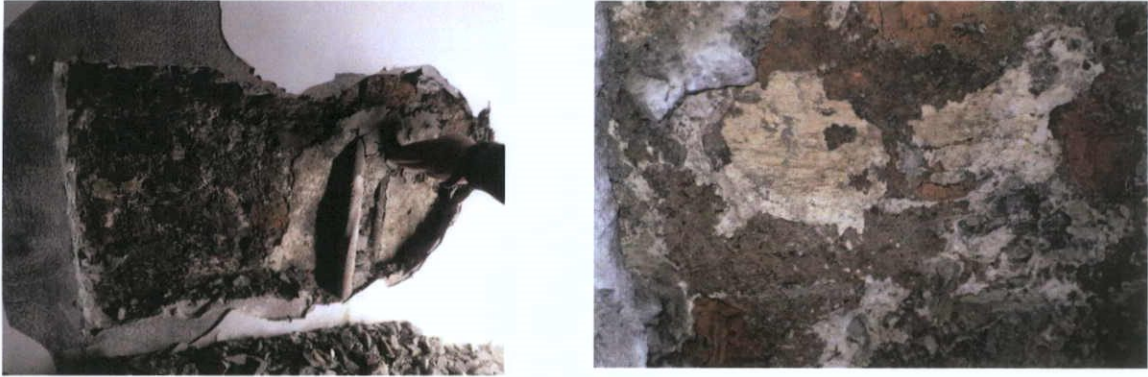
Fig.5.6.10: The north wall is composed of hand made and probably clamp-fired red place brick, concealed behind a cement-based plaster. This brick masonry wall is very different in composition to the other walls in the building, and is more similar to the party walls found behind the internal plasterwork of the buildings between No.18 and Nos.20-21 Moore Street. While only a relatively small section of brickwork was exposed – this appears to be an early wall for the area, and may even be a late eighteenth or early nineteenth century brick wall.

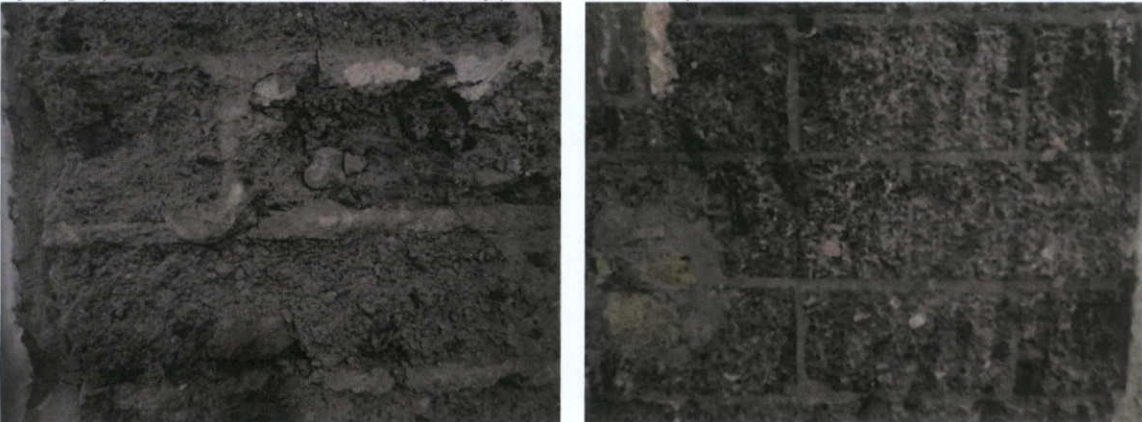
Fig.5.7.5: Concrete blockwork with natural stone, clinker and occasional iron fragments used to form the party wall with No.17 Moore Street, with a similar concrete block of smaller dimension used to form the rear wall of No.18 Moore Street.
