**Appendix A6** Building Materials Analysis Report

This report was prepared at the request of Molloy & Associates Conservation Architects to inform the Dublin Central Built Heritage Review for Hammerson Plc. The purpose of the work was to analyse the physical fabric of buildings on O'Connell Street, Parnell Street, Henry Street, Moore Street, Moore Lane and Henry Place; and to use the physical evidence gathered through study of the building materials to gain a better understanding of the significance and dating of each of the buildings. This report is Volume 2 (of 2)<sup>1</sup> and focuses on the buildings contains in Sites 1 and 2 in the Dublin Central project.

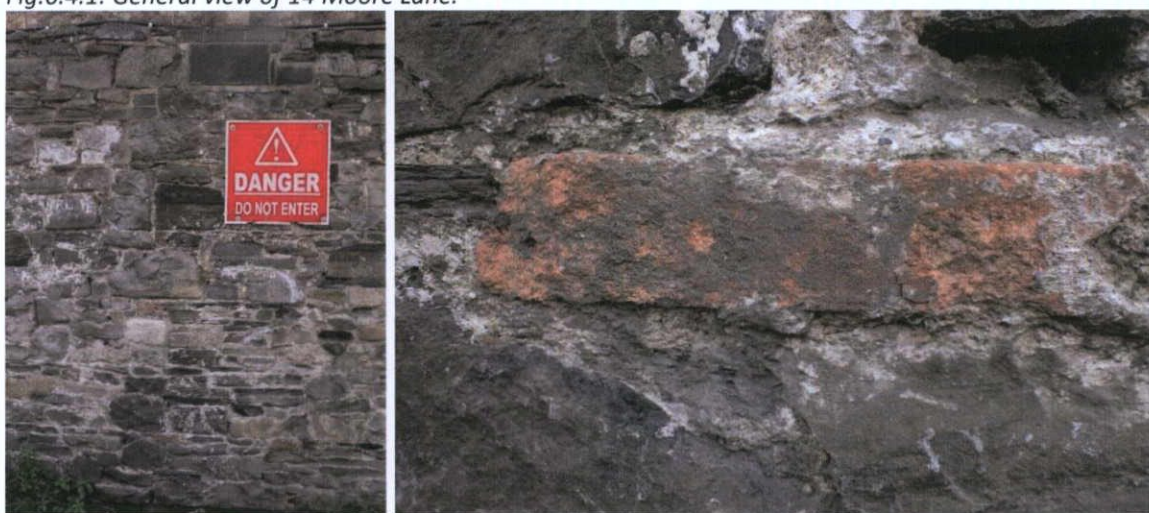
Fig.6.4.2: Calp limestone masonry section with thin brick forming part of the fabric. Note that the masonry contains flaggy and rounded stones. The masonry is similar to the Calp limestone masonry forming the internal east wall at 9 Henry Place (probably the remnants of a nineteenth century stable).

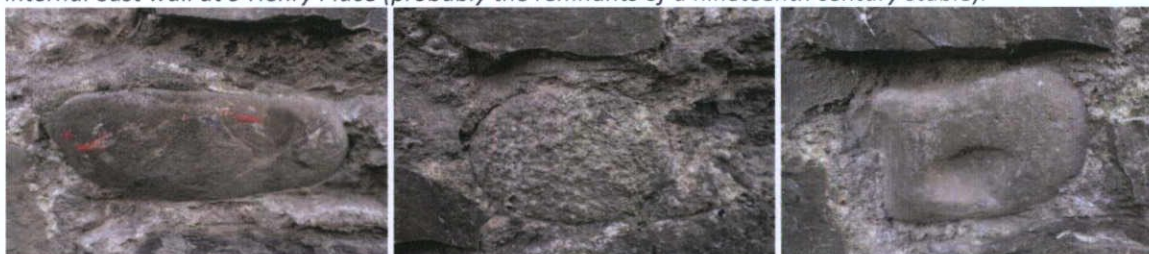
Fig.6.4.3: Rounded cobble-sized limestone is also found in the wall fabric.

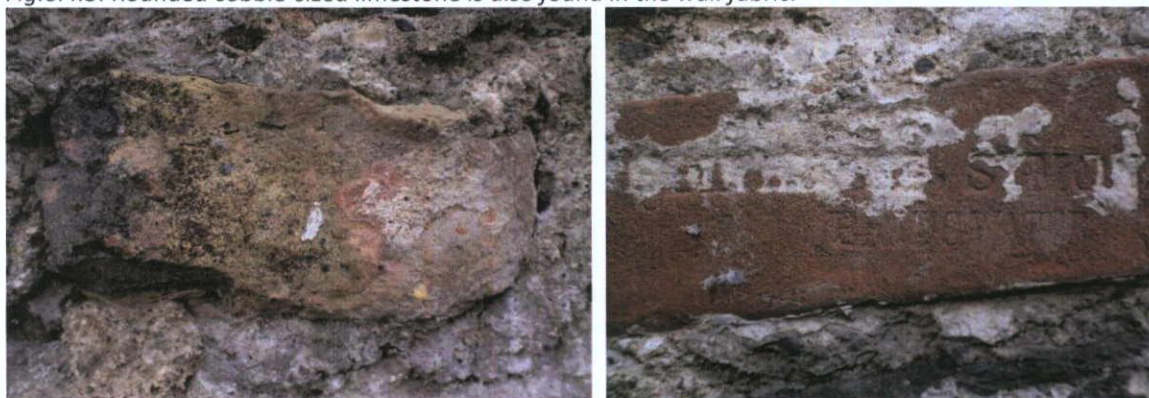
Fig.6.4.4: Irregular distorted clamp-fired vitrified yellow brick, possibly 18<sup>th</sup> century (left) and imported stamped 'Colhurst Symon & Co. Ltd Bridgwater' from Somerset. This brickmaker was in operation from 1857 until the 1960s

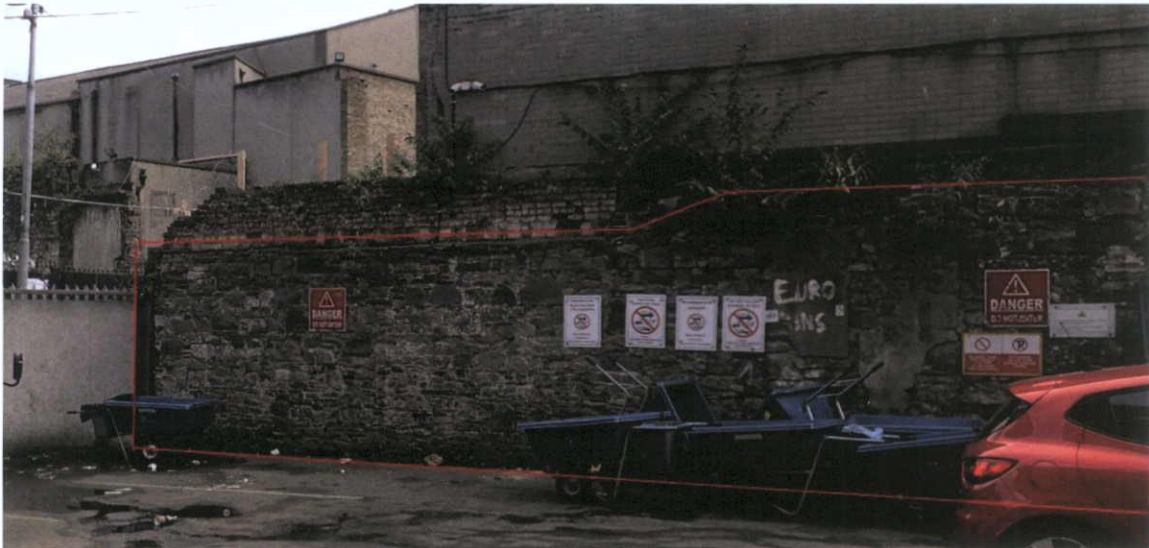
Fig.6.4.5: The eastern section of the wall consists of hewn Calp limestone masonry bonded in a lime-based mortar.

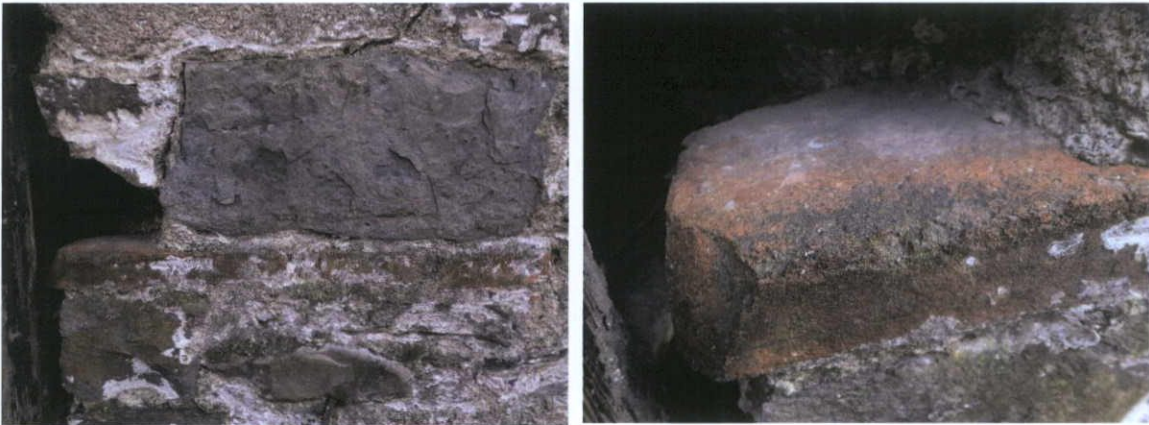
Fig.6.4.6: Ceramic tile used within the masonry.

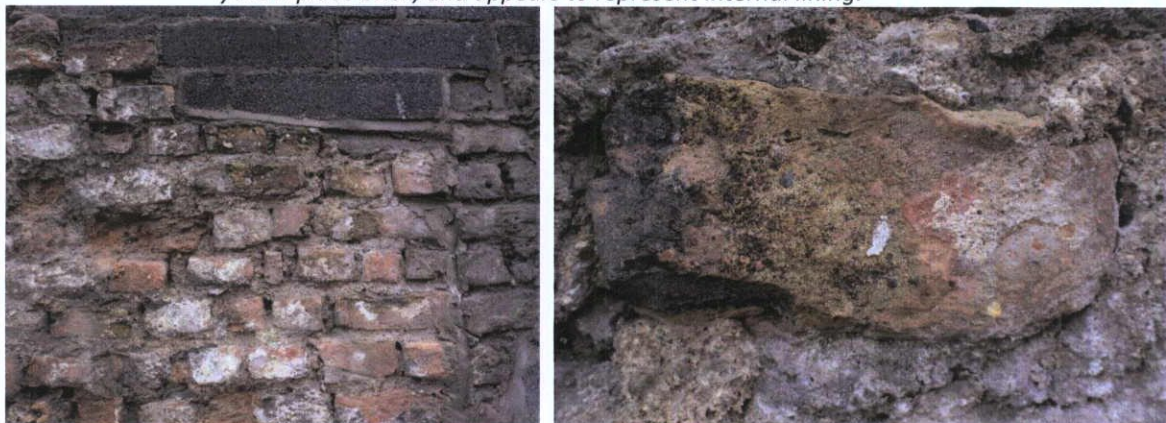
Fig.8.4.11: Poorly formed hand-made place brick, with modern concrete construction adjacent.

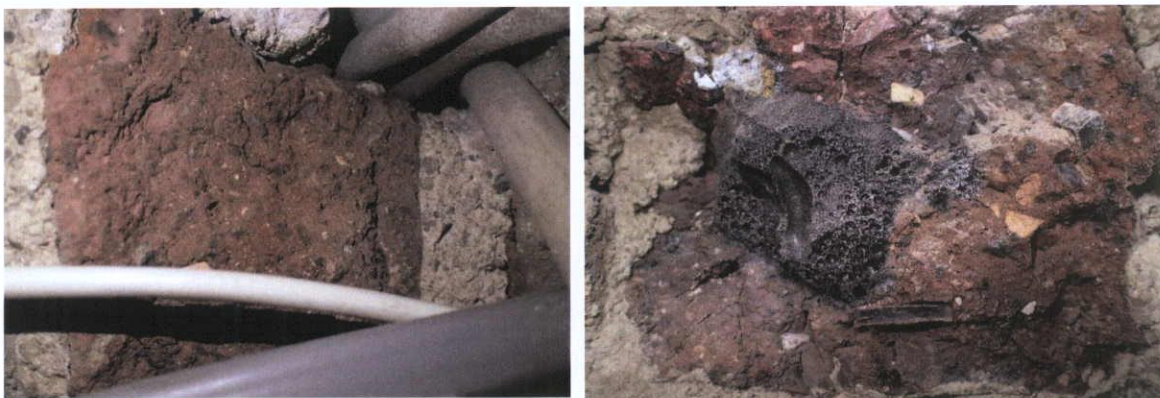
Fig.9.1.1: Brick with coarse angular limestone inclusions from the basement of No.43 O’Connell Street (left), and seen in the internal walls of No.71 Parnell Street (right).

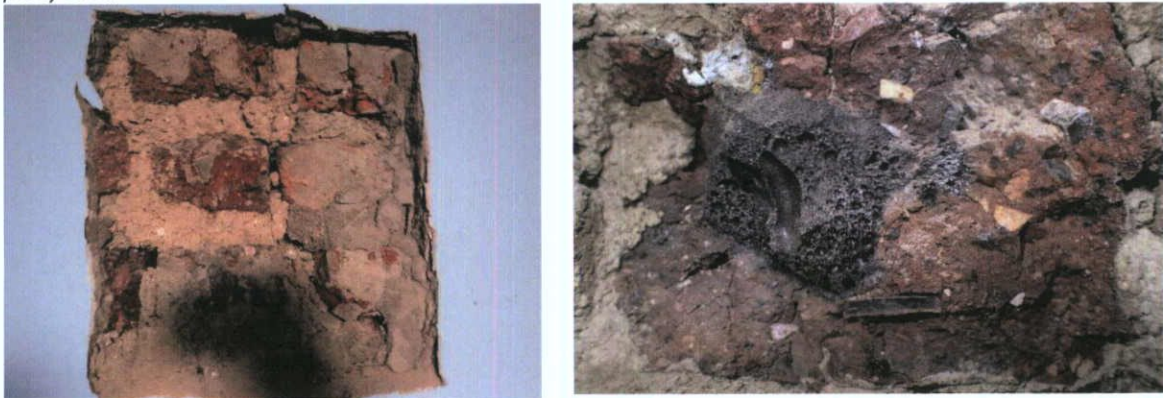
The internal walls were built with relatively low-quality irregular hand-made clamp-fired bricks showing many manufacturing defects (Fig.4.1.2). These are laid in thick, deep lime mortar joints where the bedding joint depth is c.1/3 the height of the brick. The bricks were made from unsorted and unprocessed natural raw clay containing abundant low-sphericity sub-angular limestone fragments; some of which were partially calcined during brick firing. These coarse non-plastic inclusions also include chert fragments suggesting that the brick field lay on a substrate of Dublin Calp limestone (the bedrock which underlies Dublin City and environs). This suggests these bricks were made in or close to Dublin City. The bricks also contain black, glassy, vitrified over-fired zones. The medium-grained lime-rich mortars contain poorly-sorted sub-rounded coarse (<5mm $\varnothing$ ) predominantly limestone aggregate, coarse crushed brick (1-4mm $\varnothing$ ) probably added as a pozzolan, and irregular lime lumps c.2mm $\varnothing$  extending to >5mm in places indicating poor-quality mixing and craftsmanship.

Fig.4.1.2: The internal party wall contains clamp-fired brick laid in thick beds of lime-based mortar. The hand-made brick contains coarse limestone inclusions and black over-fired vitrified zones.

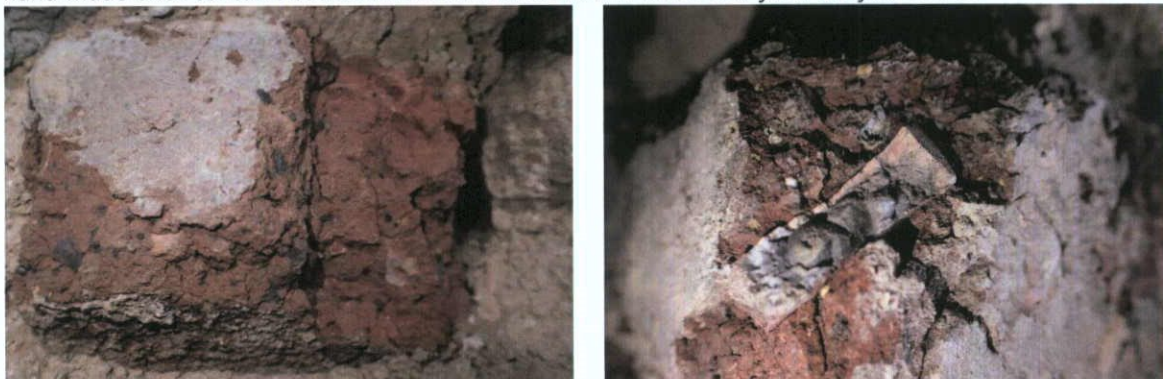
Fig.4.1.3: Coarse burnt inclusions (left) and calcined limestone inclusion (right).

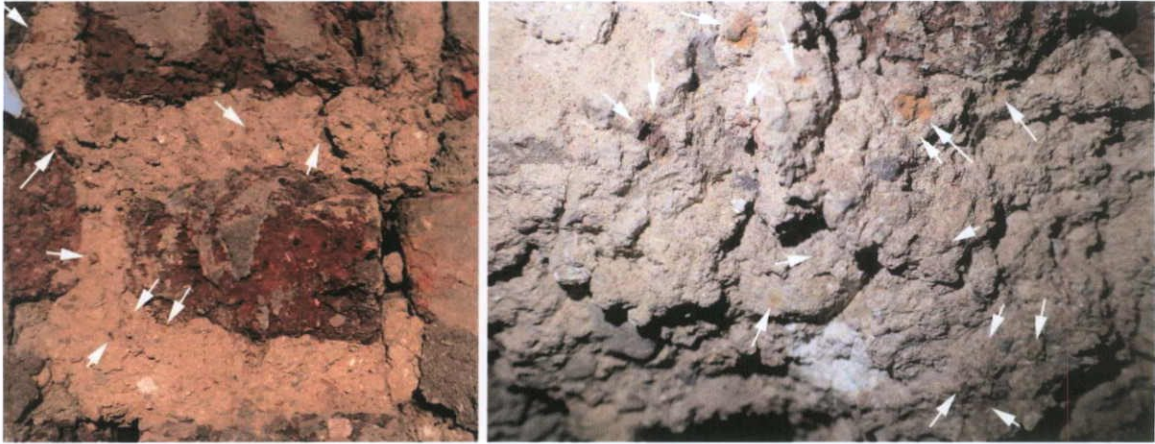
Fig.4.1.4: Brick pozzolan (arrowed) was added to the mortar. This imparts hydraulic qualities to the mortar, while the larger brick fragments also function as porous aggregate. The mortars commonly show relatively coarse 'lime lumps'.

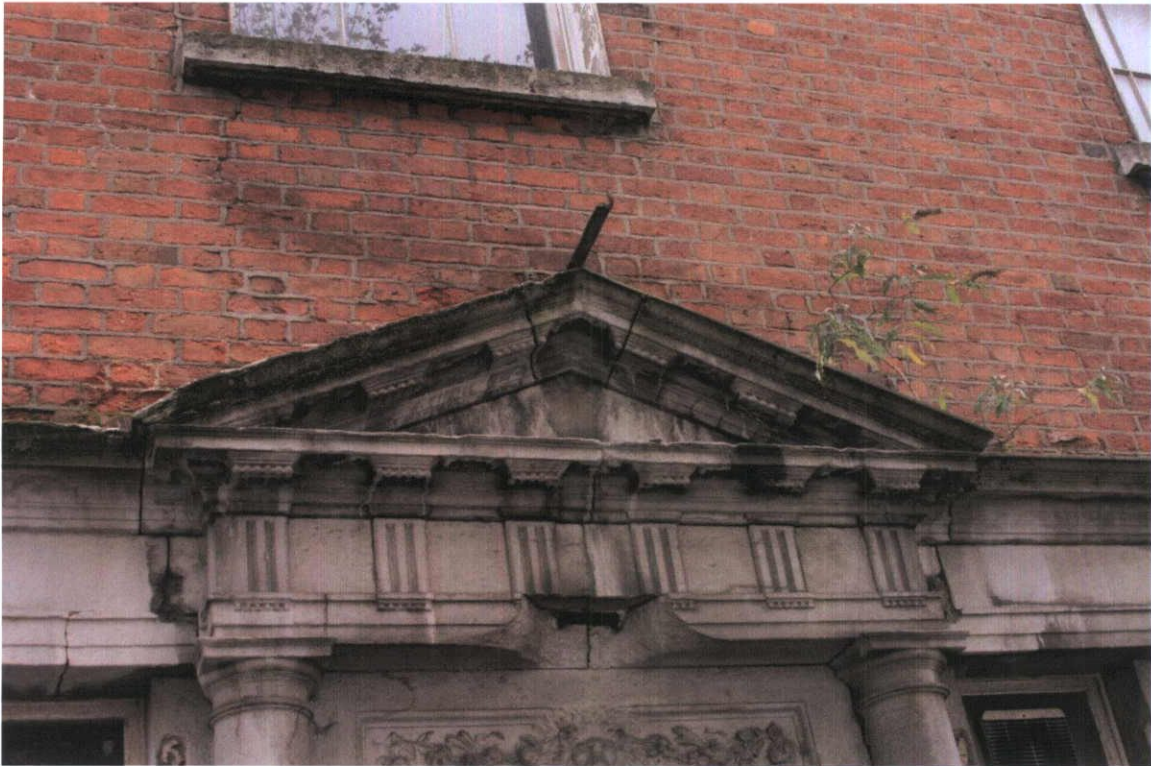
*Fig.4.3.2: The red facing brick is laid in Flemish bond and has been repointed throughout in a Portland Cement-based mortar. The repointing is failing (losing bond) in areas of saturation, and loss of the surface of the brick is evidence in many areas.*

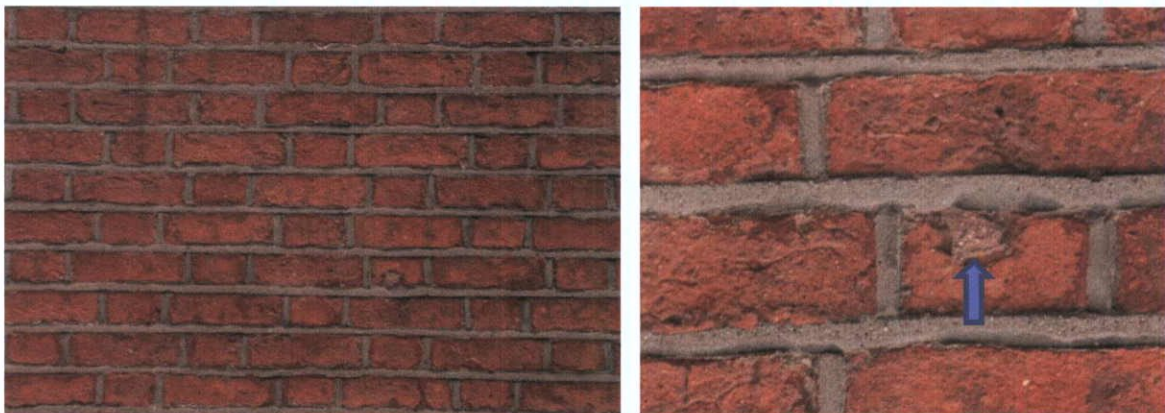
*Fig.4.3.3: Repointed eighteenth-century brickwork with probably coloured Portland Cement repair (arrowed). Where the repointing mortar has failed, the underlying lime bedding mortar is exposed along with the brick core.*

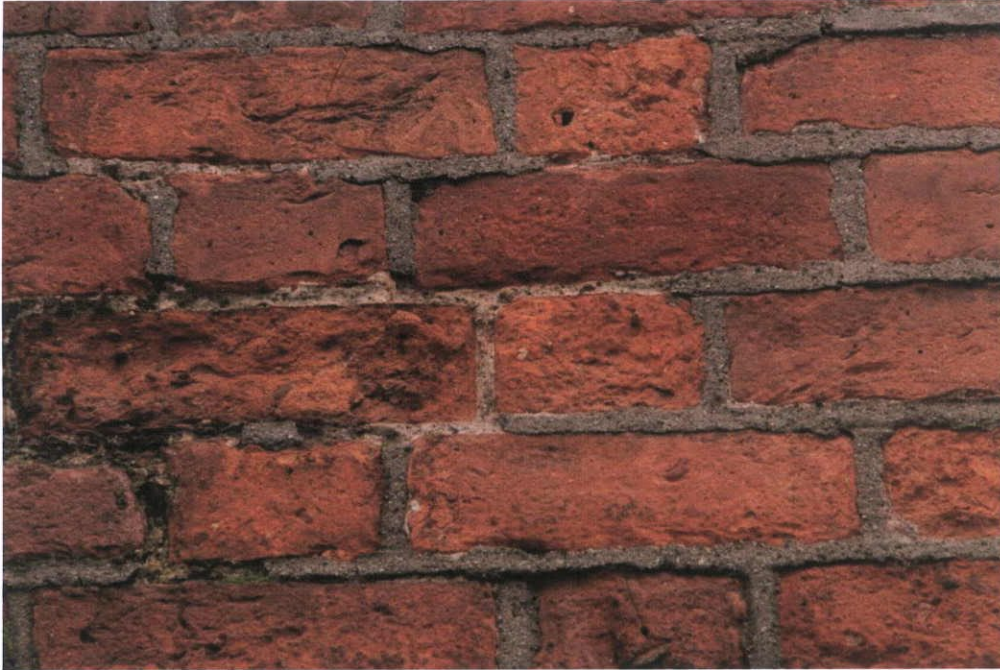
Fig.4.3.4: The façade brick is handmade and contains abundant inclusions of pebbles and fired material. The lime bedding mortar contains relatively coarse aggregate (up to  $\frac{1}{2}$  the joint height).

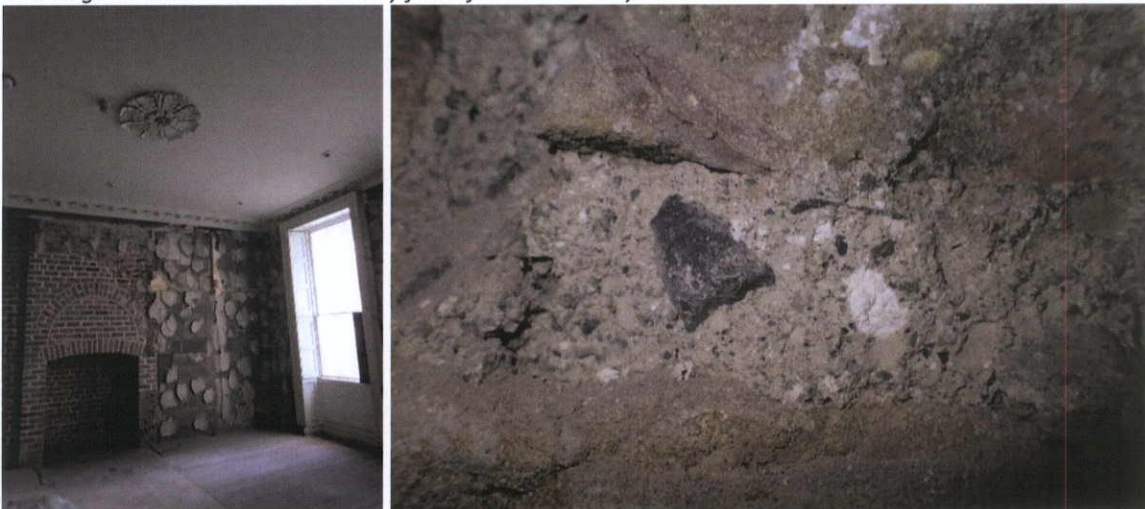
Fig.4.3.6: The ground floor shows later alterations, but the party wall shows place brick laid in a coarse-grained lime bedding mortar with poorly sorted limestone, quartz and chert aggregate and large lime lumps.

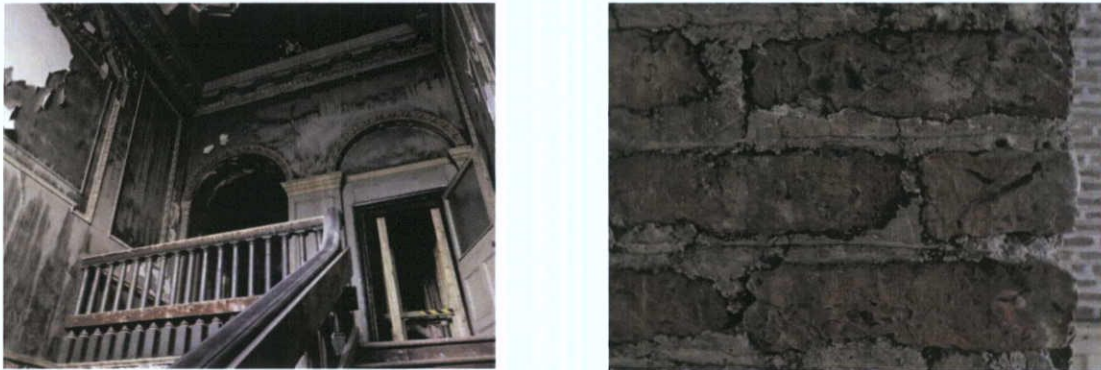
Fig.4.3.8 (left): The internal wall surfaces of the staircase retains decorative plasterwork finishes and enrichment. These were not sampled, but analysis of Georgian plasterwork elsewhere in north Dublin City indicates that the flatwork and the enrichment are composed of different materials – each of which uses very high-grade components and required a great deal of craftsmanship in successful execution.

Fig.4.3.9 (right): The internal walls were built with place brick, lower in quality than the facing brick used for the façade (Fig.4.3.4) and showing numerous manufacturing defects. The lime mortar of the internal walls has been horizontally struck throughout.

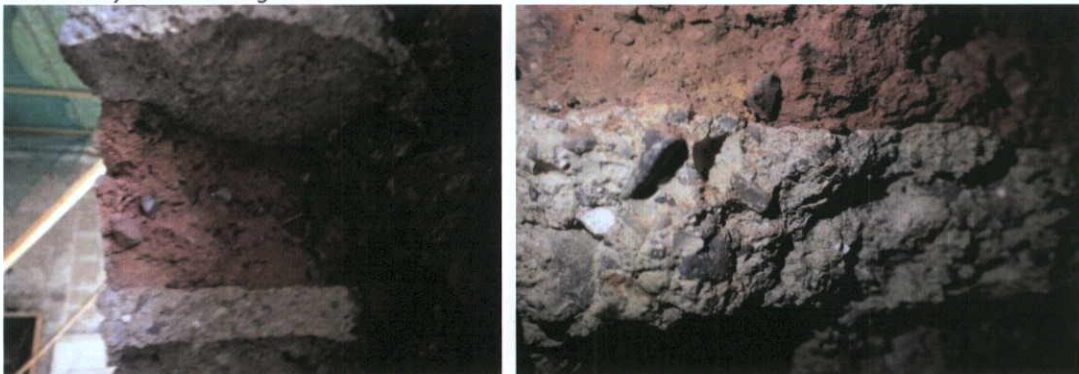
Fig.4.3.10: The large aggregate in the coarse-grained bedding mortars is similar in shape, dimension and mineralogical composition to the stone inclusions seen in the handmade bricks – suggesting a similar source. This is probably brick from the Moore Street brickfield.

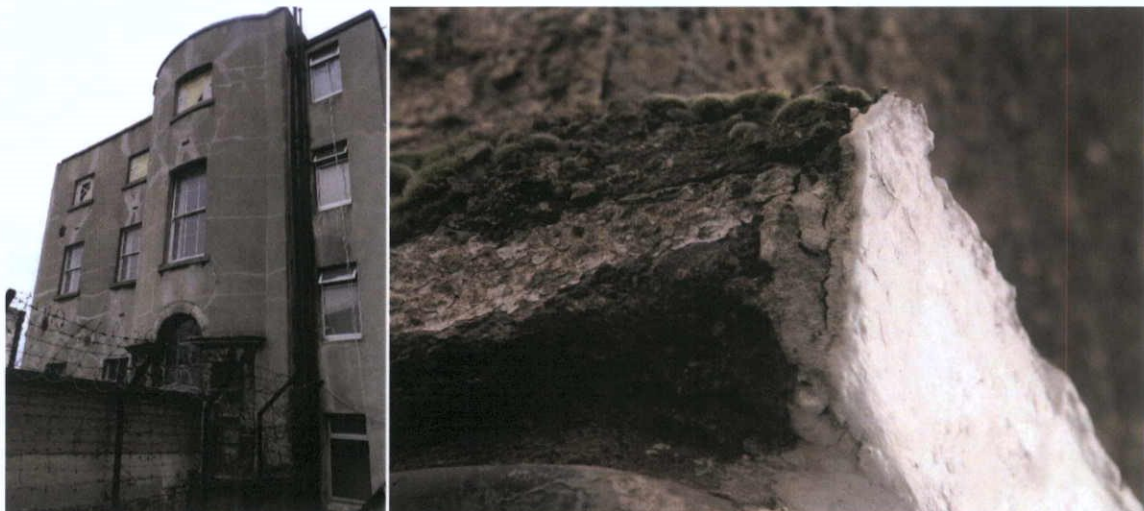
Fig.4.3.13: The rear retains a tripartite arched window in the curving bay, mirroring the treatment of the main door. The rear has been re-rendered throughout in a Portland Cement-based mortar.

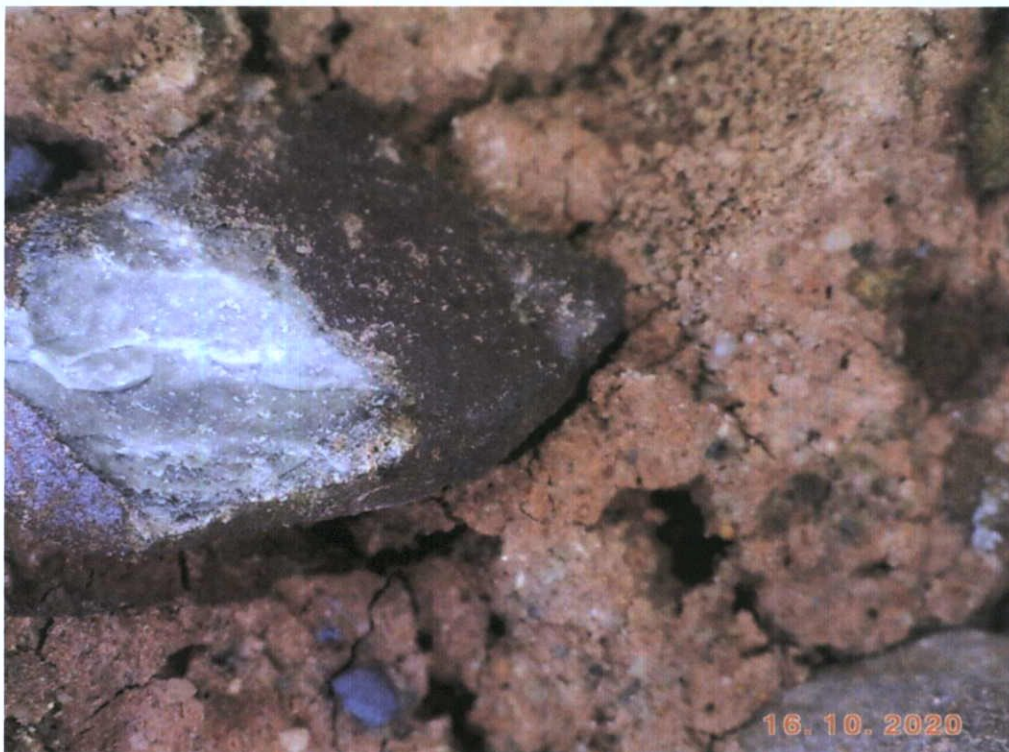
Fig.4.3.15: Microscopic detail of the core of a brick, likely to originate from the Moore Street brickfield. The brick contains poorly sorted and often partially calcined limestone and fine quartz.

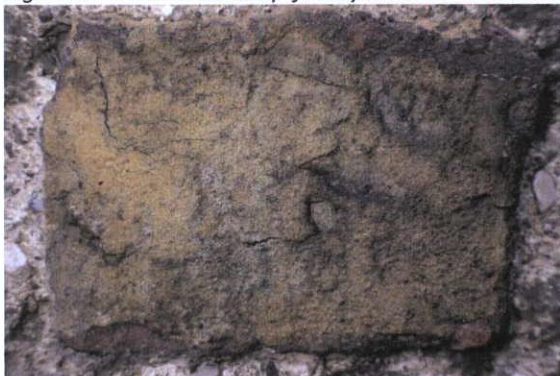
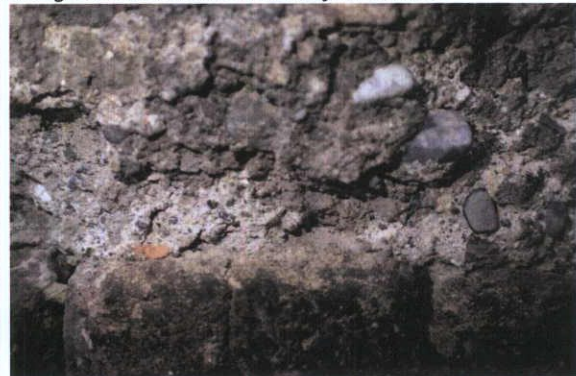
Fig.4.4.6: Clamp-fired yellow stock brick showing shrinkage cracks and over-burnt edges; laid in a coarse-grained lime mortar of rounded limestone pebbles with angular chert and quartzite and crushed brick pozzolan added.

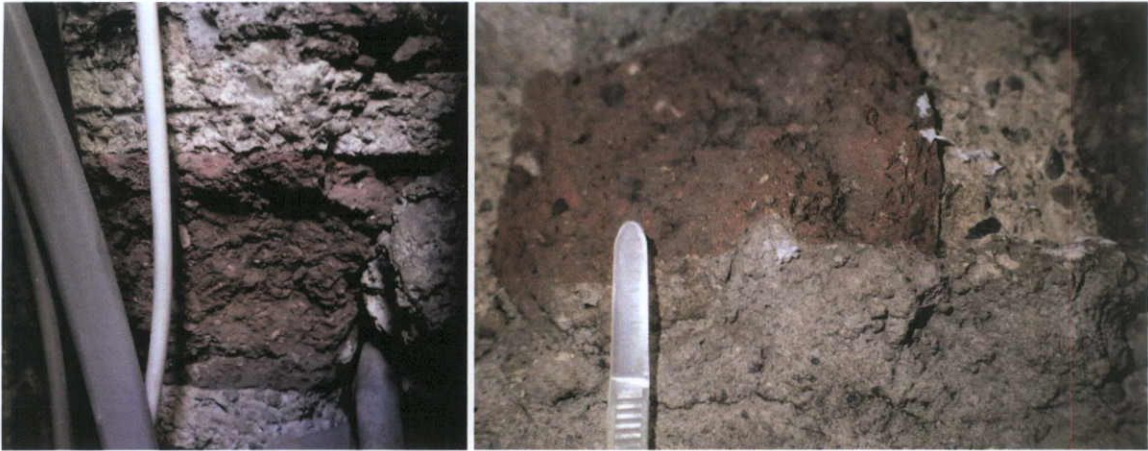
*Fig.5.1.8: The coarse-grained lime bedding joints are horizontally struck joints. The lime mortar contains limestone, quartz, chert and lime limps. The clamp-fired brick is similar to that seen in No.42. The mortar and clamp-fired brick contain similar aggregate (morphology, size range and mineralogy) suggesting a similar source of raw materials. This is probably brick from the Moore Street brickfields.*

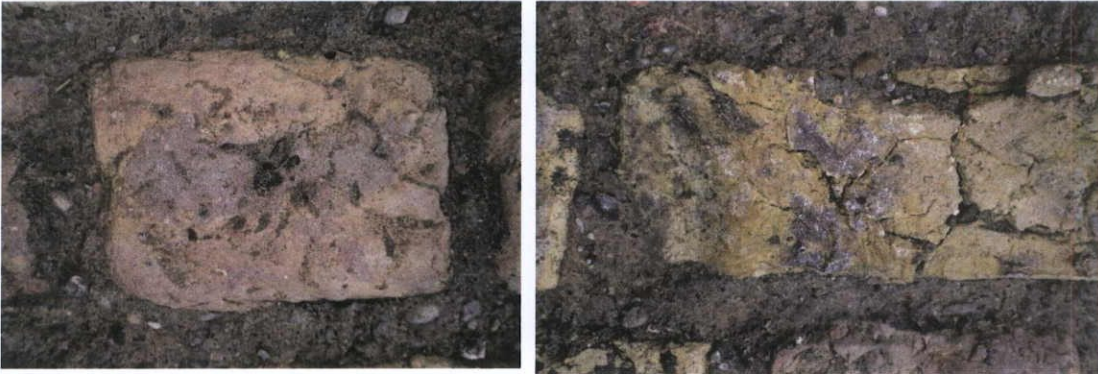
Fig.5.2.5: Stretcher and header views of yellow-pink stock brick with shrinkage cracks laid in coarse-grained pozzolanic lime mortar.

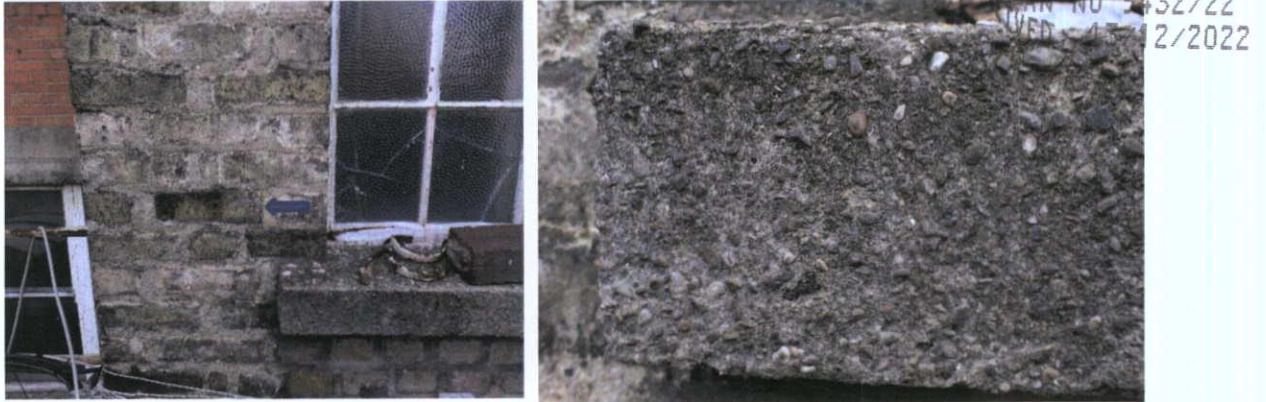
Fig.5.2.7: The window cills are of concrete. The 1920s yellow stock brick also includes occasional earlier clamp-fired yellow stock brick (arrowed), likely to be an example of salvage.

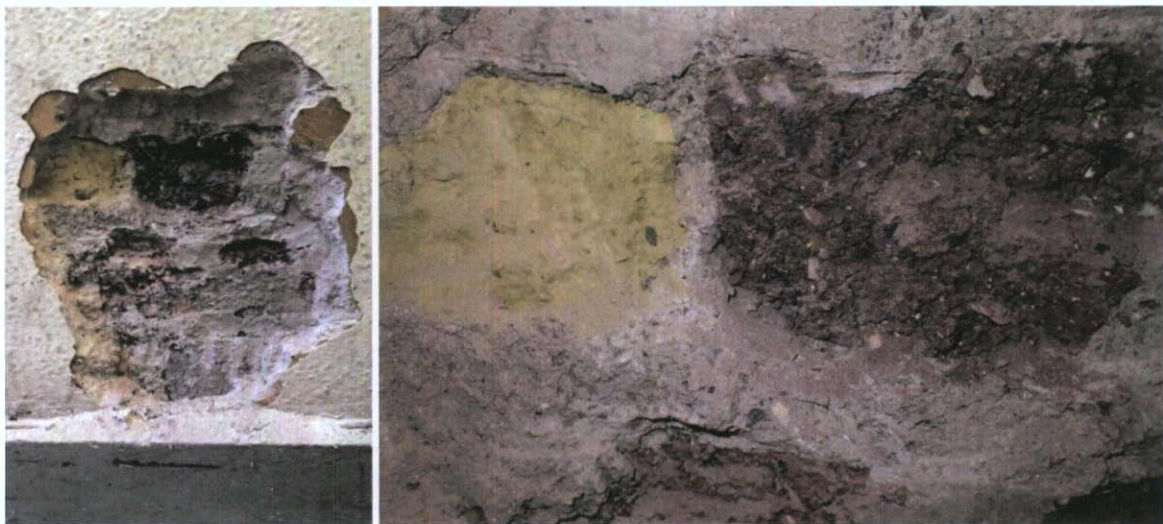
Fig.5.2.17: Ground floor, south wall, interior showing 1920s yellow stock brick and dark-red hand-made clamp-fired brick above skirting level, both bedded in a cementitious bedding mortar. The red brick appears to be a Georgian period brick, similar to others seen along the west side of O'Connell Street and possibly an example of a brick from the Moore Street brickfield. This appears to be a salvaged brick, reused in the masonry of the 1920s construction work.

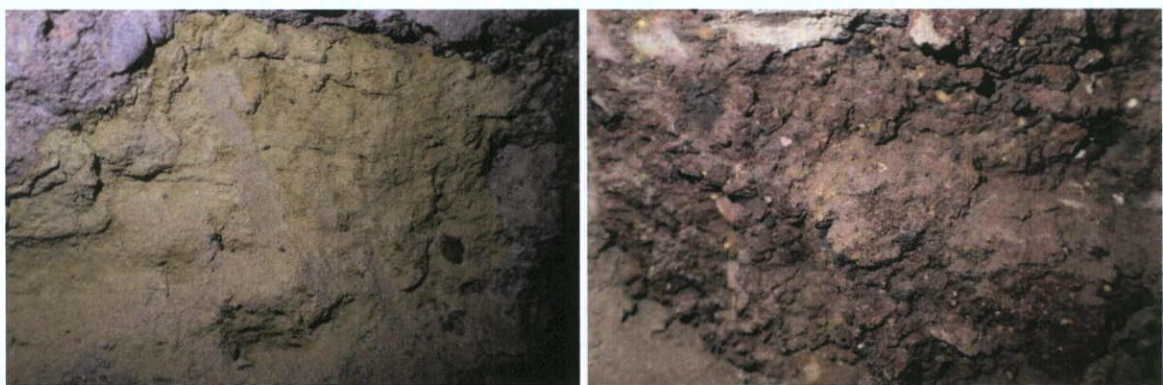
Fig.5.2.18: Detail of the fine-grained yellow stock brick from the 1920s (left) and the dark-red clamp-fired Georgian brick which contains abundant natural stone inclusions, partially calcined limestone and burnt 'hot spots' suspended in the matrix.

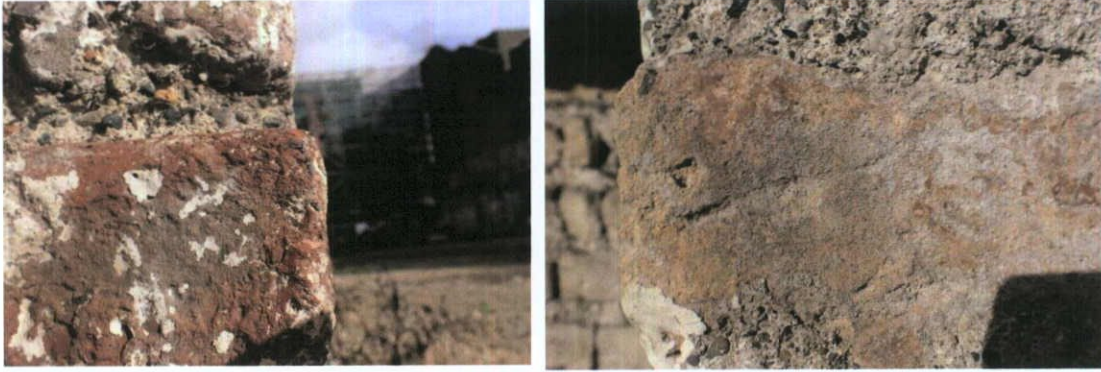
Fig.5.3.10: The stock brick at the chimney retains surface defects from the moulding process.

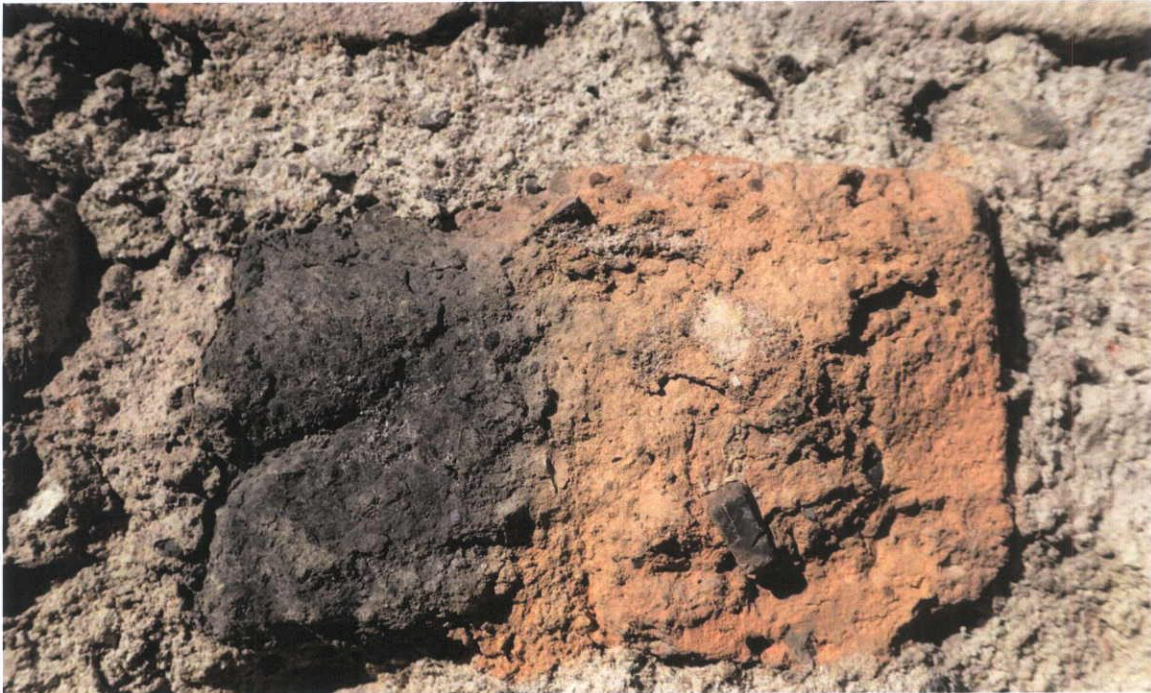
Fig.5.3.19: Partially overburnt clamp fired brick with angular limestone inclusions, some partially calcined.

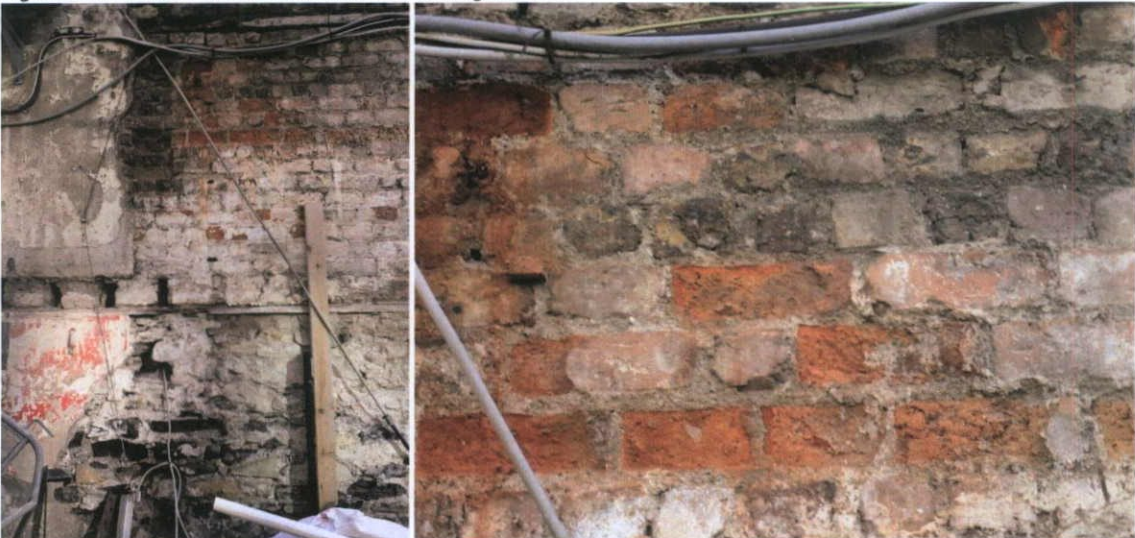
Fig.5.3.26: The red stock brick, in poor condition with the fireskin lost in many places, and the lower section of Calp limestone masonry also visible (left, bottom).
