BUILDING HISTORY

BUILDING SURVEY

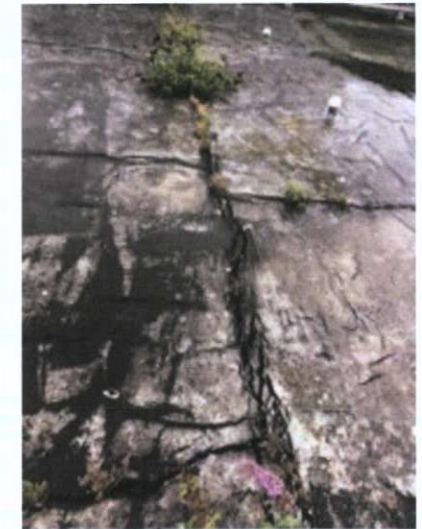
Plate 28: West roof — cracking

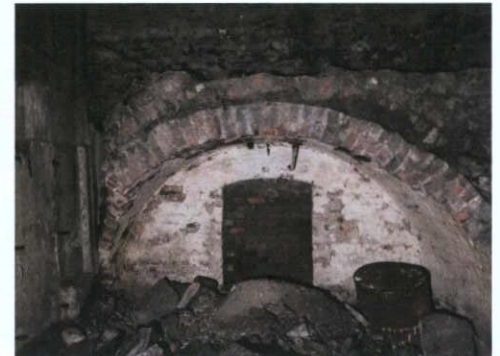
Plate 33: Broken end of brick vault

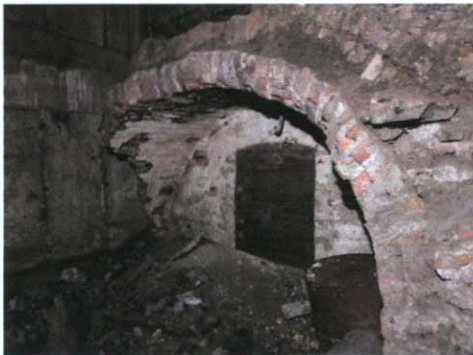
Plate 34: Broken end of brick vault

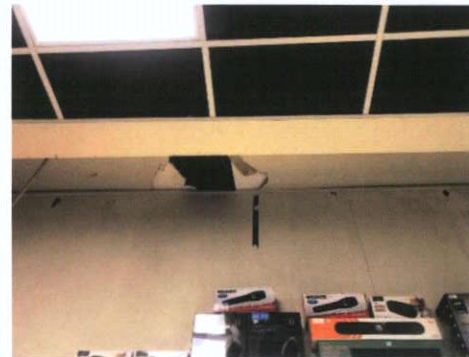
Plate 44: Damage to ceiling in main retail space

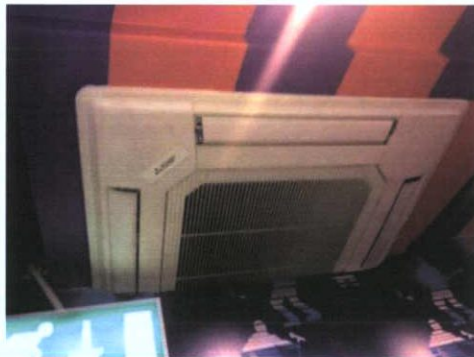
Plate 120: Air Conditioning unit blocked by partition wall

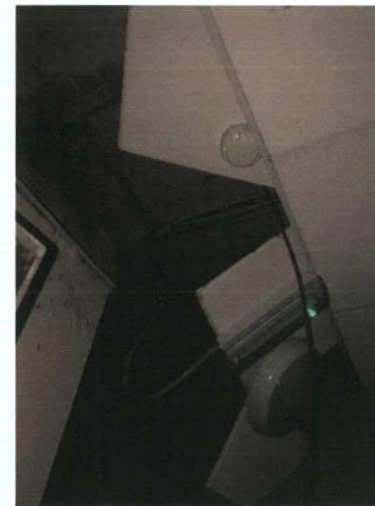
Plate 138: Damage to lighting in fire exit staircase

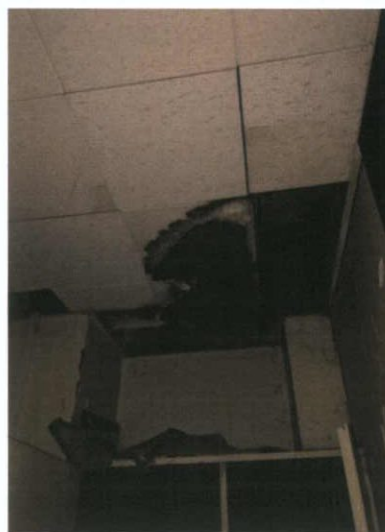
Plate 296: Damage to ceiling of kitchenette

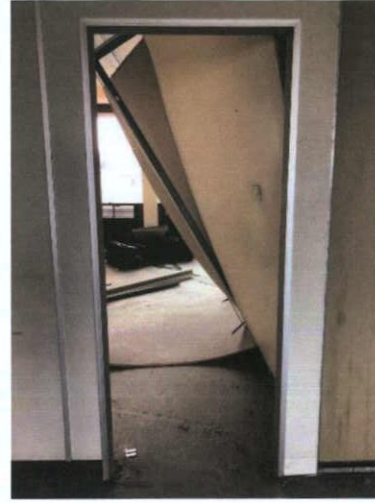
Plate 334: Room 1 — Entrance with damaged stud partition

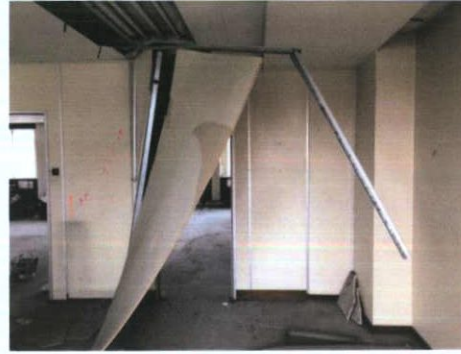
Plate 338: South wall showing damaged partition
