EIAR Chapter 15 Cultural Heritage (Architectural)

Dublin Central Project – Site 2 & No.61 O'Connell Street Upper

Appendix 15.7 Building inventory, record and description for No.50-51 O'Connell Street Upper

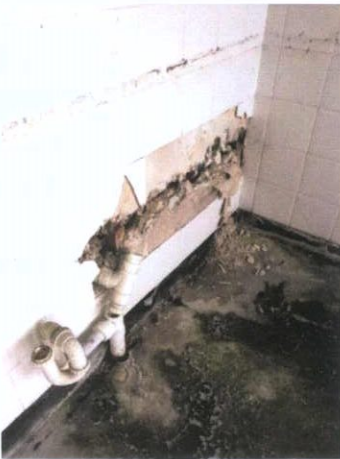
Plate 399: Damage to wall

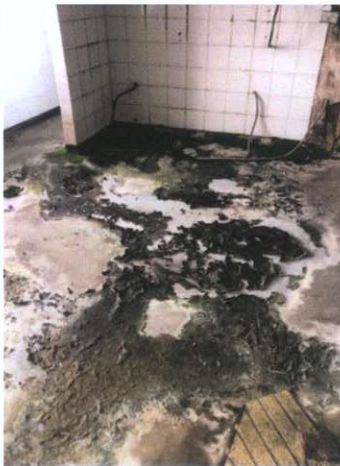
Plate 400: Rot due to leaking roof

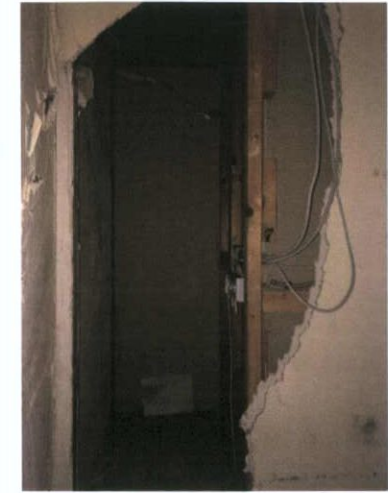
Plate 414: Room 3 — East wall alcove damage

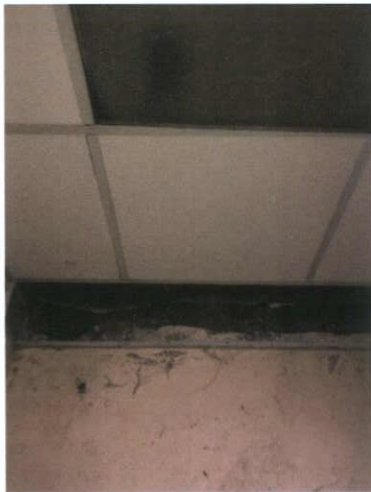
Plate 415: Room 3 — Ceiling damage

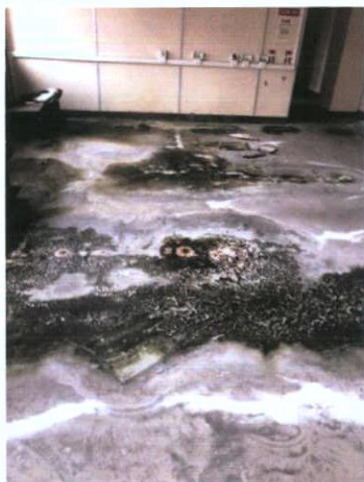
Plate 423: Room 7 — Rot on floor

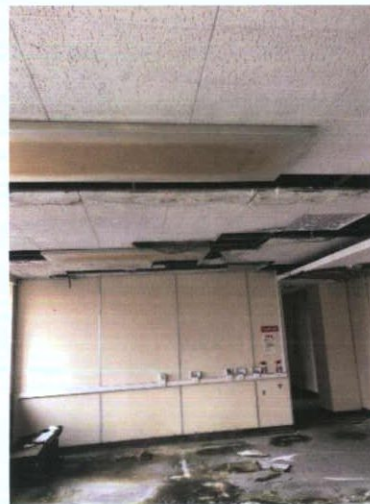
Plate 425: Room 7 — Ceiling damage

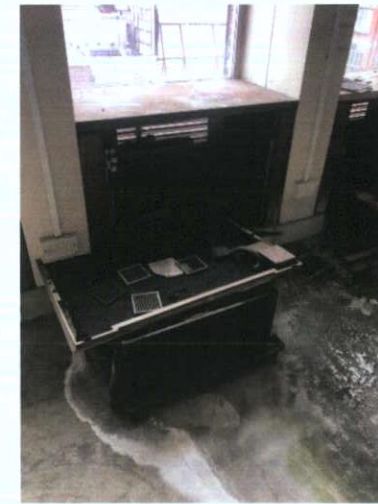
Plate 426: Room 7 — Ventilation units removed

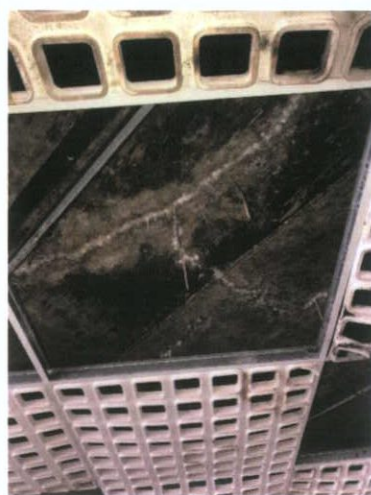
Plate 432: Room 8 — Water leaking through ceiling

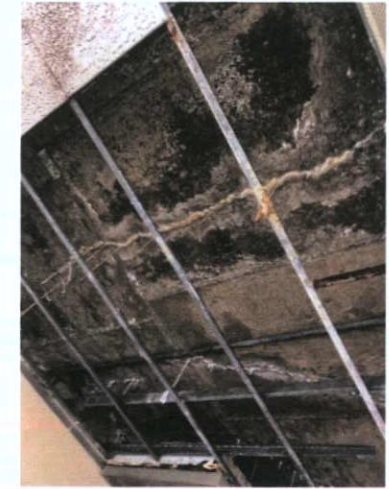
Plate 438: Room 9 — Suspended ceiling damage

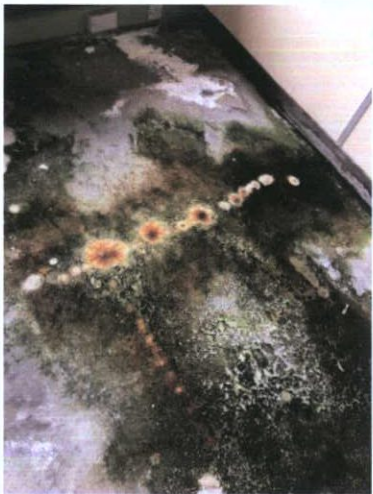
Plate 439: Room 9 — Concrete floor covered in rot

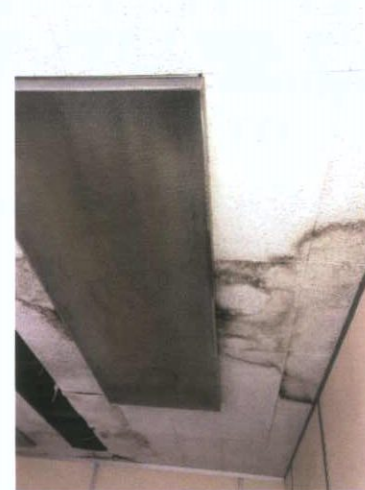
Plate 449: Room 11 — Ceiling water damage

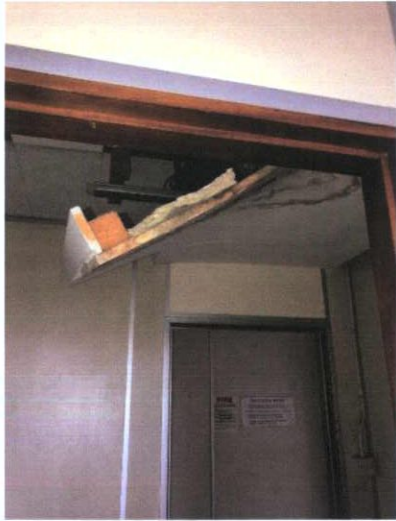
Plate 451: Damage to ceiling in secondary hallway

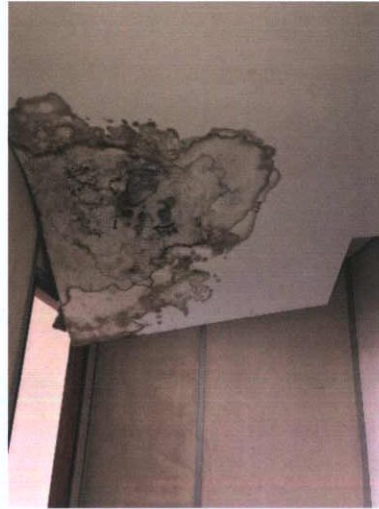
Plate 452: Damage to ceiling in secondary hallway

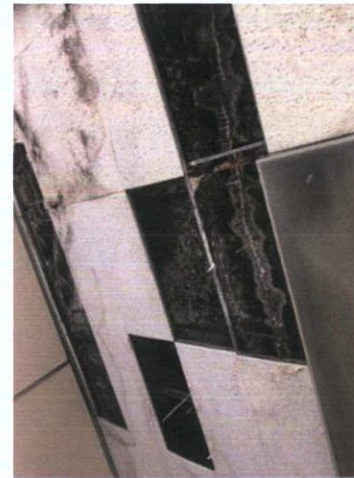
Plate 457: Room 12 — Roof leaking into room

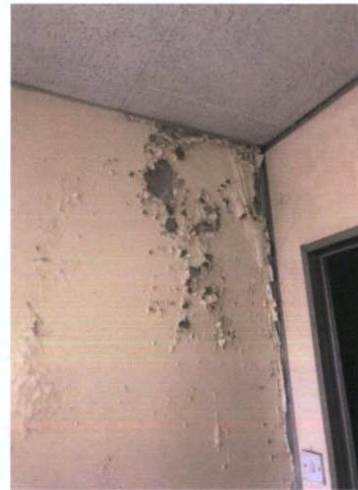
Plate 469: Room 15 — Damage to east wall

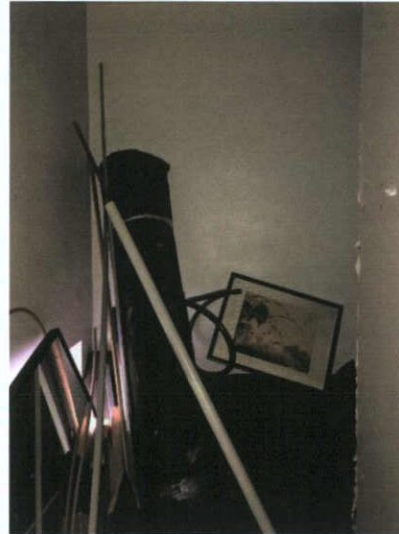
Mandy handrails are damaged and doors to floors are blocked by miscellaneous items. This stairwell is not fit for use as a fire escape in its current condition.

Plate 506: Storage on level 2 landing

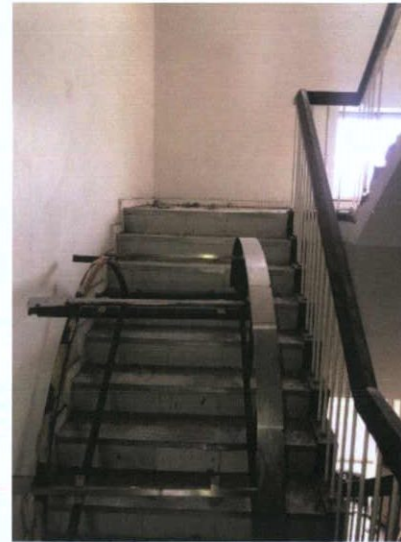
Plate 507: Storage on stair blocking path

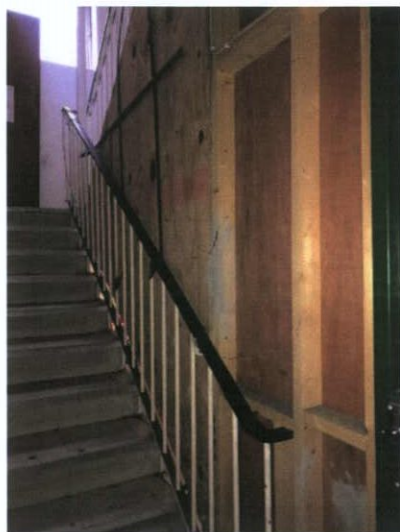
The stair is still usable but shows signs of wear. It is not suitable for use as a fire escape as it is blocked by a locked door at level 1.

Plate 516: Stair wall to block upper levels
