3.0 DESCRIPTION OF PROPOSED REPAIR WORKS TO RETAINED FAÇADES WITH SITE 2

Note: Buildings façades were inspected from the ground only, detailed condition assessments will be prepared post inspection at close-range.

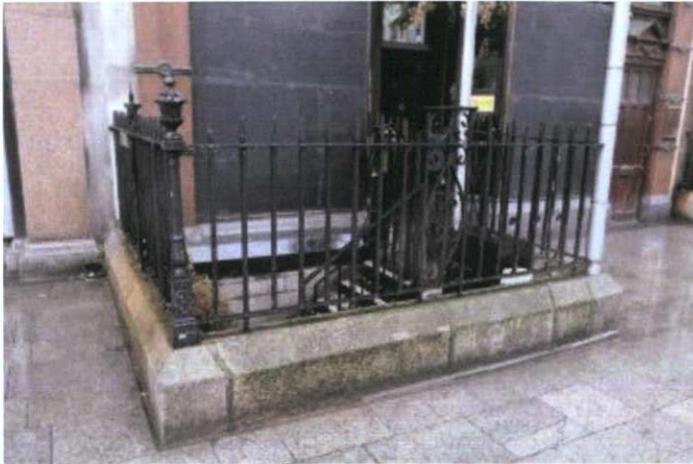
Fig. 8 Modified basement lightwell: wrought iron railings with cast iron urns on cut granite plinth. Railings have been modified and stairs is not original. It is proposed to repair and repaint the ironwork and repoint the granite plinth. The later stairs will be removed.

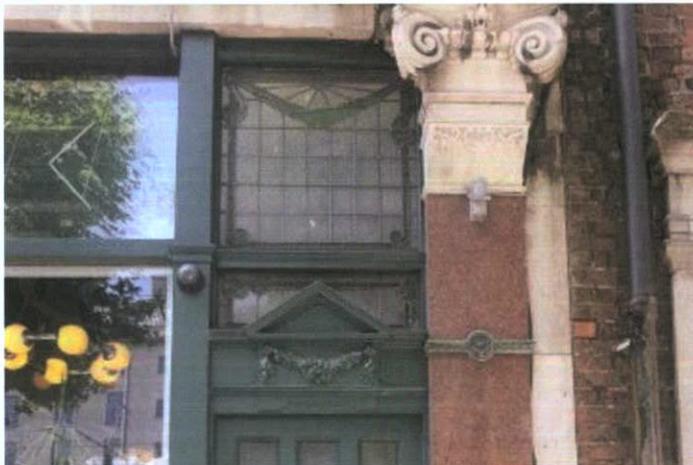
Fig. 11 Original leaded transom light above panelled side door, with carved swag beneath pediment. All original joinery and leaded glazing to be retained, masonry elements will be gently cleaned and original joinery elements repaired and repainted.

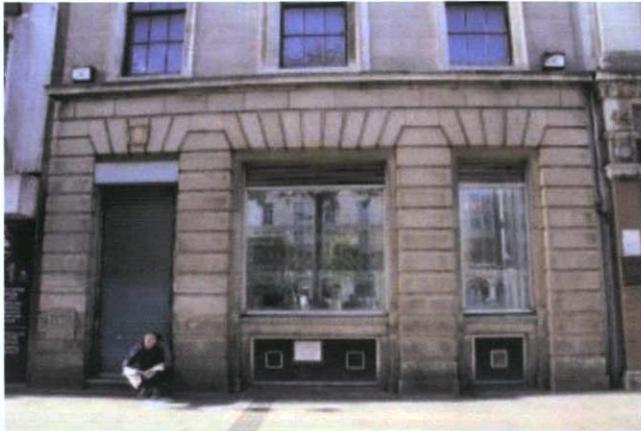
Fig. 23 Channelled granite shopfront with square-headed door opening to ground floor, with nosed granite threshold. Steel security shutter on door to be removed.

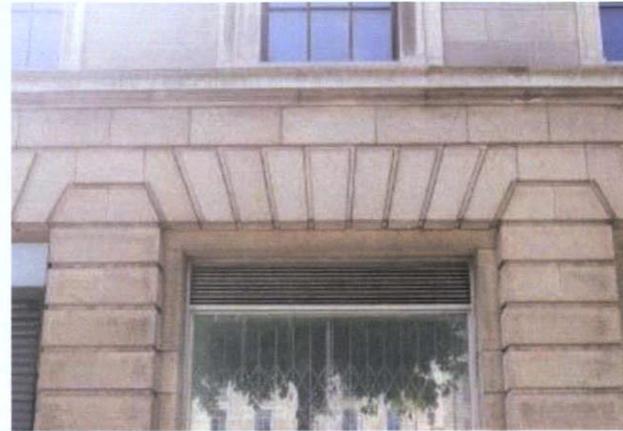
Fig. 24 Square-headed window openings; Late 20th century windows with ventilation grilles over to be replaced.

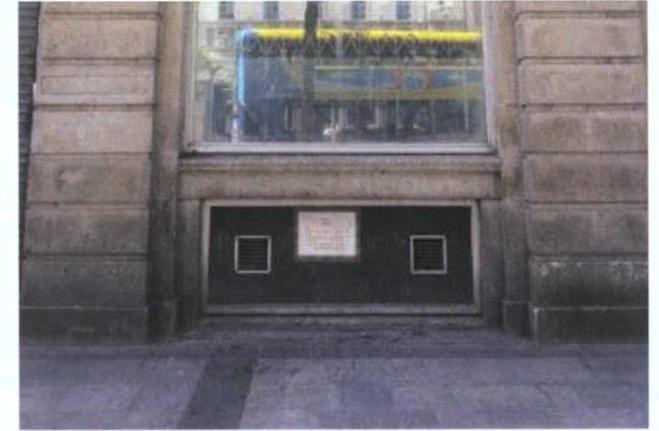
Fig. 25 Late 20th century insert in stall riser, framed in granite. Panel to be replaced. All masonry elements to be retained and gently cleaned down.

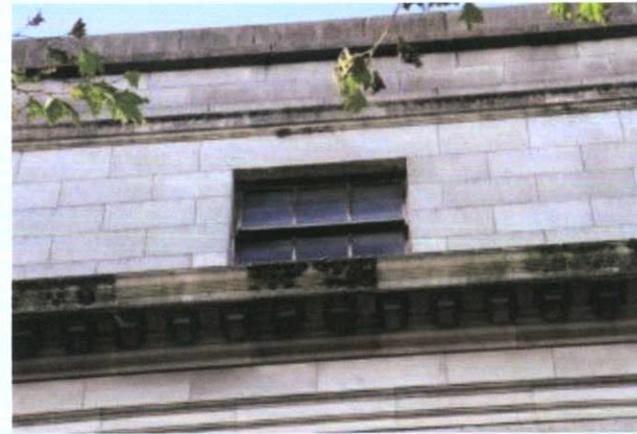
Fig. 27 Dentilled granite cornice at third floor level to be inspected at close range and lead flashing applied if required.

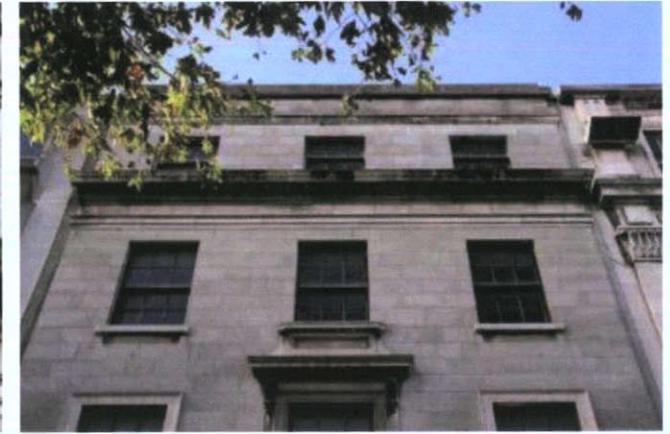
Fig. 28 Coursed, ashlar granite parapet to be cleaned and repointed as required.

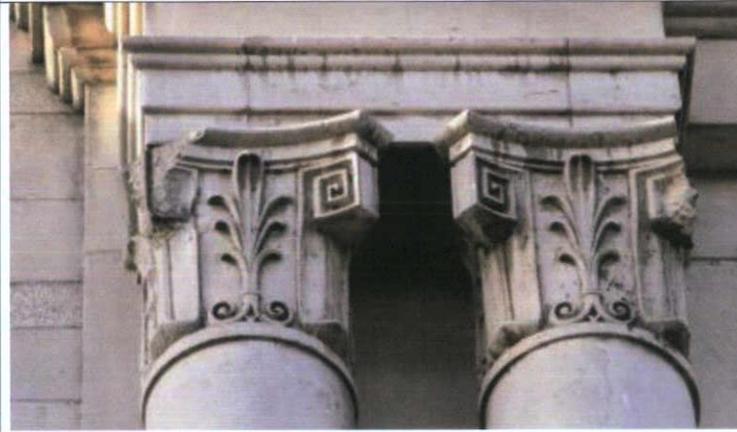
Fig. 35 Example of damage to capitals requiring stone graft repair.

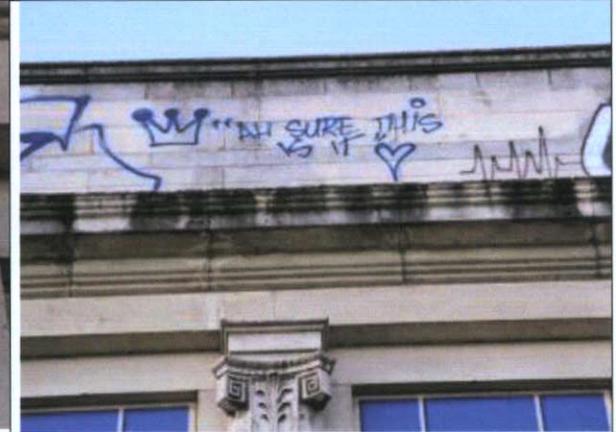
Fig. 36 Detail of graffiti staining to be removed from parapet.

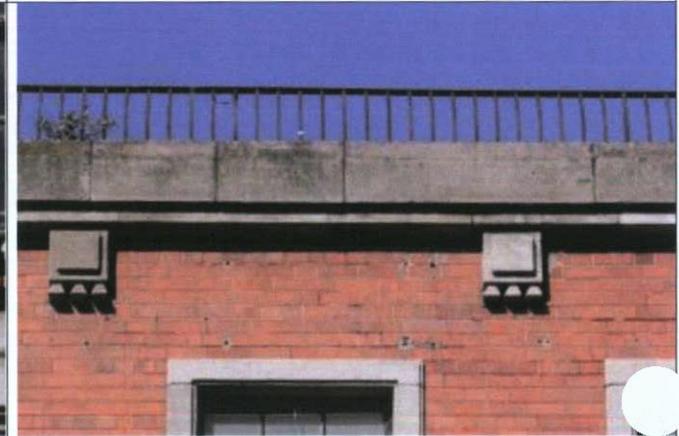
Fig. 44 Parapet railing, damage to brickwork from removed fixings

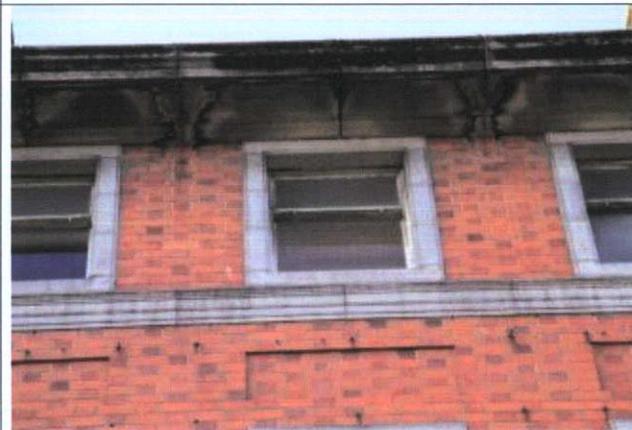
Fig. 51 Granite cornice, with water-staining evident.

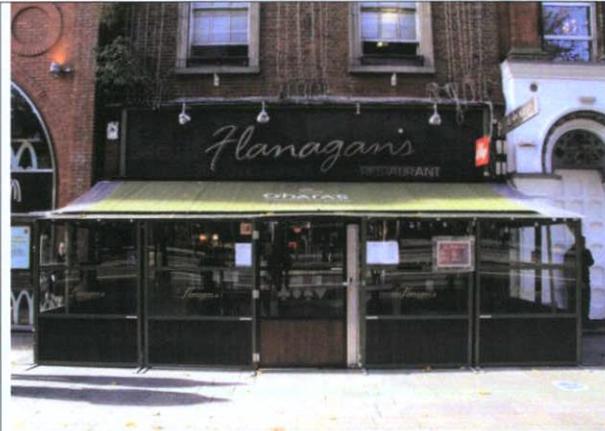
Fig. 55
Contemporary shopfront, with external seating area. Explorative site investigations are required to determine the condition & extent of historic fabric that might be concealed behind the existing shopfront.

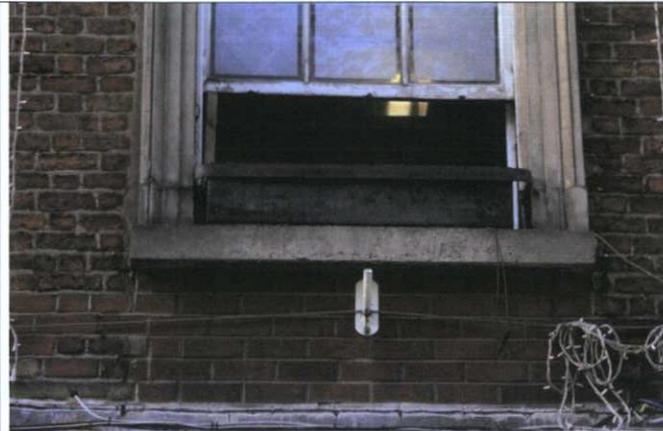
Fig. 56
Note reconstructed / infilled brick below first floor cills. Historic photographs show the design of the earlier windows as having lower cills with scrolling architraves. The first floor windows are not original. The existing composition will be retained and repaired.

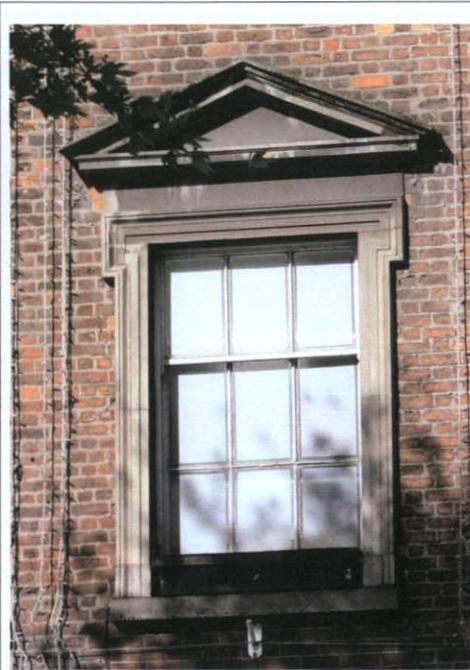
Fig. 57
Level 1 windows: Lugged, Roman cement architraves and hood mouldings, repaired with cement, pedimented to first floor. The architraves will be retained and repaired.

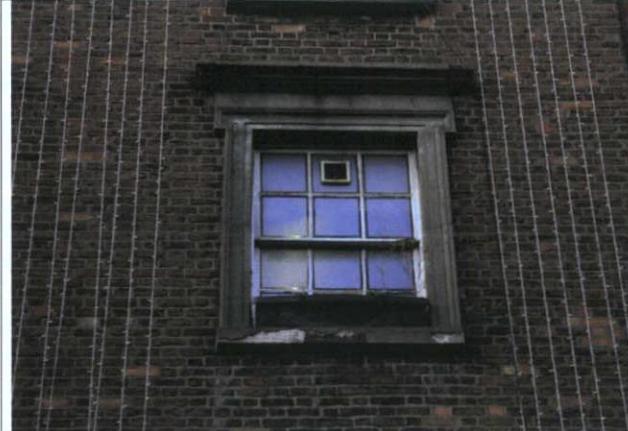
Fig. 58
Level 2 Windows: Moulded Roman cement architraves; granite sills with later rendered finish coat applied, and now failing. The architraves will be retained and repaired.

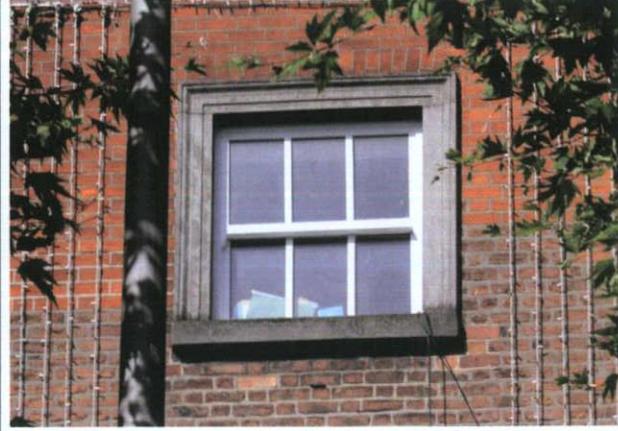
Fig. 59
Level 3 windows: Roman cement architraves. Recent sash windows have been installed at third floor, not matching original window profiles. Historic photos depict the earlier timber sashes as having slimmer profiles with 4 over 4 fenestration pattern. It is proposed to replace the 3rd floor windows with a new timber sash to match the original. Architraves will be repaired.

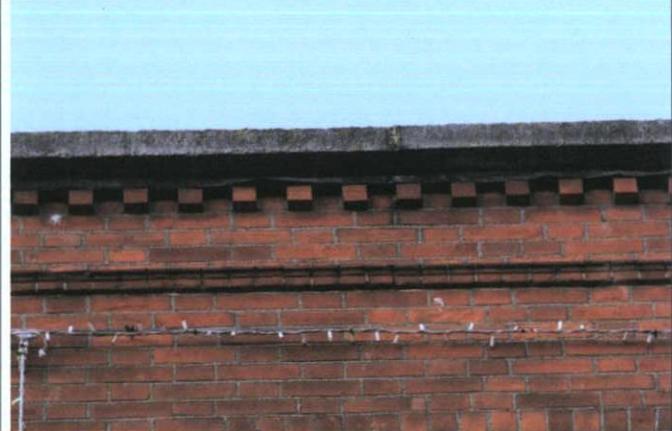
Fig. 60
Detail of the reconstructed parapet, with granite coping on flashing and dentil brick cornice. The brickwork and granite coping will be repointed.

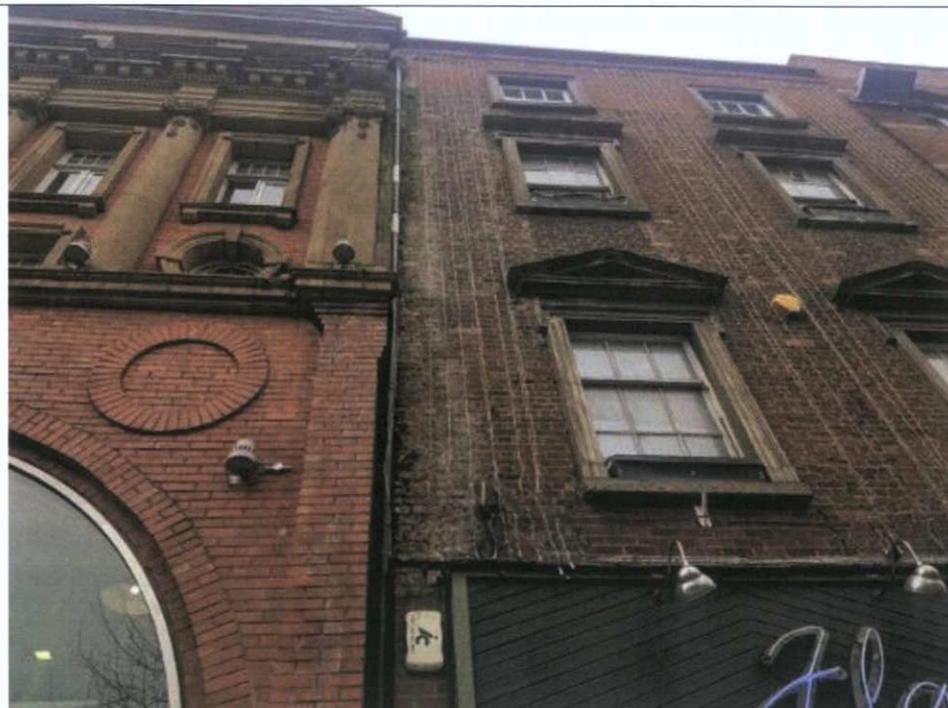
Fig. 61
Detail of eroded pointing and decayed brick behind the rainwater downpipe. The rainwater downpipe will be repaired and replaced to match original profile. Biocide will be applied and vegetation removed. The affected brickwork will require repair and repointing.

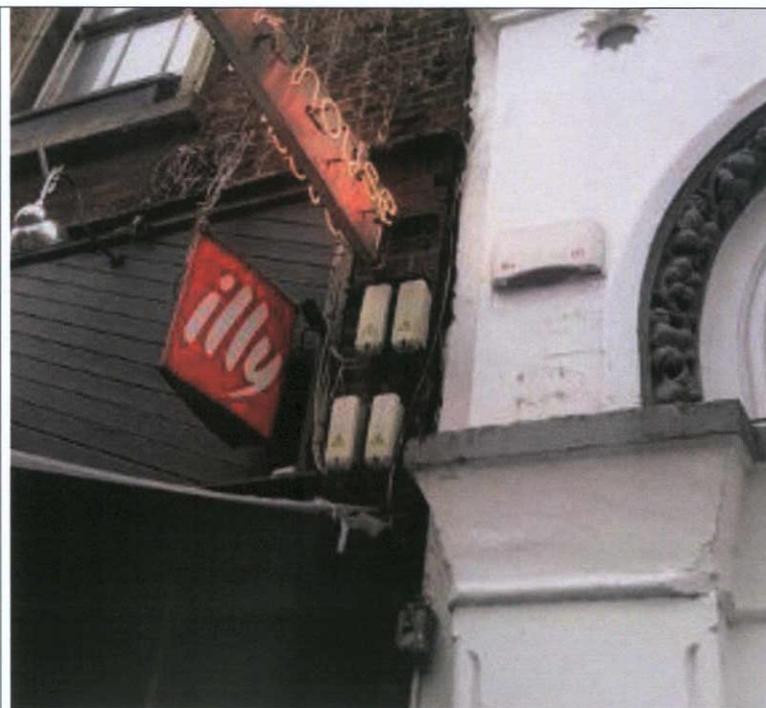
Fig. 62
Detail of contemporary brick positioned in front of the fascia and shopfront. Underlying fabric to be inspected for surviving historic fabric. It is clear from examination of historic photographs that the early 20th century shopfront has either been significantly altered or previously altered.
