4.0 DESCRIPTION OF THE PROJECT

4.1 Location, Size and Scale of the Development

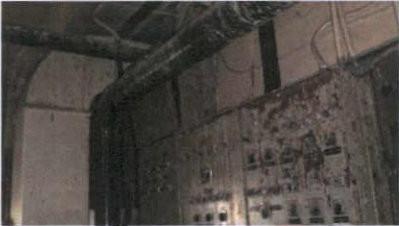
3	Fingal Co. Co. Office and Carpark Moore Lane	6 th floor boiler room	2027302	Woven rope gaskets to air handling ductwork joints	NQ	Chrysotile	2	1	1	1	5	Removal and disposal as asbestos waste by a competent contractor prior to work likely to cause disturbance.

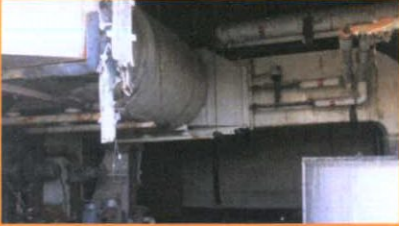
4	Fingal Co. Co. Office and Carpark Moore Lane	6 th floor boiler room		Gaskets to generator		Presumed						Further inspection is required by a competent contractor prior to any disturbance.

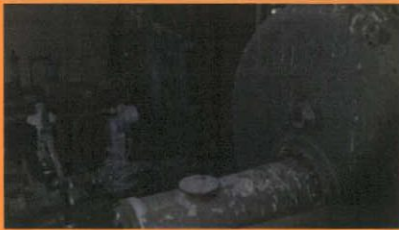
7	Fingal Co. Co. Office and Carpark Moore Lane	6 th floor boiler room		Integral areas of boilers		Strongly presumed to contain asbestos						Removal and disposal by a competent contractor prior to any works likely to cause disturbance.

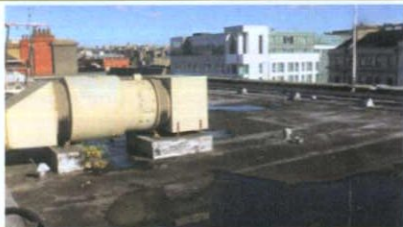
12	Fingal Co. Co. Office and Carpark Moore Lane	5 th floor roof		Rope seals to air handling ductwork	NQ.	Chrysotile	2	1	1	5	5	Removal and disposal as asbestos waste by a competent contractor prior to work likely to cause disturbance.

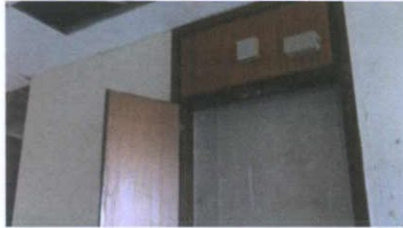
16	Fingal Co. Co. Office and Carpark Moore Lane	5 th floor lobby		Drop ceilings with lay-in ceiling tiles under roof slab.		NAD

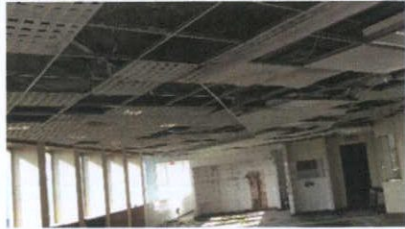
26	Fingal Co. Co. Office and Carpark Moore Lane	5 th floor offices		Radiator units under windows		NAD

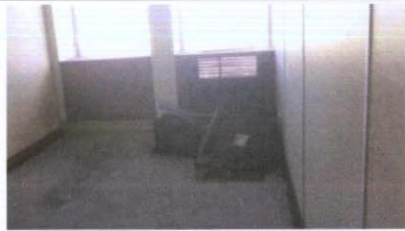
27	Fingal Co. Co. Office and Carpark Moore Lane	5 th floor kitchen and associated rooms to back.		Adhesive under lino	80 SM approx	Chrysotile	1	0	0	1	2	Removal and disposal as asbestos waste by a competent contractor prior to work likely to cause disturbance.

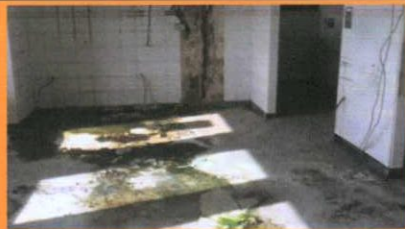
28	Fingal Co. Co. Office and Carpark Moore Lane	5 th floor kitchen	2027313 2027314	VFT and adhesive		Chrysotile	1	0	0	1	2	Removal and disposal as asbestos waste by a competent contractor prior to work likely to cause disturbance.

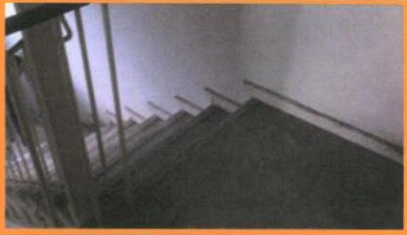
31	Fingal Co. Co. Office and Carpark Moore Lane	5 th floor stairway	2027312	Threads		Chrysotile	1	0	0	1	2	Removal and disposal as asbestos waste by a competent contractor prior to work likely to cause disturbance.

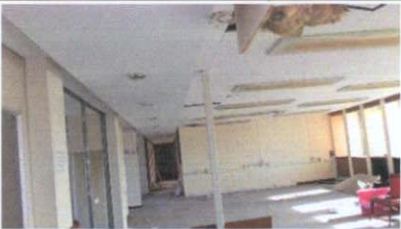
36	Fingal Co. Co. Office and Carpark Moore Lane	4 th floor back stairway.		Plenum at stairway.		NAD

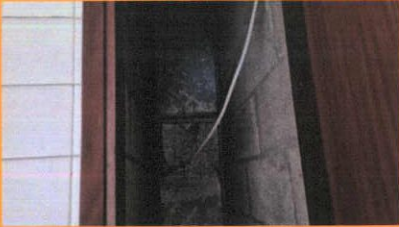
43	Fingal Co. Co. Office and Carpark Moore Lane	4 th floor Gents WC				NAD

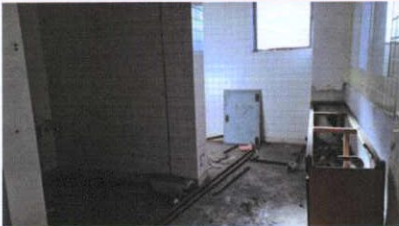
44	Fingal Co. Co. Office and Carpark Moore Lane	4 th floor Kitchenette	2027316	Sink pads		Chrysotile	1	0	0	1	2	Removal and disposal as asbestos waste by a competent contractor prior to work likely to cause disturbance.

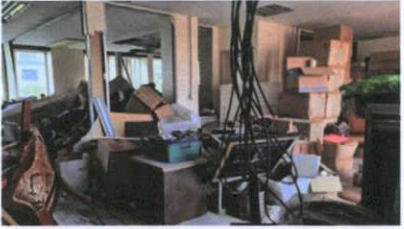
50	Fingal Co. Co. Office and Carpark Moore Lane	4 th floor offices over takeaway				NAD

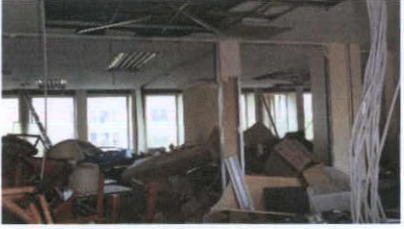
51	Fingal Co. Co. Office and Carpark Moore Lane	4 th floor offices over takeaway				NAD

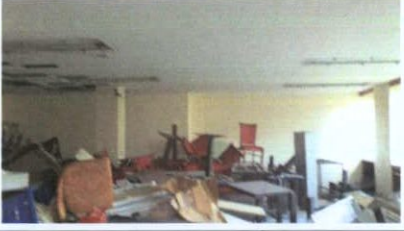
52	Fingal Co. Co. Office and Carpark Moore Lane	4 th floor offices over takeaway				NAD

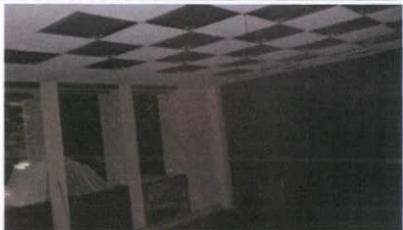
54	Fingal Co. Co. Office and Carpark Moore Lane	3 rd floor Comms room				NAD

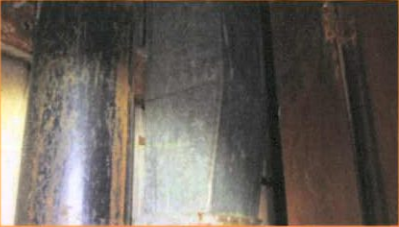
58	Fingal Co. Co. Office and Carpark Moore Lane	3 rd floor Gents WC Riser		Woven rope gaskets to air handling duct		Chrysotile	2	1	1	1	5	Removal and disposal as asbestos waste by a competent contractor prior to work likely to cause disturbance.

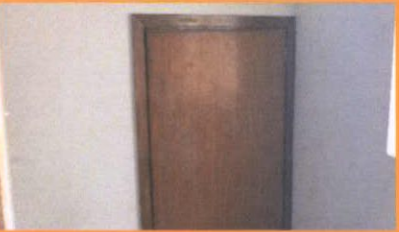
62	Fingal Co. Co. Office and Carpark Moore Lane	3 rd floor corridor		Plasterboard partitions to offices and rooms. MMMF in walls.		NAD

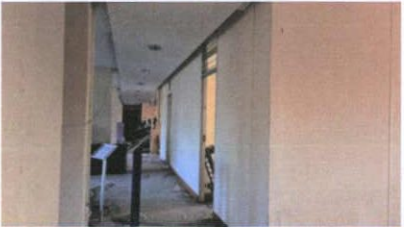
66	Fingal Co. Co. Office and Carpark Moore Lane	2 nd floor SW office	2027321 2027322	VFT Adhesive under tiles and on floor outside office	80 SM approx.	Chrysotile	1	0	0	1	2	Removal and disposal as asbestos waste by a competent contractor prior to work likely to cause disturbance.

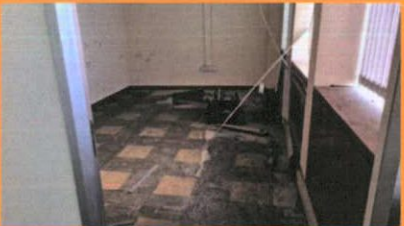
67	Fingal Co. Co. Office and Carpark Moore Lane	2 nd floor office	2027323	Red/brown adhesive to ductwork		Chrysotile	1	0	0	1	2	Removal and disposal as asbestos waste by a competent contractor prior to work likely to cause disturbance.

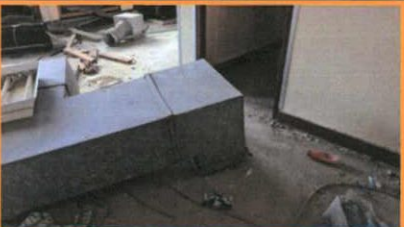
68	Fingal Co. Co. Office and Carpark Moore Lane	2 nd floor office		Red adhesive to ductwork		Chrysotile	1	0	0	1	2	Removal and disposal as asbestos waste by a competent contractor prior to work likely to cause disturbance.
