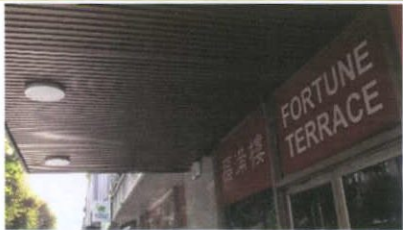
78	Fingal Co. Co. Office and Carpark Moore Lane			Misc. individual retail outlets not accessible.		Presumed to contain asbestos						Investigate prior to work likely to cause disturbance.	No photo
79	Fingal Co. Co. Office and Carpark Chinese Restaurant	Fortune TCE				No visible asbestos containing materials identified.

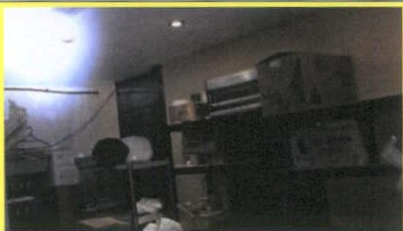
94	Fingal Co. Co. Office and Carpark Chinese Restaurant	1 st floor Lift lobby area		No access		VFT and adhesive presumed under fixed flooring						Investigation by a competent contractor prior to work likely to cause disturbance.

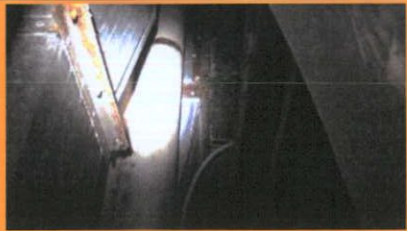
108	Fingal Co. Co. Office and Carpark Chinese Restaurant	2 nd floor Ladies WC service riser		Woven rope gaskets to air handling duct		Chrysotile	2	1	1	1	5	Removal and disposal as asbestos waste by a competent contractor prior to work likely to cause disturbance.

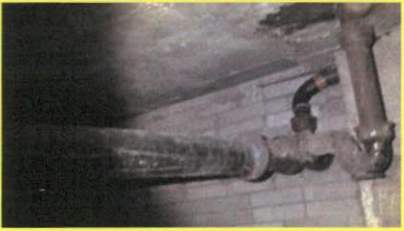
122	Fingal Co. Co. Office and Carpark	Basement		Lead sealed cast-iron pipework collars		Presumed to contain asbestos woven rope packing						Investigation by a competent prior to work likely to cause disturbance.

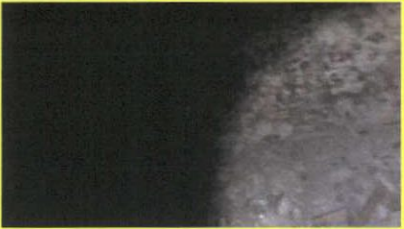
123	Fingal Co. Co. Office and Carpark	Basement Floors		Rubble heaps throughout the basement floors.		Presumed to contain asbestos						Investigation by a competent prior to work likely to cause disturbance.

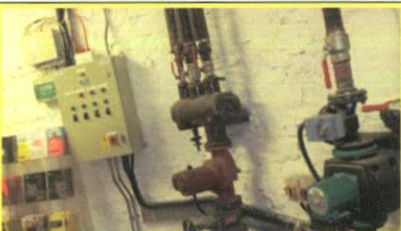
27	No. 59/60 O'Connell Street	Basement main boiler room		Pipework flange gaskets		Presumed asbestos						Investigation by a competent contractor prior to work likely to cause disturbance.

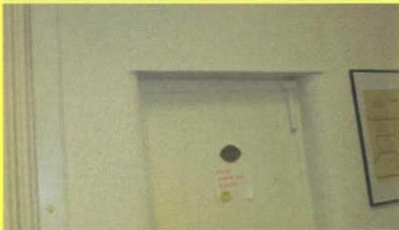
64	No. 59/60 O'Connell Street	Ground floor front office		Integral areas of strongroom and door		Presumed asbestos						investigation by a competent contractor prior to work likely to cause disturbance.

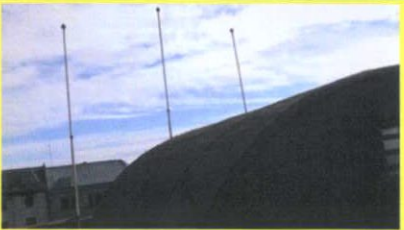
86	No. 59/60 O'Connell Street	Tank room		Roofing felt		Presumed asbestos						investigation by a competent contractor prior to work likely to cause disturbance.

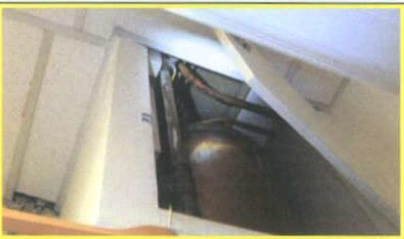
88	No. 59/60 O'Connell Street	2 nd floor WC		Immersion flange gasket to copper cylinder		Presumed asbestos						investigation by a competent contractor prior to work likely to cause disturbance.
