**Site Full Name:**  
No. 58 O'Connell Street  
Dublin 1

## Introduction

About Safety Ltd. was instructed to carry out a Refurbishment and Demolition Asbestos Survey of the above property. The survey and sampling was carried out taking cognizance of the requirements of the Health and Safety Executive (UK) document, *HSG 264, Asbestos: The Survey Guide*.

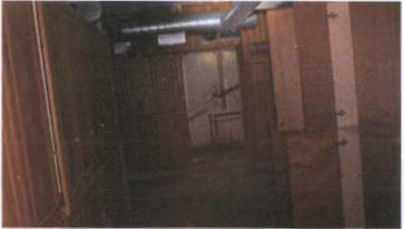
6	No. 58 O'Connell St.	Basement Front of building	2028424	Textured paint to wall		No visible asbestos containing materials identified.

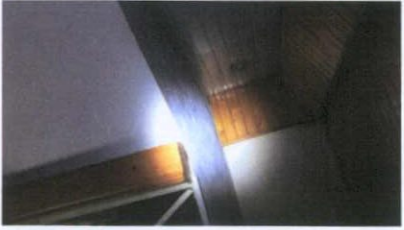
7	No. 58 O'Connell St.	Basement	2028425	Textured coating to ceiling		No visible asbestos containing materials identified.

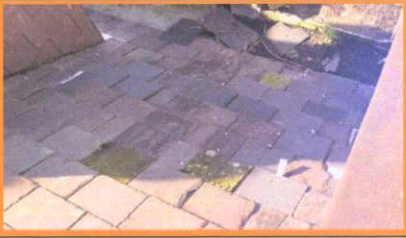
26	No. 58 O'Connell St.	Roof Flat roof	2028430	Substrate roofing felt		NAD

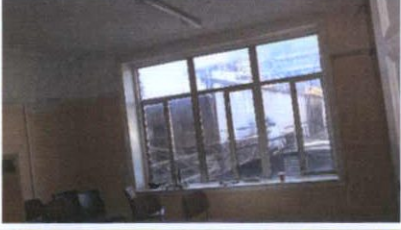
4	No. 43 O'Connell St.	Back buildings and roof		No access		Presumed to contain asbestos						Investigation prior to work likely to cause disturbance.

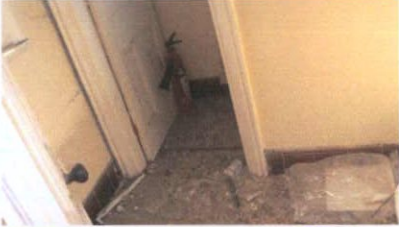
18	No. 43 O'Connell St.	4 <sup>th</sup> floor Front rooms		No access		Presumed to contain asbestos.						Investigation prior to work likely to cause disturbance.

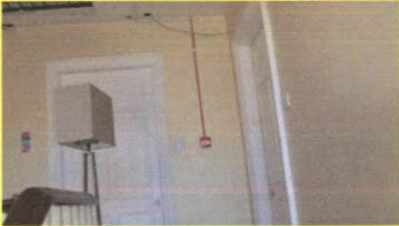
19	No. 43 O'Connell St.	4 <sup>th</sup> floor Roof access		No access padlocked		Presumed to contain asbestos.						Investigation prior to work likely to cause disturbance.

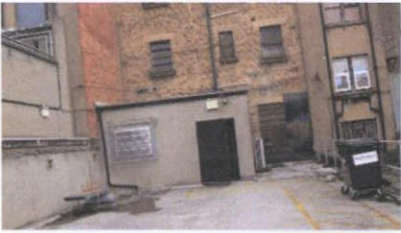
30	No. 57 O'Connell St.	Façade		Pipe in wall between 3 <sup>rd</sup> and 4 <sup>th</sup> floor windows		Presumed asbestos						Investigation by a competent contractor prior to work likely to cause disturbance.
