## *Asbestos Contaminated Soils (ACS)*

This report is based on a Refurbishment & Demolition survey of an occupied building.

Report on:

## Appendix B – Schedule of Survey Sheets

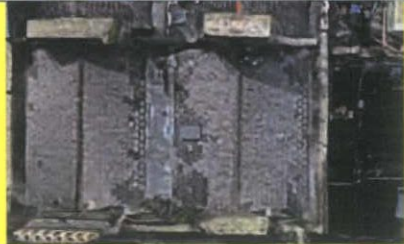
32	No. 61 O'Connell Street	External Roofs		No access to main roof pitched roof or flat extension roof.		Presumed to contain asbestos						Investigation by a competent contractor prior to work likely to cause disturbance.

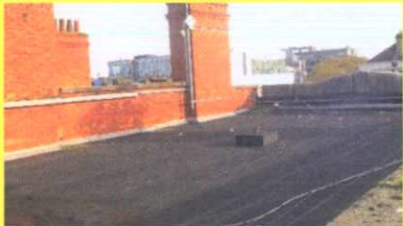
2	No. 44 O'Connell Street	Main roof and lower flat roofs		Substrate roofing felts		Presumed to contain asbestos						Investigation by a competent asbestos contractor prior to work likely to cause disturbance.

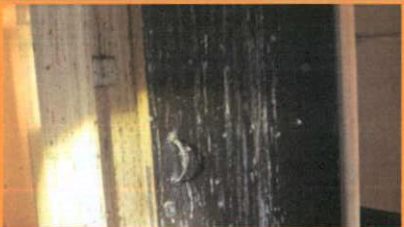
10	No. 44 O'Connell Street	2 <sup>nd</sup> floor Door between floors	2030419	Internal areas of fire door. Encapsulated		Amosite	2	1	1	2	6	Removal and disposal as asbestos waste by a competent contractor prior to work likely to cause disturbance.

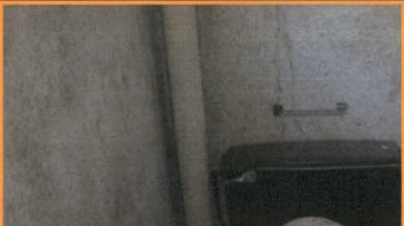
11	No. 44 O'Connell Street	1 <sup>st</sup> floor Back corridor WC at stairway		Bakelite cistern	1	Amosite	1	0	0	2	3	Removal and disposal as asbestos waste by a competent contractor prior to work likely to cause disturbance.

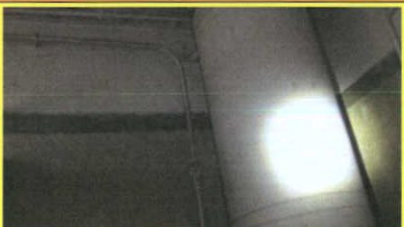
12	No. 44 O'Connell Street	1 <sup>st</sup> floor Back corridor WC		Integral areas of old electrical heaters		Presumed to contain asbestos.						Investigation by a competent asbestos contractor prior to work likely to cause disturbance.

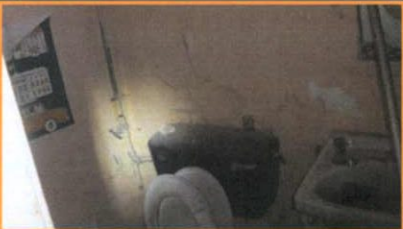
19	No. 44 O'Connell Street	1 <sup>st</sup> floor Front corridor		Bakelite cistern	1	Amosite	1	0	0	2	3	Removal and disposal as asbestos waste by a competent contractor prior to work likely to cause disturbance.

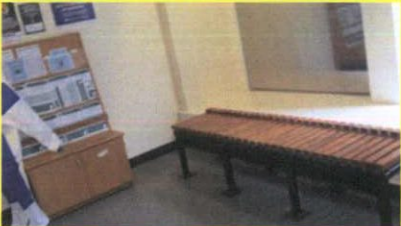
26	No. 44 O'Connell Street	Ground floor Reception area		Fixed floor not disturbed		Presumed asbestos						Investigation by a competent asbestos contractor prior to work likely to cause disturbance.

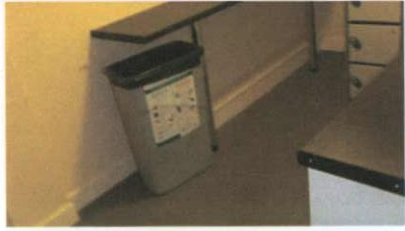
30	No. 44 O'Connell Street	Ground floor Locker room		Fixed floor not disturbed		Presumed to contain VFT and/or adhesive						Investigation by a competent asbestos contractor prior to work likely to cause disturbance.

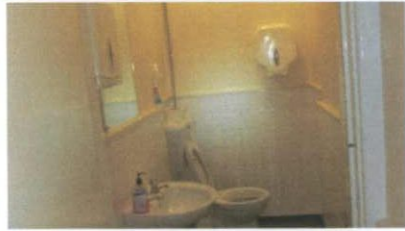
31	No. 44 O'Connell Street	Ground floor WC		Fixed floor not disturbed		Presumed to contain VFT and/or adhesive						Investigation by a competent asbestos contractor prior to work likely to cause disturbance.

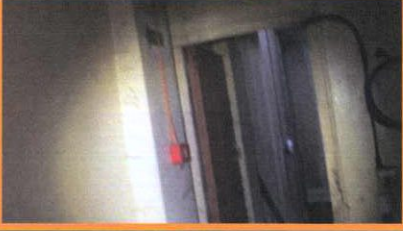
35	No. 44 O'Connell Street	Ground floor Back corridor		Integral areas of fire doors		Amosite						Removal and disposal as asbestos waste by a competent contractor prior to work likely to cause disturbance.

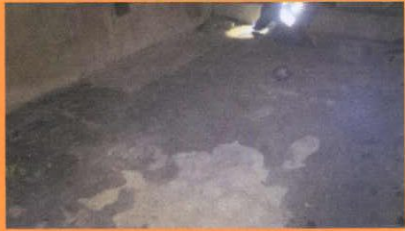
39	No. 44 O'Connell Street	Ground floor Back corridor Room at stairway	2030421	VFT adhesive	25 SM approx.	Chrysotile						Removal and disposal as asbestos waste by a competent contractor prior to work likely to cause disturbance.

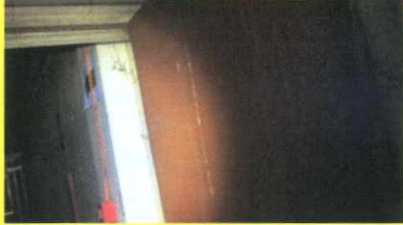
43	No. 44 O'Connell Street	Basement		Integral areas of fire doors		Strongly presumed to contain asbestos						Investigation by a competent asbestos contractor prior to work likely to cause disturbance.
