A4.7.6.2. Summary of forensic analysis findings

A4.7.7 No 11 Moore Street**A4.7.7.1. Significance to 1916**

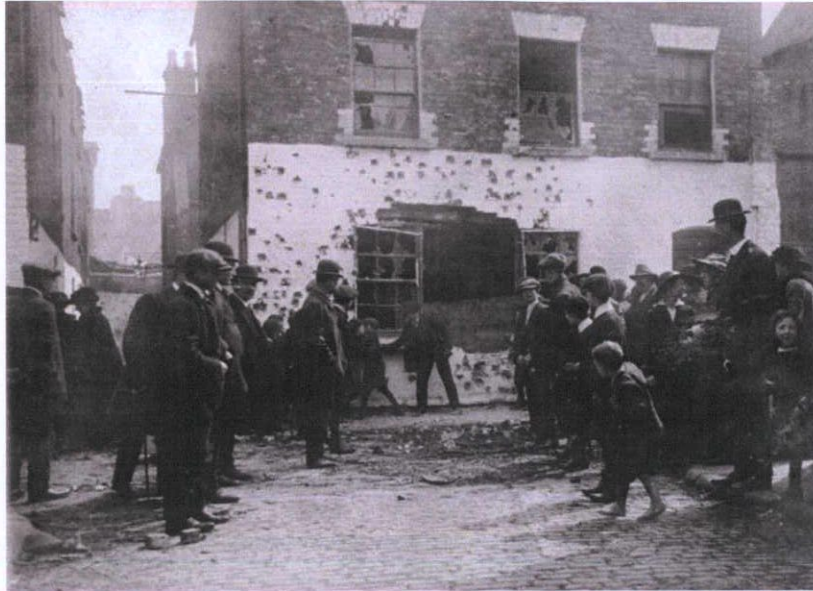
P 35 'Unknown building' damaged in 1916, thought be 10 Henry Place, at the junction of Moore Lane and Henry Place. Property Loss Archives describes the front of 10 Henry Place blown in by shell fire.

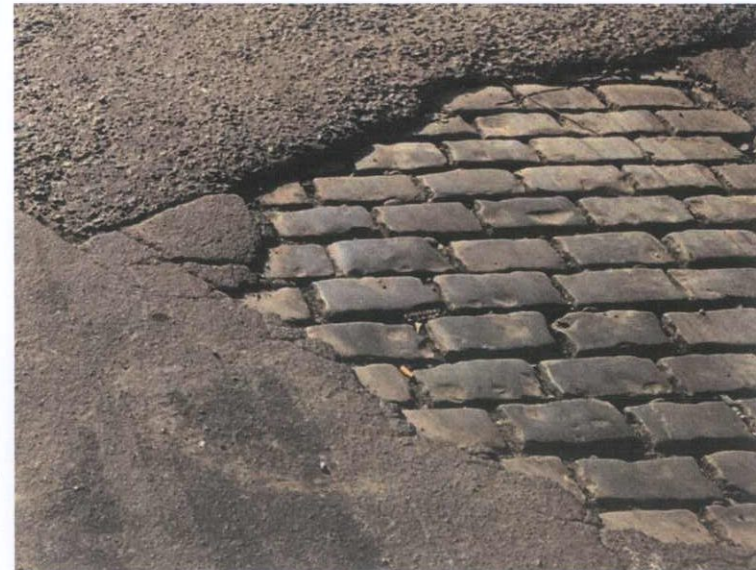
P 39 Original setts on Moore Lane visible under modern road surface.

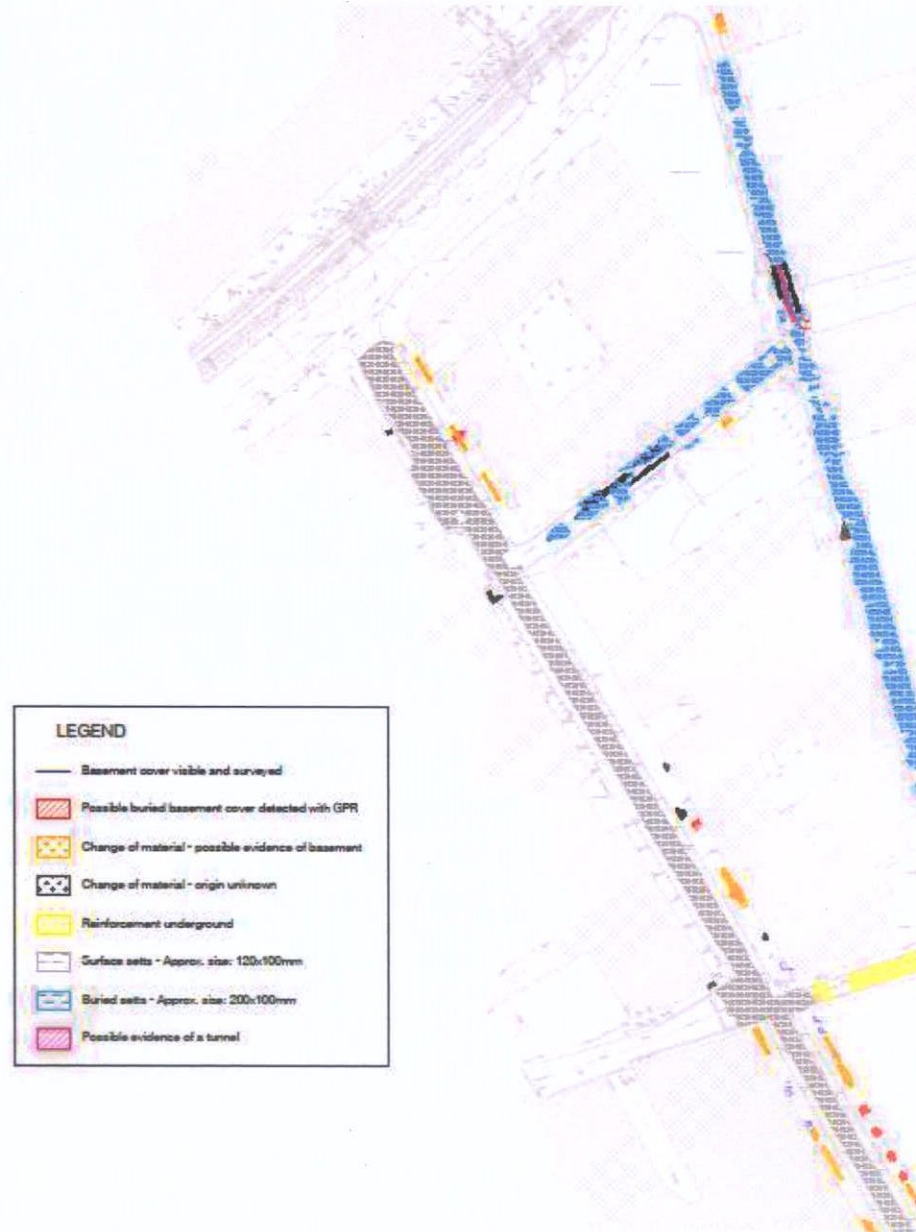
P 49 The GPR survey of the internal street network, indicating existence of setts below tarmac surfaces. Please Note, due to their concealed presence, it is not possible to confirm the extent of disturbance to accommodate extensive ground works in the past. Source:Murphy Geospatial [fix image](#)

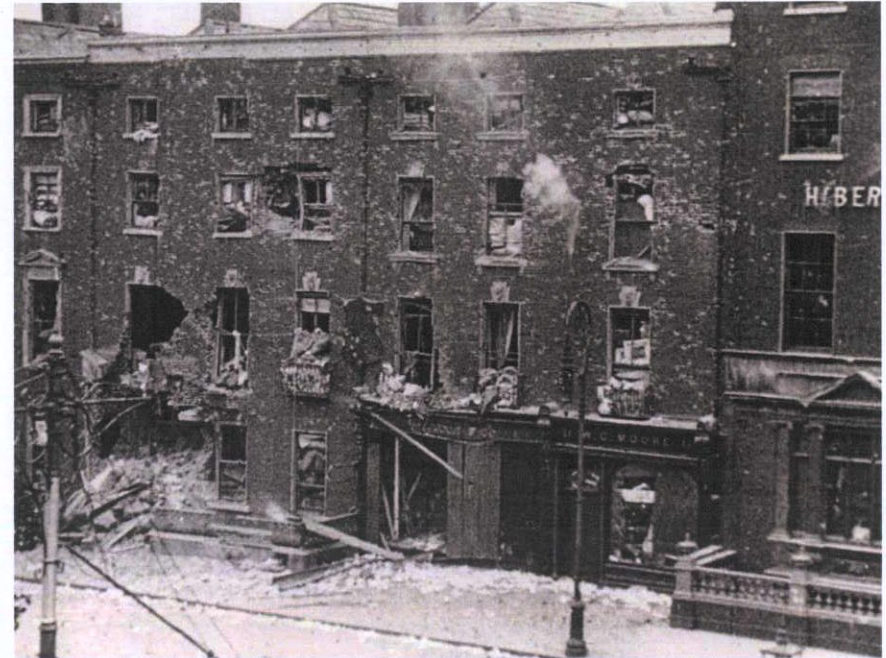
P 54 Destruction of numbers 10 to 12 O'Connell Street Upper.

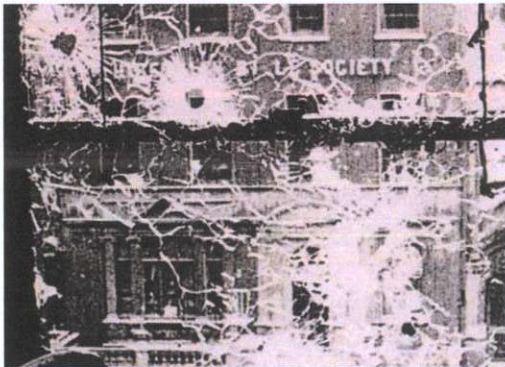
P 55 Shattered window at the Sackville Club, 59 O'Connell Street Upper (Source: George Morrison)

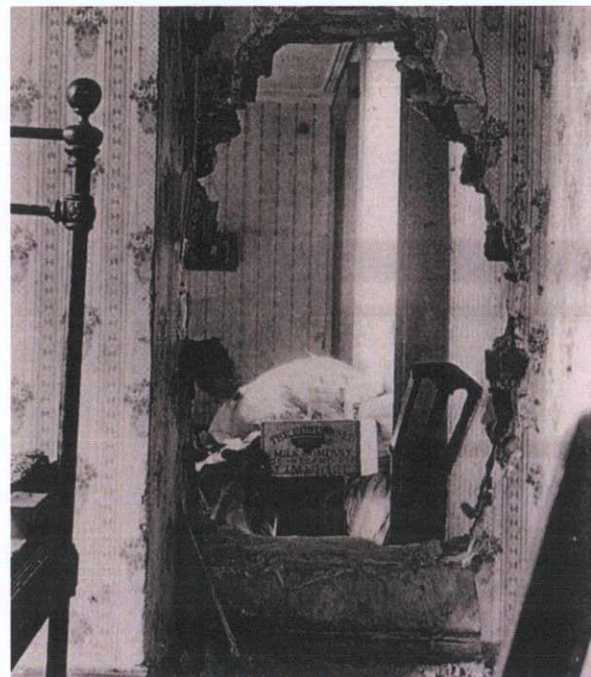
P 56 Hole in the party wall between properties on the eastern side of O'Connell Street, July 1922.
(Source: George Morrison)

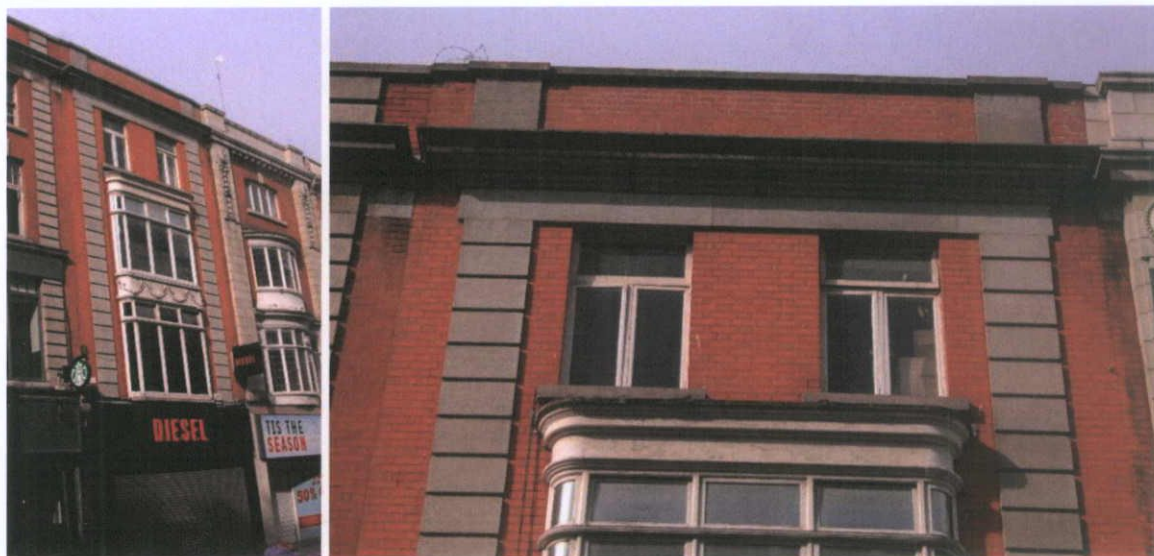
Fig.4.2.1: The façade of 38 Henry Street is of well-fired red brick with limestone detailing, with the parapet rebuilt in a different brick and heavier Portland Cement-based mortar.

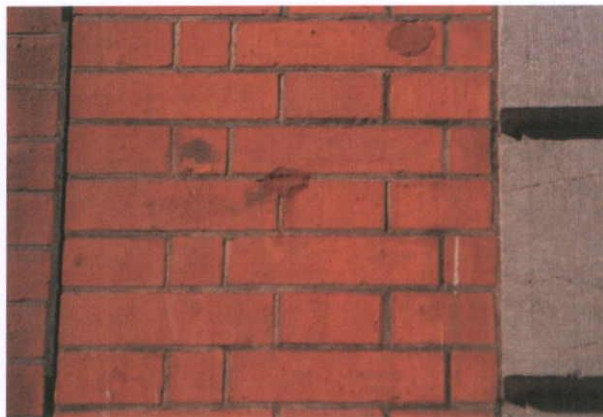
Fig.4.2.2: The brickwork and limestone detailing on the façade of 38 Henry Street has been cleaned and small 'plastic' mortar repairs (appearing dark red) seen.

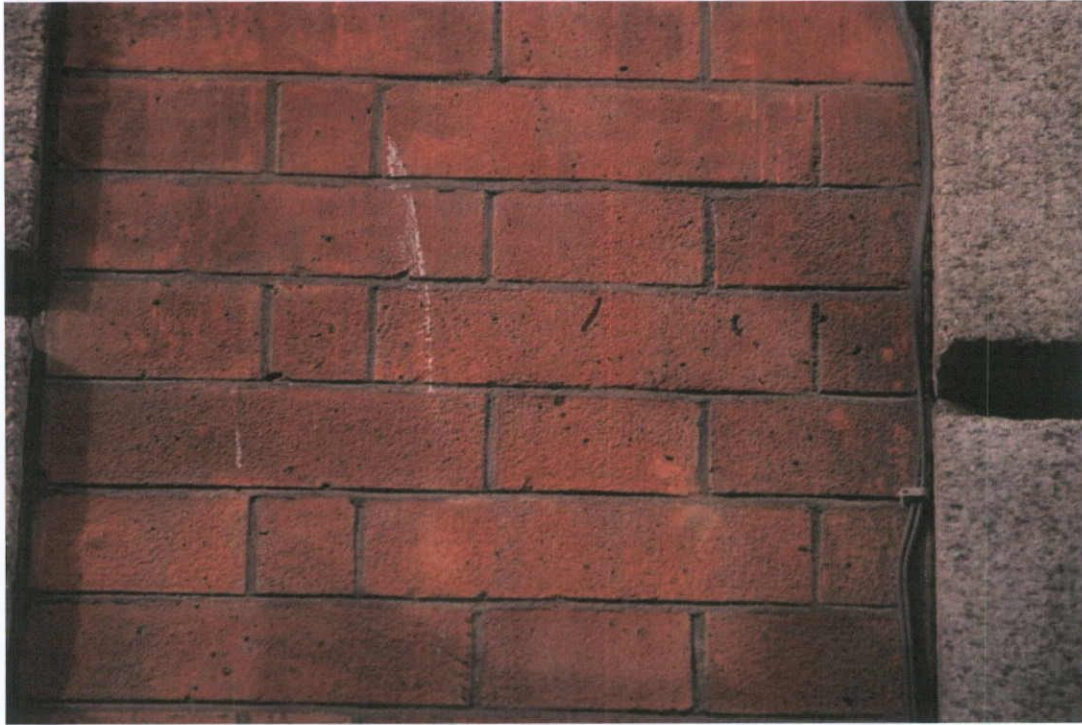
Fig.4.3.3: Detail of the brickwork on the façade of 39 Henry Street showing a damaged surface (probably from past cleaning) and the edge of the Leinster granite detail.

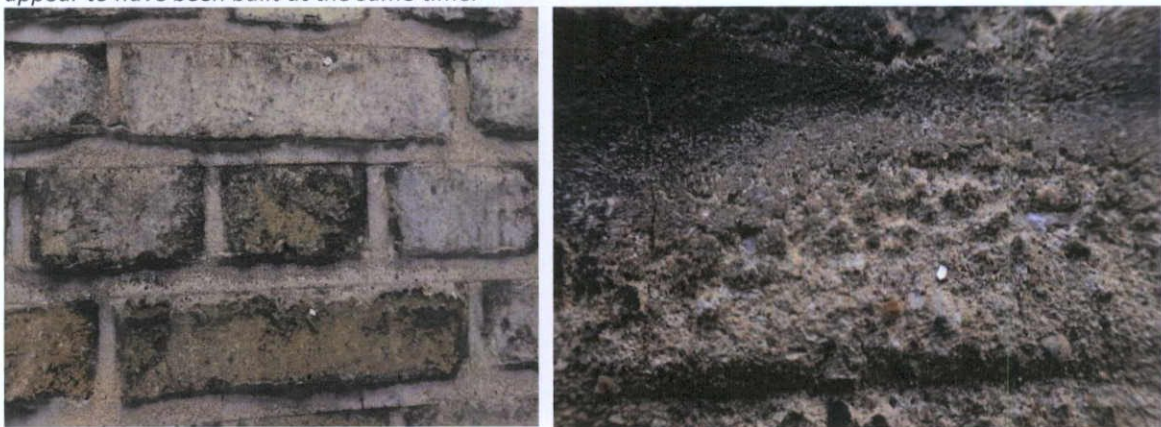
Fig.4.3.5: The rear elevation shows soiled Portland Cement pointing mortar.

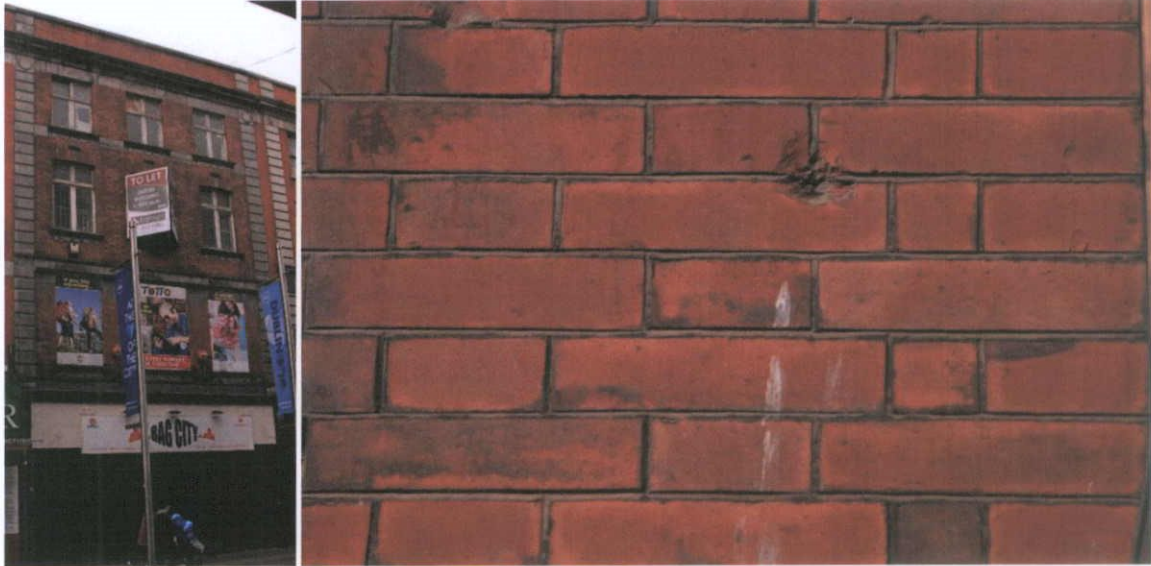
Fig.4.4.1: The brickwork on the soiled façade of No.40 Henry Street consists of well-fired machine-cut red clay brick with weatherstruck Portland Cement-based pointing mortars. Leinster granite was used for architectural detailing. The work probably dates to c.1917-1920.

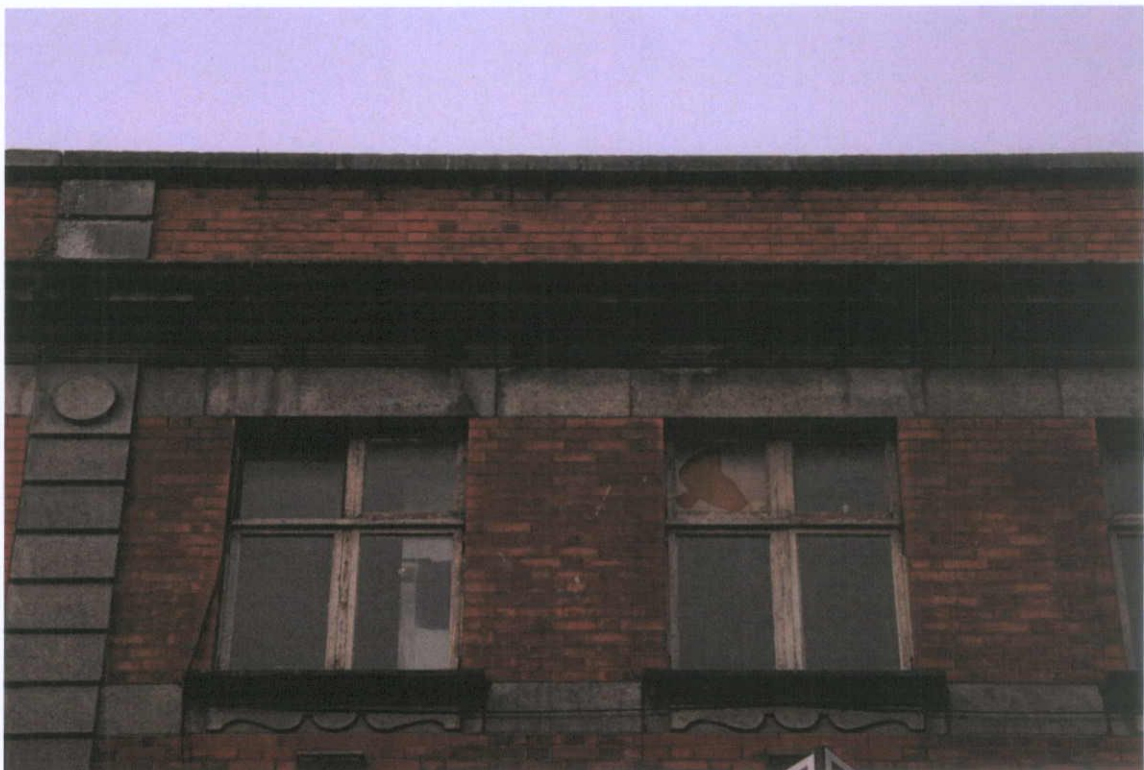
Fig.4.4.2: Soiled brick and granite detailing at upper floor level.

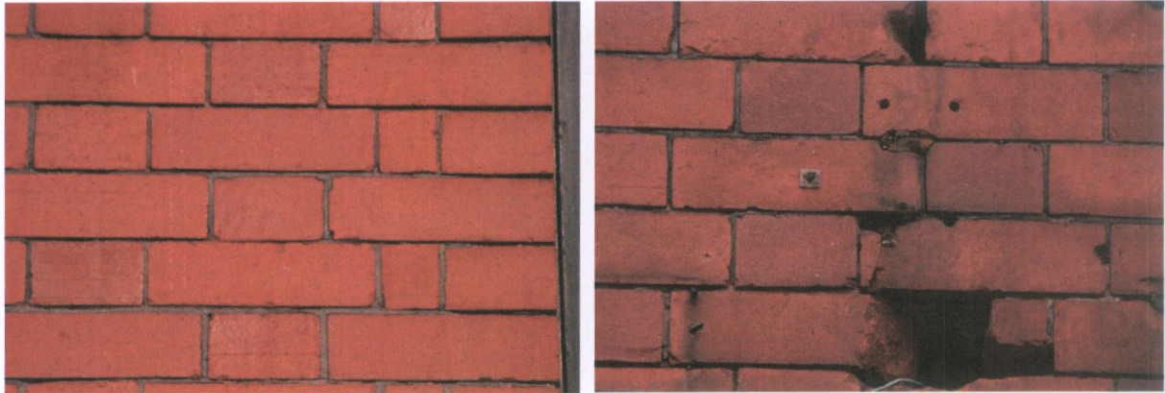
Fig.4.6.1: Homogenous red brickwork at first floor level of 1-2 Moore Street showing a grey-coloured Portland Cement-based pointing mortar (but also some joint recession suggesting this may be later repair work). The façade shows some minor damage exposing the bedding (right).

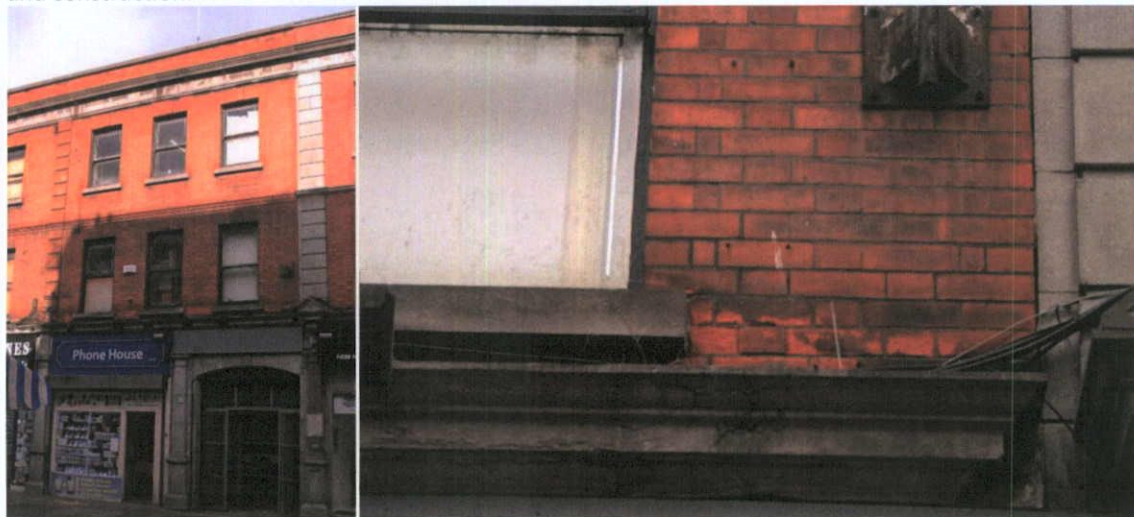
Fig.4.7.2: No.3 Moore Street built with machine-cut homogenous red brick with limestone used for window cills and architectural detail. The masonry is soiled, exaggerating certain stone features.

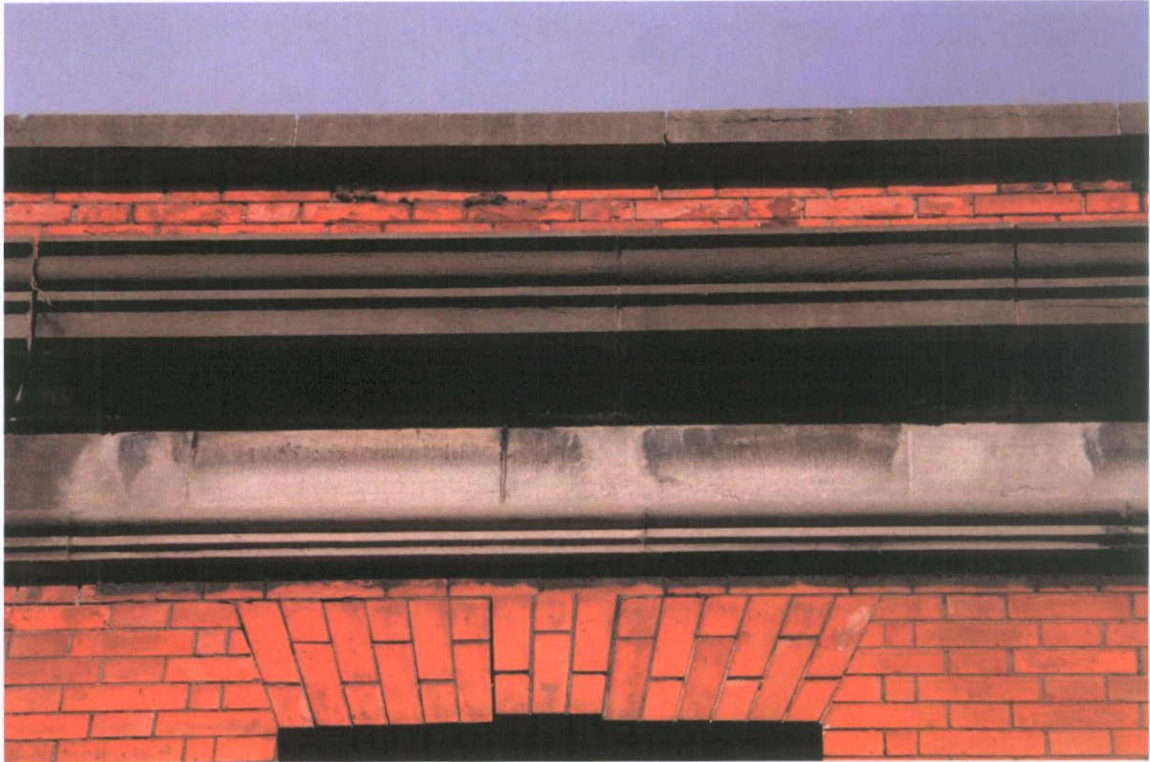
Fig.4.7.3: Detail showing the soiled limestone frieze and coping stones.

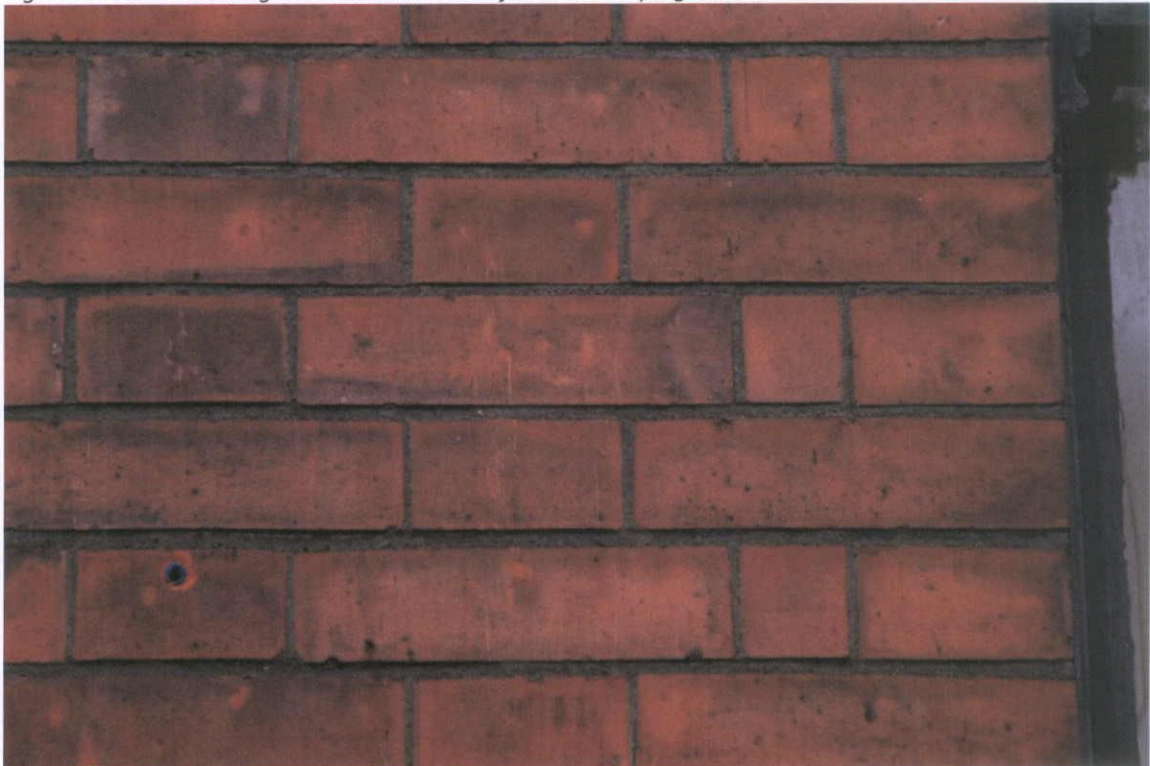
Fig.4.7.4: The soiled brickwork is machine-cut kiln-fired, consistent with c.1917 work.
