**4.11 7 Moore Street:** The three-storey two-bay brick-fronted terraced building rising to a granite frieze and cornice, similar to the c.1917 limestone terrace of Nos.3-6 Moore Street built immediately to south, but lacking the brick ‘soldier’ quins and brick specials used as a string course between the first and second floors. Despite being a different construction project to the adjacent terrace, the brick in both developments match (compare Figs.4.2.10 & 4.11.2) and reflect the brick in common usage at the time.

**4.12 8-9 Moore Street:** This building comprises two eighteenth century buildings combined into one premises; now appearing as a painted three-storey four-bay brick-fronted building, and connected to Nos.11-13 Henry Place at the rear. The façade brickwork is painted yellow, while the north gable has been painted black. Two buildings are marked in this location on John Rocque's 1760 map, and when the internal brick lining was broken open (see Fig.4.12.7), the brick contains distinctive angular limestone aggregate also seen at No.42 O'Connell Street and other Georgian buildings in the area, and may be brick made at the 'Old Brick Field' noted on Moore Street on Rocque

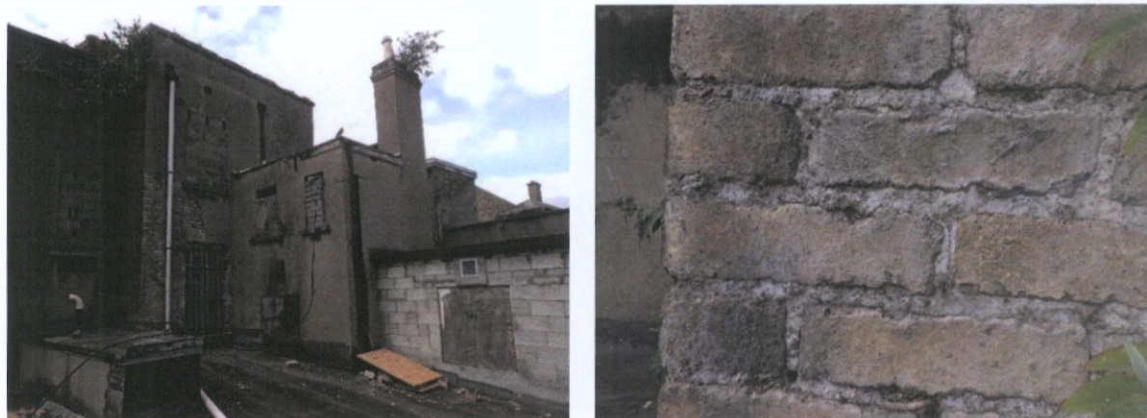
*Fig.4.11.3: General view of the rear of No.7 Moore Street, which extends further than the terrace immediately to the south, and was constructed using a yellow stock brick (normally concealed beneath a Portland Cement render).*

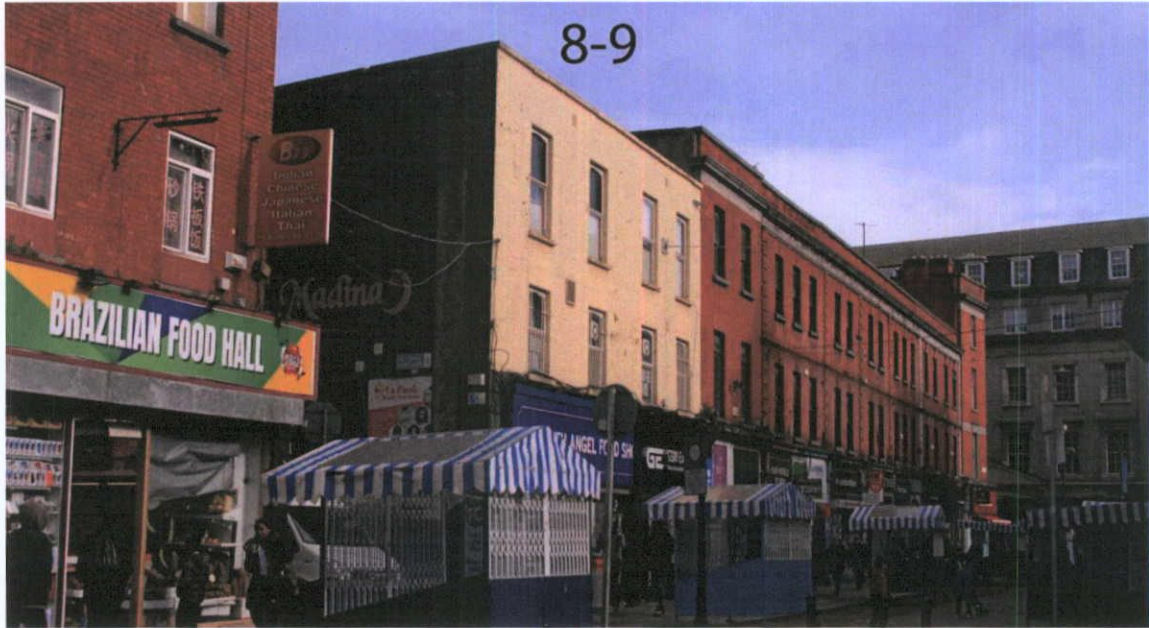
Fig.4.12.1: Nos.8-9 Moore Street forming the corner with Henry Place.

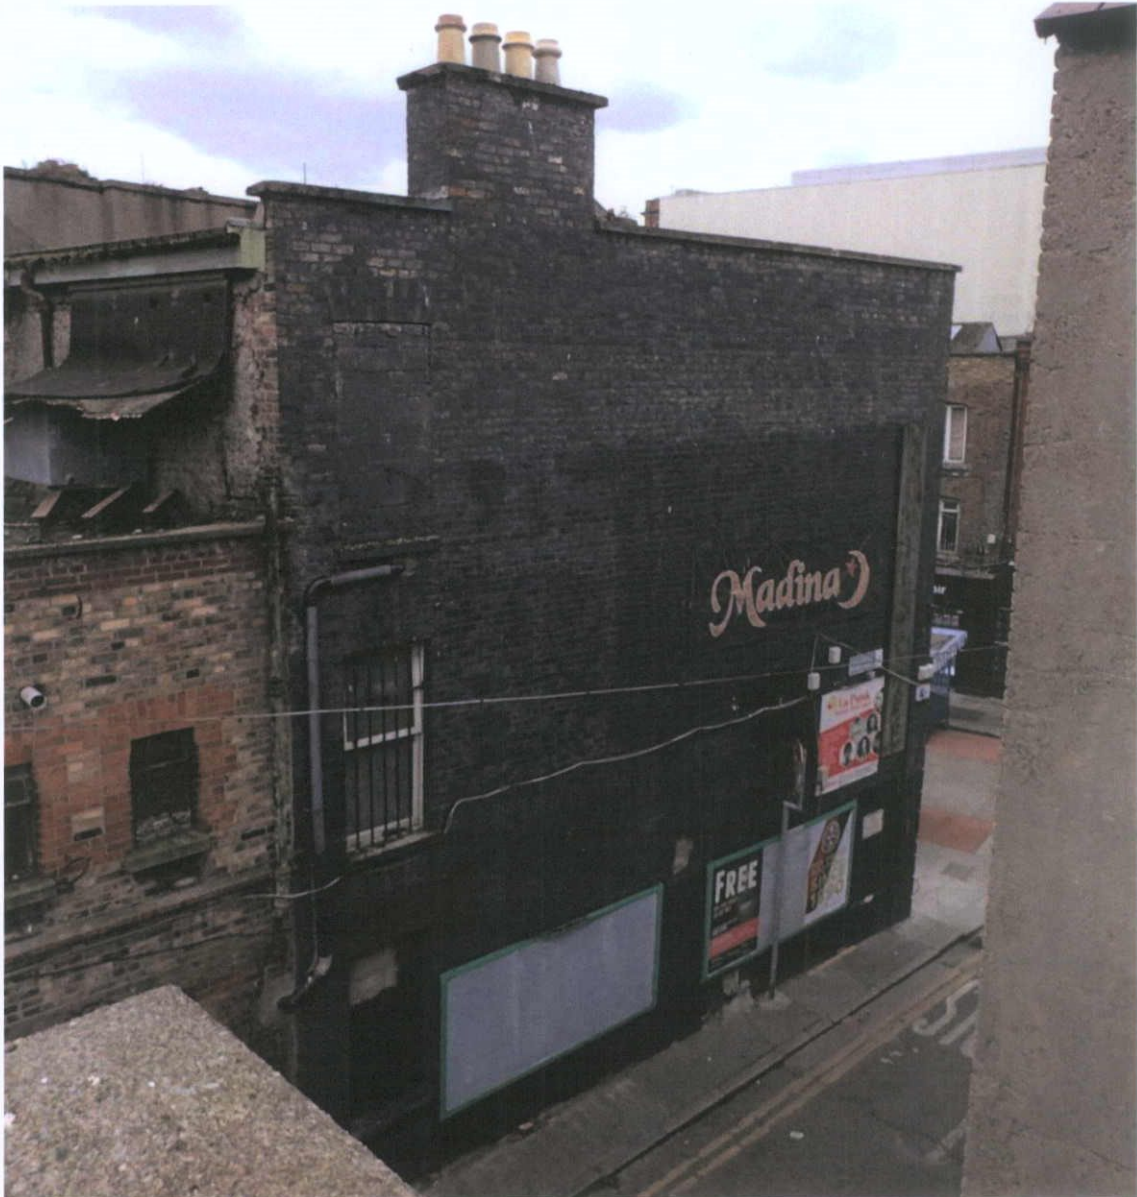
Fig.4.12.4: View of the painted north wall of No.9 Moore Street.

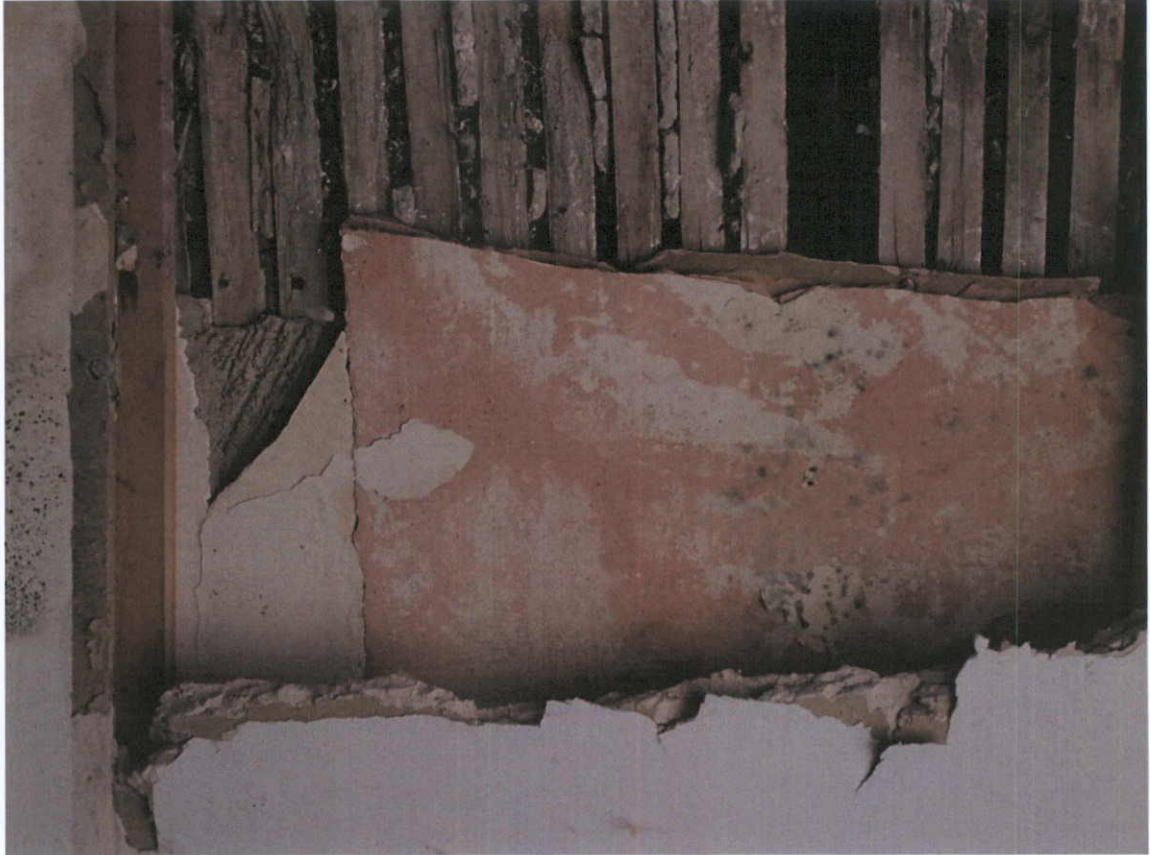
The ceiling plasterwork is pink gypsum applied on timber lath. However, the lathwork has the ribs of a lime-based keying surviving between the laths (Fig.4.12.6) which appear to be remnants of earlier lime-based plasterwork: this is at least of nineteenth century date, but may be earlier. The internal wall plaster contains burnt fuel fragments, abundant brick pozzolan and crushed brick aggregate.

*Fig.4.12.6: Lime lath-and-plaster ceiling surviving at the first floor of Nos.8-9 Moore Street (concealed behind poorly-applied later ceiling plaster layers).*

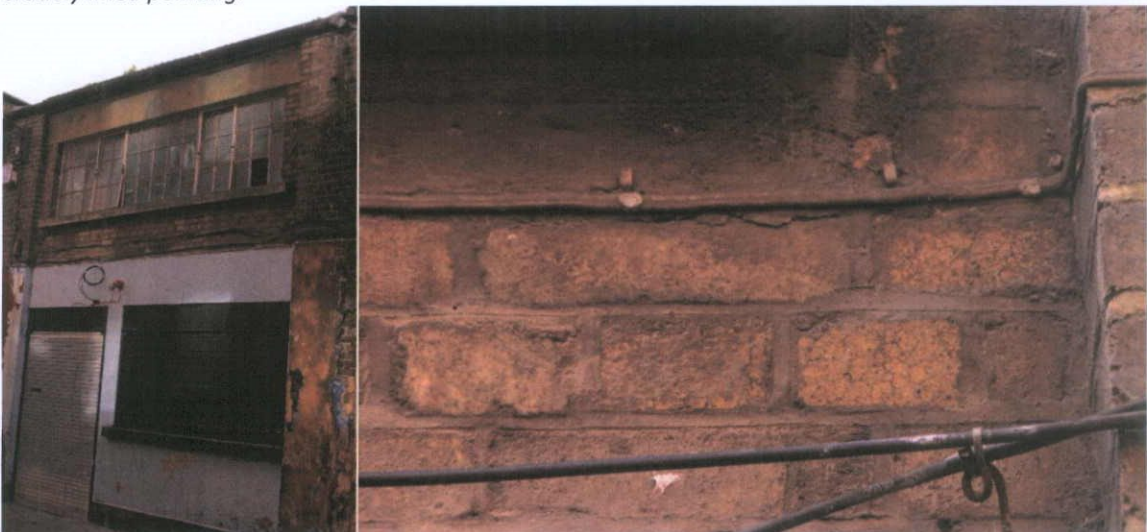
Fig.4.13.2: The brick is pointed in lined Portland Cement-based mortar, and the buff-coloured brick has crazele (network of minor cracks also called crack networks, termed 'crazing' for terracotta).

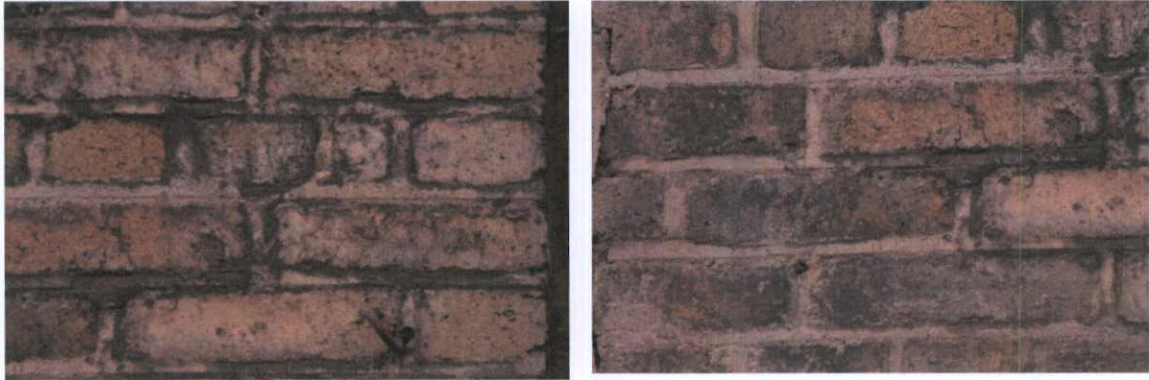
Fig.4.13.3: Soiled buff-coloured brick in lined flush pointing.

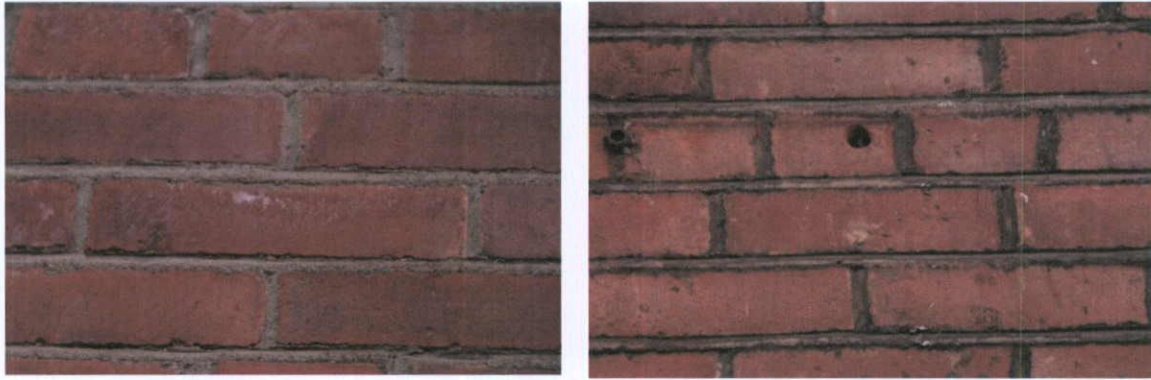
*Fig.4.14.5: The brick at first floor level is remarkably free from airborne particulate soiling (which is commonly found on building surfaces which have not been previously cleaned in Dublin City). Some soiling is found on the weatherstruck joints – suggesting that the brickwork was either cleaned (or possibly built) not too long before the Air Pollution Act 1987.*

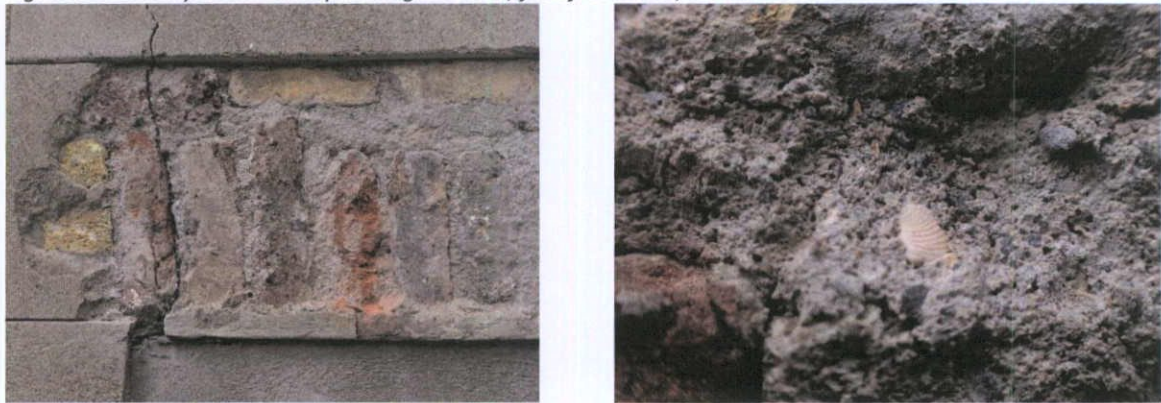
Fig.4.16.5: The first floor window head on the south elevation has a mix of 19<sup>th</sup> and c.1920s yellow stock brick (suggesting repair) bedded in a lime-cement mortar with shell included in the aggregate.

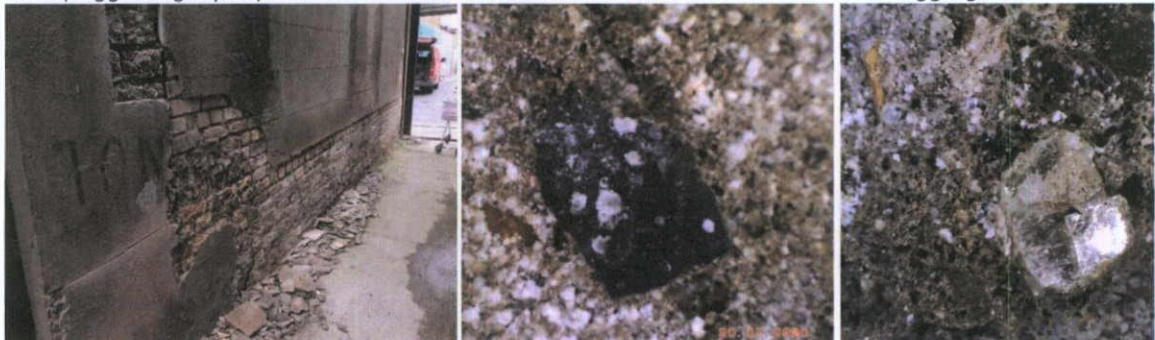
Fig.4.16.6: The north end of the east wall is coated with a Portland Cement render above a c.1920s yellow stock brick masonry substrate.

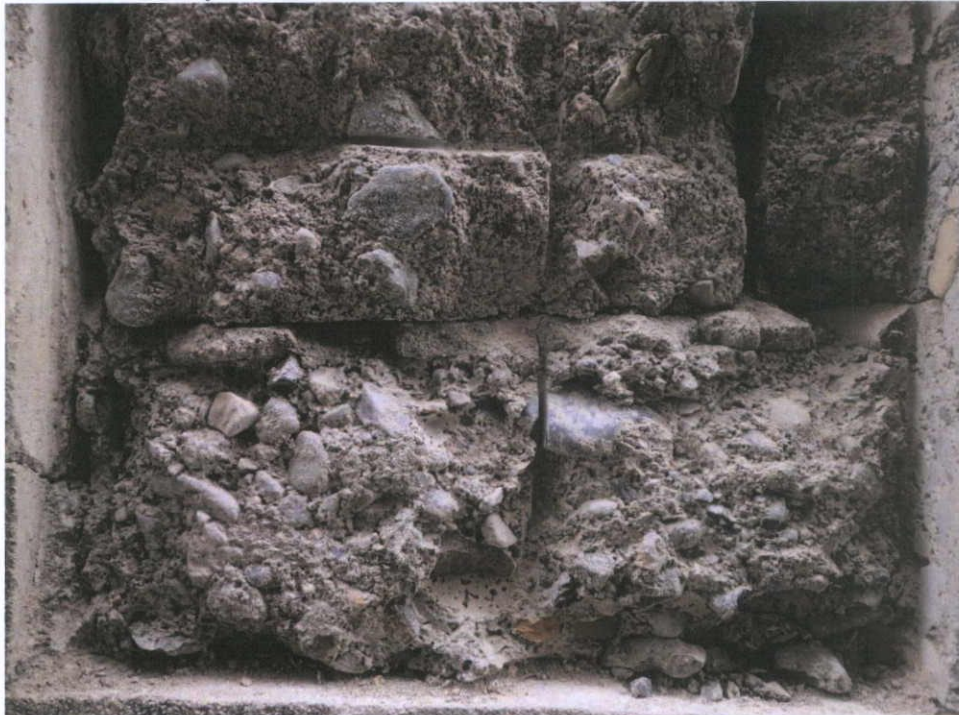
Fig.4.16.14: 1959 concrete repair, east elevation, ground floor level.

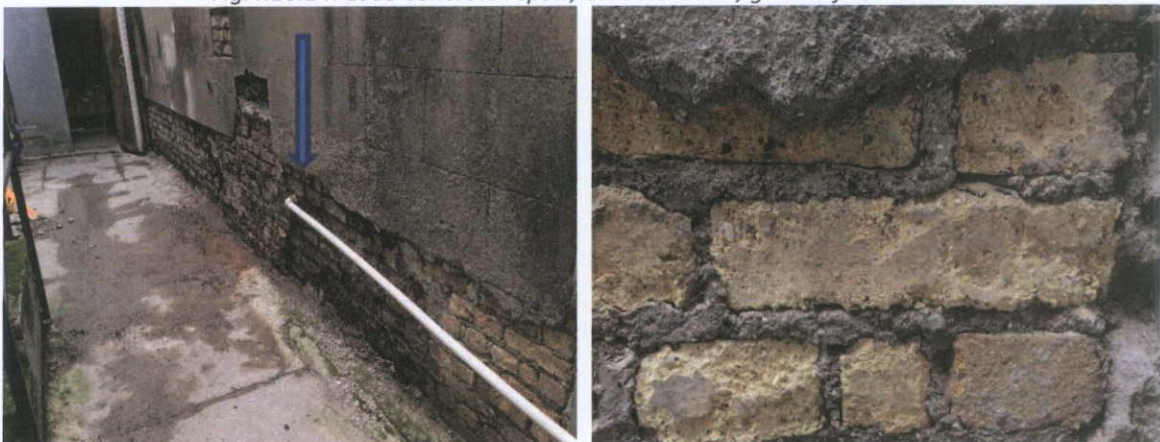
Fig.4.16.15: Junction (arrowed) between the c.1920 yellow stock brick in a cementitious bedding mortar and a section of probably nineteenth century stock brickwork in very poor condition.

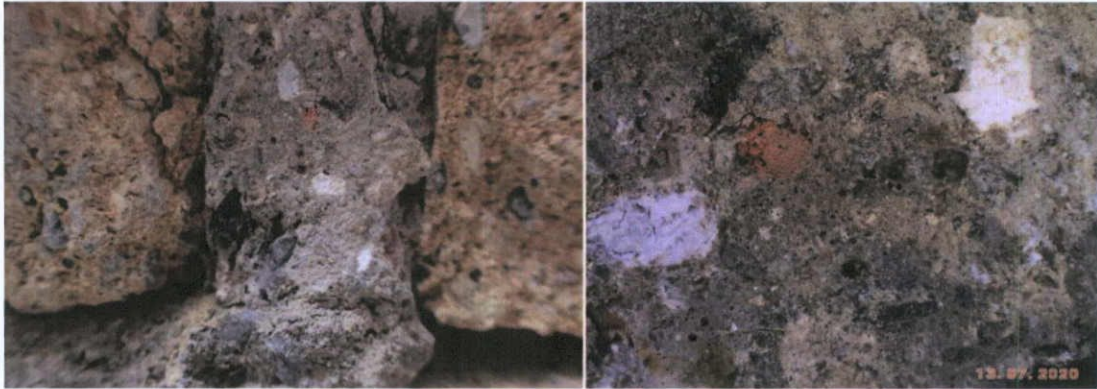
Fig.4.16.16: Detail of the cementitious bedding mortar of the c.1920s yellow stock brick.

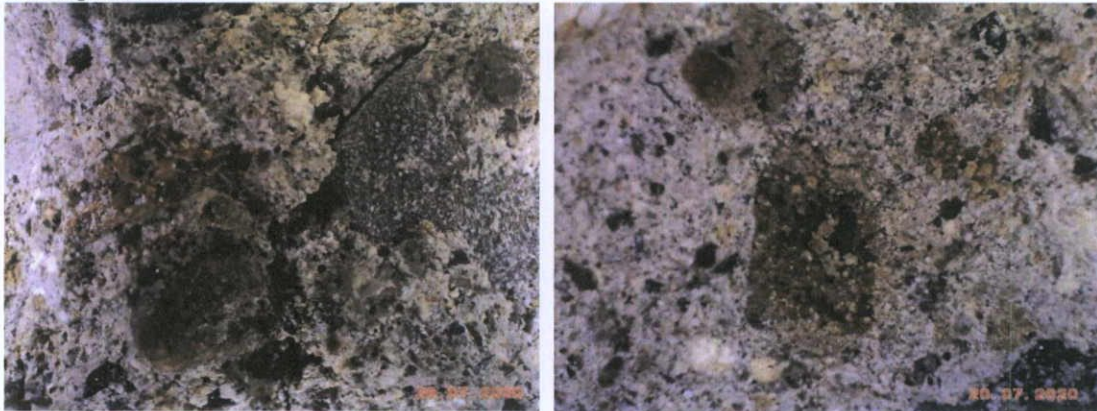
Fig.4.16.18: Crushed brick, timber and stone can be found in the cementitious bedding mortars.

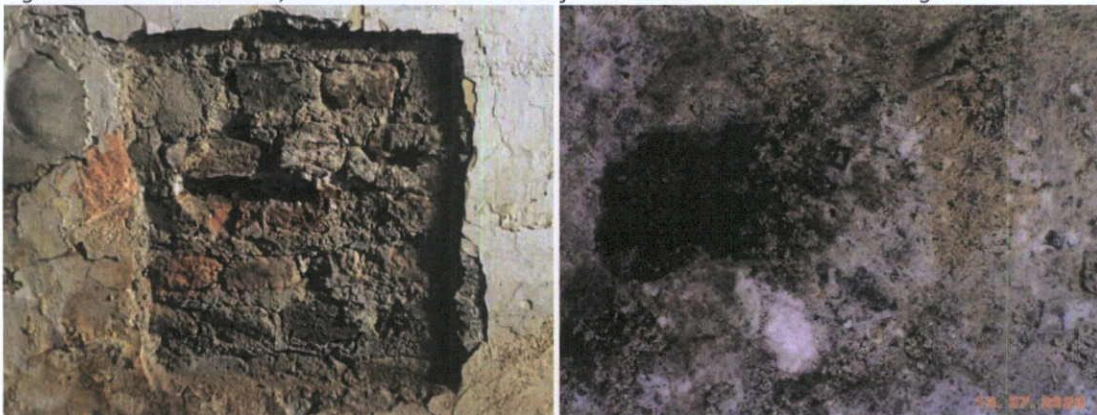
Fig.4.16.19: Nineteenth century stock brick and Calp limestone masonry at the south end of the west wall at ground floor level of No.10 Henry Place, coated with a cementitious internal plaster.

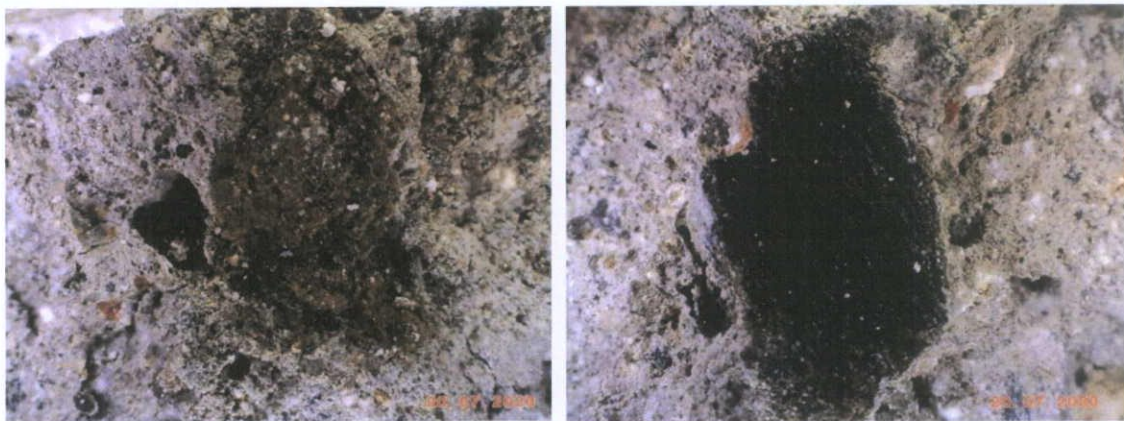
Fig.4.16.21: Crushed yellow, brown, beige, red and orange brick fragments are found in the plaster.

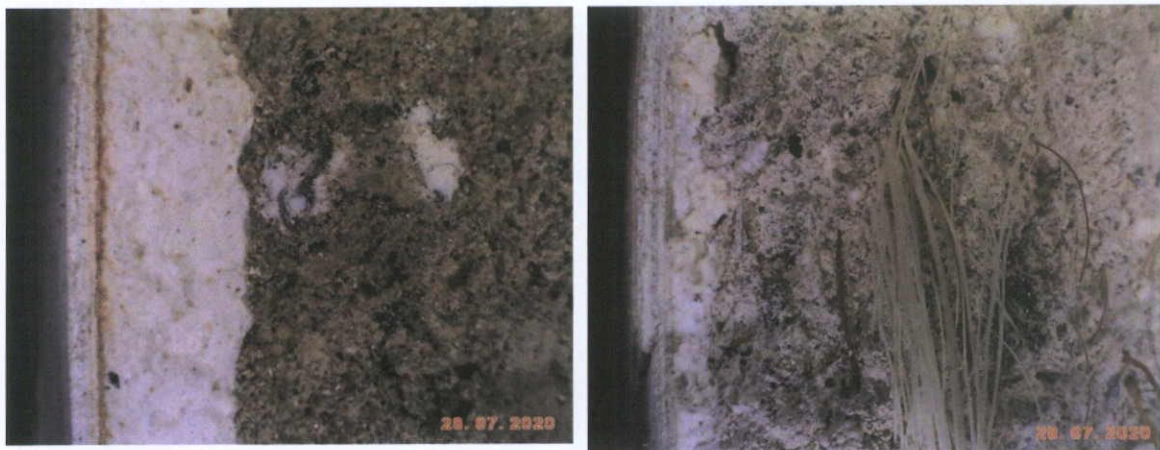
Fig.4.16.22: Detail of plaster, ground floor level, south end of the west wall. Some parts retain areas of haired lime, which were considered as trace remnants of the nineteenth century surface.

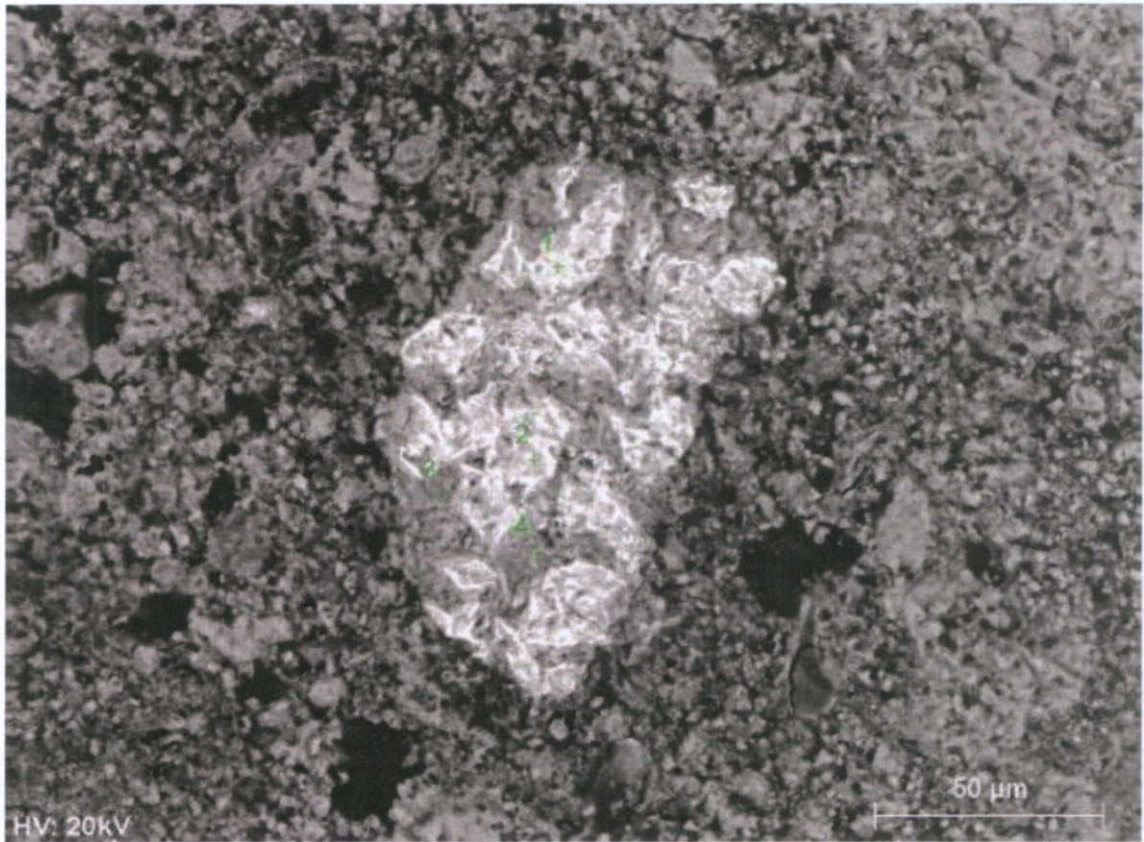
Fig.4.16.25: SEM-EDS analysis of the cementitious binder binding the 1920s yellow stock brick showing clinker phases

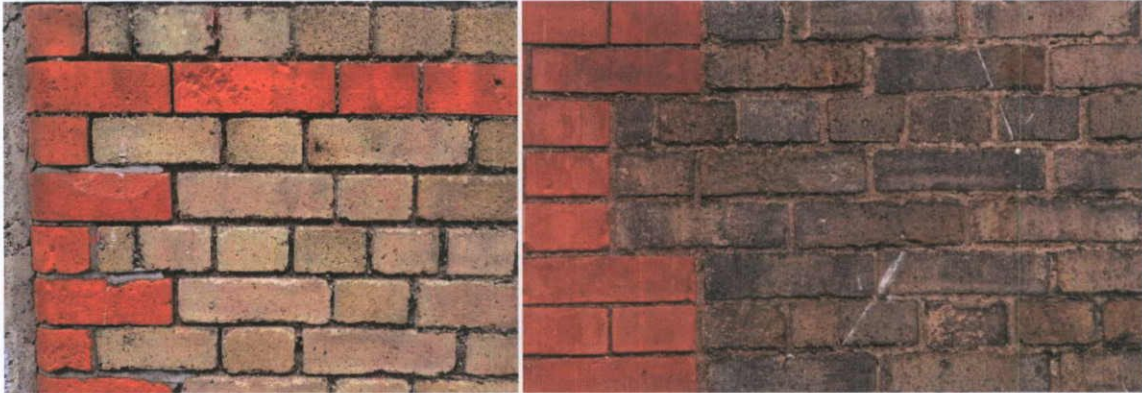
Fig.4.17.2: 'Cleaned' brickwork showing surface damage to the red and yellow brick with loss of fireskin and mortar from the bedding joints (left); soiled but intact original brick and mortar.

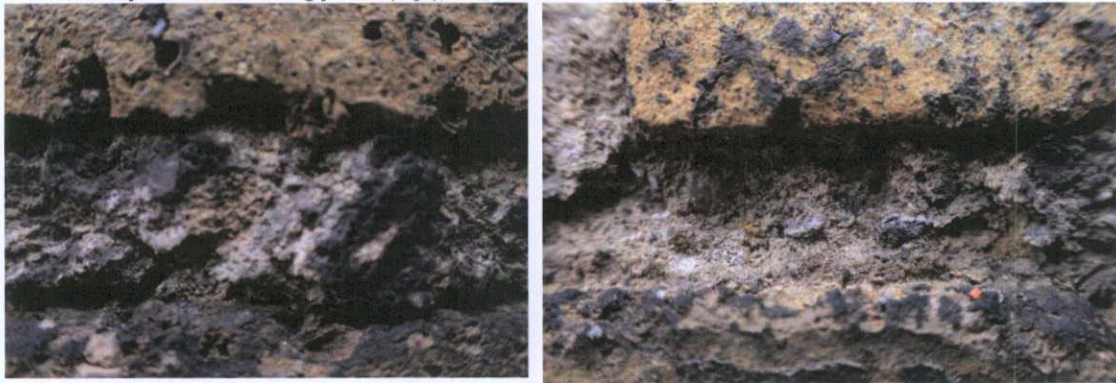
Fig. 4.17.3: Soiled, damaged surface of the bedding mortars.

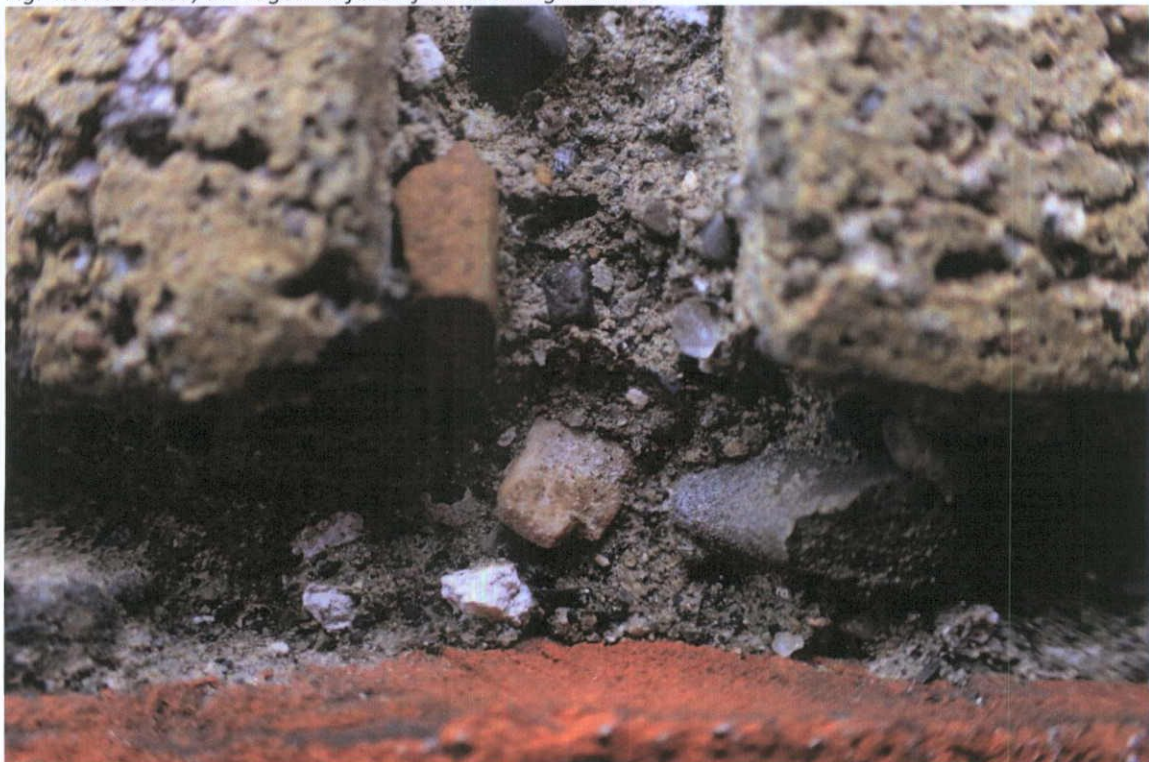
Fig. 4.17.4: Poorly sorted limestone, sandstone, quartz and chert aggregate with coarse lime lumps in a water-damaged lime binder.

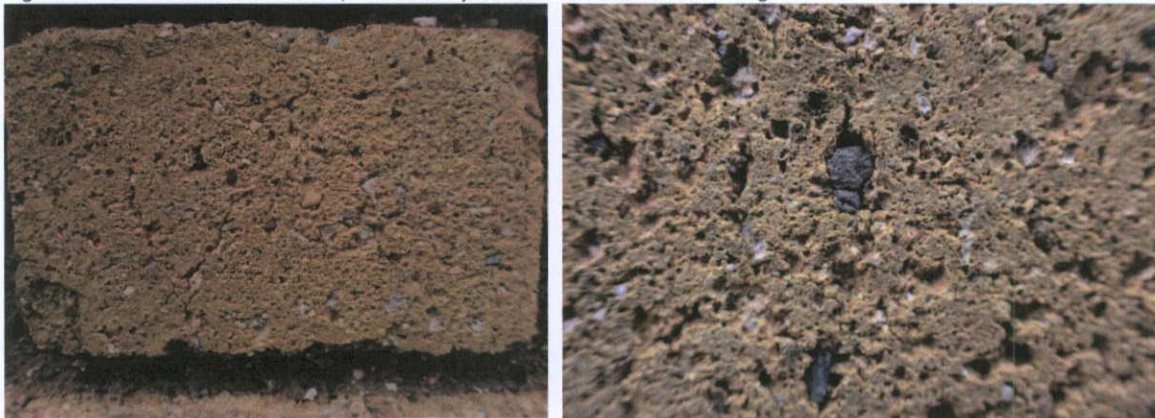
Fig. 4.17.11: Yellow brick damaged by abrasive cleaning showing the exposed brick core with abundant pebble inclusions from the unprocessed raw clay used to manufacture the brick.

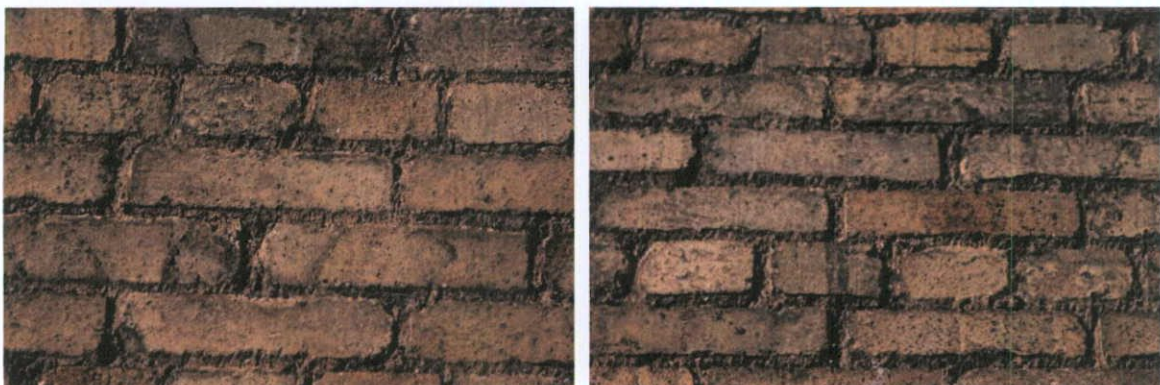
Fig.5.1.4: The south elevation is painted at ground floor level, and the upper parts are soiled and were not accessible. The yellow stock brick have some surface defects, and the soiled bedding mortars show flush finishes, weatherstruck finishes but are mostly disrupted (suggesting that the soiling is gypsum-based and the bedding contains lime). The brick appears broadly similar to that seen at Nos.17-18 Henry Place.

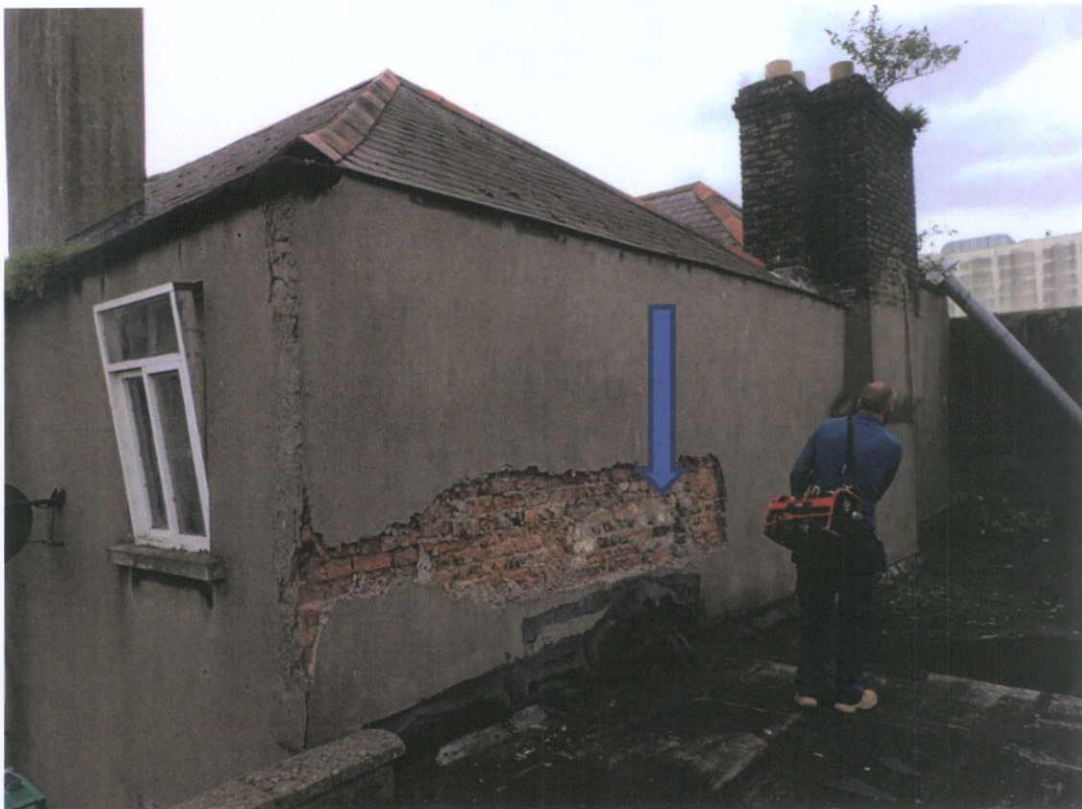
Fig.5.1.6: Exposed brickwork beneath Portland Cement render, north elevation, 10 Moore Street. The masonry has been disturbed and appears to be a 'creep hole' (arrowed). See Fig.5.1.9 also.

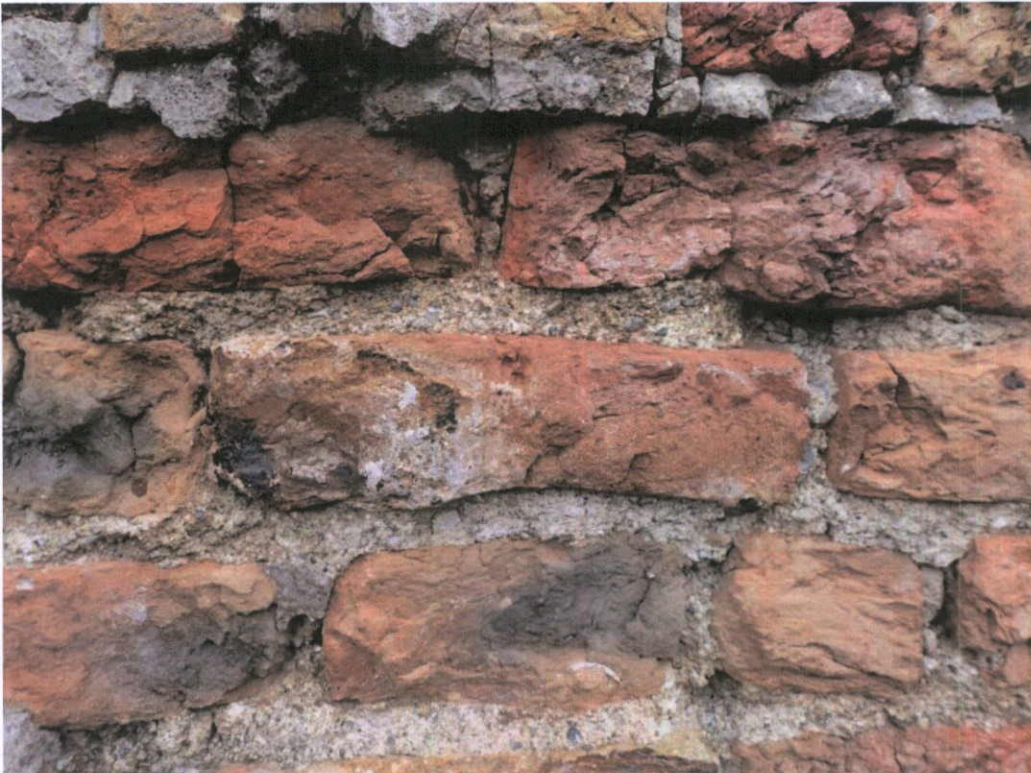
Fig.5.1.7: Detail of north elevation of No.10 Moore Street. The exposed brickwork consists of hand-made clamp-fired bricks showing a lack of sorting of the raw clay material, characteristic moulding and shaping defects, and both underfired and over-fired examples of brick. The bricks do not conform to standard imperial sizing.

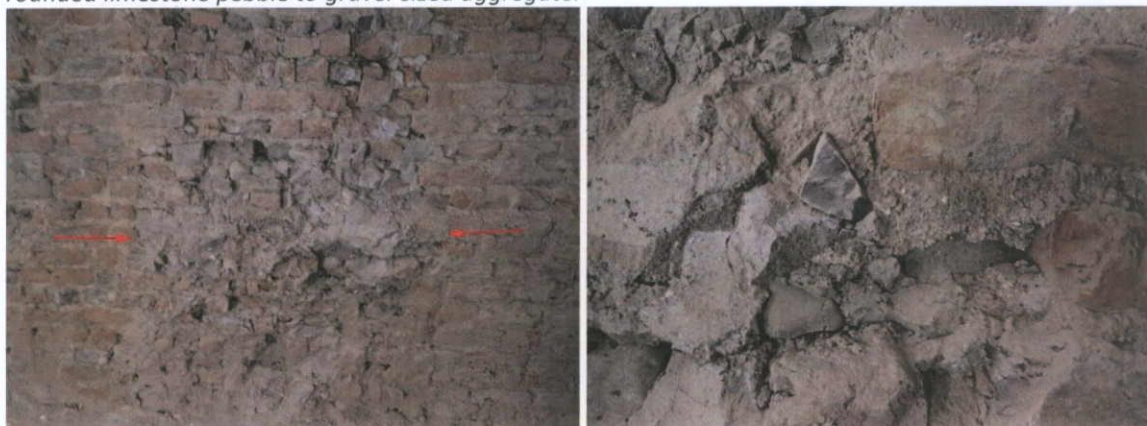
Fig.5.3.7: 'Creephole' at ground floor level, front room, south wall: showing a change in construction with the insertion of broken cobbles and other materials bonded in a cement-based mortar.

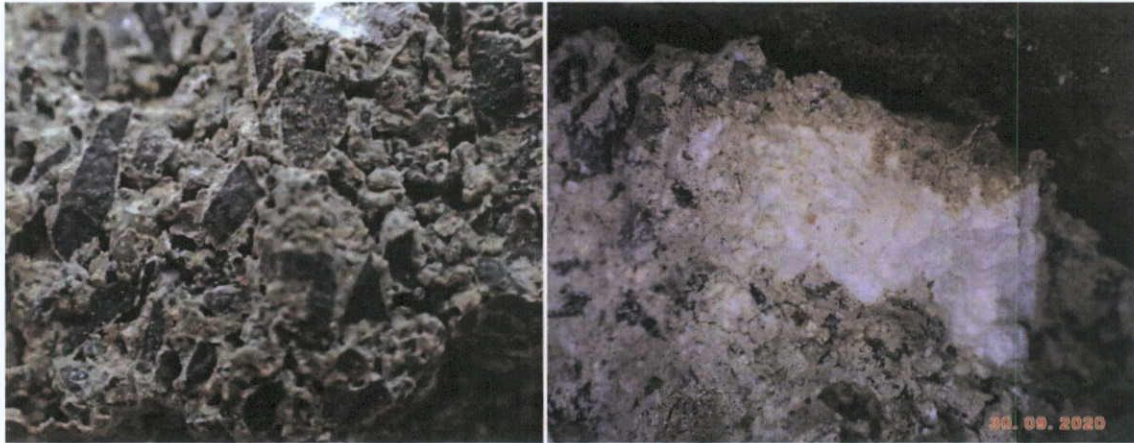
Fig.5.3.10: Detail of 20<sup>th</sup> century concrete repair to the south wall at ground floor level.

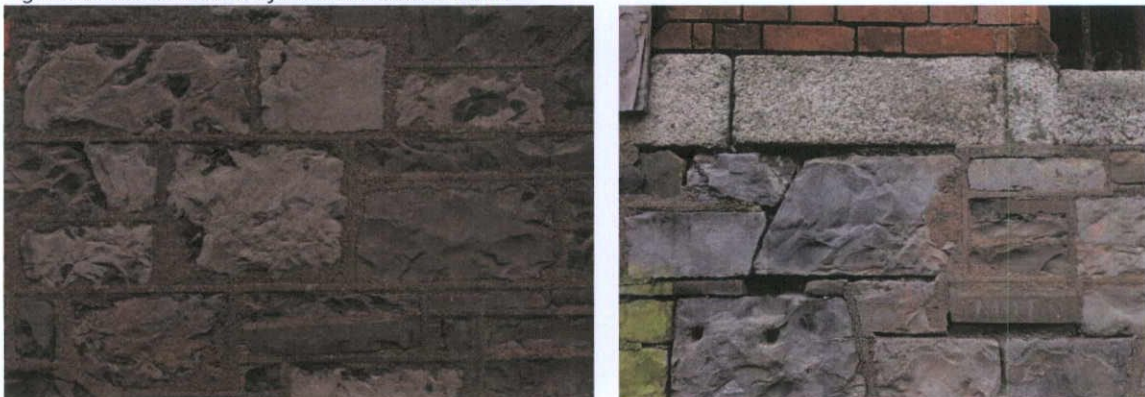
Fig.5.5.2: The coursed hewn Calp limestone masonry has been repointed with coarse-grained Portland Cement strapwork, which was also used as a repair mortar at the time of application.

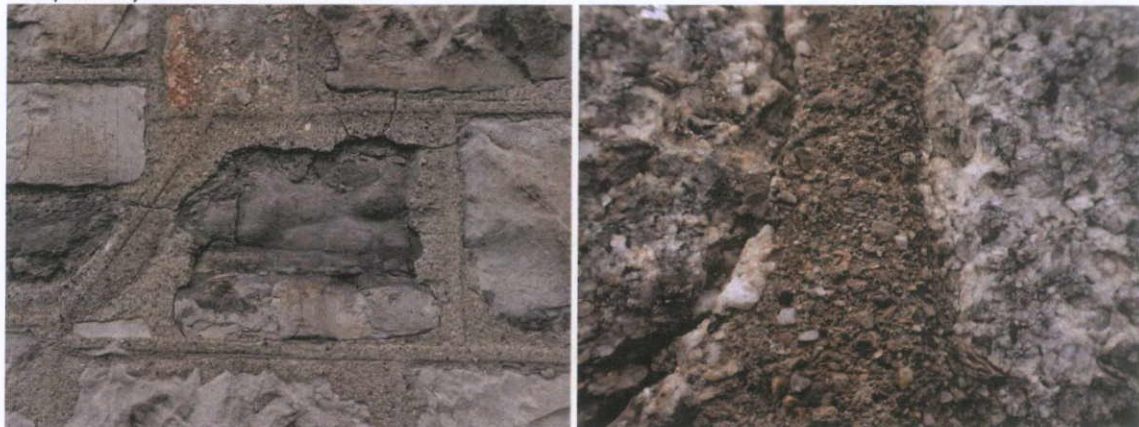
Fig.5.5.6: Mid-twentieth century Portland Cement-based repair and pointing mortar.

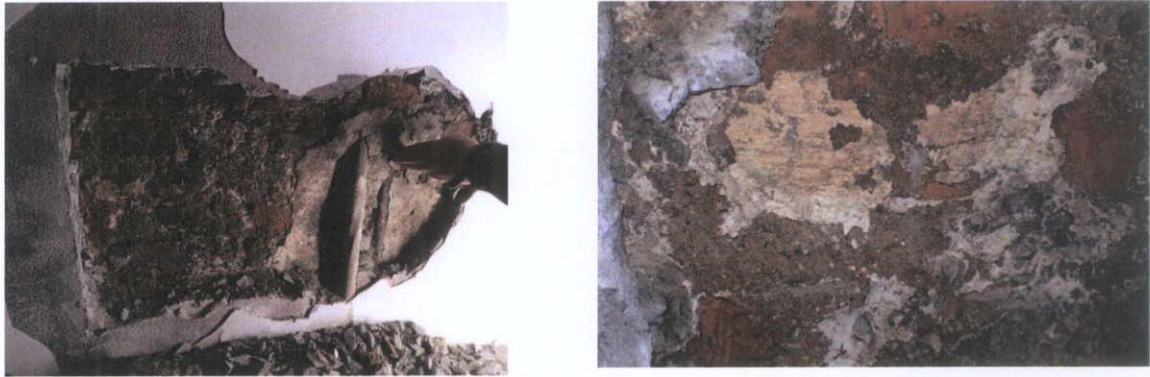
*Fig.5.6.10: The north wall is composed of hand made and probably clamp-fired red place brick, concealed behind a cement-based plaster. This brick masonry wall is very different in composition to the other walls in the building, and is more similar to the party walls found behind the internal plasterwork of the buildings between No.18 and Nos.20-21 Moore Street. While only a relatively small section of brickwork was exposed – this appears to be an early wall for the area, and may even be a late eighteenth or early nineteenth century brick wall.*
