Appendix 1 – Sampling

The sampling below relates to buildings from all five sites under consideration in the Dublin Central project.

This report was prepared at the request of Molloy & Associates Conservation Architects to inform the Dublin Central Built Heritage Review for Hammerson Plc. The purpose of the work was to analyse the physical fabric of buildings on O’Connell Street, Parnell Street, Henry Street, Moore Street, Moore Lane and Henry Place; and to use the physical evidence gathered through study of the building materials to gain a better understanding of the significance and dating of each of the buildings. This report is Volume 2 (of 2)¹ and focuses on the buildings contains in Sites 1 and 2 in the Dublin Central project.

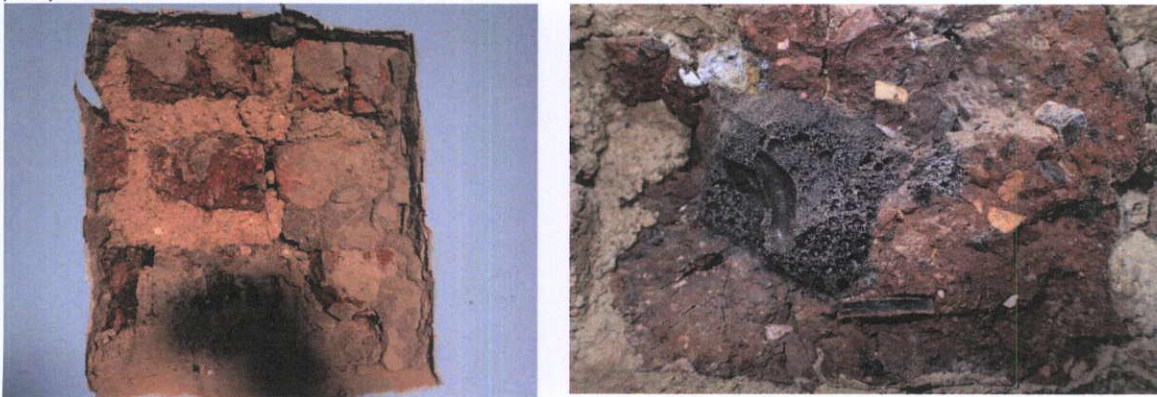
The internal walls were built with relatively low-quality irregular hand-made clamp-fired bricks showing many manufacturing defects (Fig.4.1.2). These are laid in thick, deep lime mortar joints where the bedding joint depth is c.1/3 the height of the brick. The bricks were made from unsorted and unprocessed natural raw clay containing abundant low-sphericity sub-angular limestone fragments; some of which were partially calcined during brick firing. These coarse non-plastic inclusions also include chert fragments suggesting that the brick field lay on a substrate of Dublin Calp limestone (the bedrock which underlies Dublin City and environs). This suggests these bricks were made in or close to Dublin City. The bricks also contain black, glassy, vitrified over-fired zones. The medium-grained lime-rich mortars contain poorly-sorted sub-rounded coarse (<5mm \varnothing) predominantly limestone aggregate, coarse crushed brick (1-4mm \varnothing) probably added as a pozzolan, and irregular lime lumps c.2mm \varnothing extending to >5mm in places indicating poor-quality mixing and craftsmanship.

Fig.4.1.2: The internal party wall contains clamp-fired brick laid in thick beds of lime-based mortar. The hand-made brick contains coarse limestone inclusions and black over-fired vitrified zones.

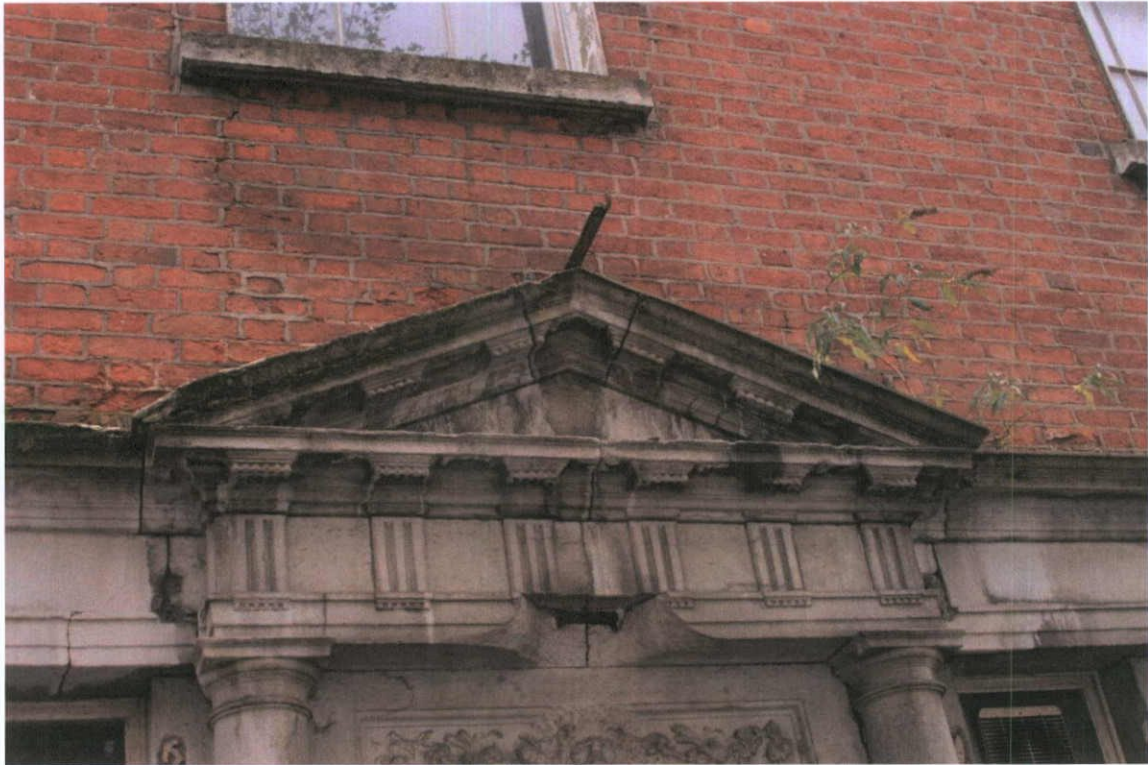
Fig.4.3.2: The red facing brick is laid in Flemish bond and has been repointed throughout in a Portland Cement-based mortar. The repointing is failing (losing bond) in areas of saturation, and loss of the surface of the brick is evidence in many areas.

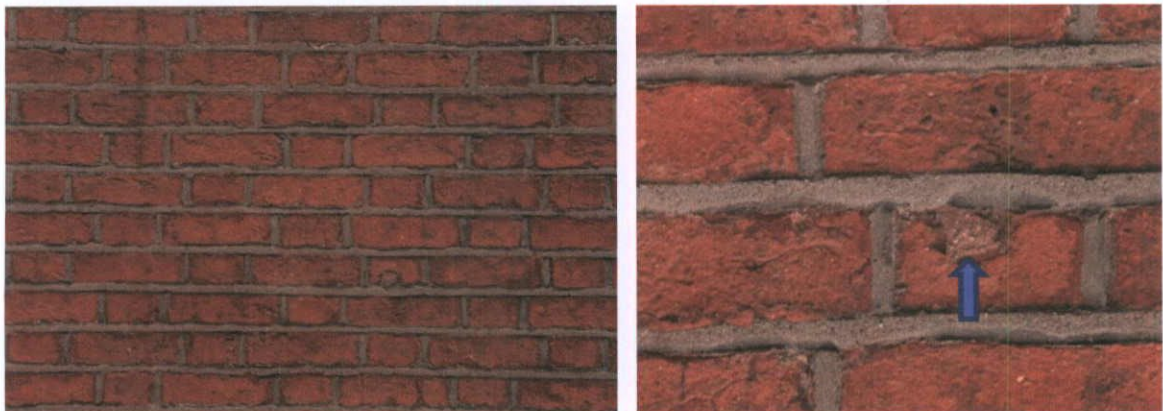
Fig.4.3.3: Repointed eighteenth-century brickwork with probably coloured Portland Cement repair (arrowed). Where the repointing mortar has failed, the underlying lime bedding mortar is exposed along with the brick core.

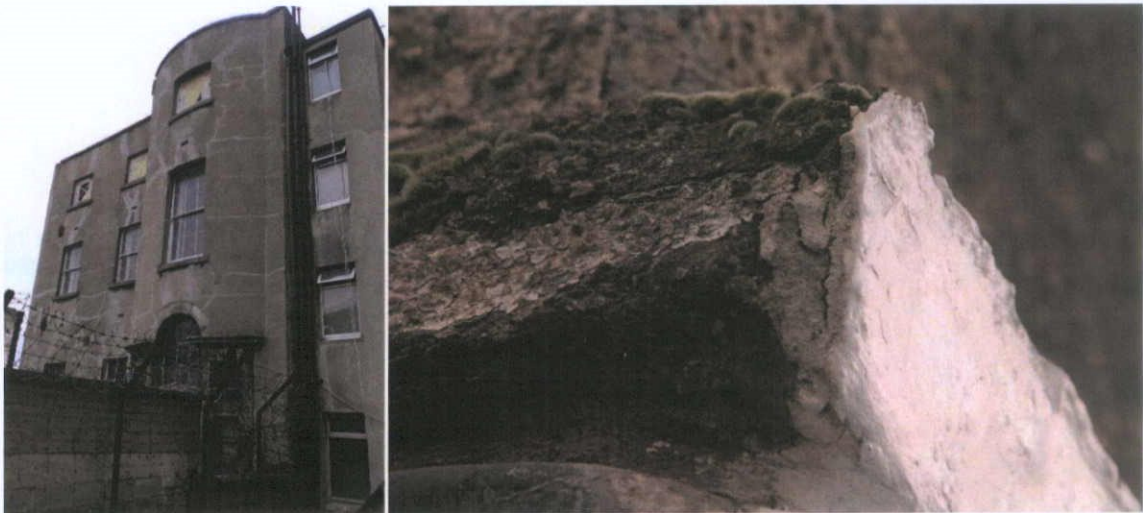
Fig.4.3.13: The rear retains a tripartite arched window in the curving bay, mirroring the treatment of the main door. The rear has been re-rendered throughout in a Portland Cement-based mortar.

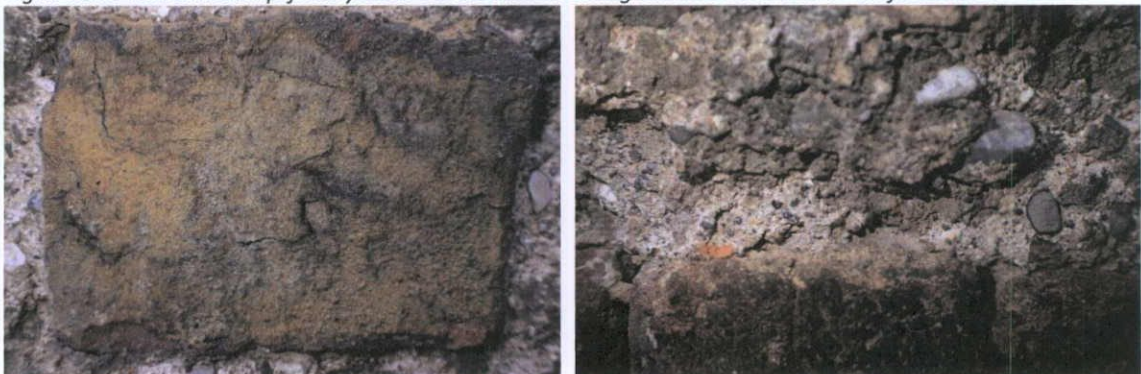
Fig.4.4.6: Clamp-fired yellow stock brick showing shrinkage cracks and over-burnt edges; laid in a coarse-grained lime mortar of rounded limestone pebbles with angular chert and quartzite and crushed brick pozzolan added.

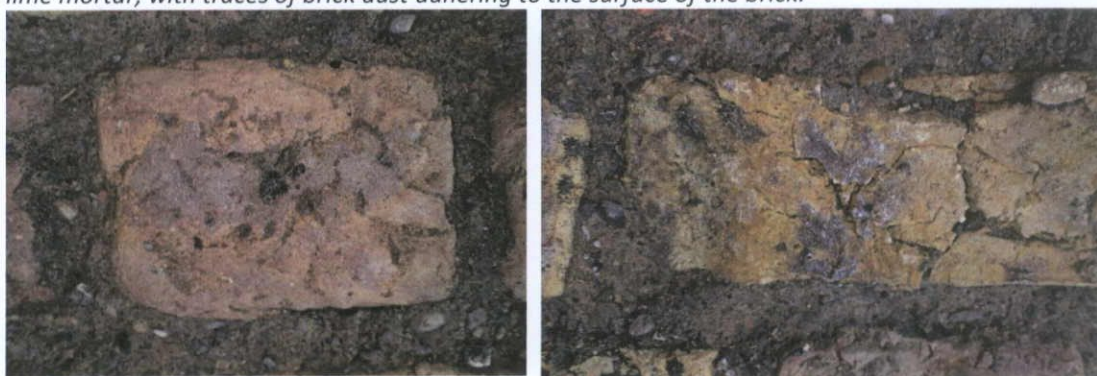
Fig.5.2.5: Stretcher and header views of yellow-pink stock brick with shrinkage cracks laid in coarse-grained pozzolanic lime mortar.

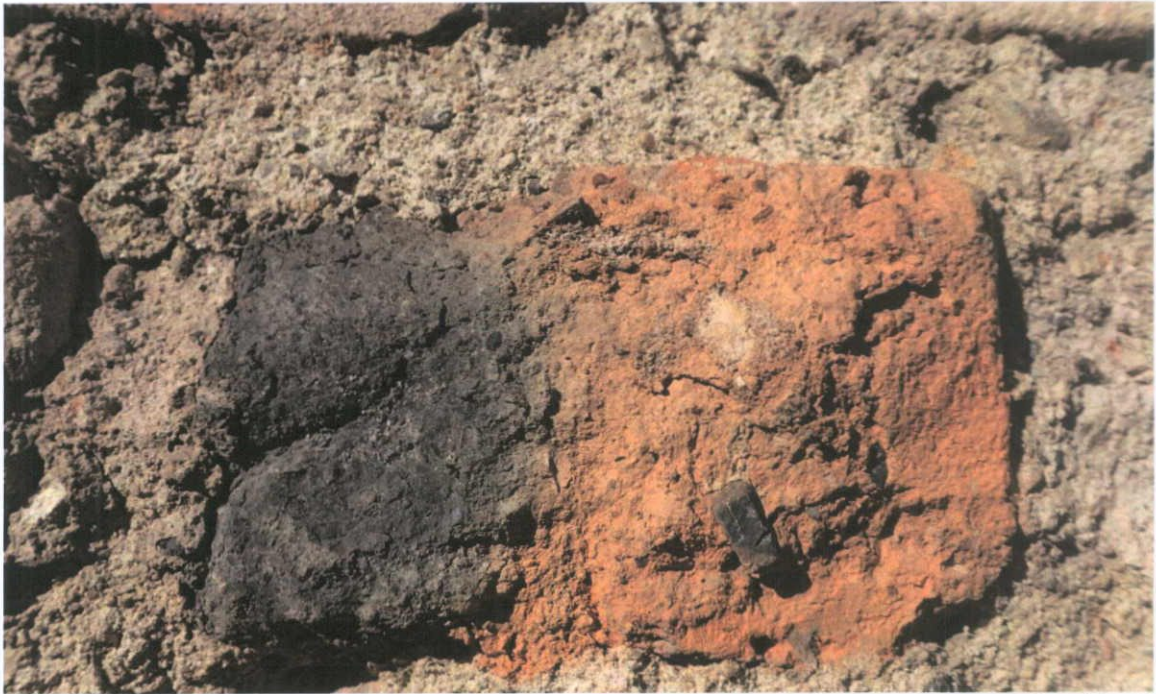
Fig.5.3.19: Partially overburnt clamp fired brick with angular limestone inclusions, some partially calcined.

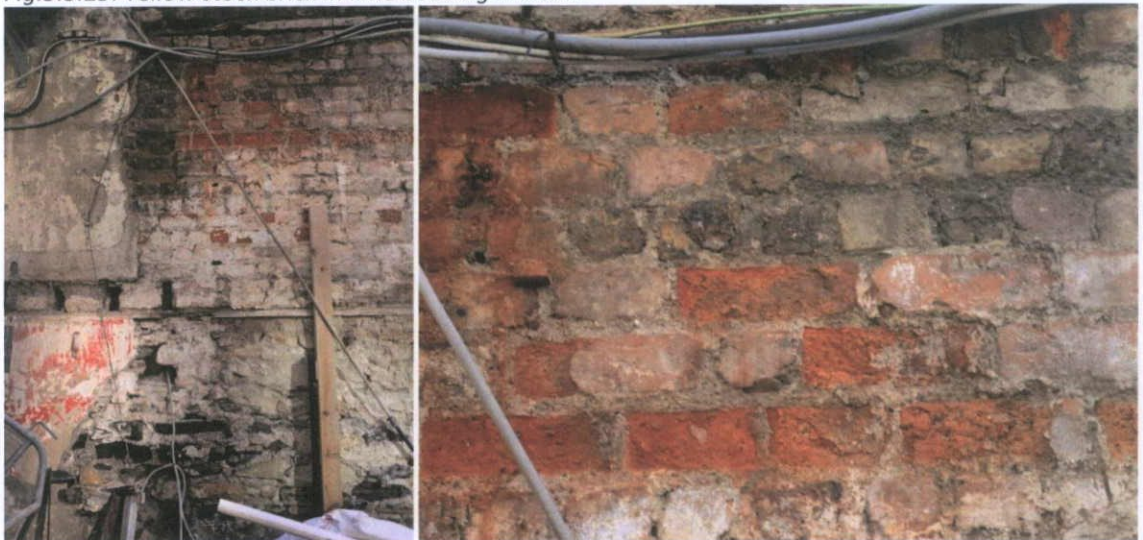
Fig.5.3.26: The red stock brick, in poor condition with the fireskin lost in many places, and the lower section of Calp limestone masonry also visible (left, bottom).

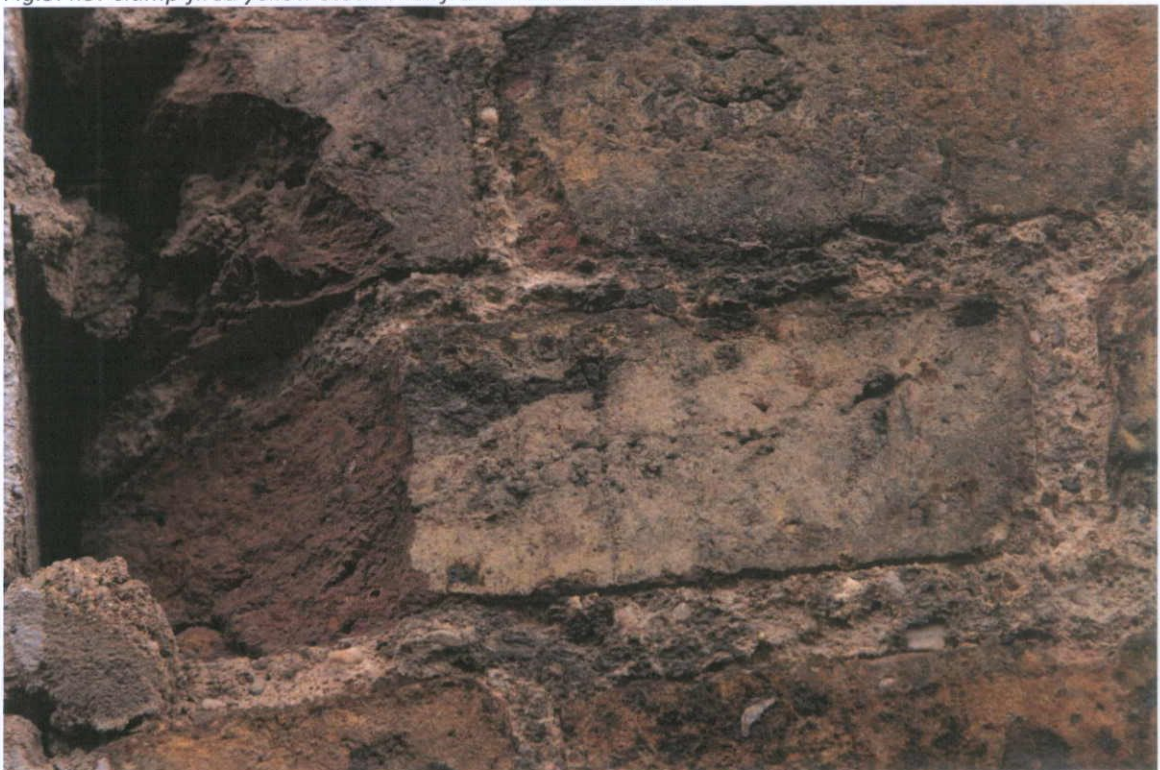
Fig.5.4.6: The yellow colour is confined to the surface, with a spall revealing the red brick core.

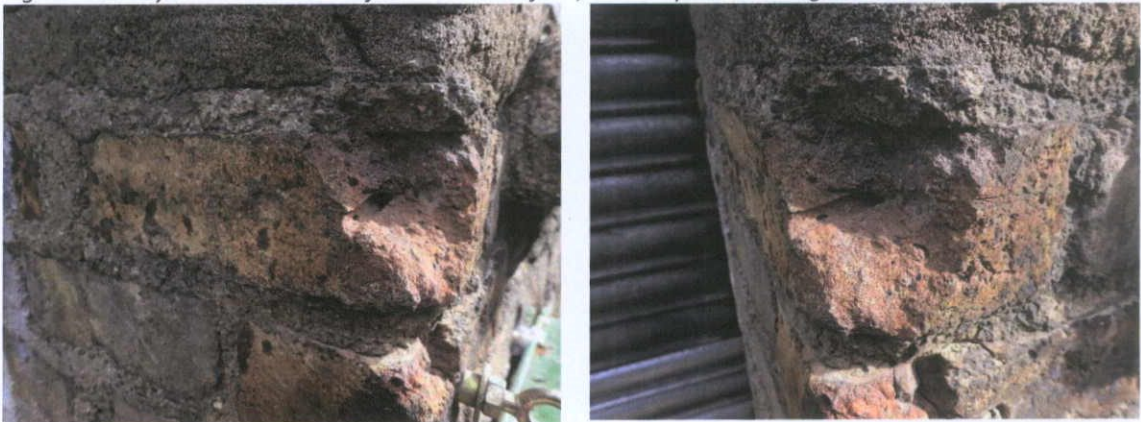
Fig.5.4.7: Groove in the brick jamb; said to be from a bullet during the 1916 Easter Rising.

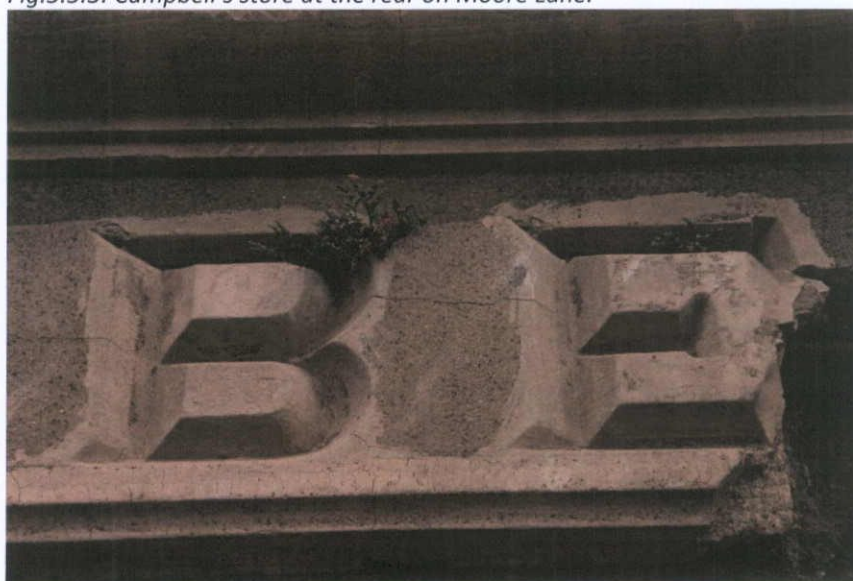
Fig.5.5.4: Detail of stucco signage.

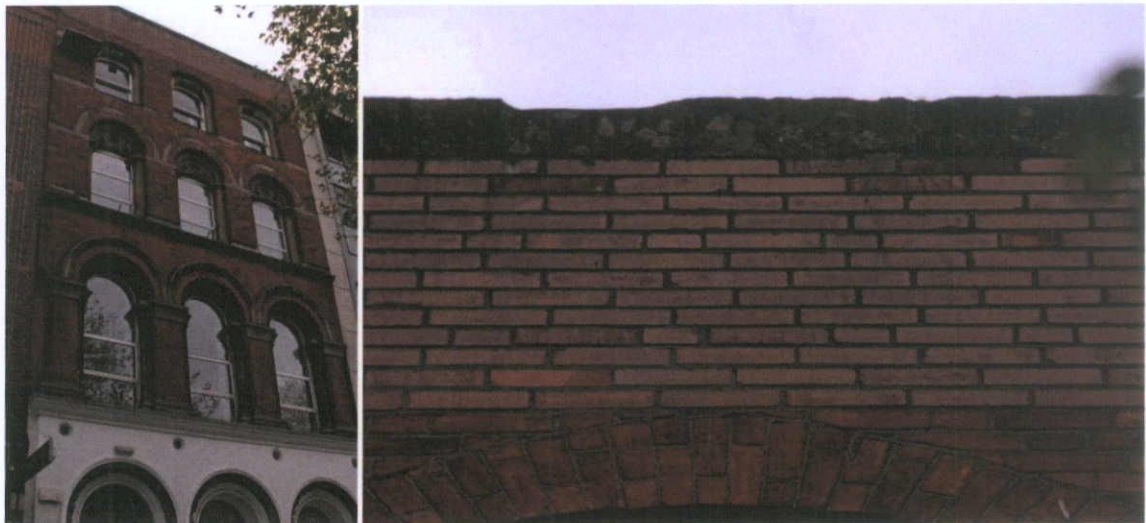
Fig.5.7.1: Façade of 60 O'Connell Street with a detail showing the more recent mid-to late twentieth century brick at parapet level; with repointed nineteenth century brickwork seen below.
