Interior – Ground Floor – Retail**Unit 2 – Fortune Terrace Restaurant****Outline of unit**

Unit 2 is the largest of the ground floor retail units. It houses The Fortune Terrace restaurant which also occupies the first floor of the building. The ground floor of the restaurant holds a front reception area, male, female and accessible WC's, security room, main dining area and ground floor kitchen. There is an emergency exit at the rear of the restaurant that leads out to the ground floor car park. There is a laminate floor to the front of the shop and a tiled floor to the rear. There are modern plaster finishes to the concrete walls, plasterboard ceiling finishes, and a number of light-weight partitions throughout, as well as a dumbwaiter within a lift shaft.

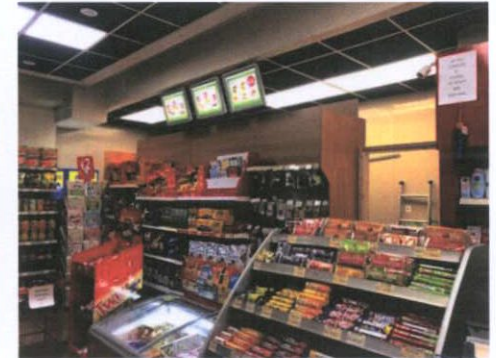
Plate 44: Damage to ceiling in main retail space

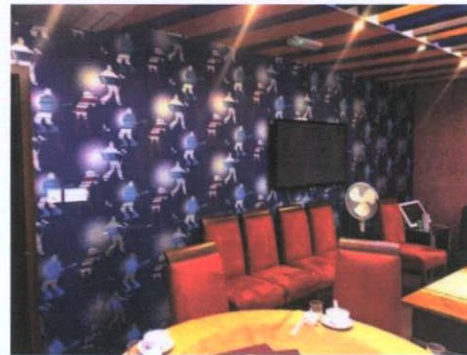
Plate 120: Air Conditioning unit blocked by partition wall

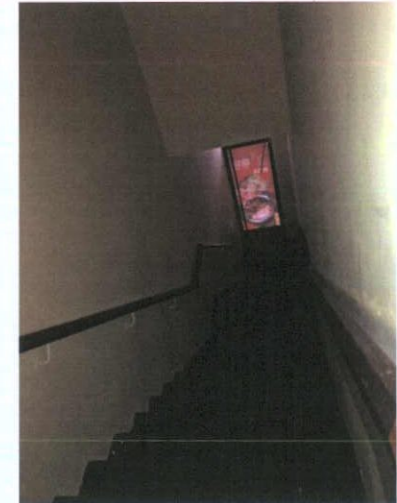
Plate 138: Damage to lighting in fire exit staircase

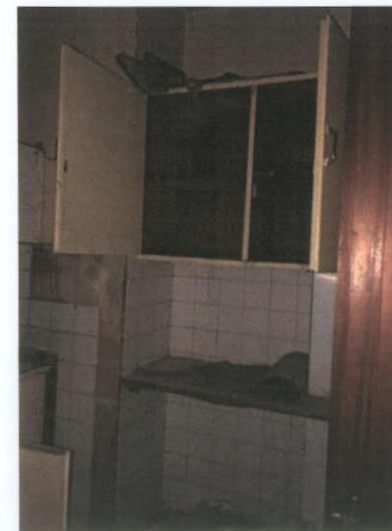
Plate 296: Damage to ceiling of kitchenette

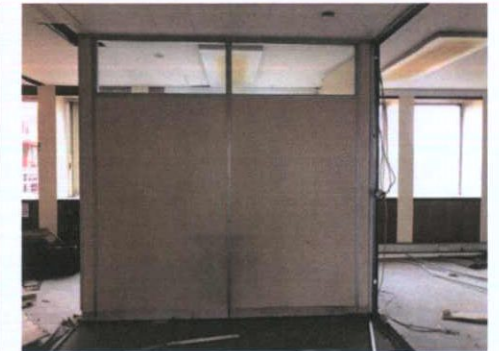
Plate 338: South wall showing damaged partition

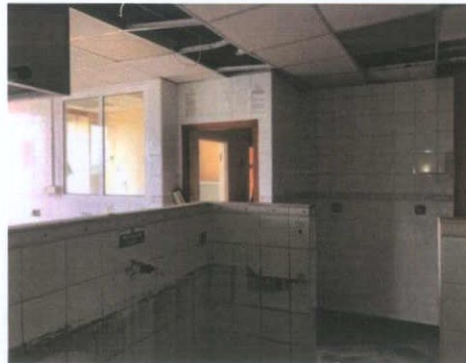
Substantial amount of damage. Roof leaking.

Plate 400: Rot due to leaking roof

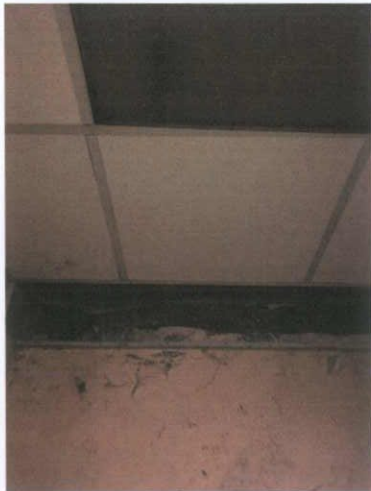
Plate 414: Room 3 — East wall alcove damage

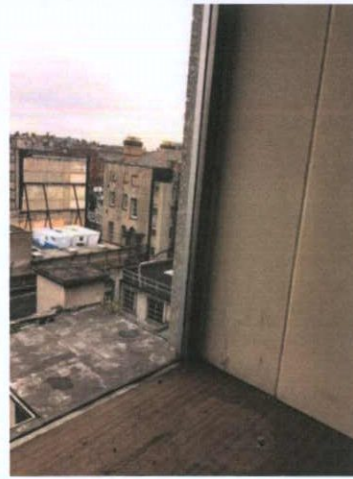
Plate 423: Room 7 — Rot on floor

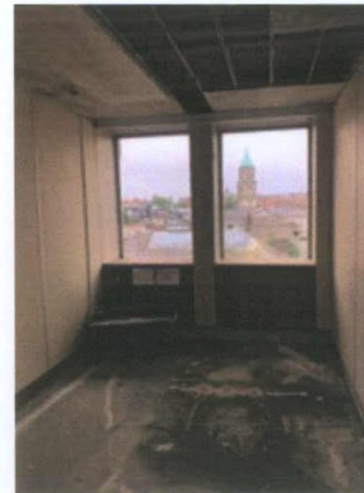
Plate 432: Room 8 — Water leaking through ceiling

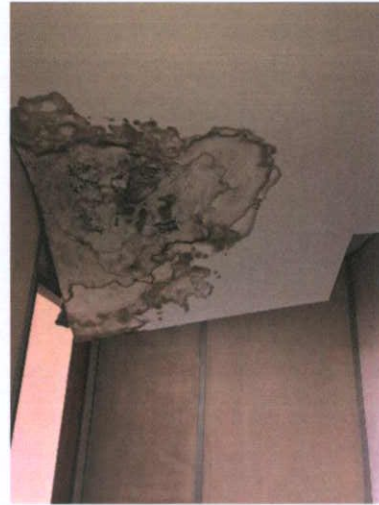
Plate 451: Damage to ceiling in secondary hallway

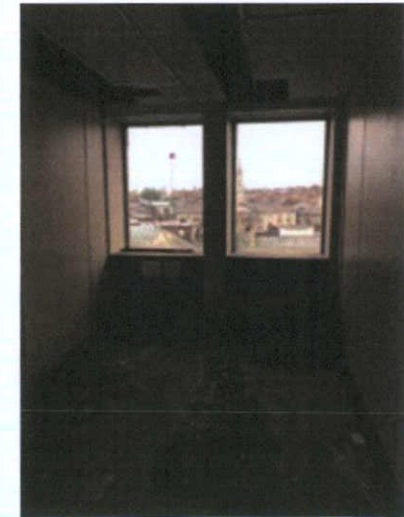
Plate 457: Room 12 — Roof leaking into room

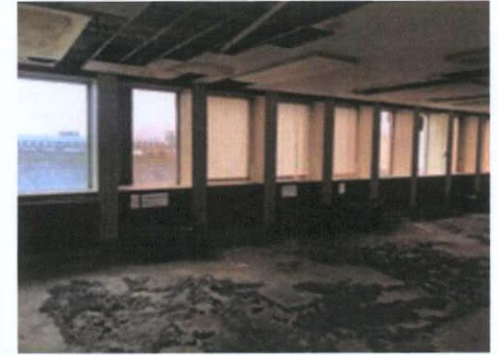
Plate 469: Room 15 — Damage to east wall

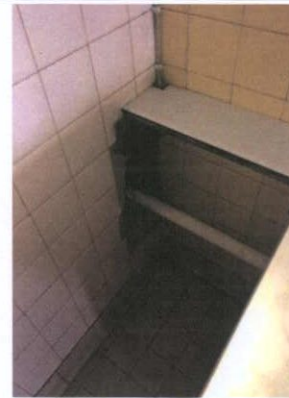
Plate 476: Room 16 — Floor covered in rot
