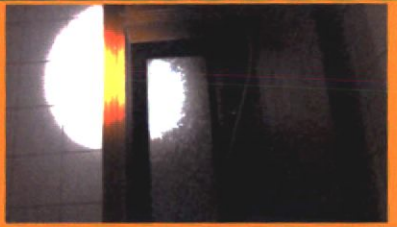
| Ref No. | Building | Location or Functional Space | Sample No. | Material Description, surface treatment and condition | Extent | Asbestos identified (presumed, strongly presumed or identified) | Product type | Condition | Surface treatment | Asbestos type | Material assessment score | Recommendations | Photo |
|---|--|---|---|---|---|---|---|---|---|---|---|---|---|
| 109 | Fingal Co. Co. Office and Carpark Chinese Restaurant | 2 <sup>nd</sup> floor Gents WC | | Woven rope gaskets to air handling duct | | Chrysotile | 2 | 1 | 1 | 1 | 5 | Removal and disposal as asbestos waste by a competent contractor prior to work likely to cause disturbance. | |
