Refurbishment & Demolition Asbestos Survey

Location: *No. 57 O'Connell Street (Carrolls)
Dublin 1*

Client: *Dublin Central GP Ltd*

Survey Date: *October, 2020*

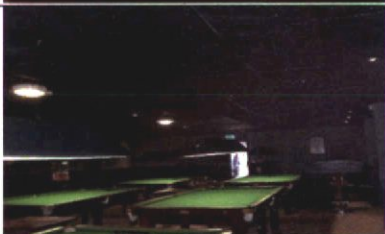
42	No. 43 O'Connell St. Ned Kellys	Ground floor Snooker room				No visible asbestos containing materials identified.

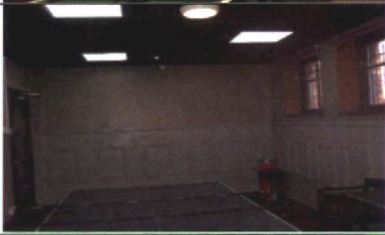
43	No. 43 O'Connell St. Ned Kellys	1 st floor Front room				No visible asbestos containing materials identified.
