Refurbishment Demolition Asbestos Survey

Site Address: Derryarkin
Co. Offaly

Date: 14th December 2020

Survey No.: 2011031

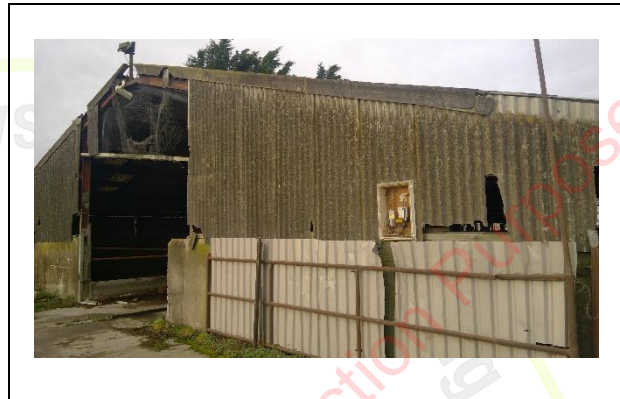
Survey No.	2011031
Survey Type	RDAS
Survey Date	23/11/20
Surveyor	Neal Christopher
Client Name	Oxygen Environmental
Site Address	Farm buildings Derryarkin Co. Offaly
Location	Main shed roof
Sample Range	2011031-01

Product type	Asbestos Cement sheeting	Score	1
Extent of damage/deterioration	Low damage	Score	1
Surface treatment	AC products	Score	1
Asbestos type	Chrysotile	Score	1
		Total	4

The Asbestos Cement sheeting, located on the roof and gable ends of the main shed, contains Chrysotile asbestos. The sheeting has a low level of damage and poses a very low risk. The AC sheeting should be removed by a competent asbestos contractor prior to demolition works. The resulting waste should be disposed of as 'Asbestos Waste' at a licensed facility. On completion of the works a Certificate of Reoccupation should be issued by an independent asbestos analyst.

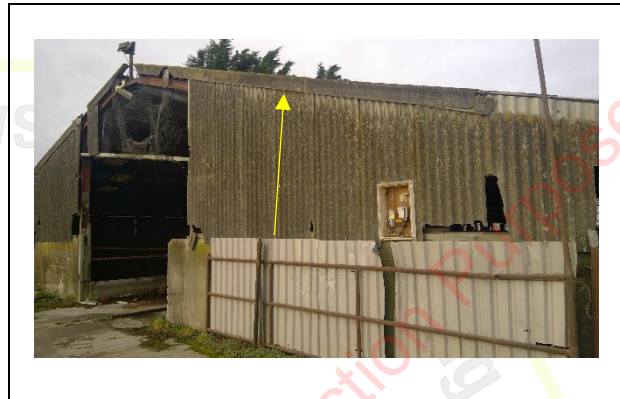
Survey No.	2011031
Survey Type	RDAS
Survey Date	23/11/20
Surveyor	Neal Christopher
Client Name	Oxygen Environmental
Site Address	Farm buildings Derryarkin Co. Offaly
Location	Main shed roof
Sample Range	2011031-02

Product type	Asbestos Cement ridge cappings	Score	1
Extent of damage/deterioration	Low damage	Score	1
Surface treatment	AC products	Score	1
Asbestos type	Chrysotile	Score	1
		Total	4

The Asbestos Cement ridge cappings, located on the gable ends of the main shed, contains Chrysotile asbestos. The ridge cappings have a low level of damage and pose a very low risk. The AC ridge cappings should be removed by a competent asbestos contractor prior to demolition works. The resulting waste should be disposed of as 'Asbestos Waste' at a licensed facility. On completion of the works a Certificate of Reoccupation should be issued by an independent asbestos analyst.

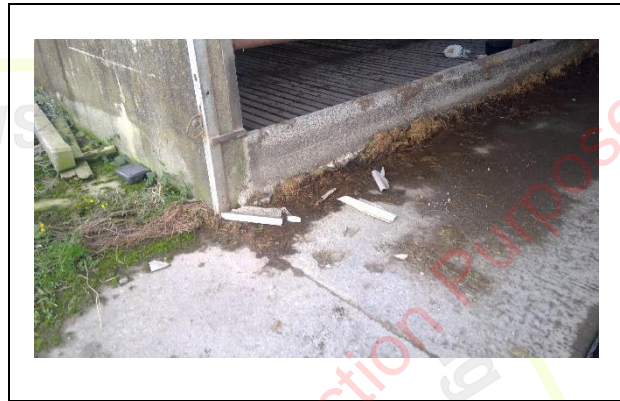
Survey No.	2011031
Survey Type	RDAS
Survey Date	23/11/20
Surveyor	Neal Christopher
Client Name	Oxygen Environmental
Site Address	Farm buildings Derryarkin Co. Offaly
Location	Main shed surround
Sample Range

Product type	Asbestos Cement debris	Score	1
Extent of damage/deterioration	High damage	Score	3
Surface treatment	AC products	Score	1
Asbestos type	Strongly Presumed Asbestos	Score	3
		Total	8

The Asbestos Cement debris, surrounding the main shed, is strongly presumed to contain asbestos. The debris has a high level of damage and poses a medium risk. The AC debris should be removed by a competent asbestos contractor prior to demolition works. The resulting waste should be disposed of as 'Asbestos Waste' at a licensed facility. On completion of the works a Certificate of Reoccupation should be issued by an independent asbestos analyst.

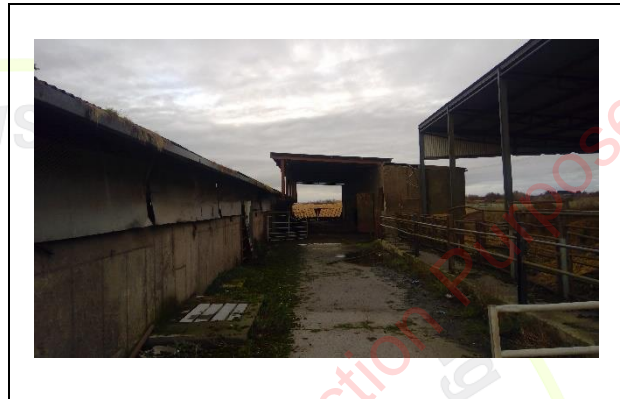
Survey No.	2011031
Survey Type	RDAS
Survey Date	23/11/20
Surveyor	Neal Christopher
Client Name	Oxygen Environmental
Site Address	Farm buildings Derryarkin Co. Offaly
Location	Shed 2
Sample Range	2011031-03

Product type	Asbestos Cement sheeting	Score	1
Extent of damage/deterioration	Low damage	Score	1
Surface treatment	AC products	Score	1
Asbestos type	Chrysotile	Score	1
		Total	4

The Asbestos Cement sheeting, located on the roof of shed 2, contains Chrysotile asbestos. The sheeting has a low level of damage and poses a very low risk. The AC sheeting should be removed by a competent asbestos contractor prior to demolition works. The resulting waste should be disposed of as 'Asbestos Waste' at a licensed facility. On completion of the works a Certificate of Reoccupation should be issued by an independent asbestos analyst.

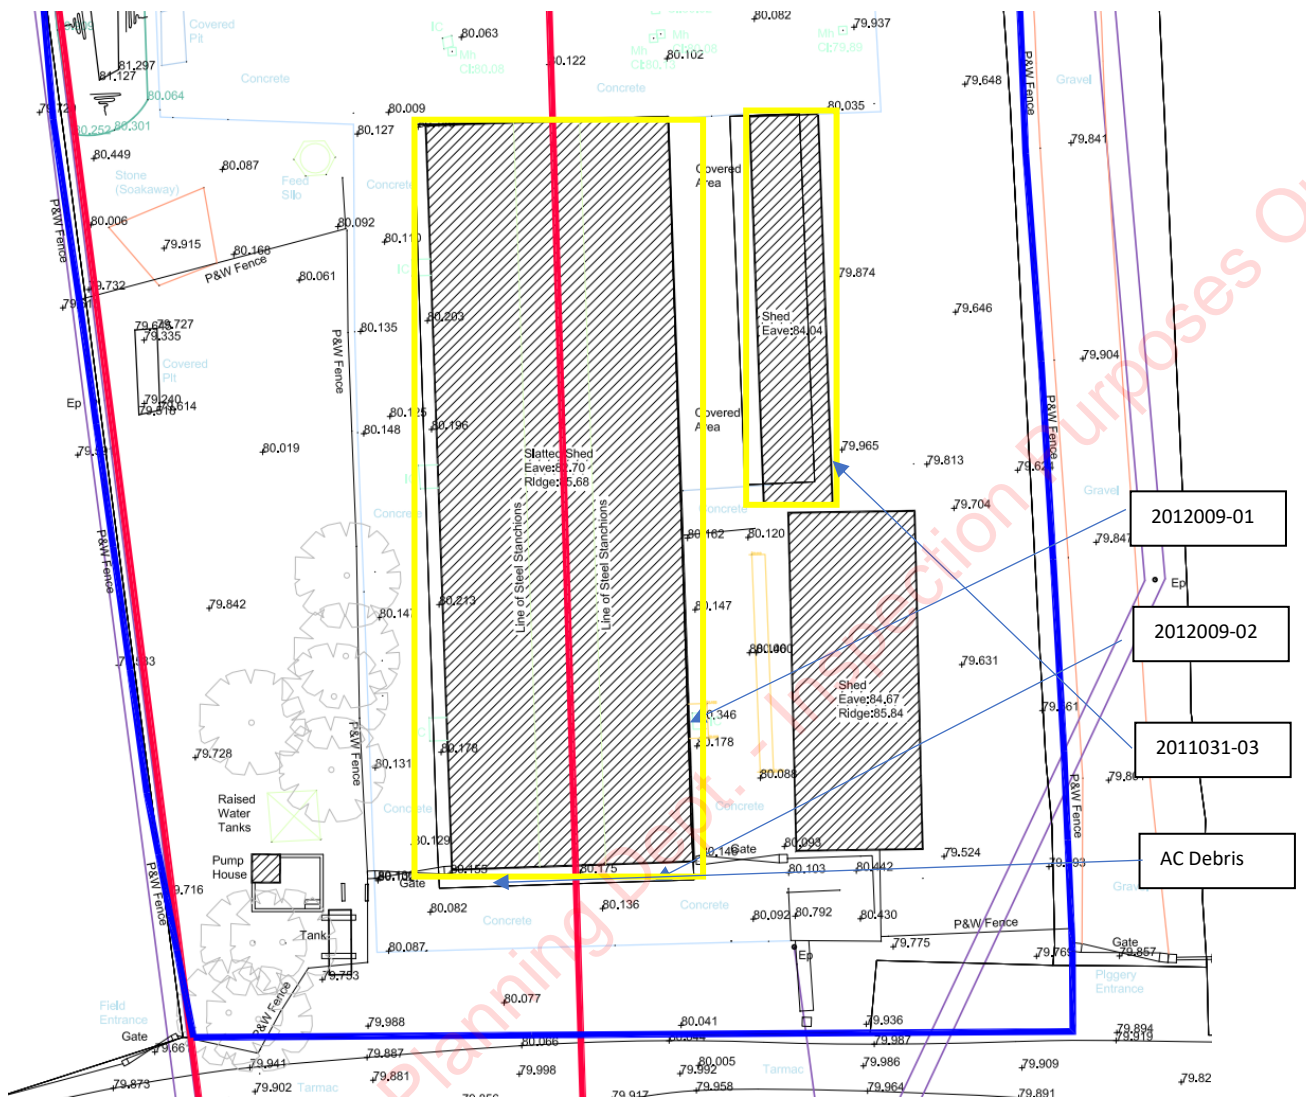
ACMs marked in yellow

The Asbestos Cement sheeting, ridge cappings and debris, located on the main shed and shed 2, contains Chrysotile asbestos. The ACMs should be removed by a competent asbestos contractor prior to demolition works. The resulting waste should be disposed of as 'Asbestos Waste' at a licensed facility. On completion of the works a Certificate of Reoccupation should be issued by an independent asbestos analyst.
