**TREE SURVEY REPORT**

**WESTGATE, DROGHEDA**

**M. LARGE TREE SERVICES LTD.**

LOUTH COUNTY COUNCIL

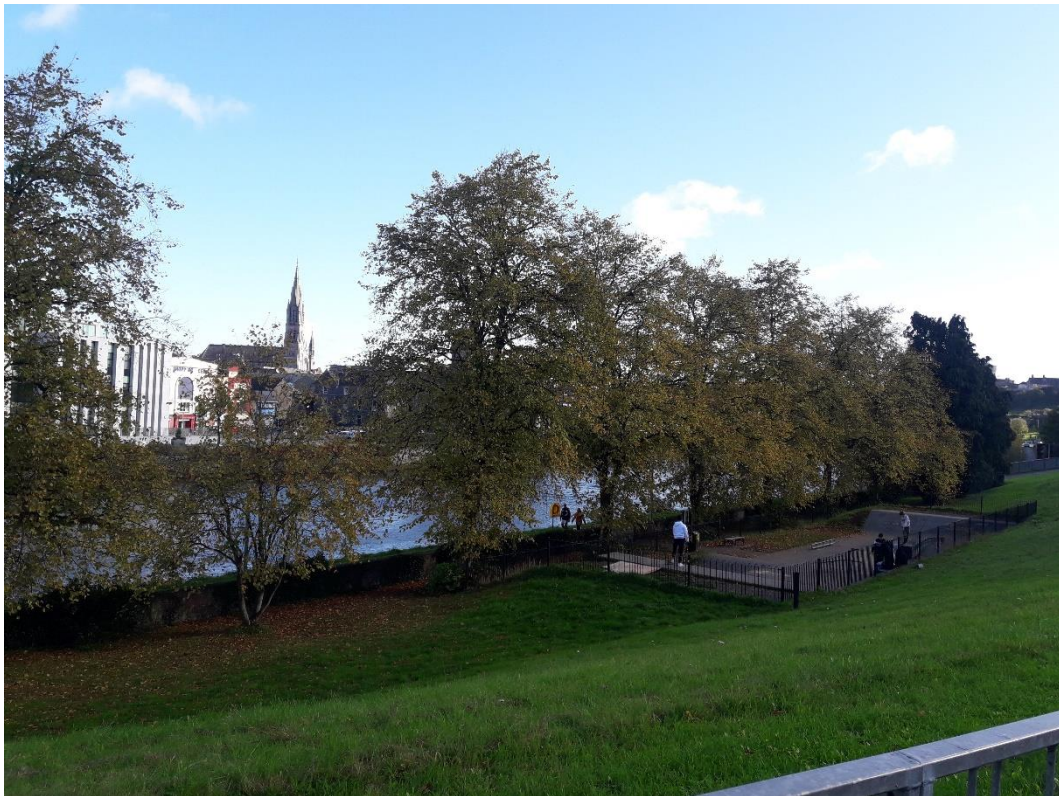
*Photograph 1: An overview of trees 16 (right) to 25.*

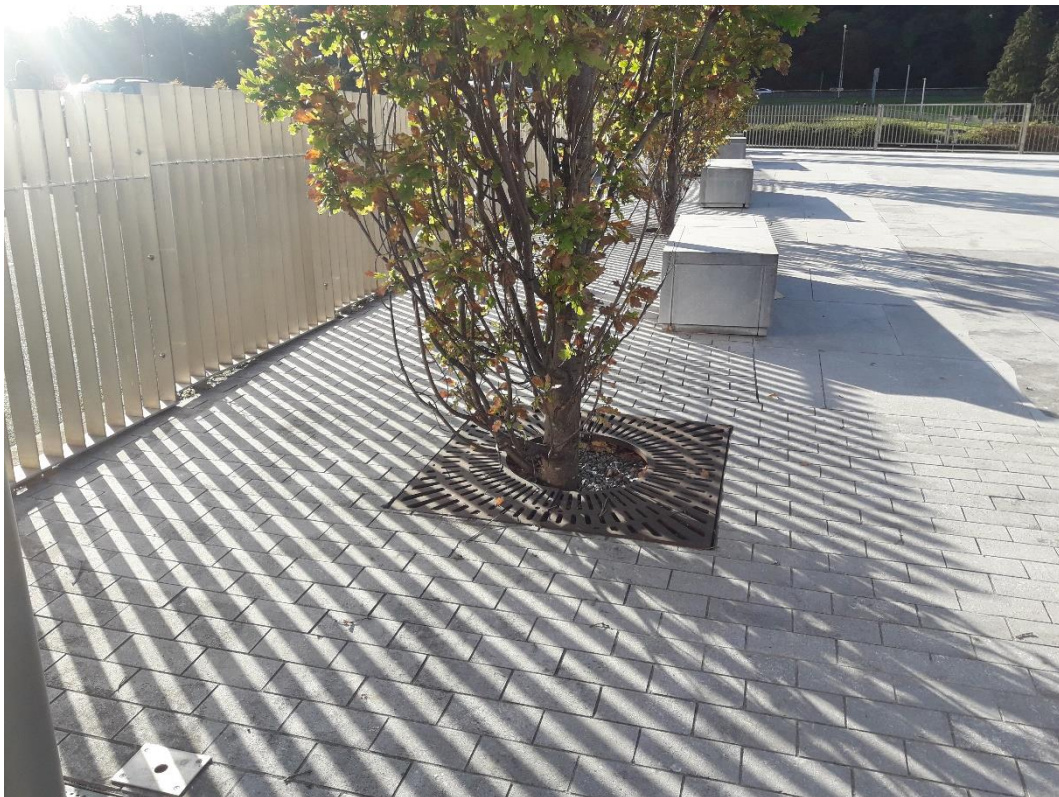
Many trees are growing close to paths, roads, and other hard surfaces. These surfaces act as a barrier to root development and trees affected should be monitored for any loss of vigour. In addition, damage may be caused by the weight of vehicles to any roots that have grown under these surfaces. Root growth may even cause damage to the surfaces, potentially creating a risk to the public or vehicles. In all cases, regular monitoring is required to identify potential problems as early as possible.

*Photograph 2: The base of tree 1 growing within a hard, paved surface.*

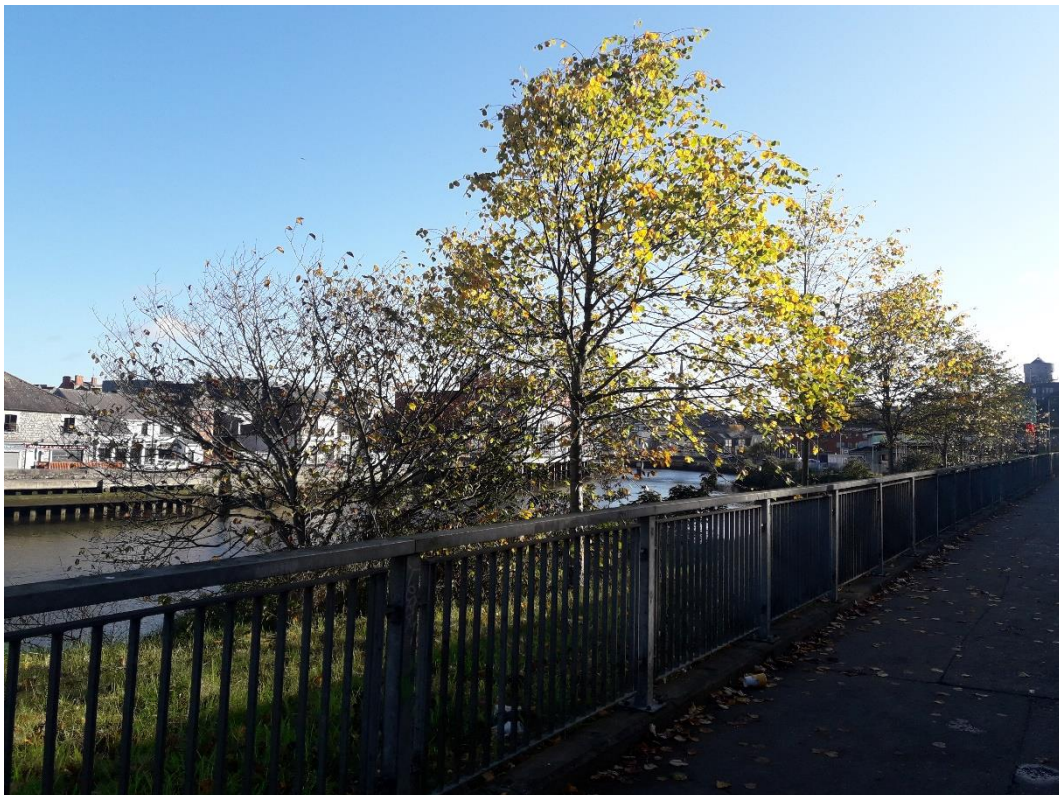
The term “reduce endweight to balance crown” is used where a tree has more branching in one direction, causing it to become unbalanced. Whilst an unbalanced crown is not necessarily an immediate problem, uneven weighting in a tree can increase the likelihood of wind-throw. The shortest “extent” of each crown-spread should be taken as a guide and the remaining branches pruned close to that length.

*Photograph 3: Note how number 10 (right) is becoming slightly unbalanced due to suppression from the tree.*

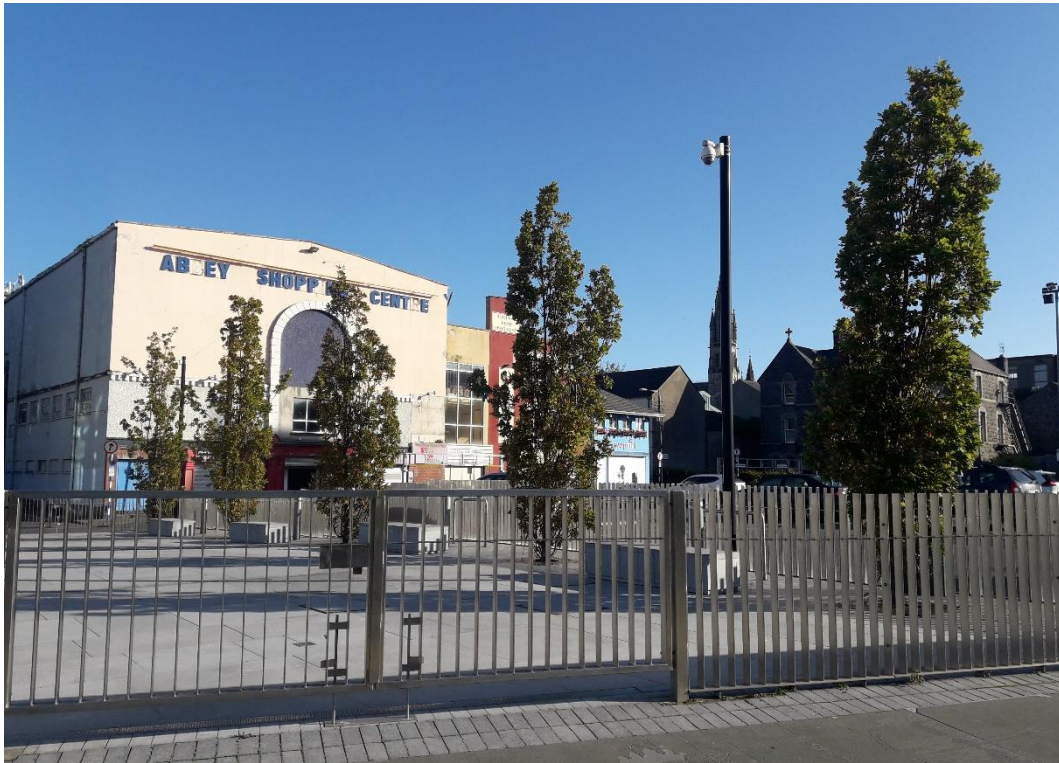
*Photograph 4: An overview of trees 1-5 (left to right).*

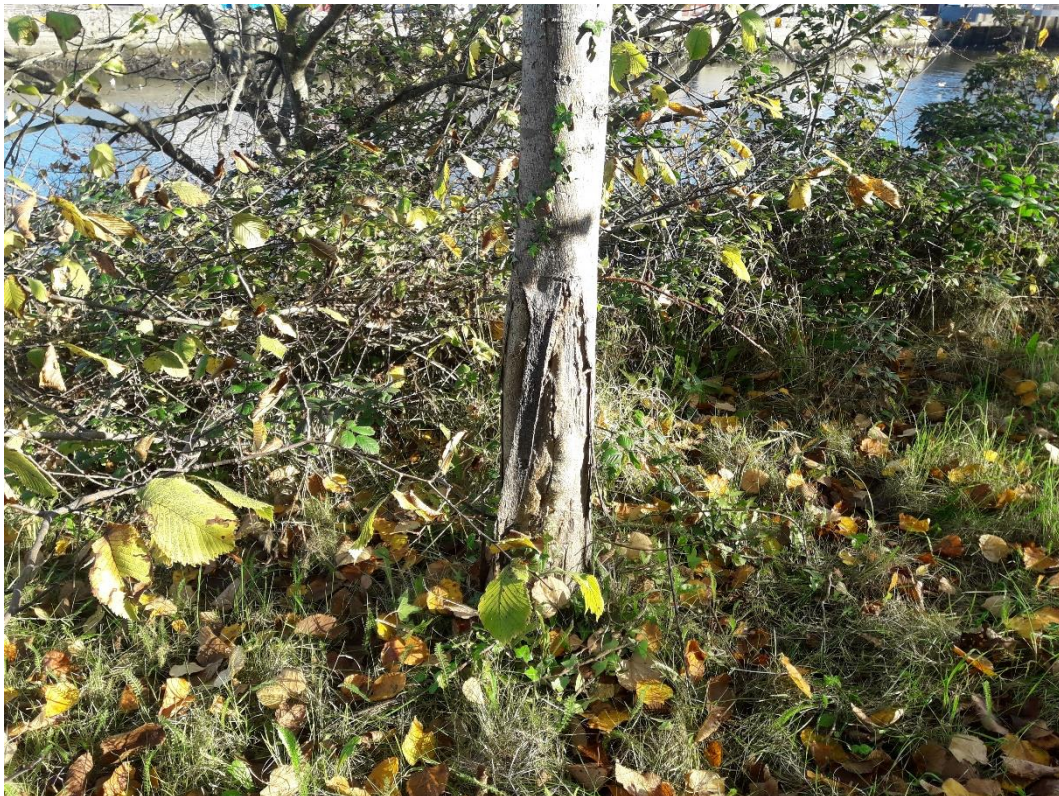
*Photograph 5: Minor damage at the base of tree 10. This type of wounding is unlikely to have long term detrimental effects of the tree.*

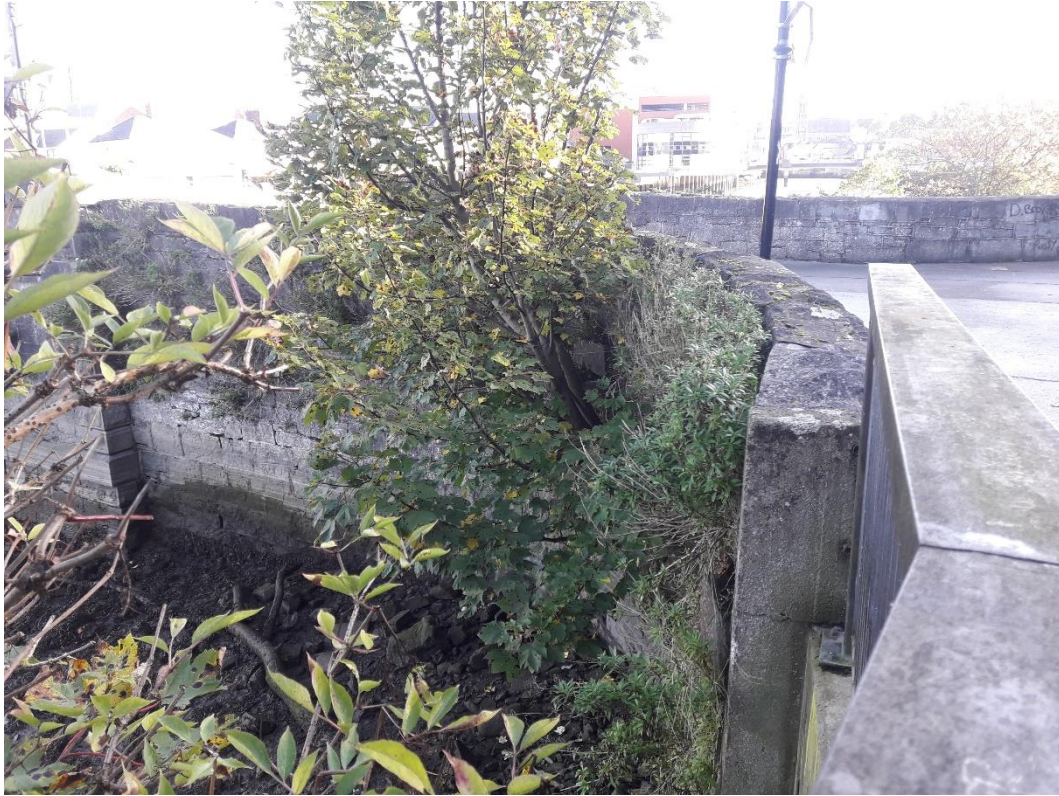
*Photograph 6: Tree 12, growing from the wall of the bridge.*

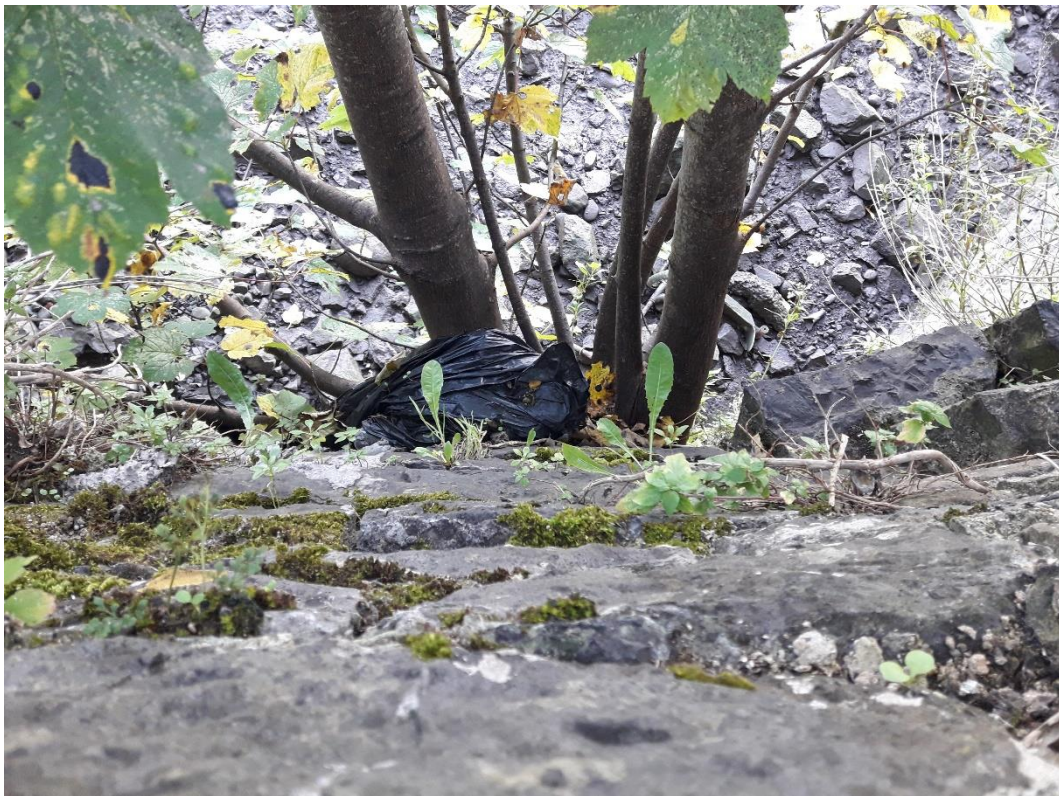
*Photograph 7: As they expand, the roots of tree 12 will push and weaken the structural integrity of the wall.*

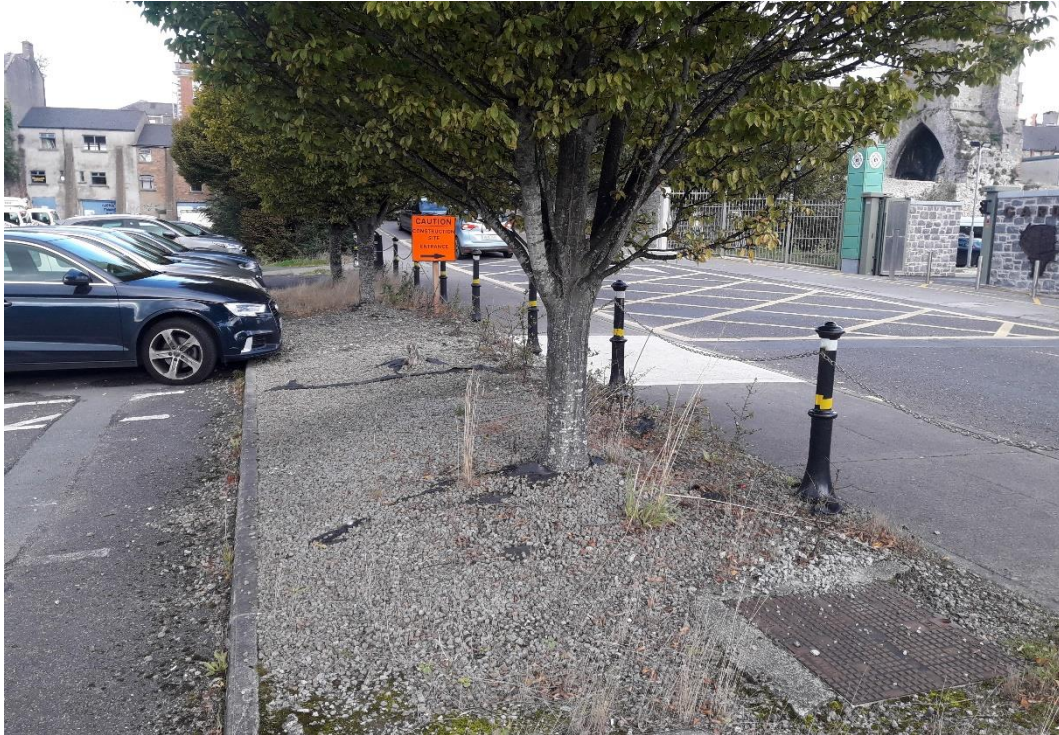
*Photograph 8: The base of tree 31. Note close proximity of the carpark and the pavement/road. These surfaces will affect the growth and development of the roots.*

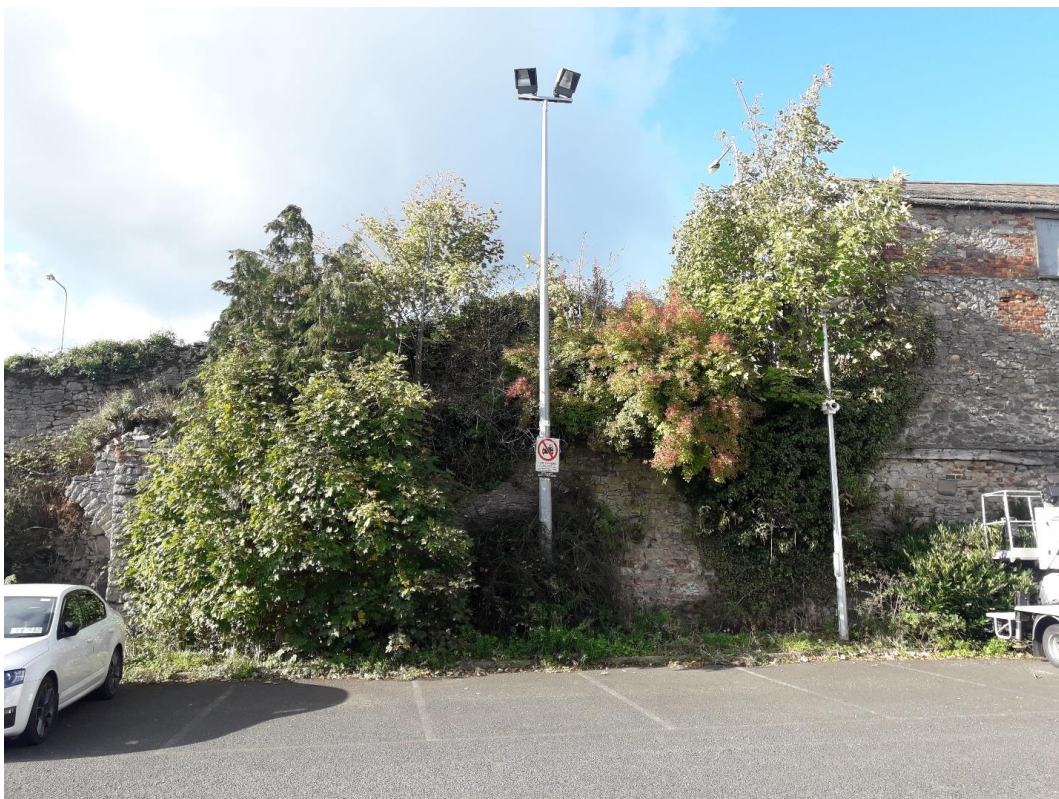
*Photograph 9: Group 38. These self-seeded trees are growing on top of (or at the base of) the old stone wall. As with tree 12, the root systems are unlikely to fully develop, resulting in the failure of the trees, and the weakening of the wall.*
