Cush Wind Farm

## Annex 13.1: Road Safety Audit

Cush Wind Farm, Co. Offaly

Stage 1 Road Safety Audit

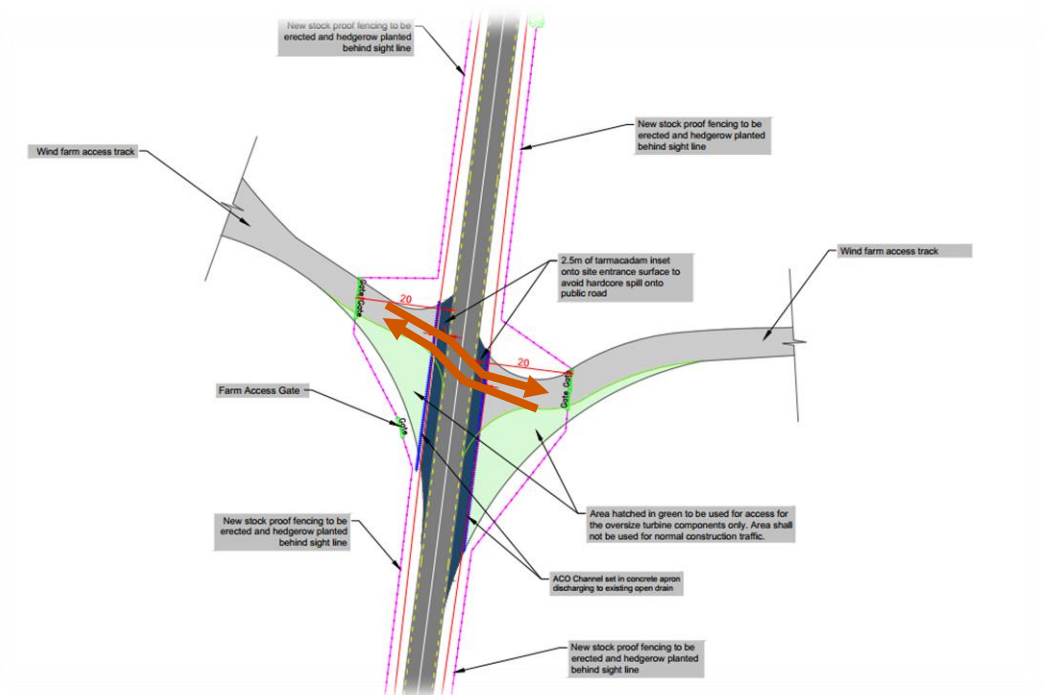
Figure 2.1 – Construction Site Entrance Stagger

Location: Temporary Construction Site Entrances

The partial stagger setup of the construction site entrances may increase the risk of the occurrence of opposition conflicts between the traffic streams at the entrances.

The stagger of the construction site entrances should be increased or alternatively the entrance be fully aligned.

2.2	YES	YES	The eastern entrance shall be shifted north so that entrances are fully aligned.	
2.3	YES	YES	The access tracks to be constructed so that the first 20meters will have a maximum gradient of 1%.

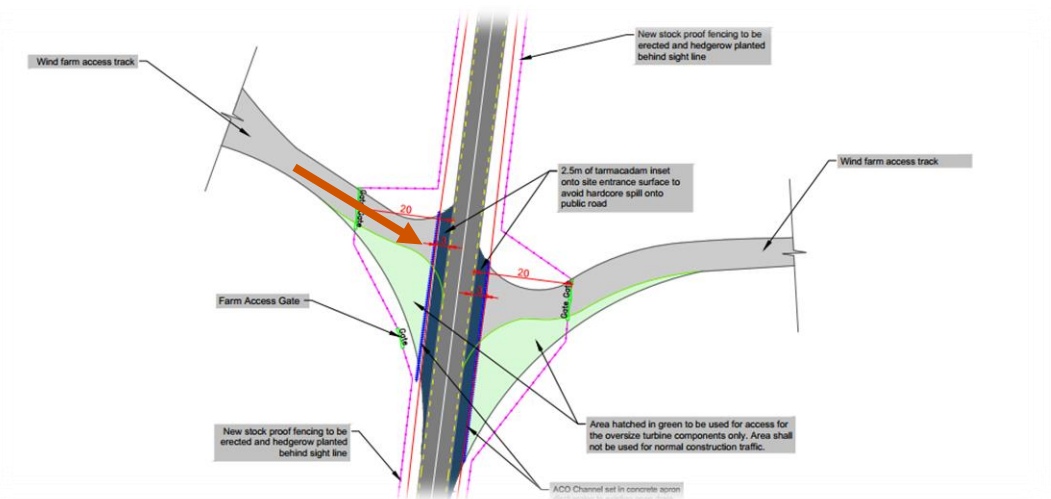
Figure 2.2 – Construction Site Access Track Approach Gradient

Location: Temporary Construction Site Entrances

A steep existing approach gradient on the western construction access track may lead to vehicle stalls on the mainline or vehicles over-shooting the junction onto the mainline resulting in vehicle conflicts.

An appropriate dwell area should be provided on the construction access track approach to the mainline.

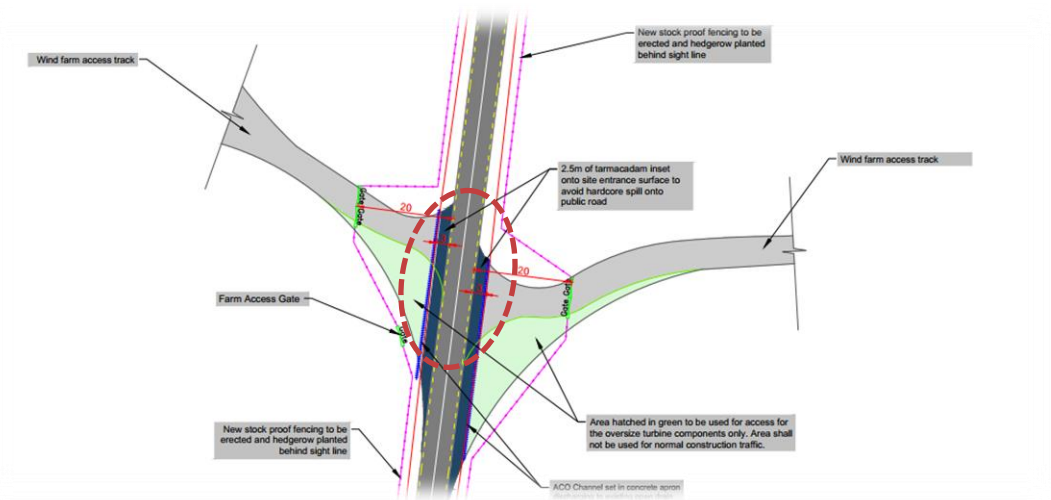
Figure 2.3 – Granular Material / Detritus Deposited on Carriageway

Location: Temporary Construction Site Entrances

Granular material / detritus from construction vehicles wheels may be deposited on the mainline carriageway impacting the safe operation of the national road.

A suitable wheel washing facility should be provided to serve each of the construction site entrances.

2.4	YES	YES	A suitable wheel washing facility will be provided to serve each of the construction site entrances	
2.5	YES	YES	The pavement on the existing private road should will made good and maintained.

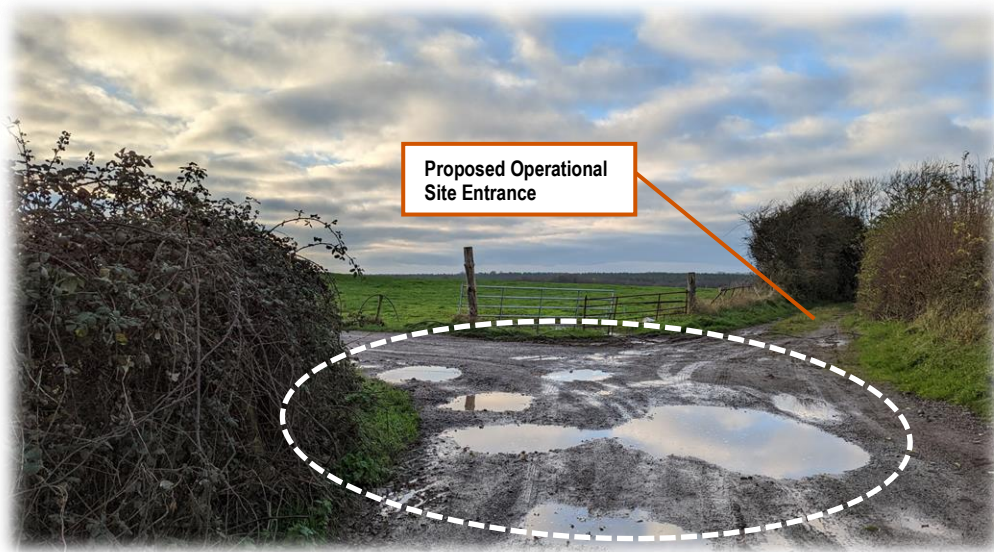
Figure 2.4 – Existing Failed Pavement

Location: Operational Site Entrance (East)

Heavy operational traffic may further damage the failed pavement on the private road leading to the occurrence of loss of control type collisions.

The pavement on the private road should be made good and maintained.

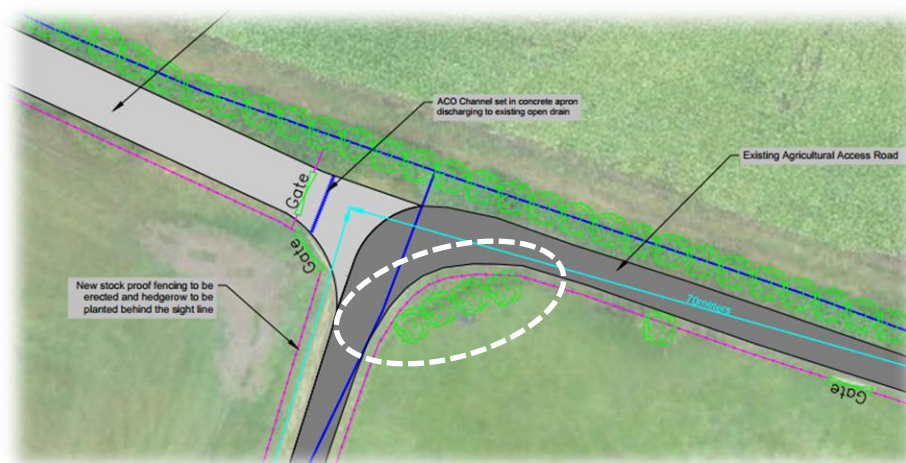
Figure 2.5 – Forward Visibility

Location: Operational Site Entrance (East)

The overgrown hedge at the bend on the private road may lead to forward visibility impact from the operational site entrance and the private road leading to vehicle conflicts.

The overgrown hedge on the private road should be lowered and maintained to ensure appropriate forward visibility is provided at the bend.

2.6	YES	YES	The overgrown hedge on the local road will be lowered and maintained to ensure appropriate forward visibility is provided at the bend.	
2.7	YES	YES	The entrance gates will be in-set an appropriate distance to ensure that the largest expected size operational vehicle can pull in completely off the local road.

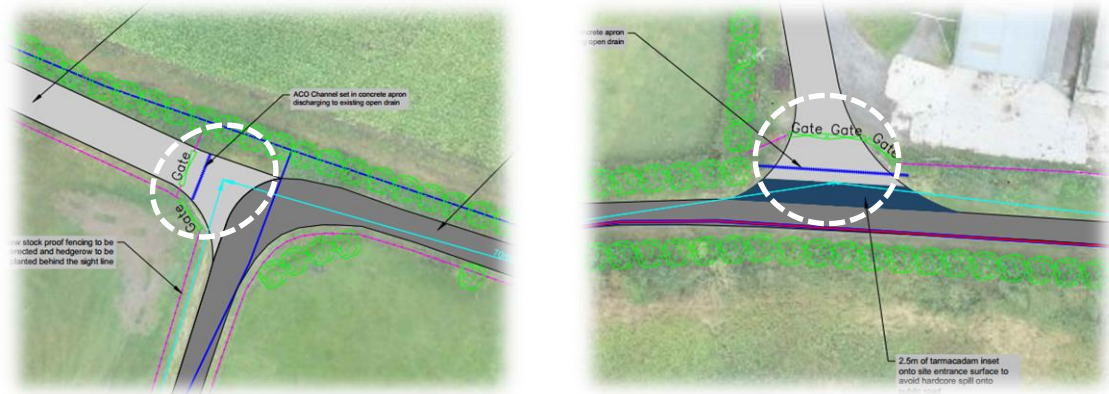
Figure 2.6 – Vehicles Blocking Road

Location: Operational Site Entrance (East) & Operational Site Entrance (West)

The gate setback may not be sufficient for large operational vehicles to pull in completely off the road leading to conflicts with approaching vehicles.

The gates should be in-set an appropriate distance to ensure that the largest expected size operational vehicle can pull in completely off the road.
